# Canterbury House Apartments Building #2 Foundation Assessment

310 Spartan Drive  
Slidell, Louisiana

May 10, 2024

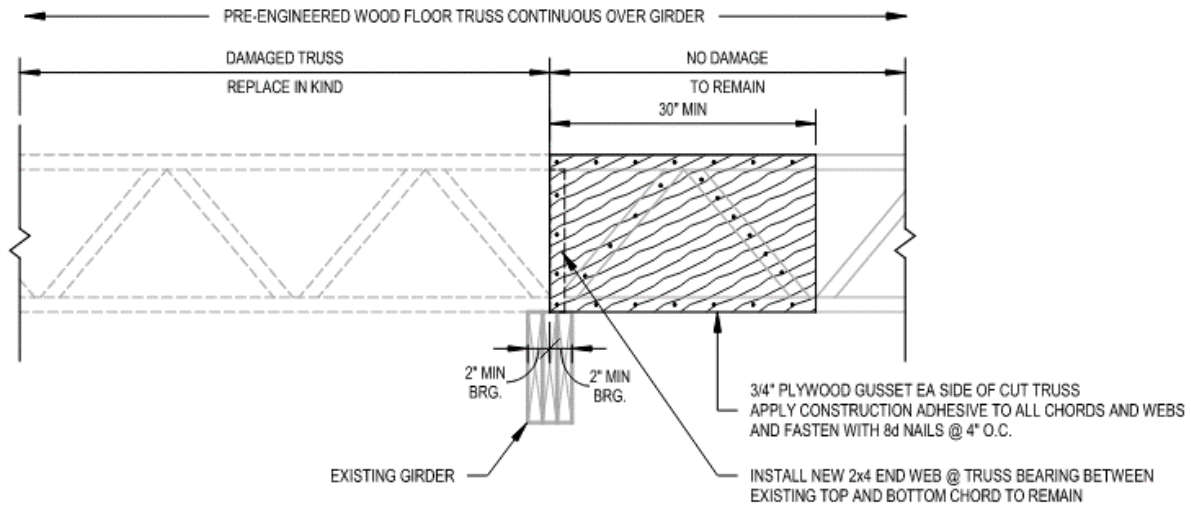
Observations by SE indicated widespread damage to truss top chords at the southwest corner of the building. An estimated 432 linear feet of floor trusses were fully compromised and in need of replacement. Where compromised, floor trusses shall be fully removed between girder supports and replaced with new pre-engineered wood floor trusses designed for a top chord dead load of 15 psf and a top chord live load of 40 psf. Follow Figure 1.0 where trusses are continuous, and damage is present at

only one side of the support. The General Contractor shall be responsible for all required temporary shoring to facilitate repairs.

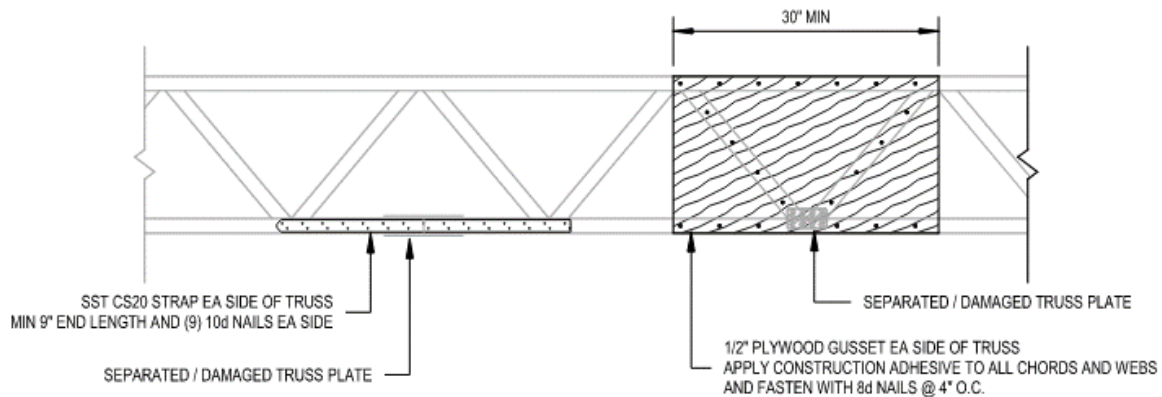
Separation was observed at various truss plates at webs and bottom chord splices as indicated on SK-1. Repair is recommended in accordance with Figure 2.0

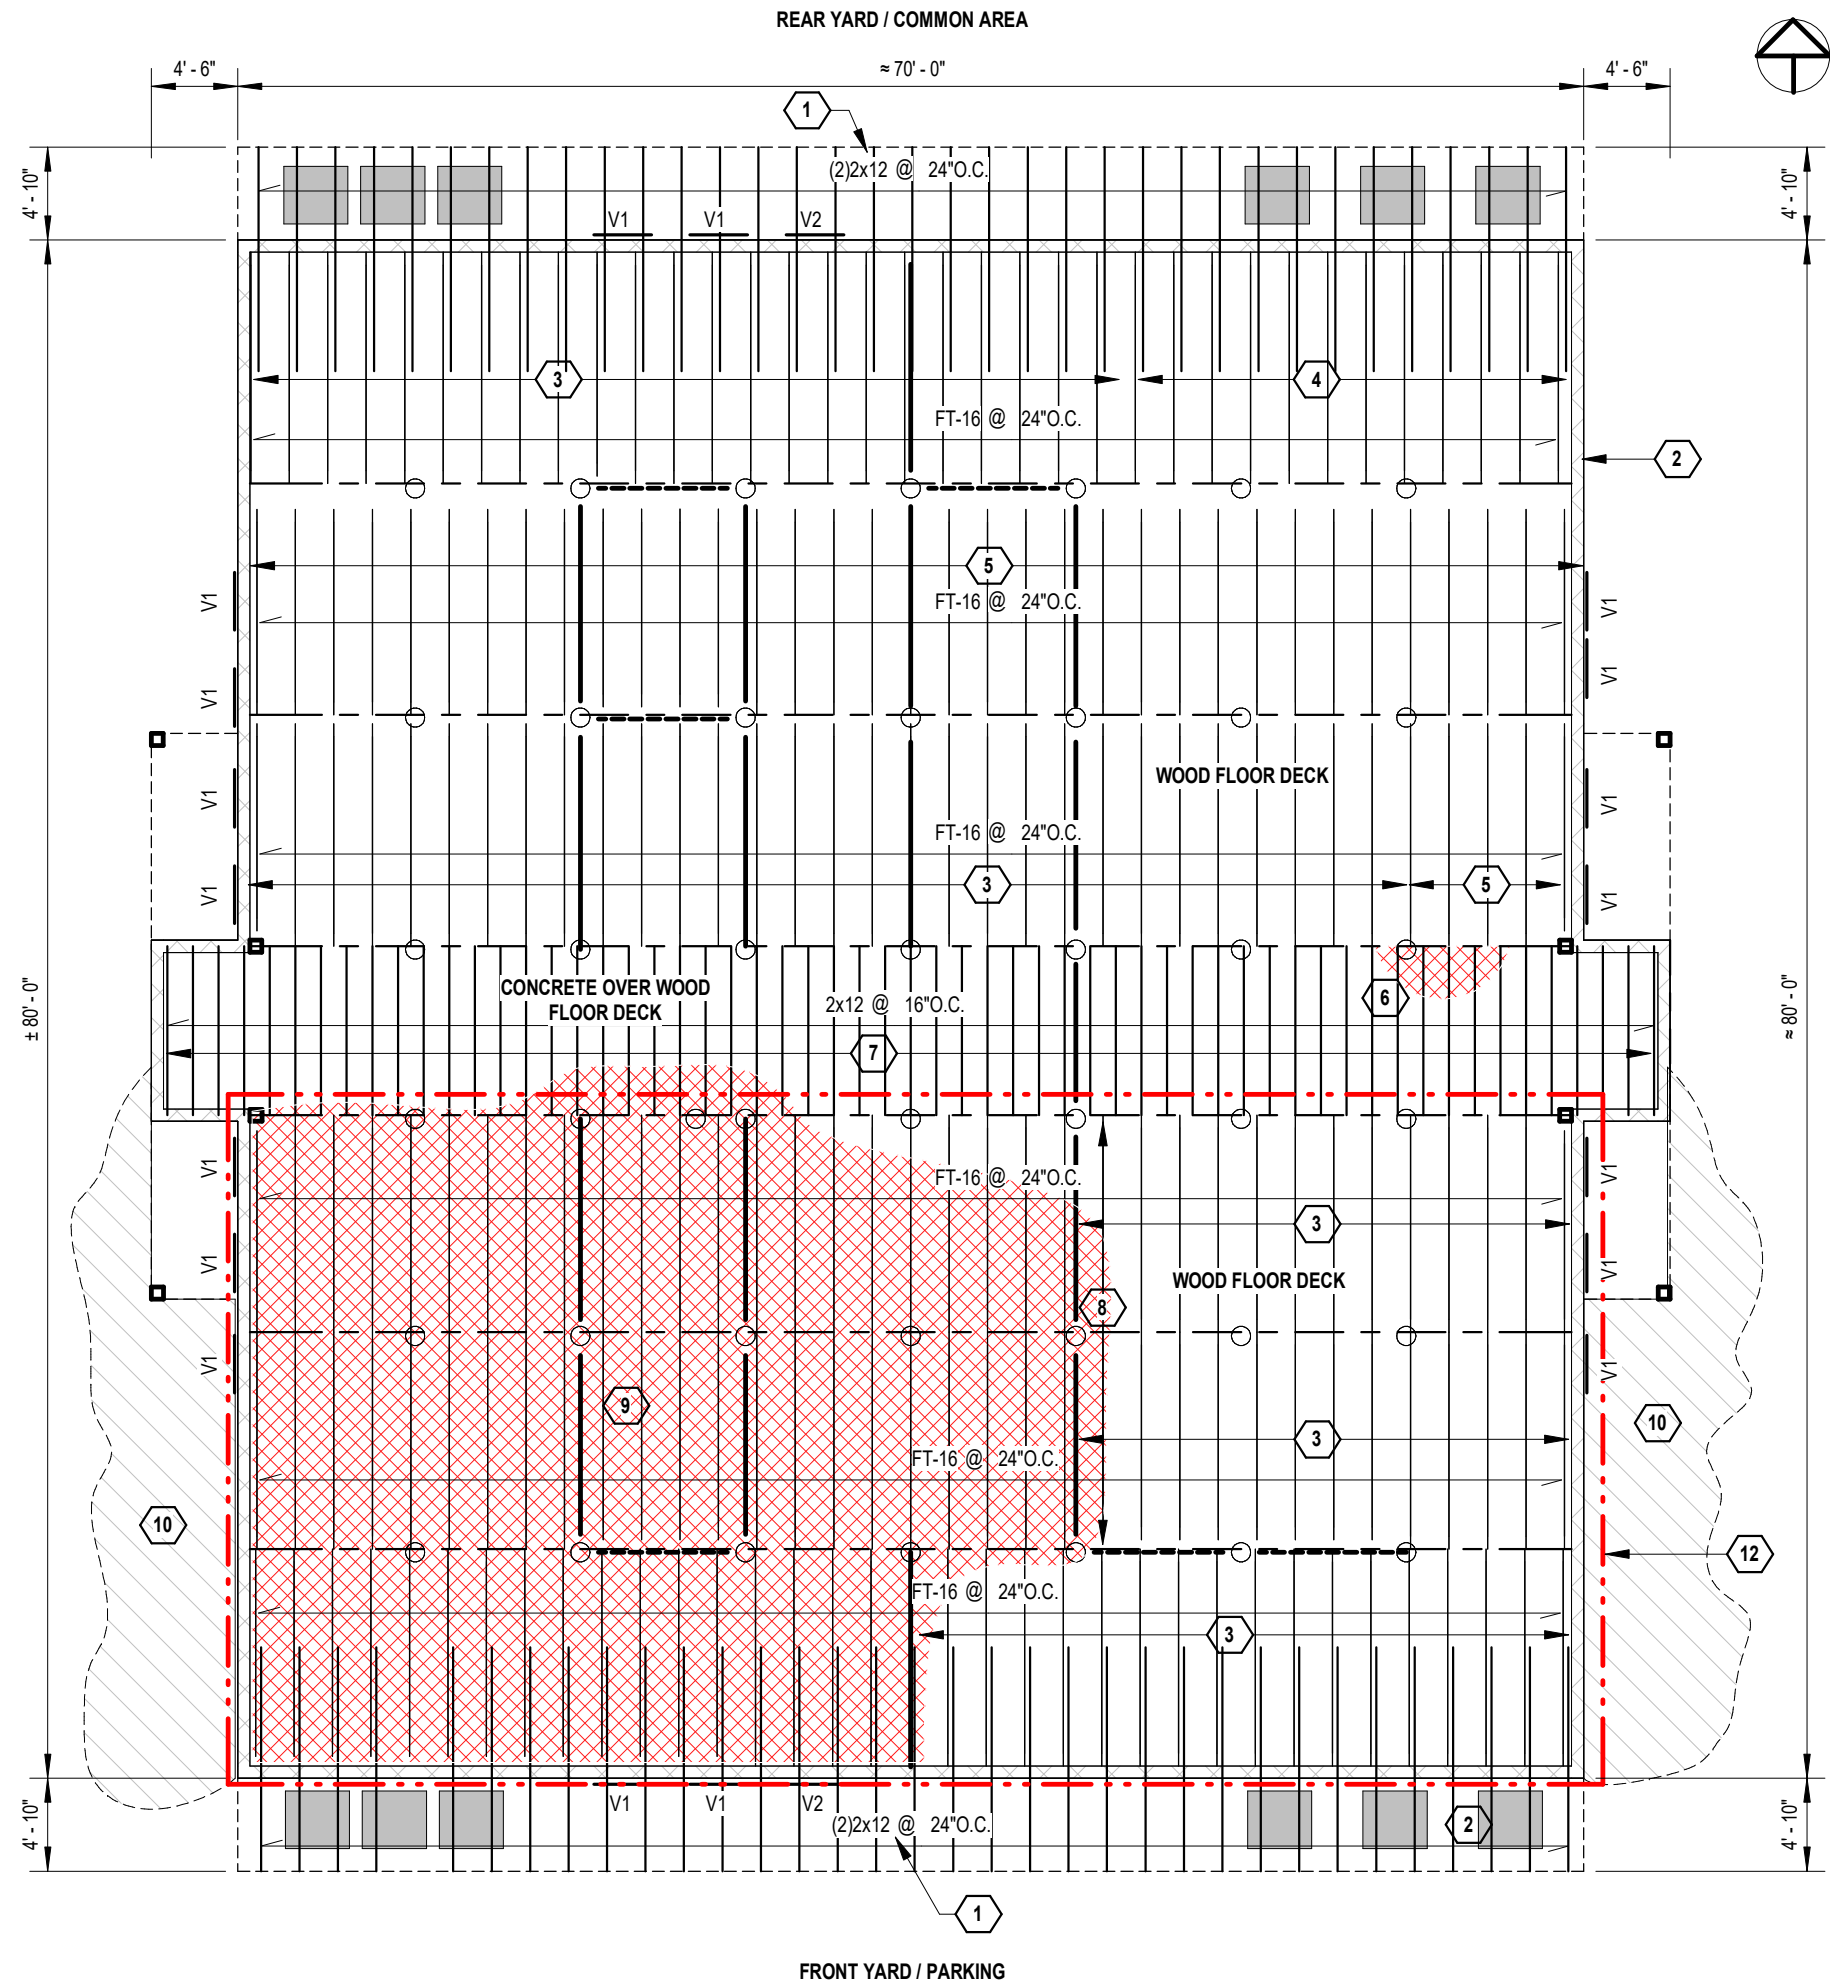
- ### # OBSERVATION KEYNOTES
- 1 NO SIGNS OF DISTRESS OR DECAY AT CANTILEVER JOISTS
  - 2 NO EXTERIOR OR INTERIOR SIGNS OF DISTRESS AT 8" CMU CHAINWALL
  - 3 NO SIGNS OF DISTRESS OBSERVED AT FLOOR TRUSS BOTTOM CHORDS OR WEBS. TOPS CHORDS AND SUBFLOOR WERE CONCEALED BY INSULATION

- 4 SEPERATION OBSERVED AT TRUSS MENDING PLATES
  - 5 MOISTURE AND EARLY SIGNS OF DECAY OBSERVED AT FLOOR TRUSS BEARING.
  - 6 DECAY OBSERVED AT SUBFLOOR AND BLOCKING. MOISTURE AND SIGNS OF EARLY DECAY OBSERVED AT JOIST ENDS

- 7 NO SIGNS OF DISTRESS AT PRESSURE TREATED JOISTS. COMPROMISED SUBFLOOR AT AREAS INDICATED BY RED HATCHING
  - 8 MOISTURE AND ADVANCED DECAY OBSERVED AT LVL BEARING. REPLACE IN FULL.

- 9 INSULATION WAS REMOVED TO EXPOSE SUBFLOOR AND FT16 TOP CHORD. MOISTURE AND EVIDENCE OF WOOD DESTROYING INSECTS WAS OBSERVED AND IS INDICATED BY RED HATCHING. ≈ 65% OF THE OSB SUBFLOOR AND WOOD FLOOR TRUSSES WERE OBSERVED TO BE COMPROMISED AND IN NEED OF REPLACEMENT.

- 10 DENSE VEGETATION WAS OBSERVED AS INDICATED AND OBSTRUCTED (1) CRAWLSPACE VENTS
  - 11 LINE INDICATES PORTION OF THE BUILDING NOT SUITABLE FOR OCCUPANCY UNTIL ALL REPAIRS IN THIS AREA HAVE BEEN MADE

- 12 DELINEATED PORTION OF THE BUILDING IS NOT SUITABLE FOR OCCUPANCY UNTIL ALL REPAIRS IN DELINEATED AREA HAVE BEEN COMPLETED

Moisture damage and decay was observed at the 4-ply 1.75"x16" flush LVL floor beam indicated on SK-1. Based on the extent and type of damage SE recommends replacing the beam along its entire length with a 2-ply 3.5"x16" Pressure treated Parallam (PSL) beam. The General Contractor shall be responsible for all required temporary shoring to facilitate repairs.

During the assessment, SE observed dense vegetation blocking airflow at total of (6) crawlspace vents on the southeast and southwest corners of the building. SE recommends removing the vegetation referenced on SK-1 to restore cross-ventilation for this portion of the crawlspace.
