Structural Inspection

May 21, 2025

RE:
105 W Pear Dr.
Slidell, La. 70461

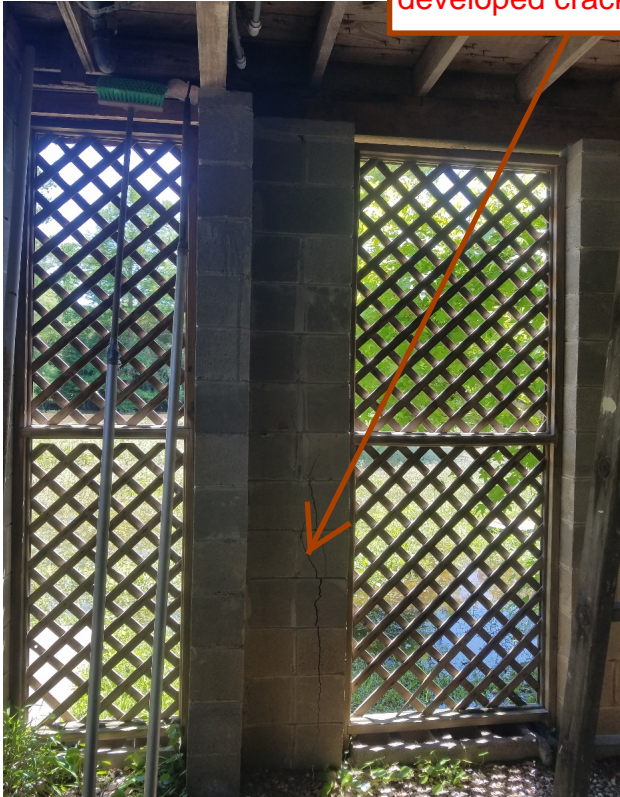
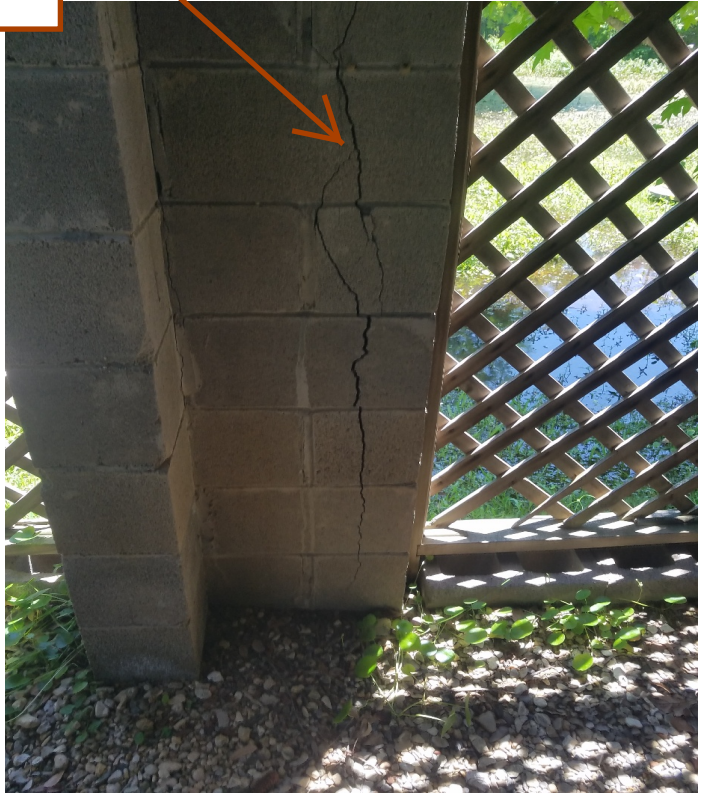
Exhibit #1

Upon inspection, the house has been raised and supported by Concrete Masonry Units (CMU). These CMU supports date back to around the 1980's. Some of the CMU's have sustained stresses causing cracks. Apparently during one or more hurricanes trees fell on the house near the locations of the damaged CMU's.

Replace all CMU's this column that have developed cracks

Remove and replace all CMU's that have developed cracks. Repoint/tuck point all mortar using a non-shrink precision grout.

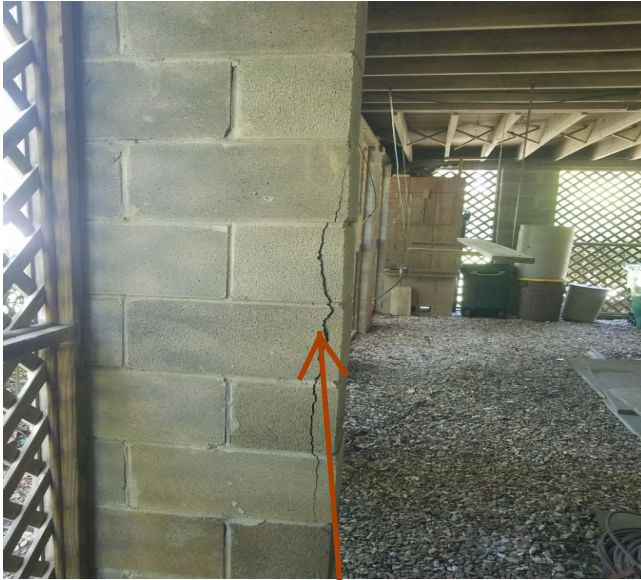
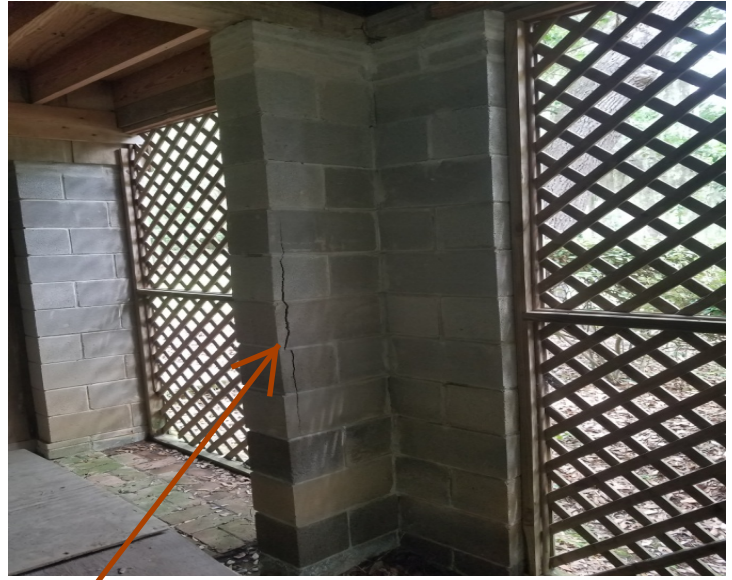
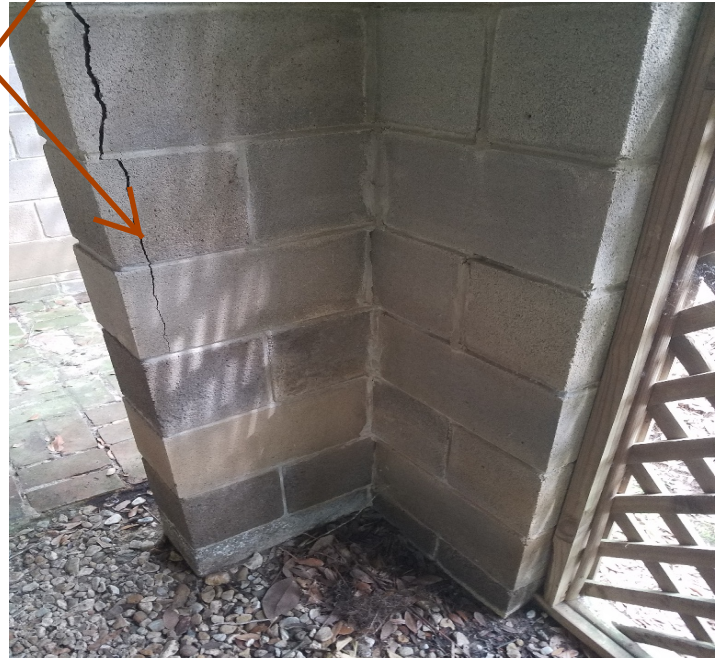
Exhibit #2

Replace all CMU's
this column that
have developed
cracks

Remove and replace all CMU's that have developed cracks. Repoint/tuck point all mortar using a non-shrink precision grout.

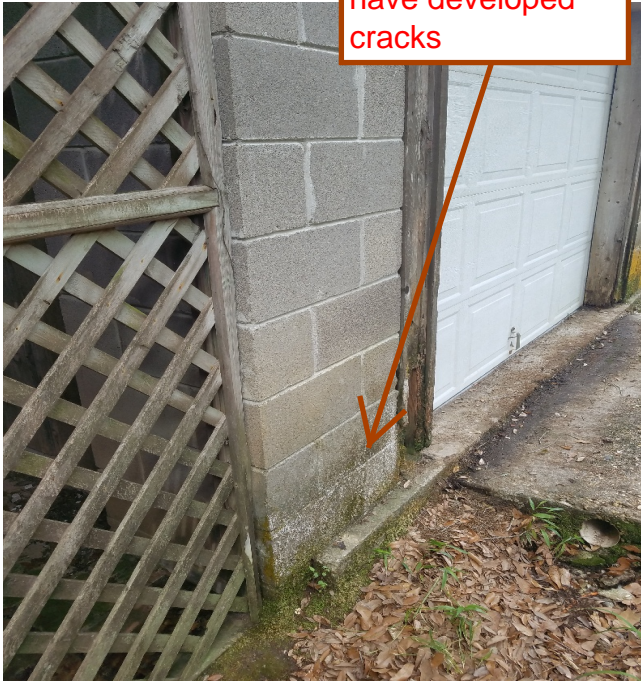
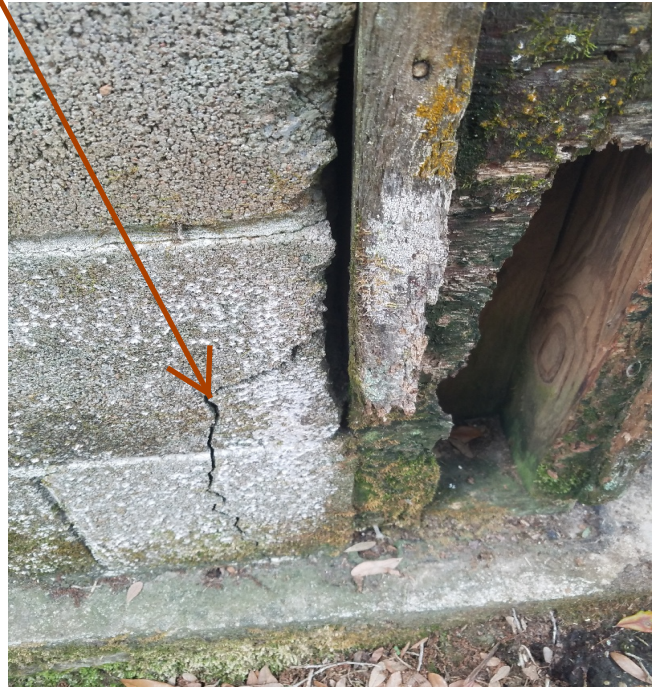
Exhibit #3

Repair all CMU's
this column that
have developed
cracks

Repair all CMU's that have cracks using an epoxy based foam. Replace rotten wood structure supporting garage door.

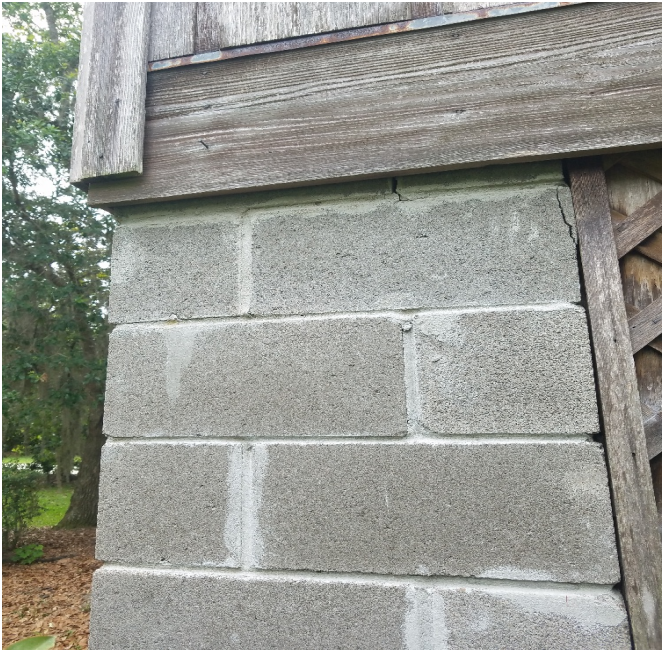
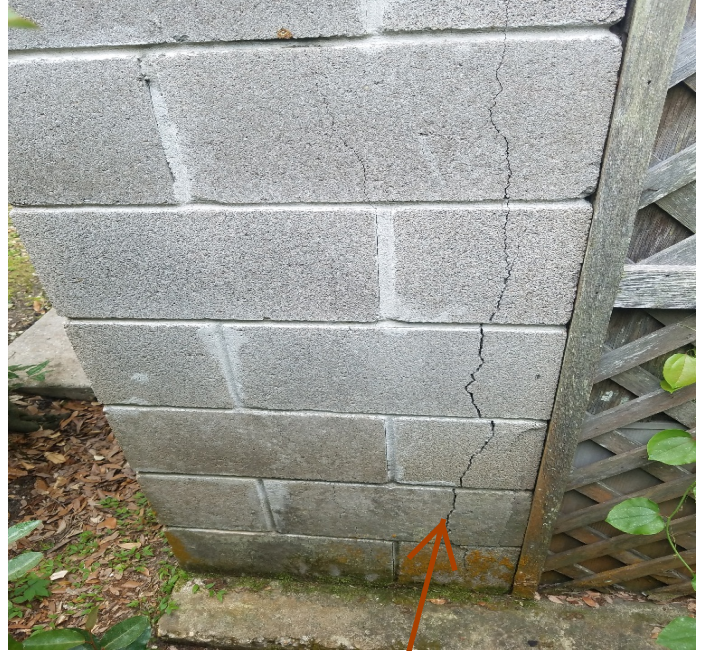
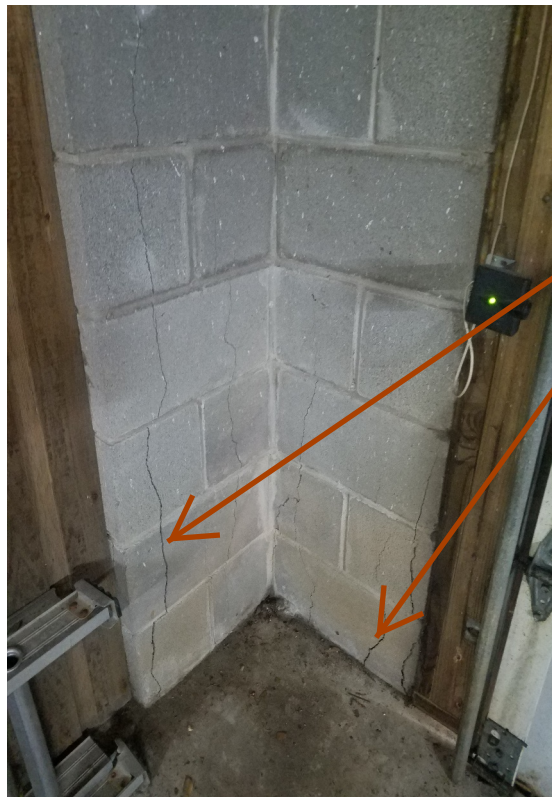
Exhibit #4

Replace all CMU's
this column that
have developed
cracks

Remove and replace all CMU's that have developed cracks. Repoint/tuck point all mortar using a non-shrink precision grout.

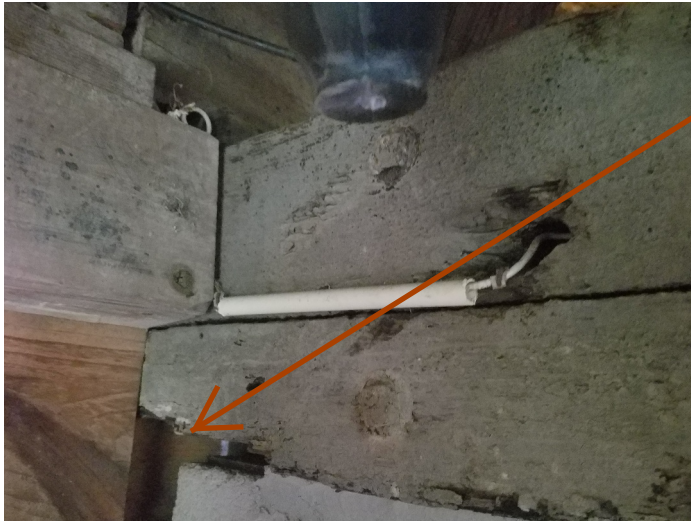
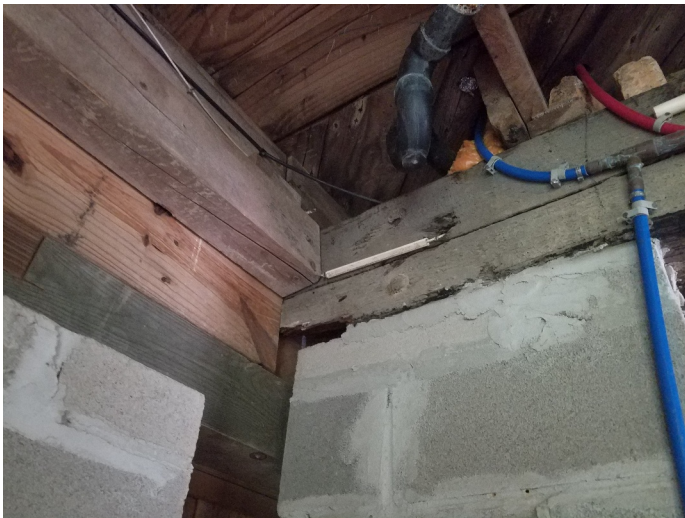
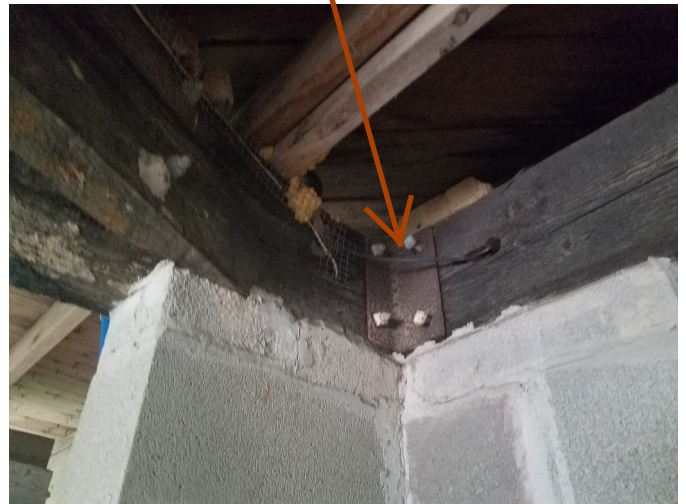
Exhibit #5

It was also noted that in the garage area the center of the house was supported using creosote beams, some of these beams are starting to show cracks along the beams.

Clean cavity and remove loose particles. Fill with epoxy spray foam.

Replace with larger angle iron.

Remove any loose wood particles and apply epoxy spray foam to fill the cavity. Remove existing angle iron connection and replace with one, angle iron, that moves the connection point away from the repaired area by 4 inches.

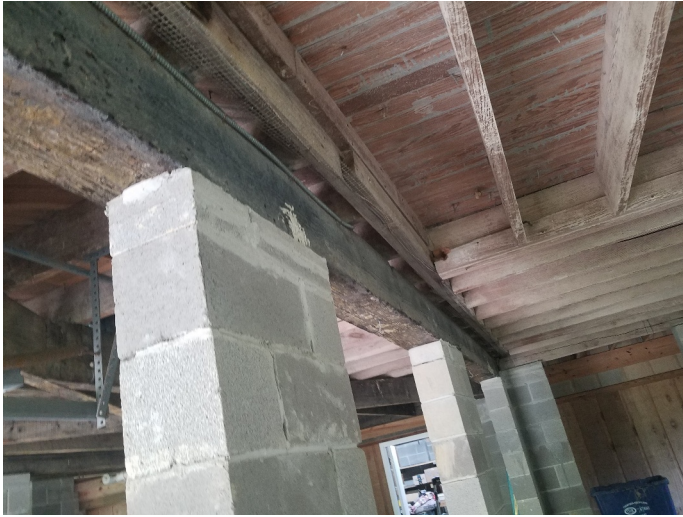
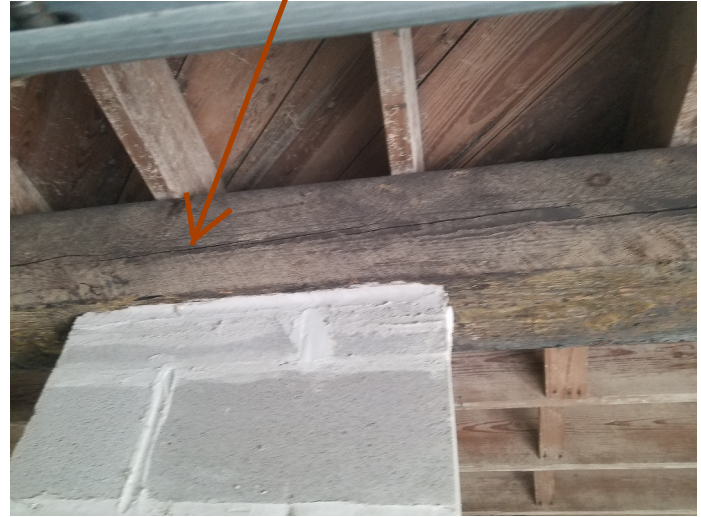
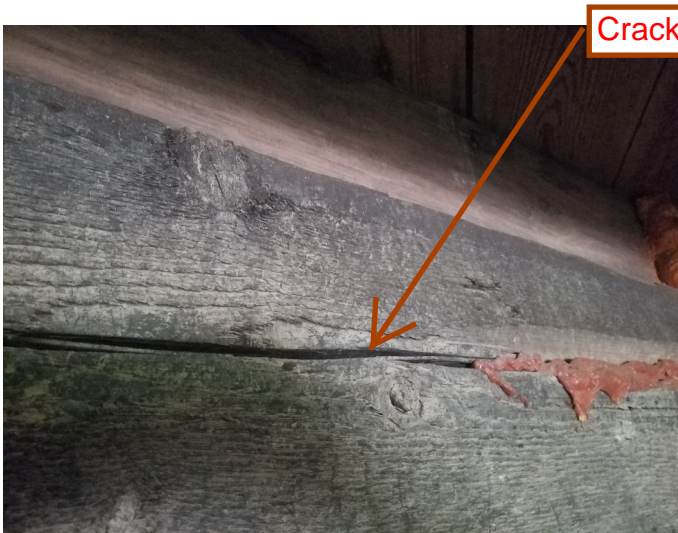
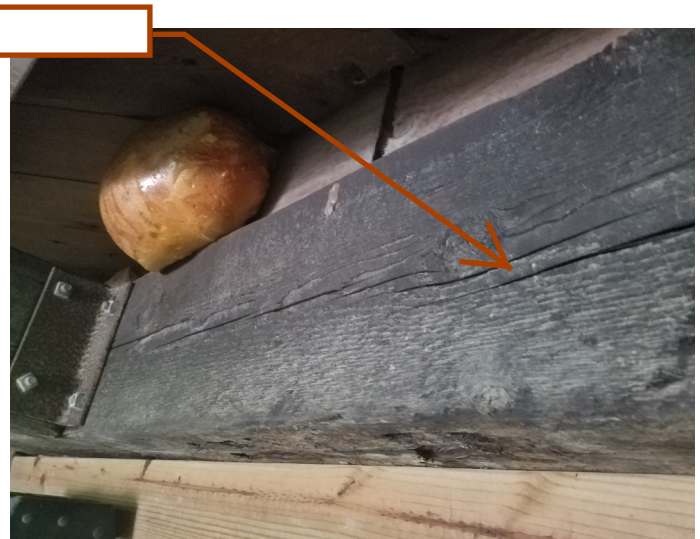
Exhibit #6

Cracks have developed along the horizontal plane along some of the creosote wood beams. Cracks like this normally do appear in these types of beams. Fill cracks with epoxy spray foam then install a Simpson Strong-Tie MP 3"x6" 20-Gauge galvanized mending plate @ 24" o.c. along each beam where the crack(s) appear. Install mending plate according to manufactures recommendations.

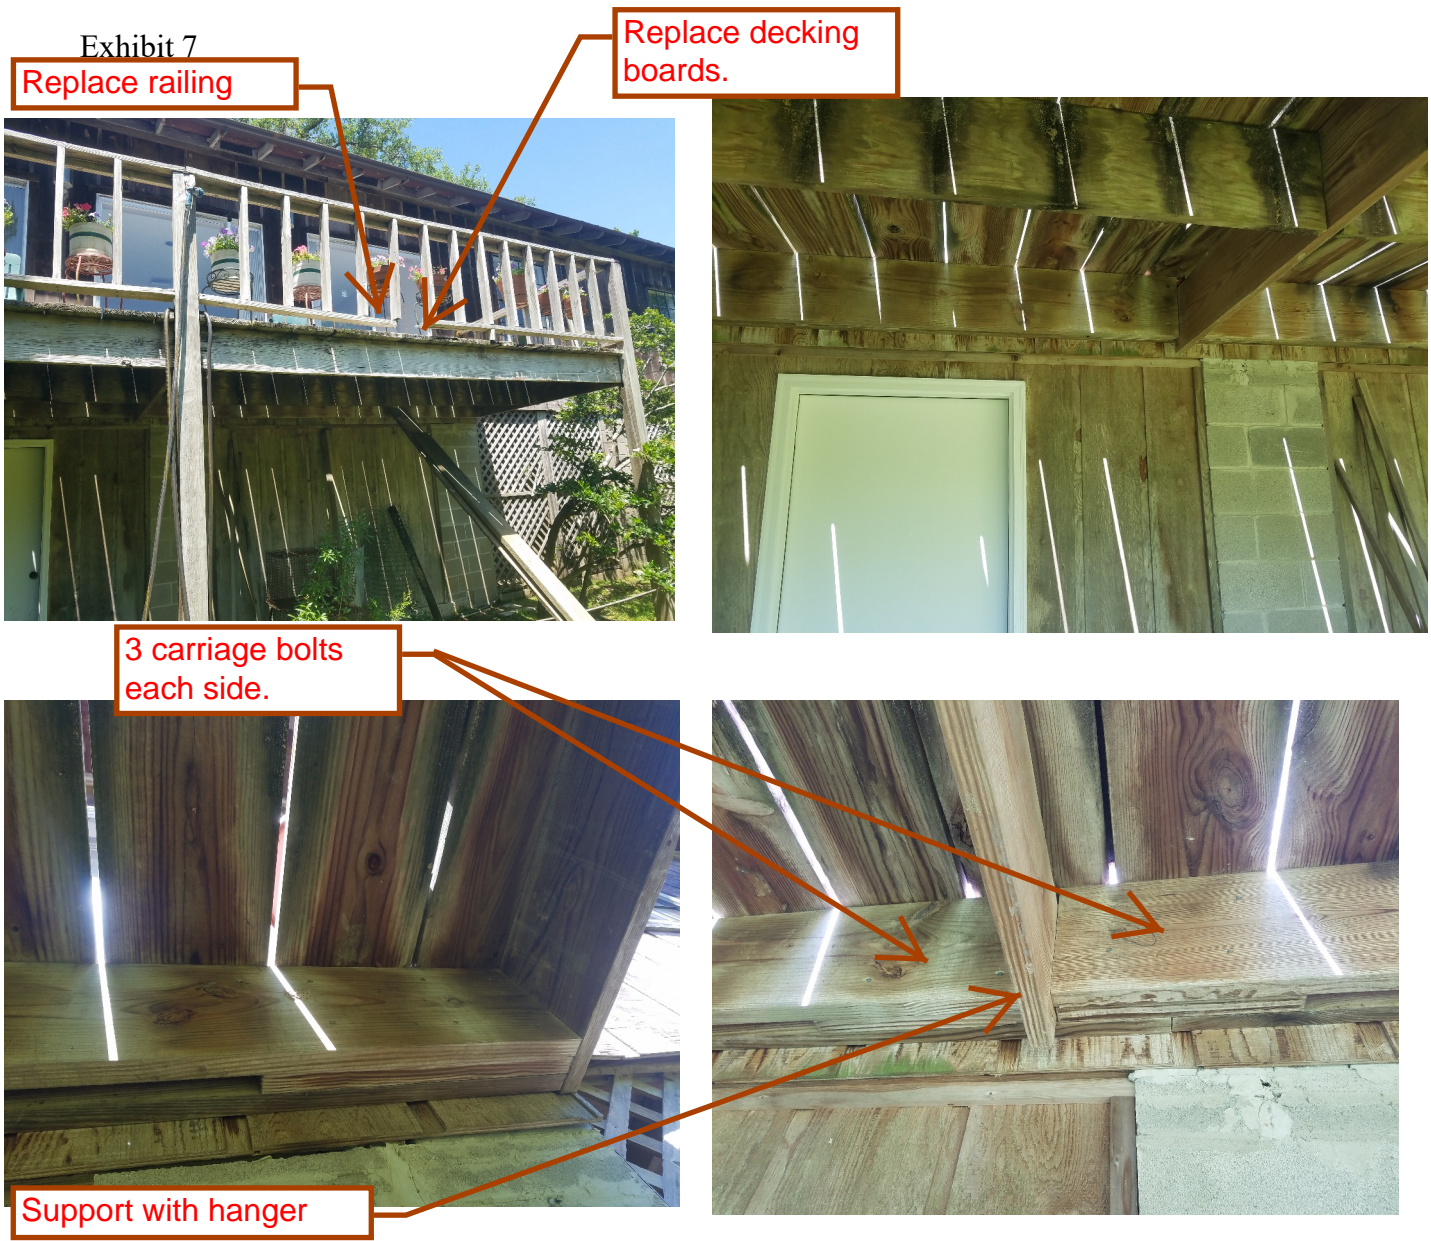
Another area that was inspected is the decking on the rear of the house. This decking was apparently installed then altered to stop water from entering the sliding glass door at the deck. The method used to alter the support for the decking was not attached properly to the structure. Also, some of the flooring boards on the deck have started to decay on the outside edges.

1. Some of the decking floor board have started to decay on the ends of the board that faces the sun. Replace the boards with new floor boards.
2. The bottom railing has been removed on one section of the deck. Replace the bottom rail with one single complete rail that extends from column to column.
3. The supports against the house have been modified to allow rainwater to drain before entering the sliding glass window. These supports shall be firmly attached to the structure. Use a minimum of 3 ½” carriage bolts @ each support location; space the bolts in a triangular configuration with a minimum of 6” between bolts. Carriage bolts shall be long enough to extend through all blocking used

to create a gap between building and deck into the structure's rim board which is directly supported by the CMU block wall.

4. There is one support board between the column and the house that is separating from the support board. Install a Simpson Strong-Tie joist hanger to support this member.
