Structural Inspection

July 10, 2025

Jason Severn
1569 Susan Lane
Slidell, La. 70458

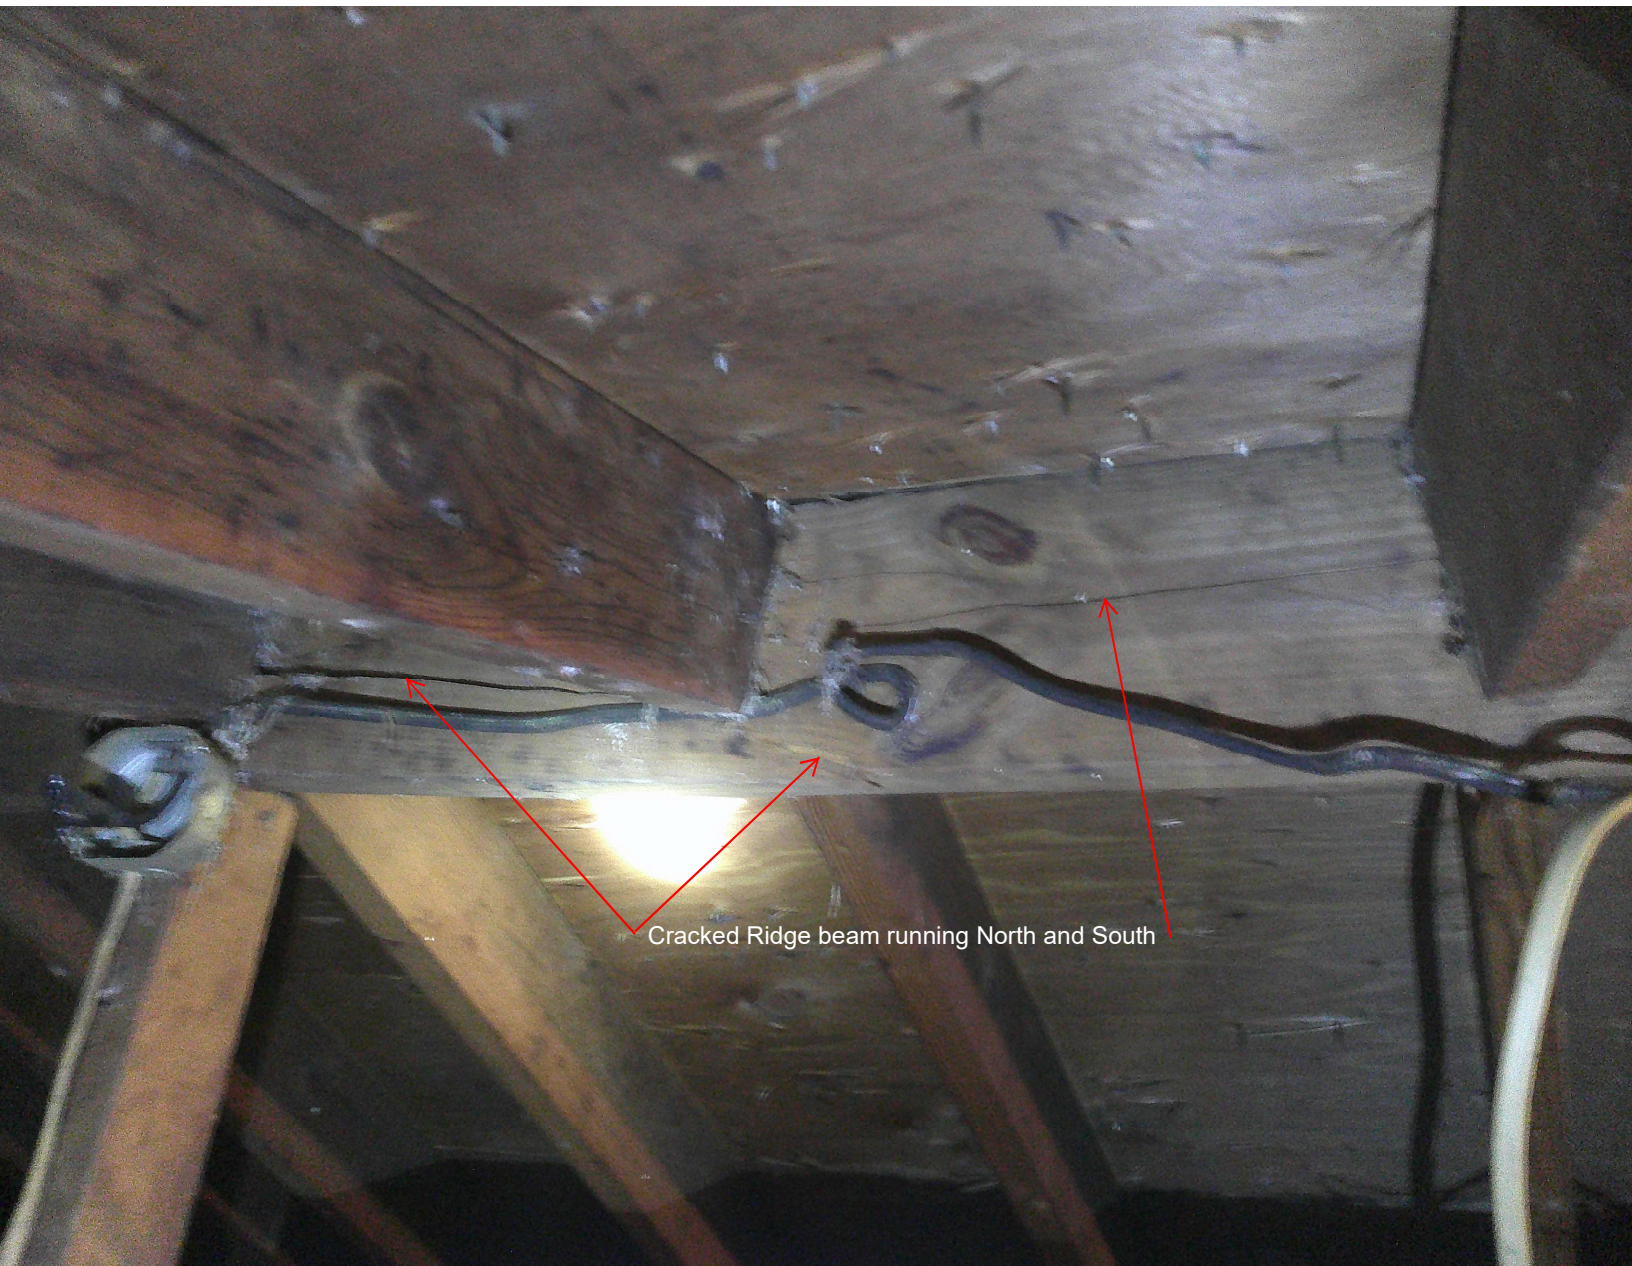
Cracked Ridge beam running North and South

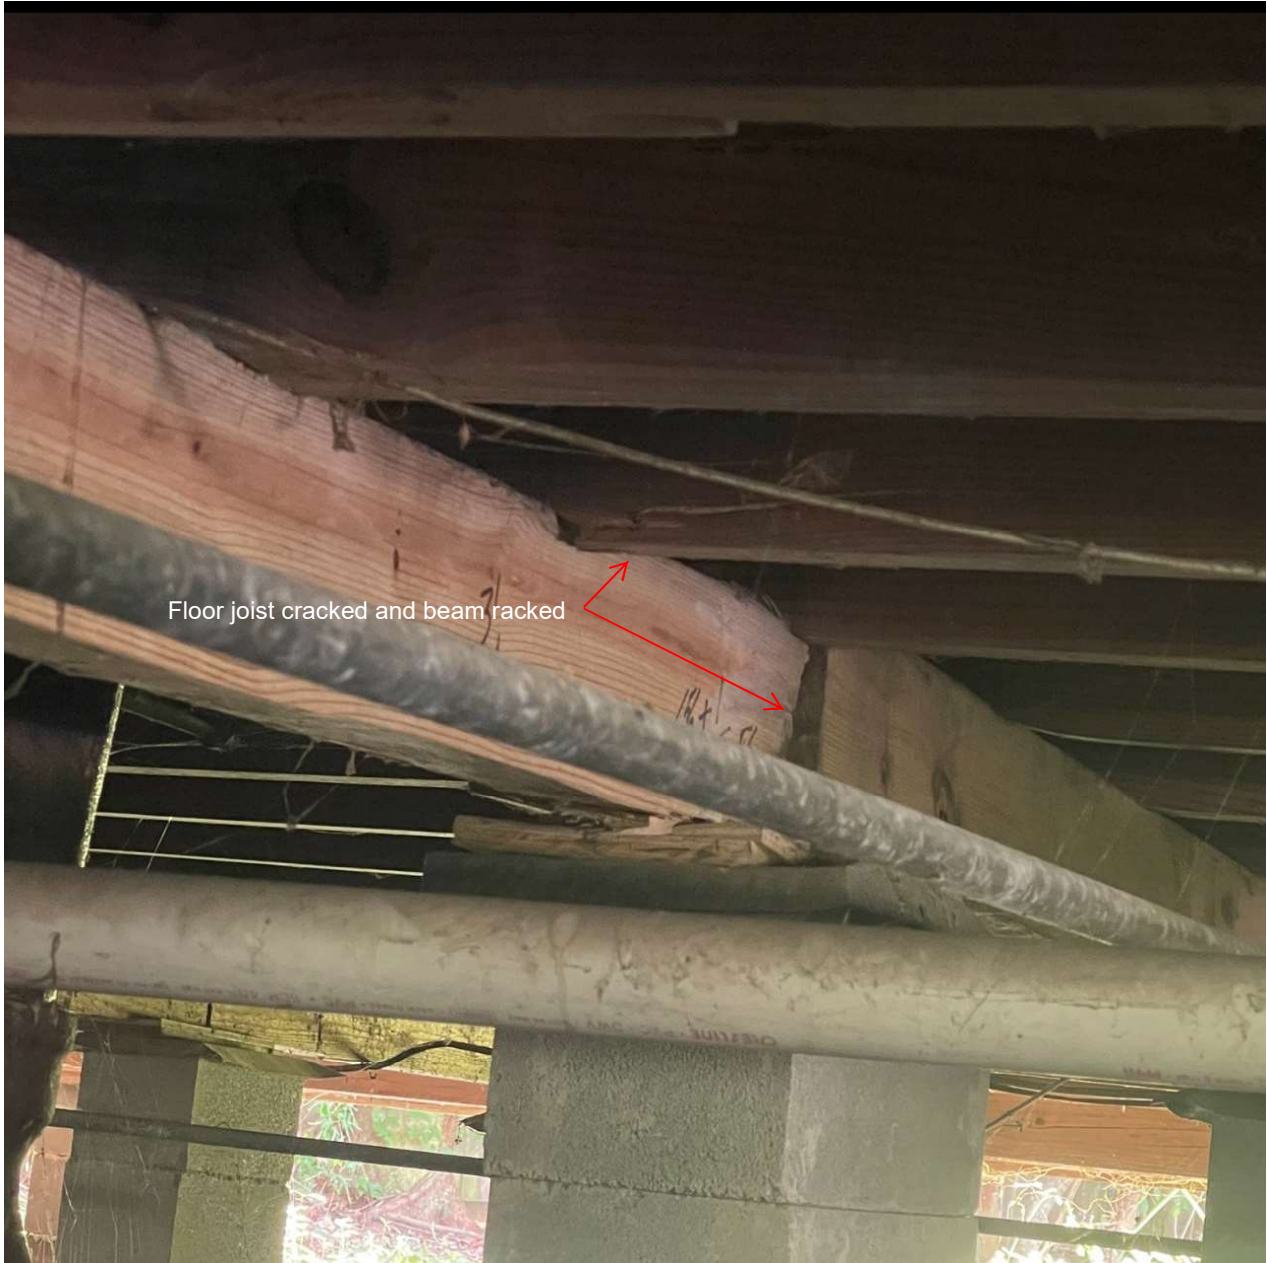
Floor joist cracked and beam racked

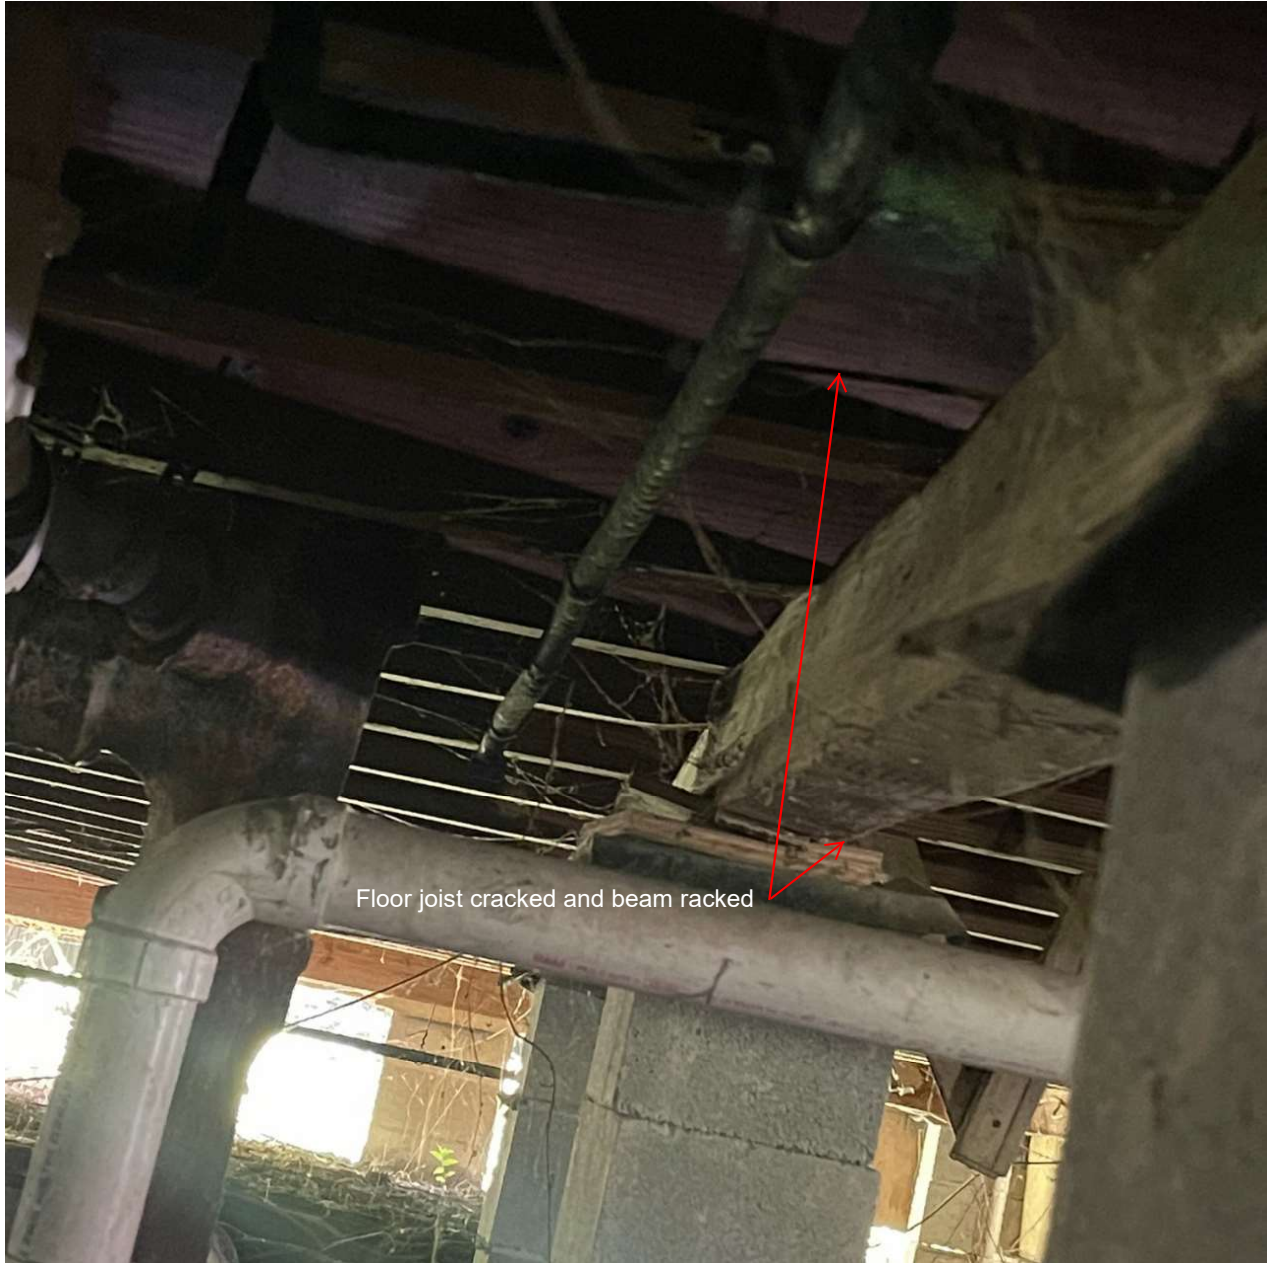
Floor joist cracked and beam racked
