## Structural Inspection

February 04, 2025

RE:  
205 Chubasco Lane  
Slidell, La. 70458

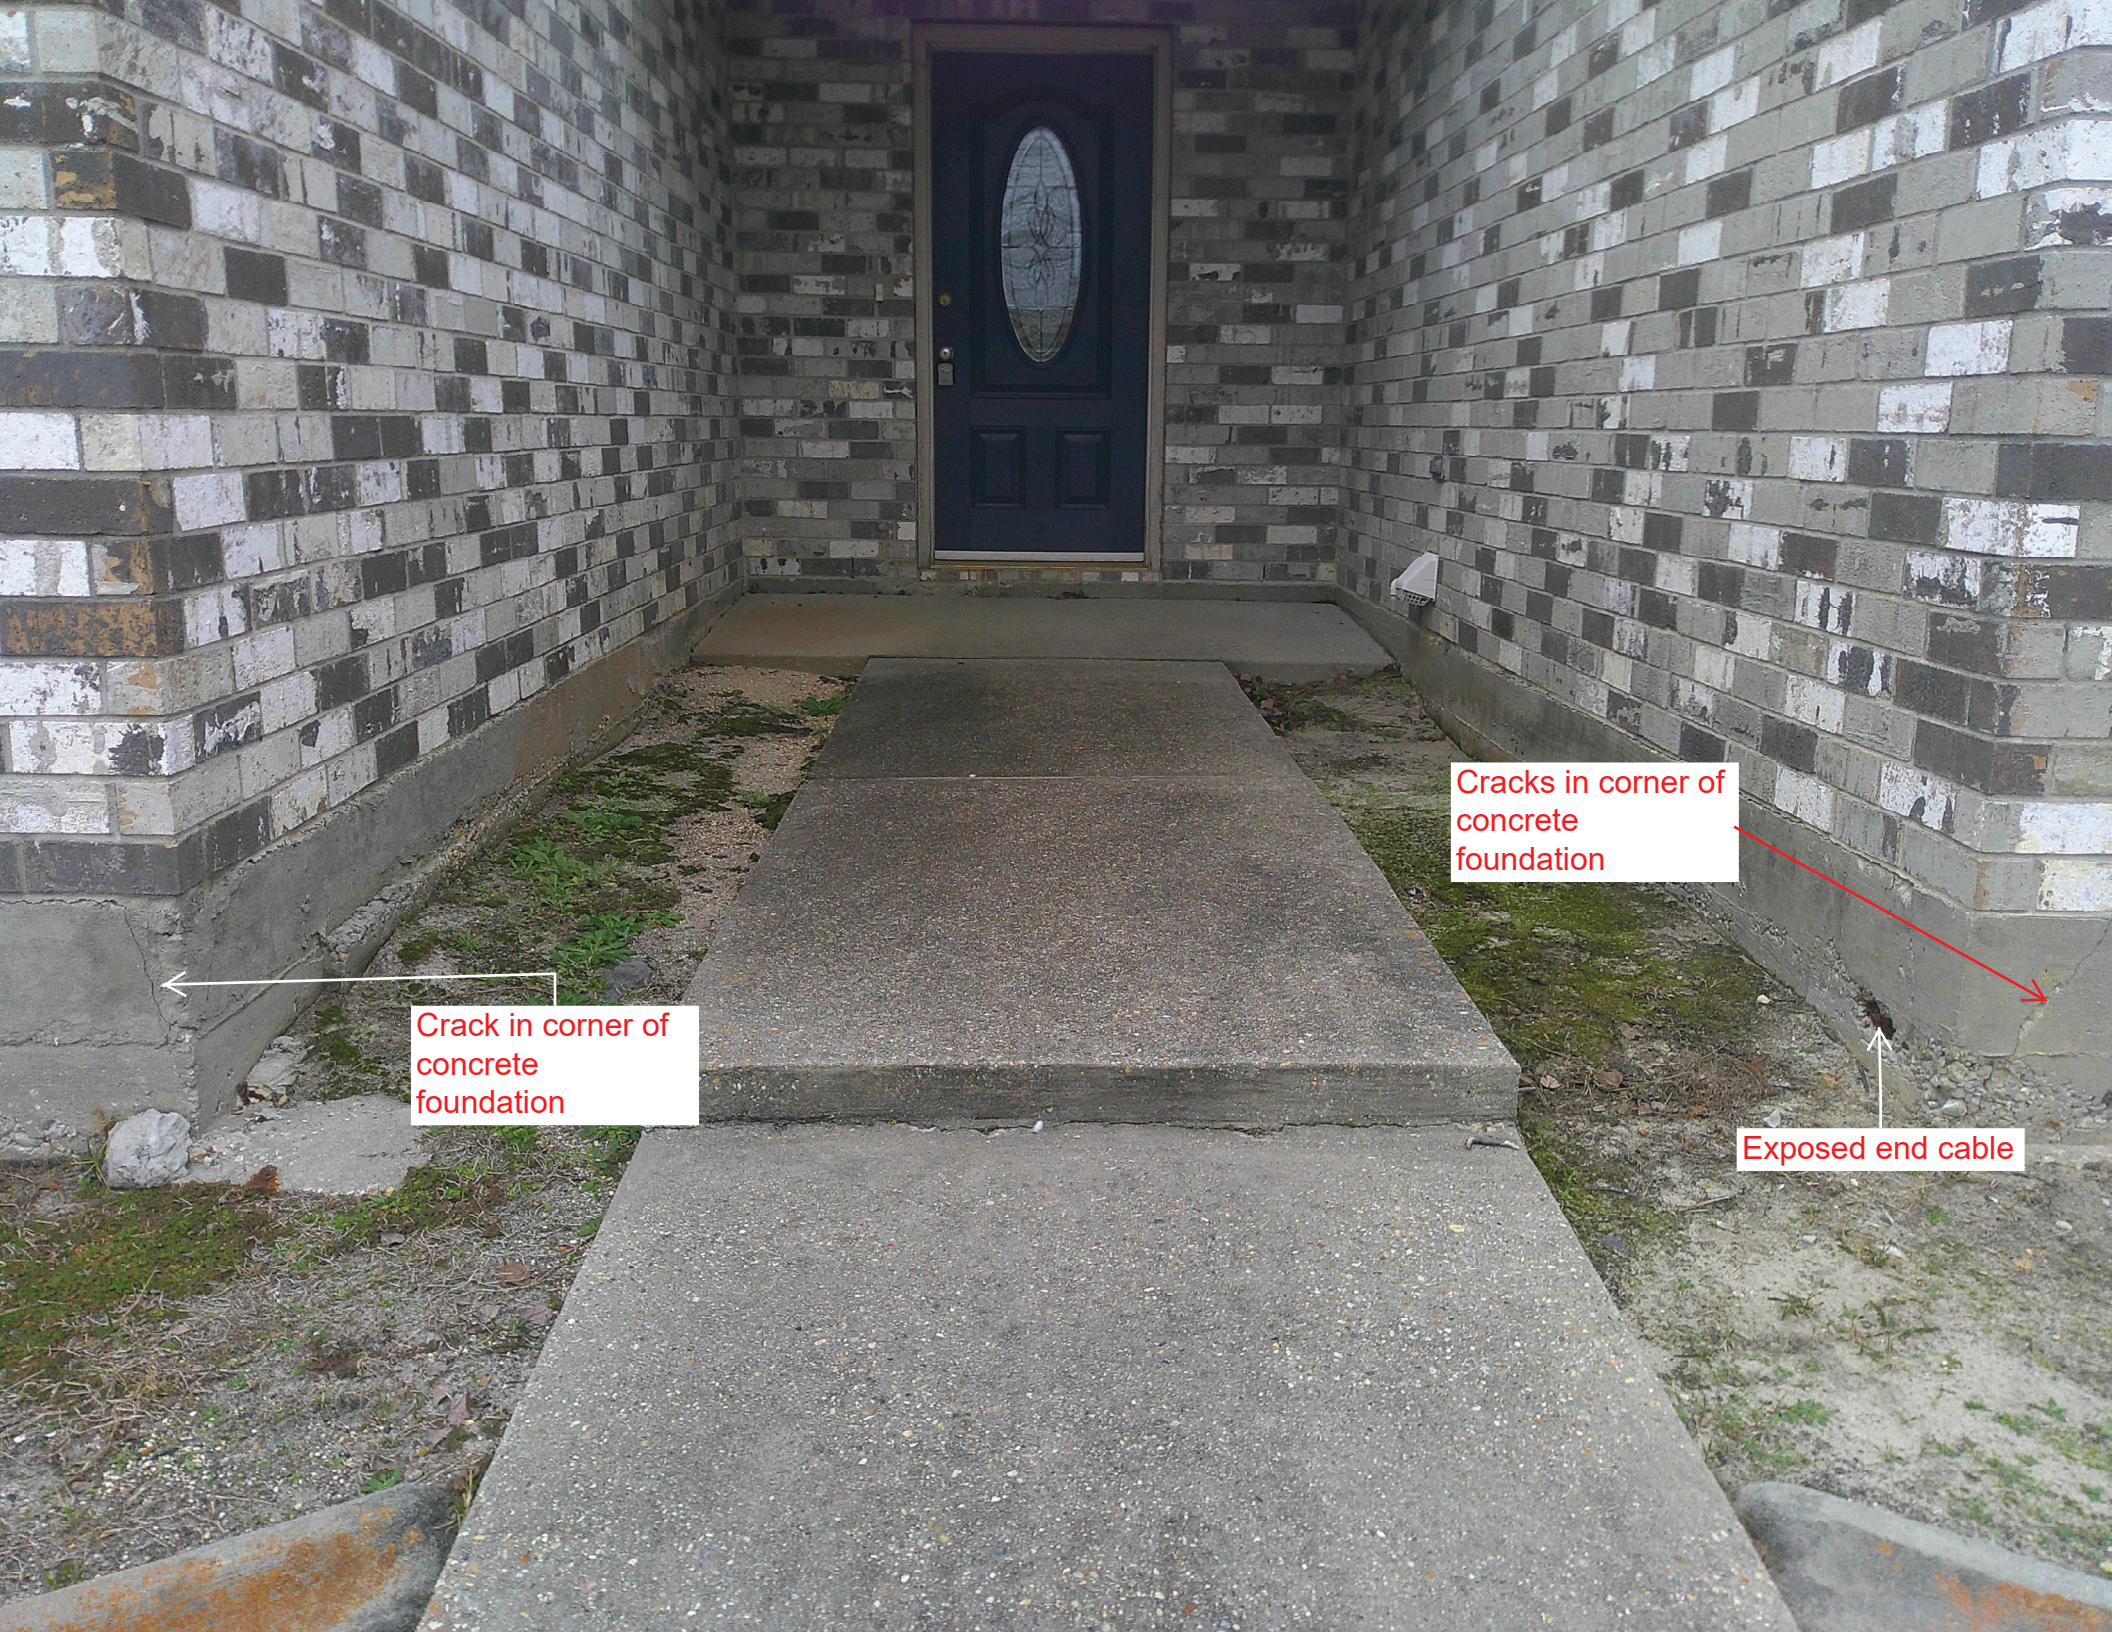
Upon inspection, the ground has settled significantly around the exterior of the foundation exposing the concrete footing. Along with it, the downspouts have created some ruts exposing the wood pilings in some areas. It was noted in some areas of the concrete foundation that the post tension end cables are exposed. Some corners of concrete foundation have cracked.

The concrete foundation of the home is pile supported and no settling was noted during this inspection. It is our opinion that the structural integrity of this home is currently sound. The corners of foundation that were noted to have cracked are normal, this happens when the form boards are removed.

Crack in corner of concrete foundation

Cracks in corner of concrete foundation

Exposed end cable

- 1) Seal the cracks and exposed end cables in the concrete and foundation with a non-shrinking grout, to prevent insects from entering the home.
- 2) Add fill up to 8" below the brick ledge all around the exterior of the concrete foundation at 45 degrees off the foundation.
- 3) Install new sod on new fill.
- 4) Add extensions to the downspouts needed to allow for proper drainage of rainwater away from the concrete foundation.

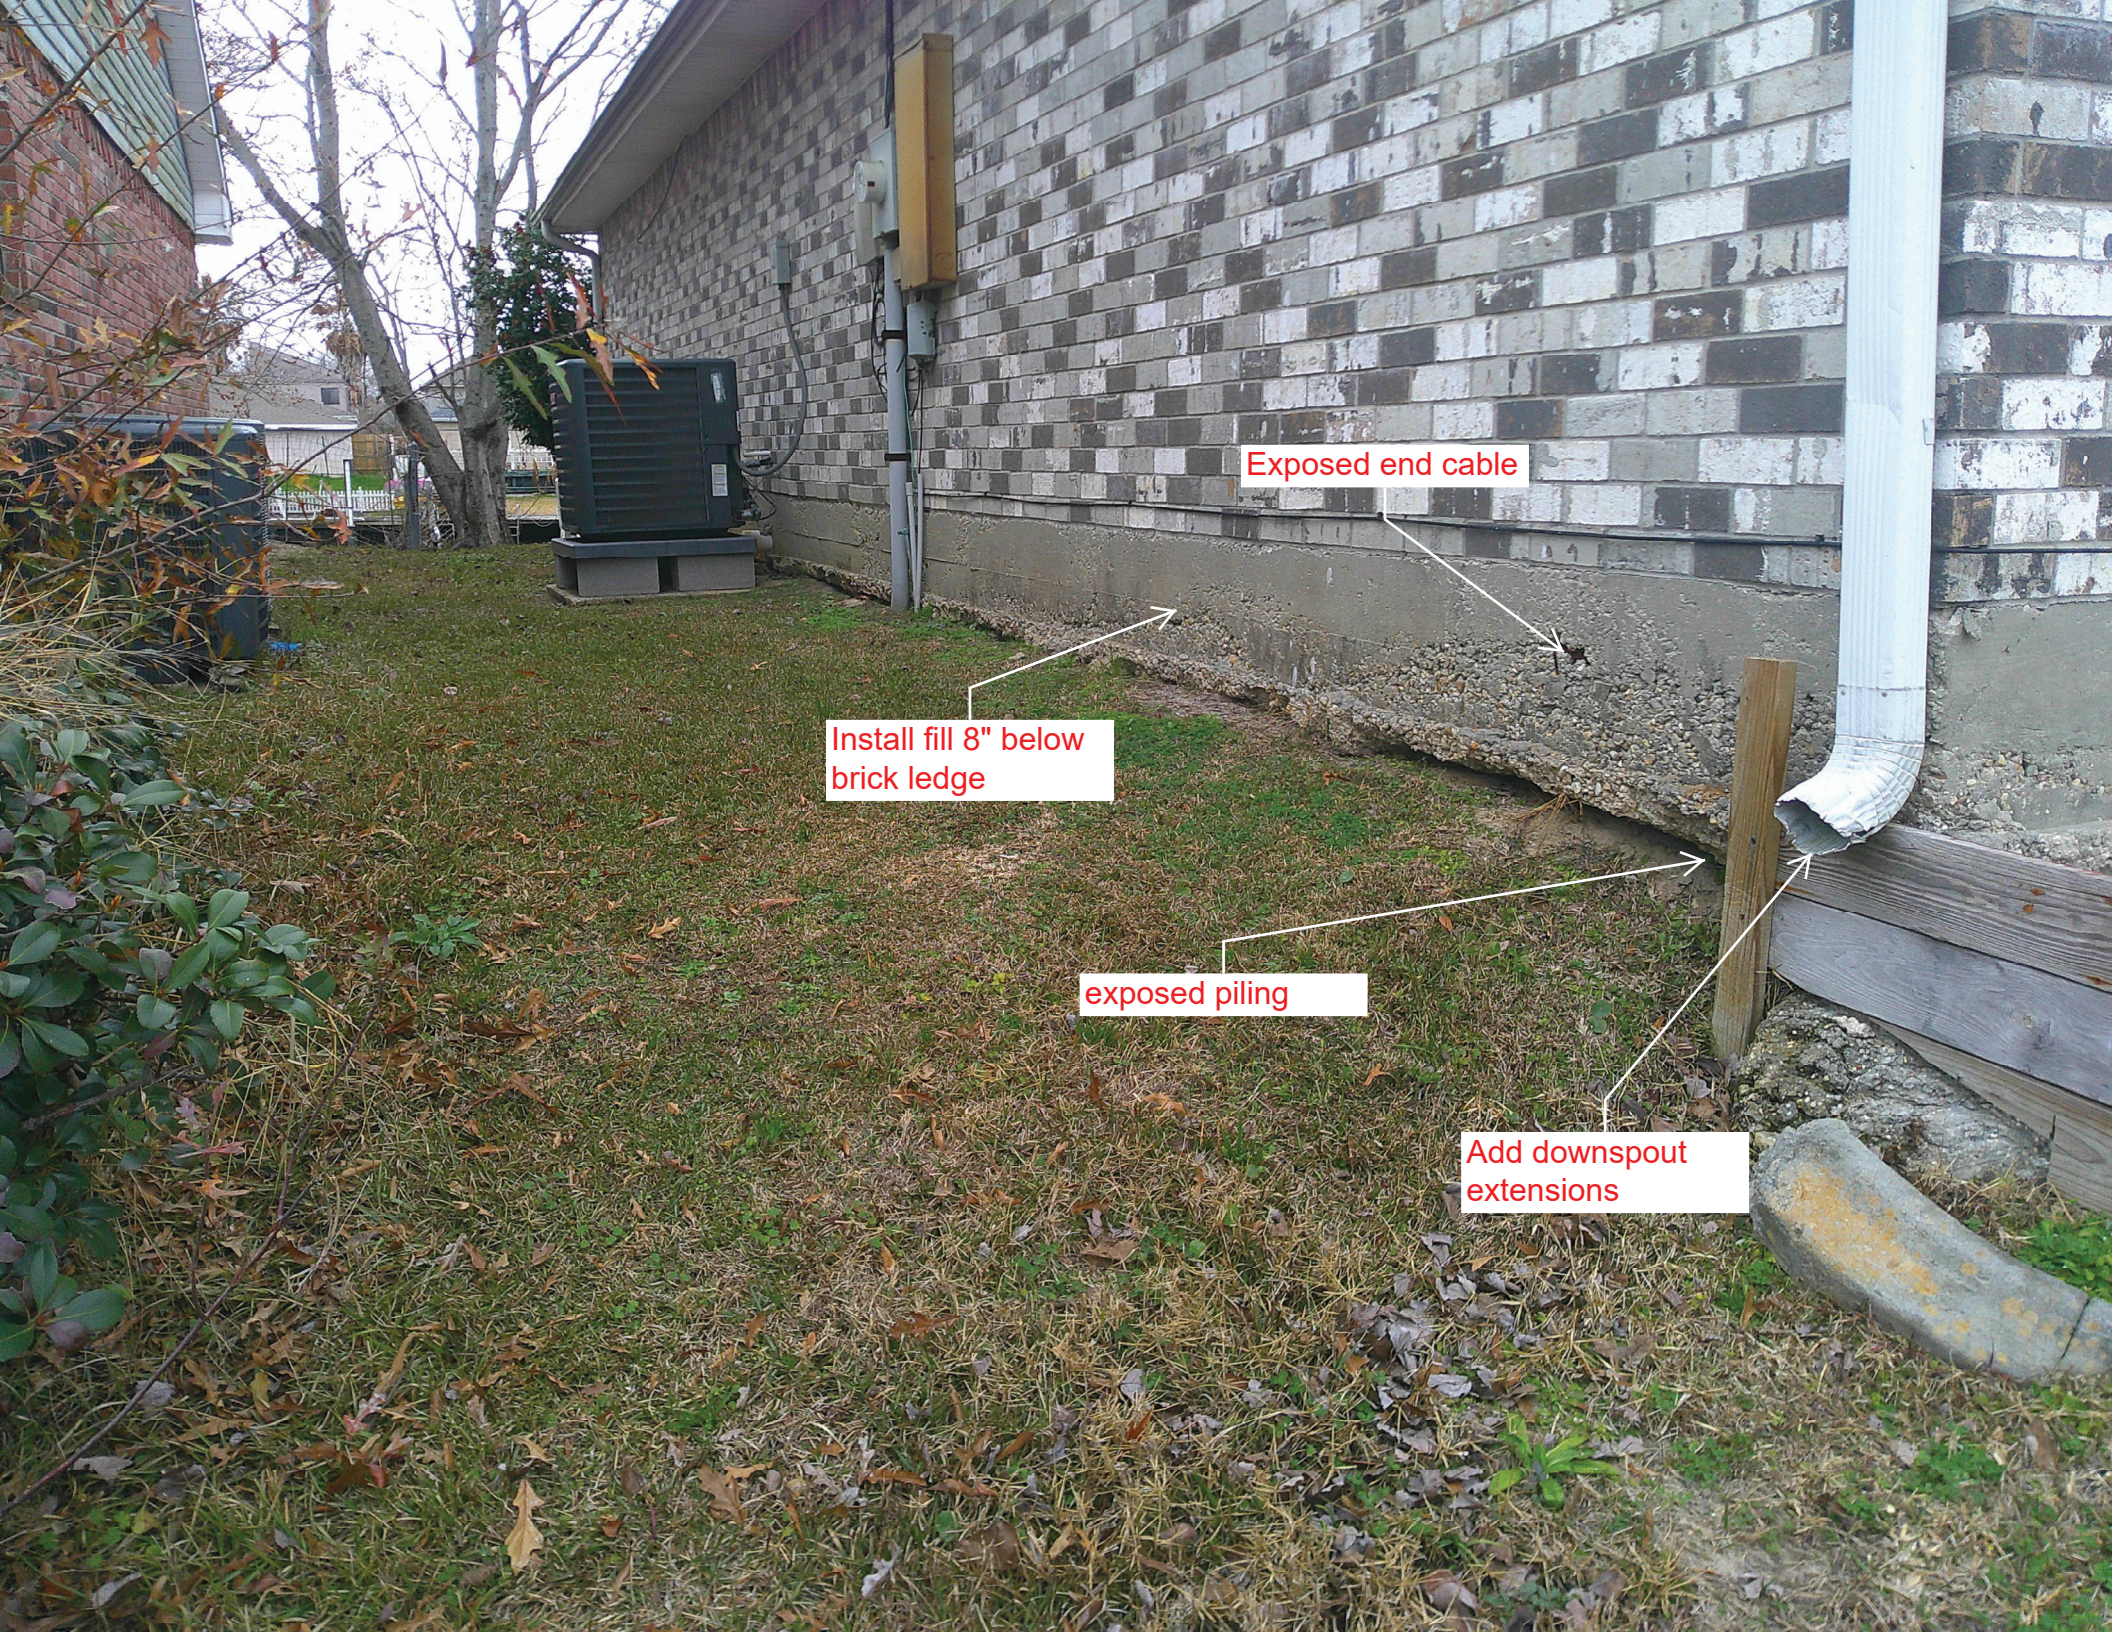
Exposed end cable

exposed piling

Install fill 8" below  
brick ledge

Add downspout  
extensions
