Structural Inspection

April 23, 2024

Torben Knudsen
52 Mistletoe Drive
Covington, La. 70433

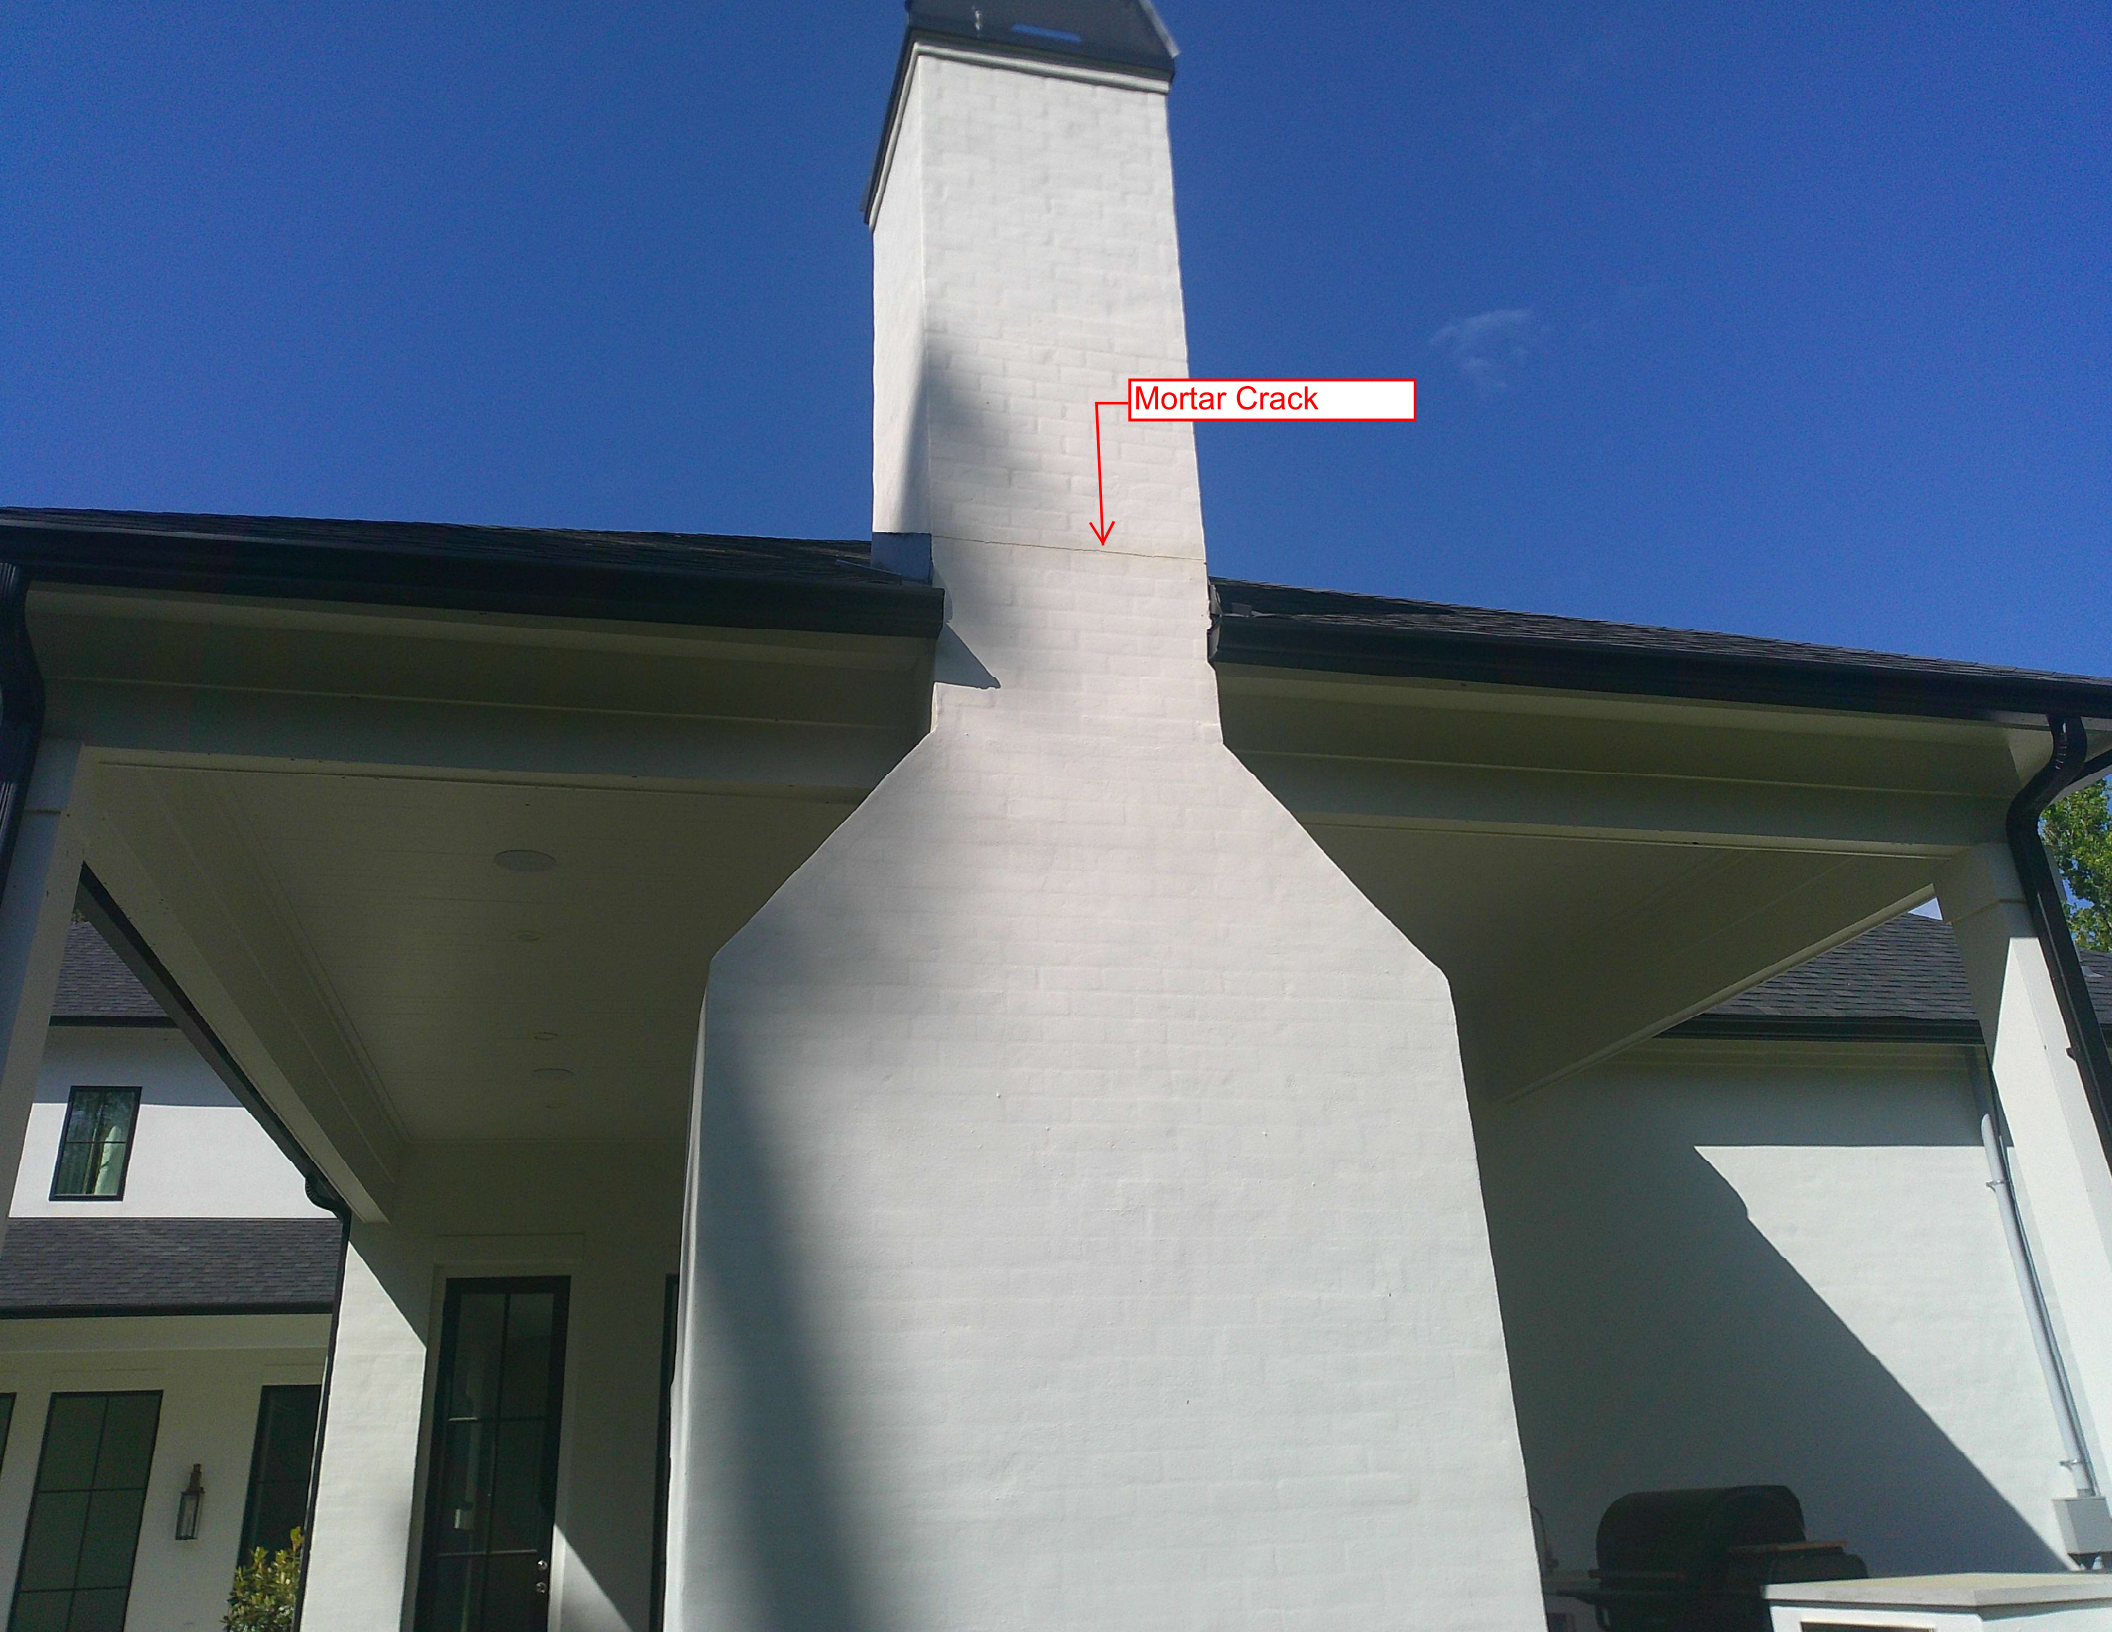
Upon inspection, the outdoor kitchen fireplace was noted to have a horizontal crack in the mortar. This crack is at the same elevation as the flashing around the chimney.

Mortar Crack

- 1) Seal the horizontal mortar crack in the outdoor fireplace with a non-shrinking grout, to prevent insects from entering.
- 2) Seal the hairline crack in the front retaining wall.

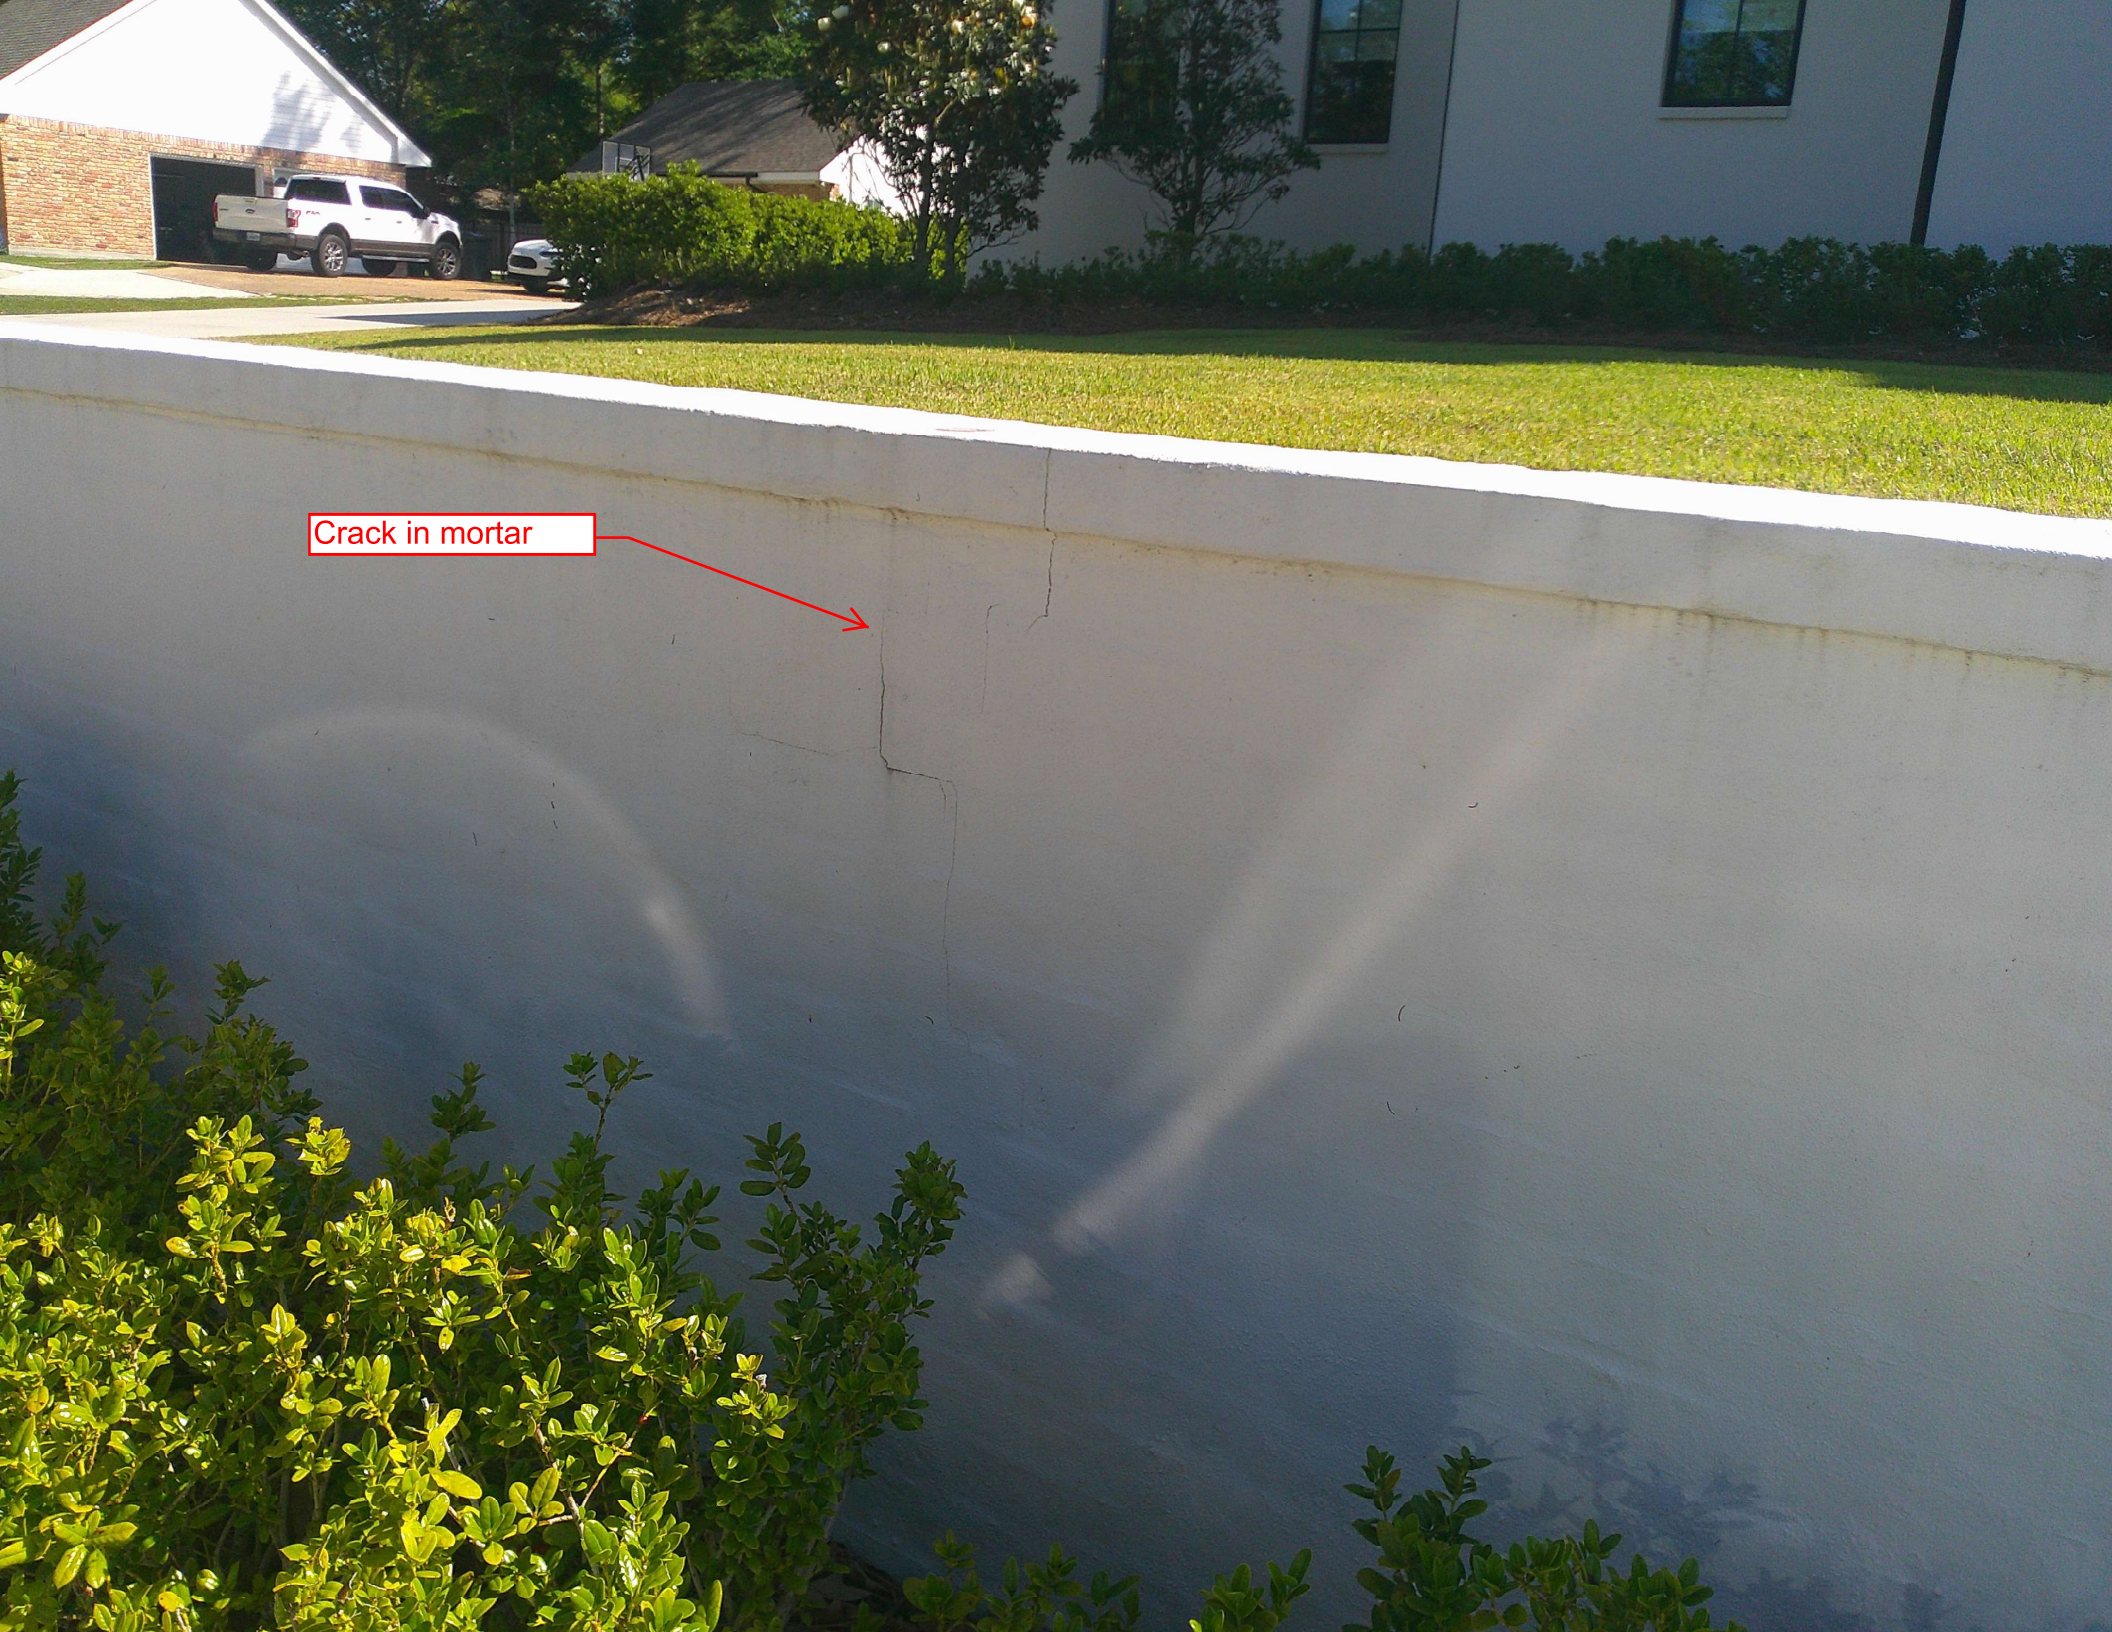
Crack in mortar
