Structural Inspection

May 12, 2026

Marlin Ford
5453 Iris Hollow Rd.
Slidell, La. 70461

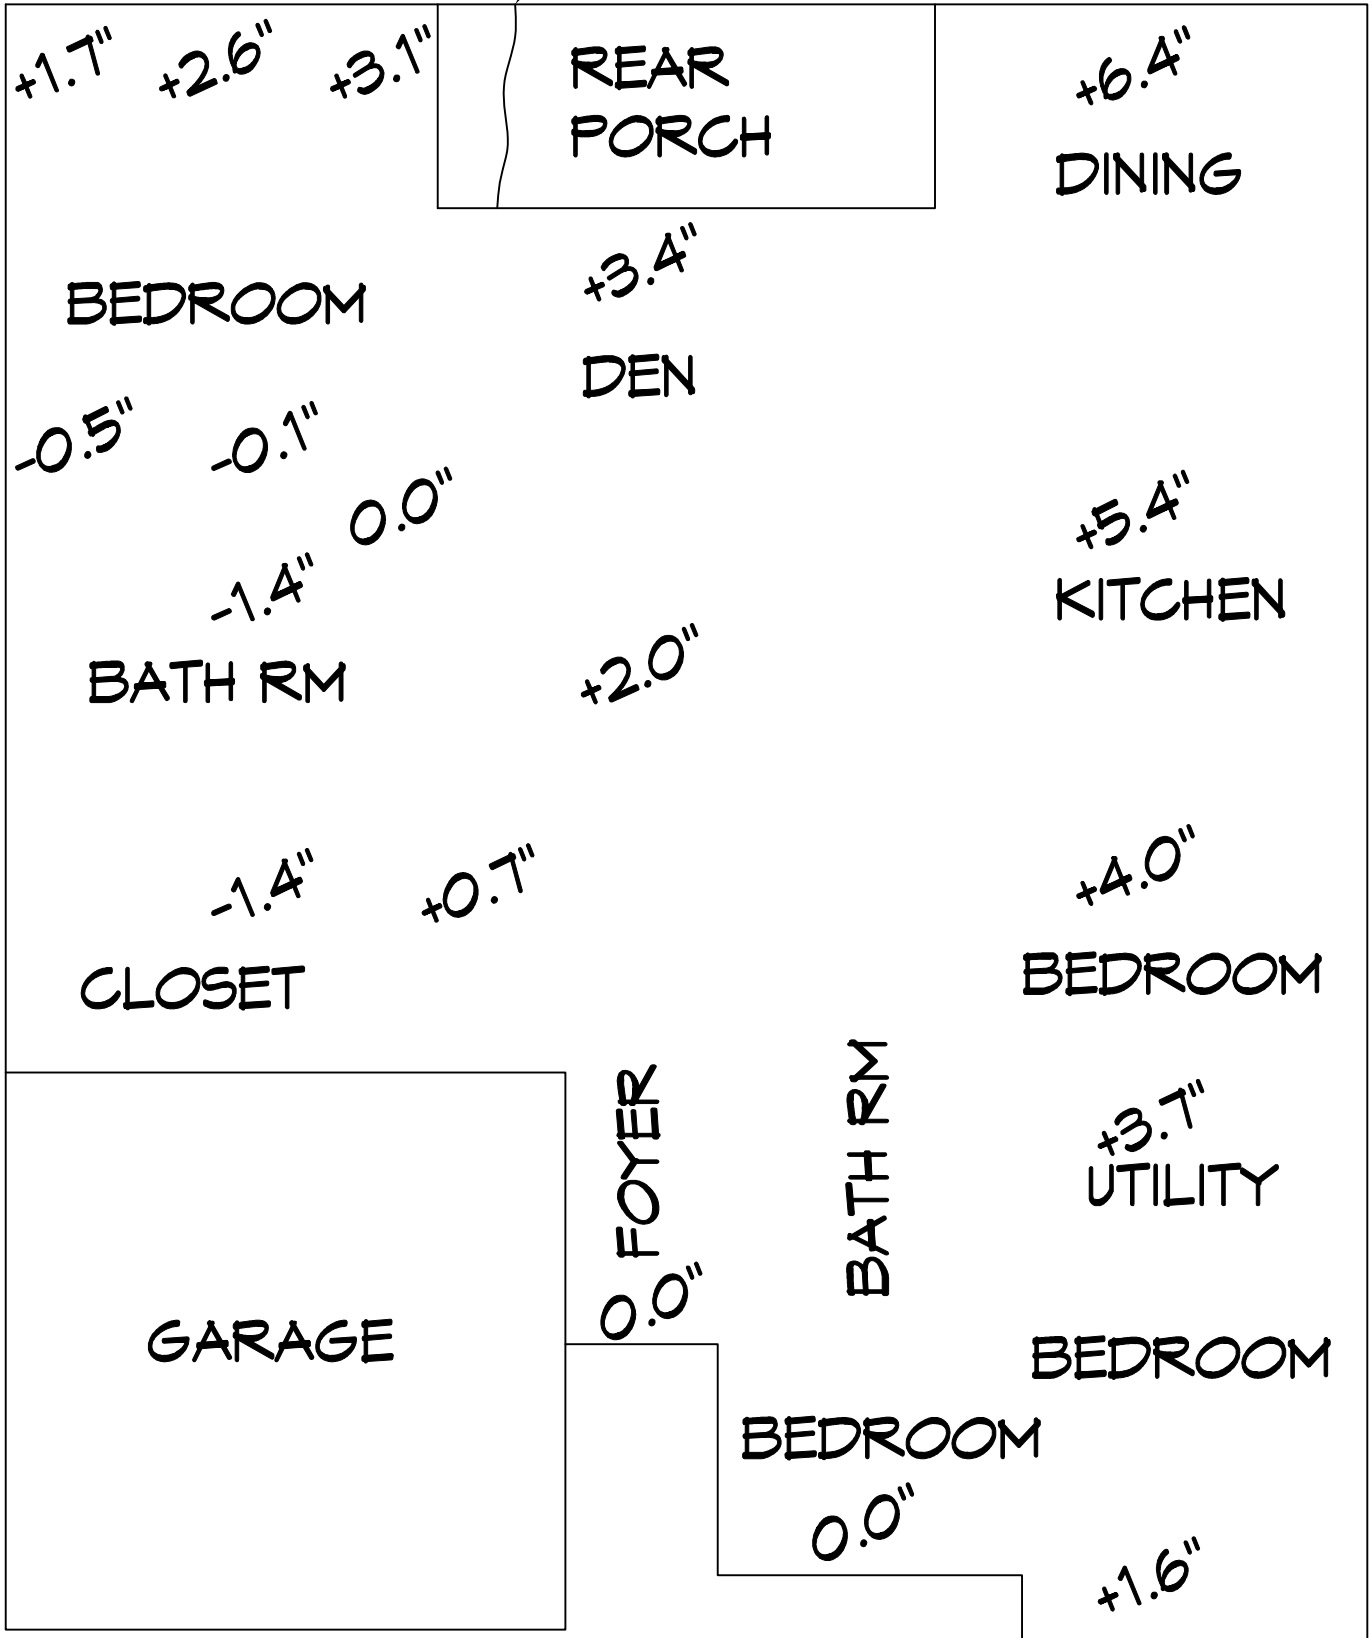
There is one small hairline crack in the foundation noted in the rear porch area and runs up the foundation to inside. There are no signs of stress in the sheet rock ceilings or walls. All interior doors open and close, the garage door swings closed by itself. All ceilings and walls appear visually straight.

HAIRLINE CRACK

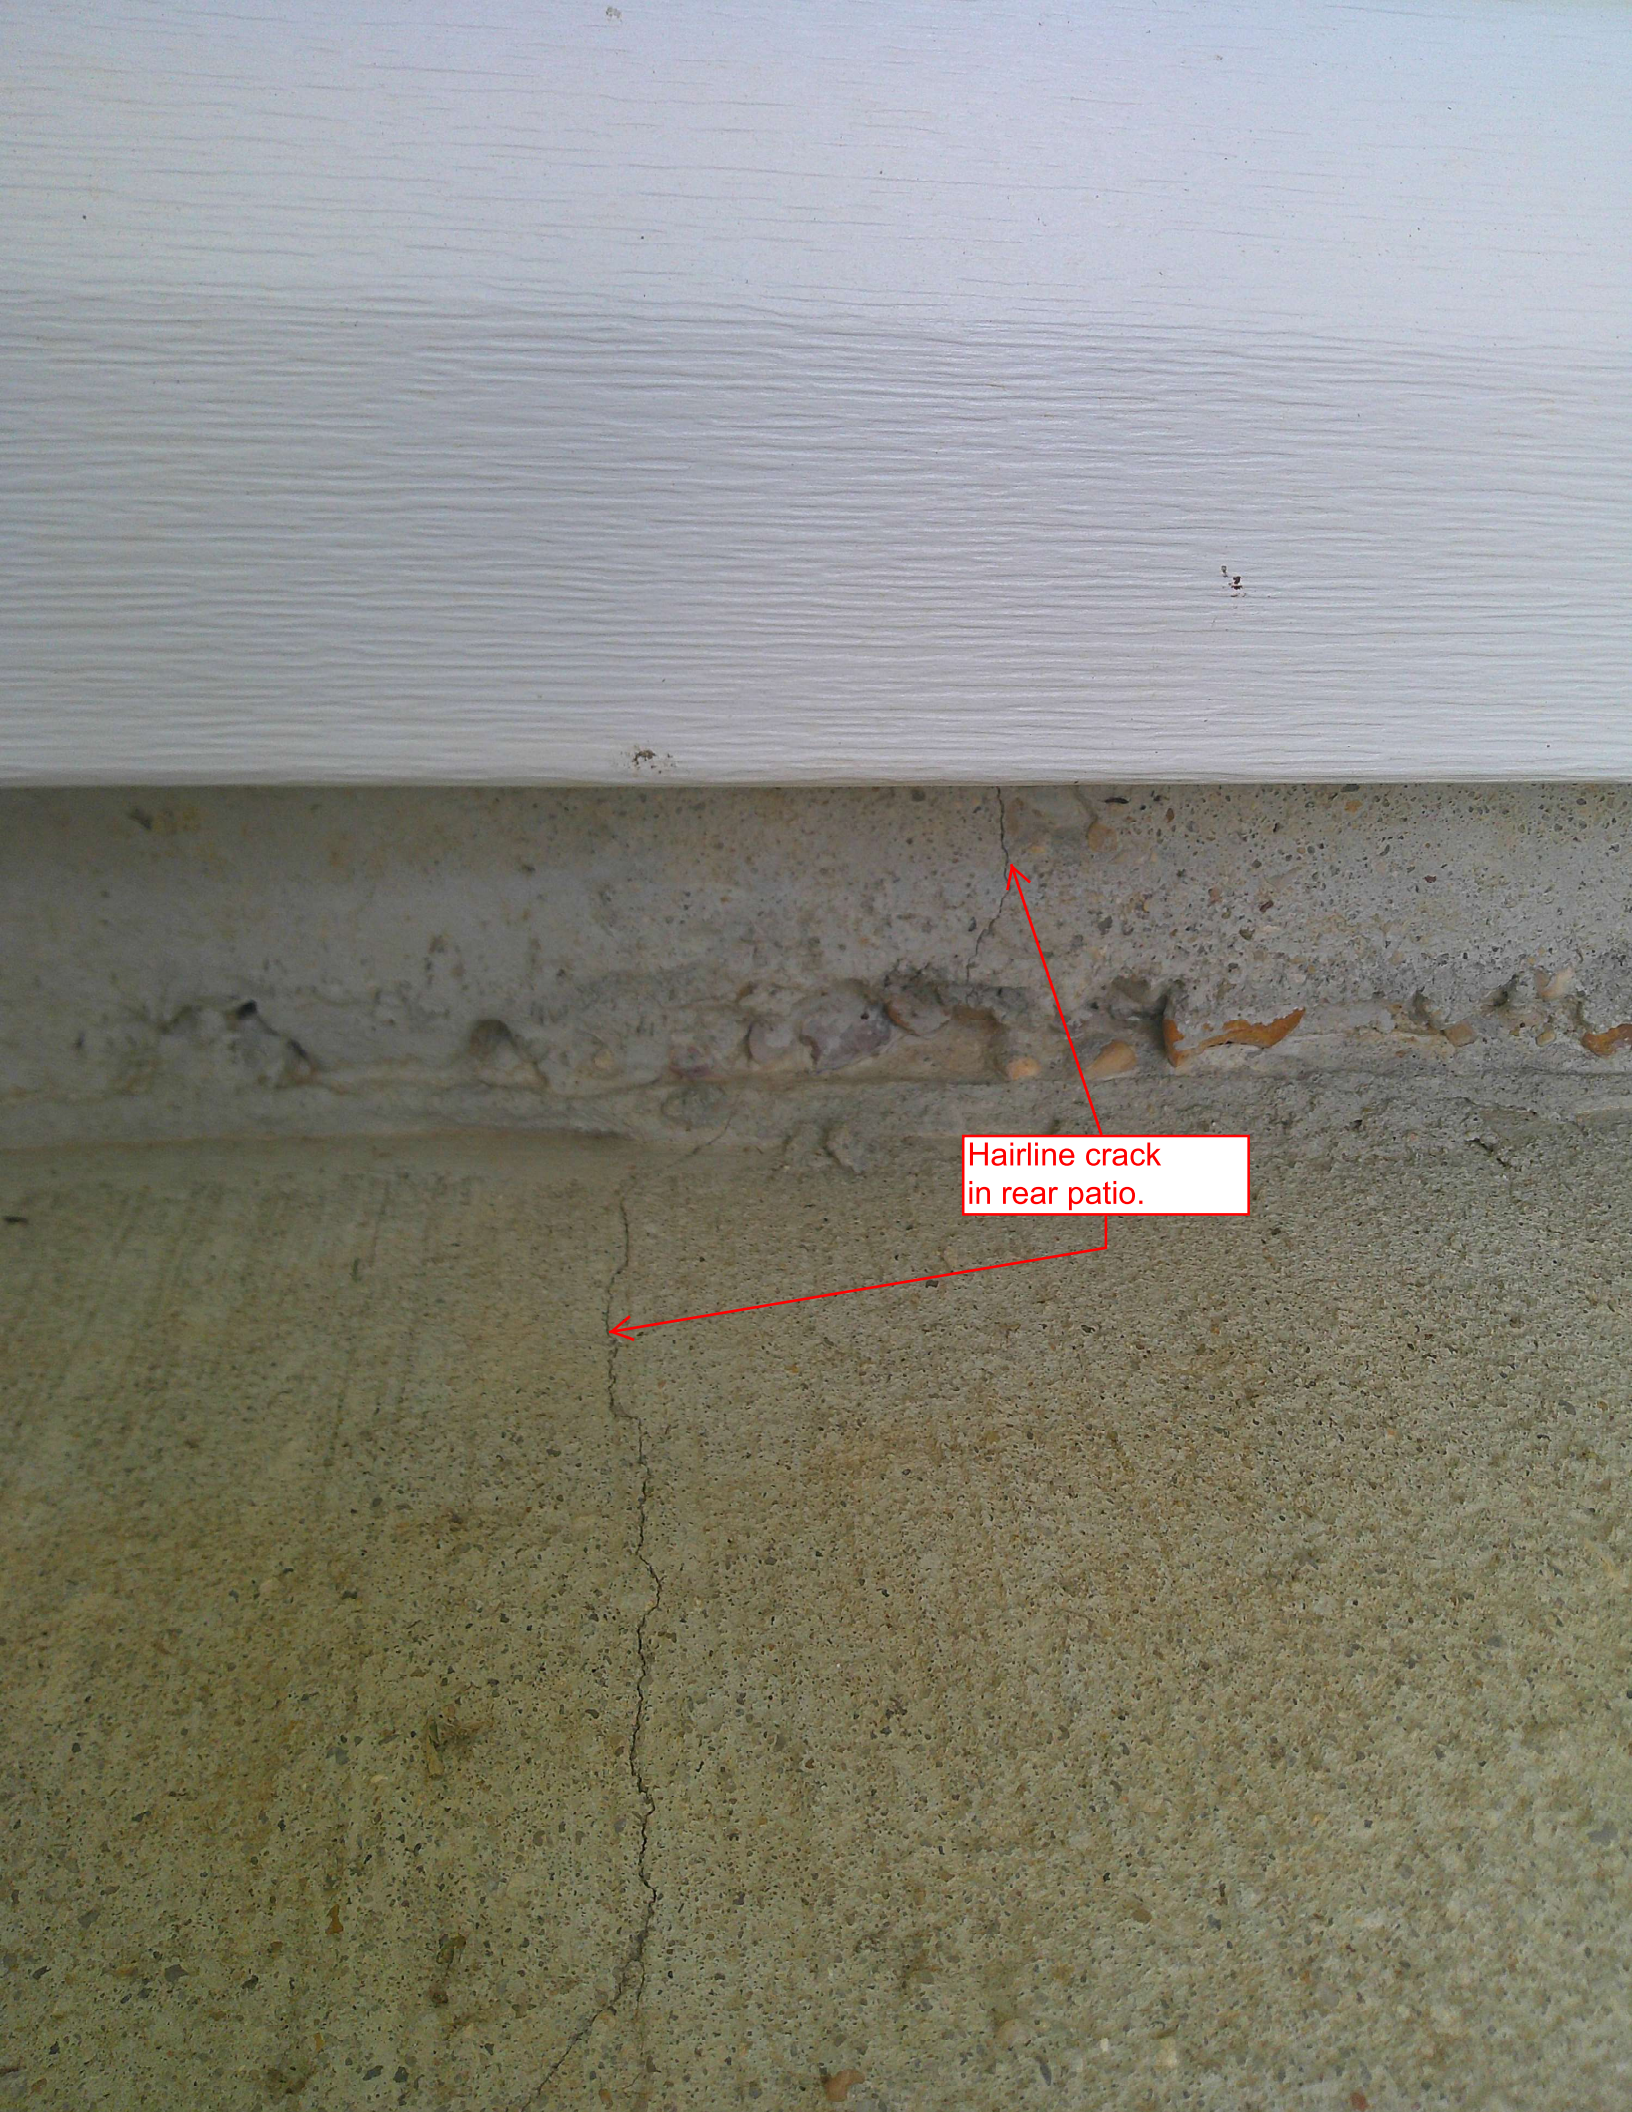
The exterior of the home was noted to have gutters and downspouts that drain directly onto the ground. The downspouts on the left side of the home drain directly onto the ground and have caused a washout of the ground. This area stays wet.

Washout from
downspout

Hairline crack
in rear patio.
