Structural Inspection

June 12, 2024

Re: 73419 Allen Road
Abita Springs, La. 70420

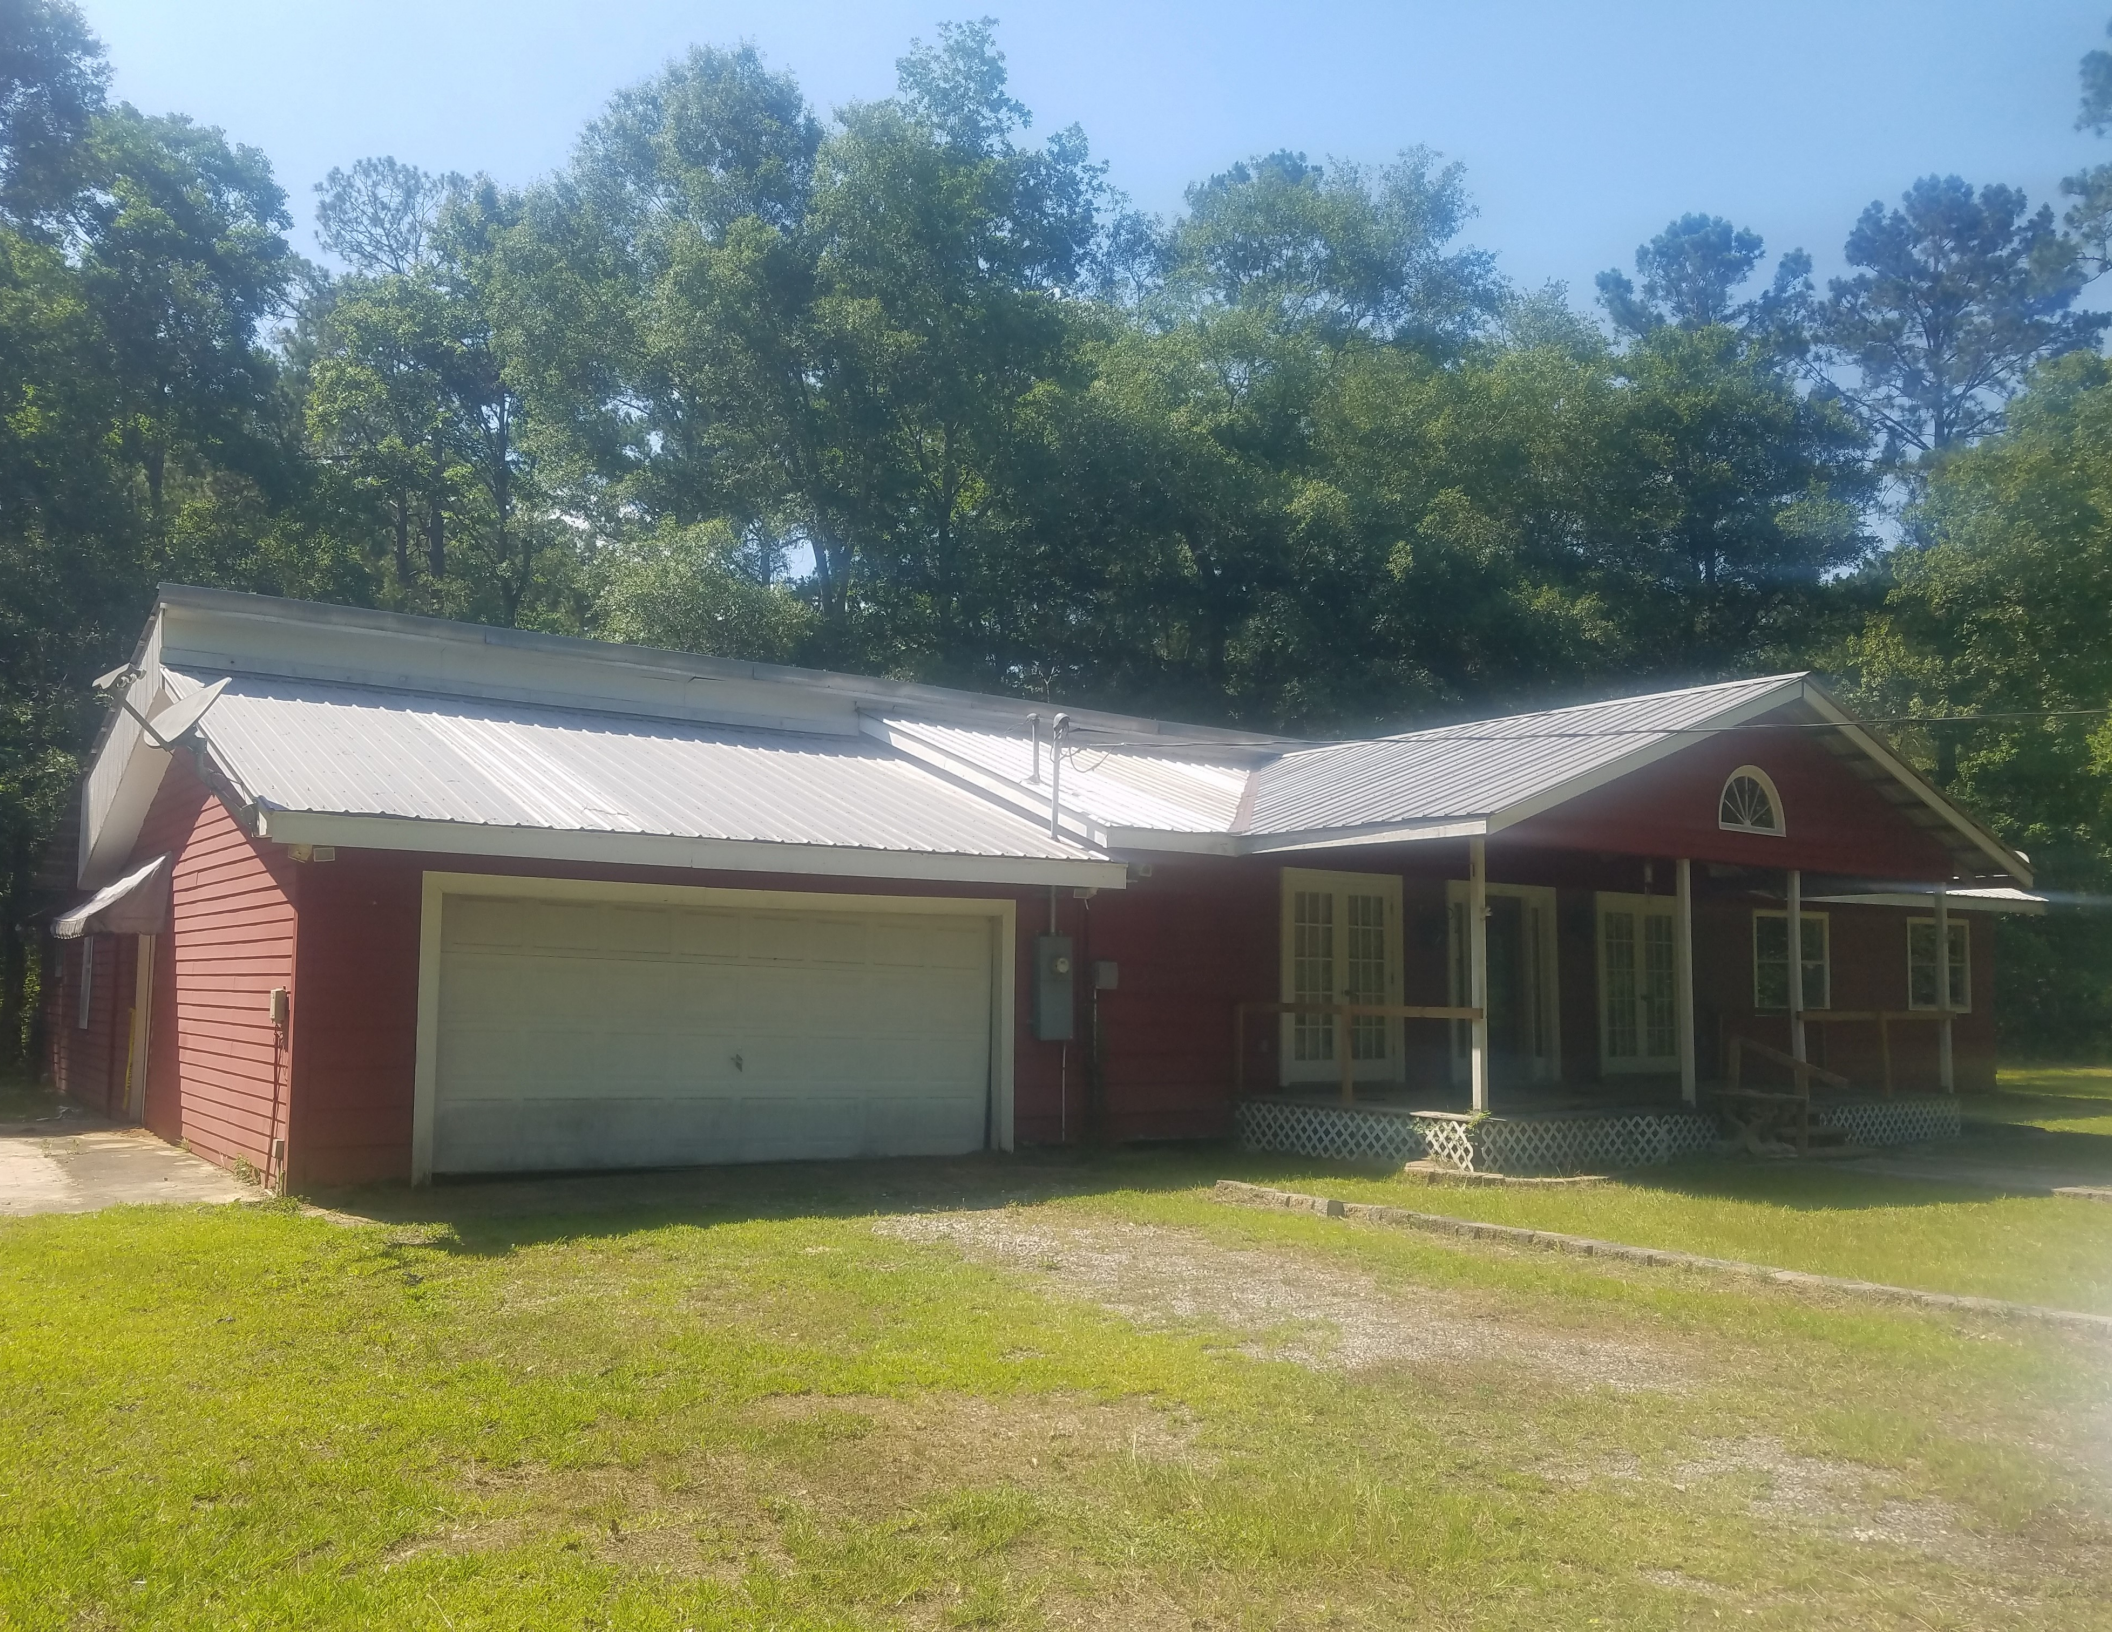
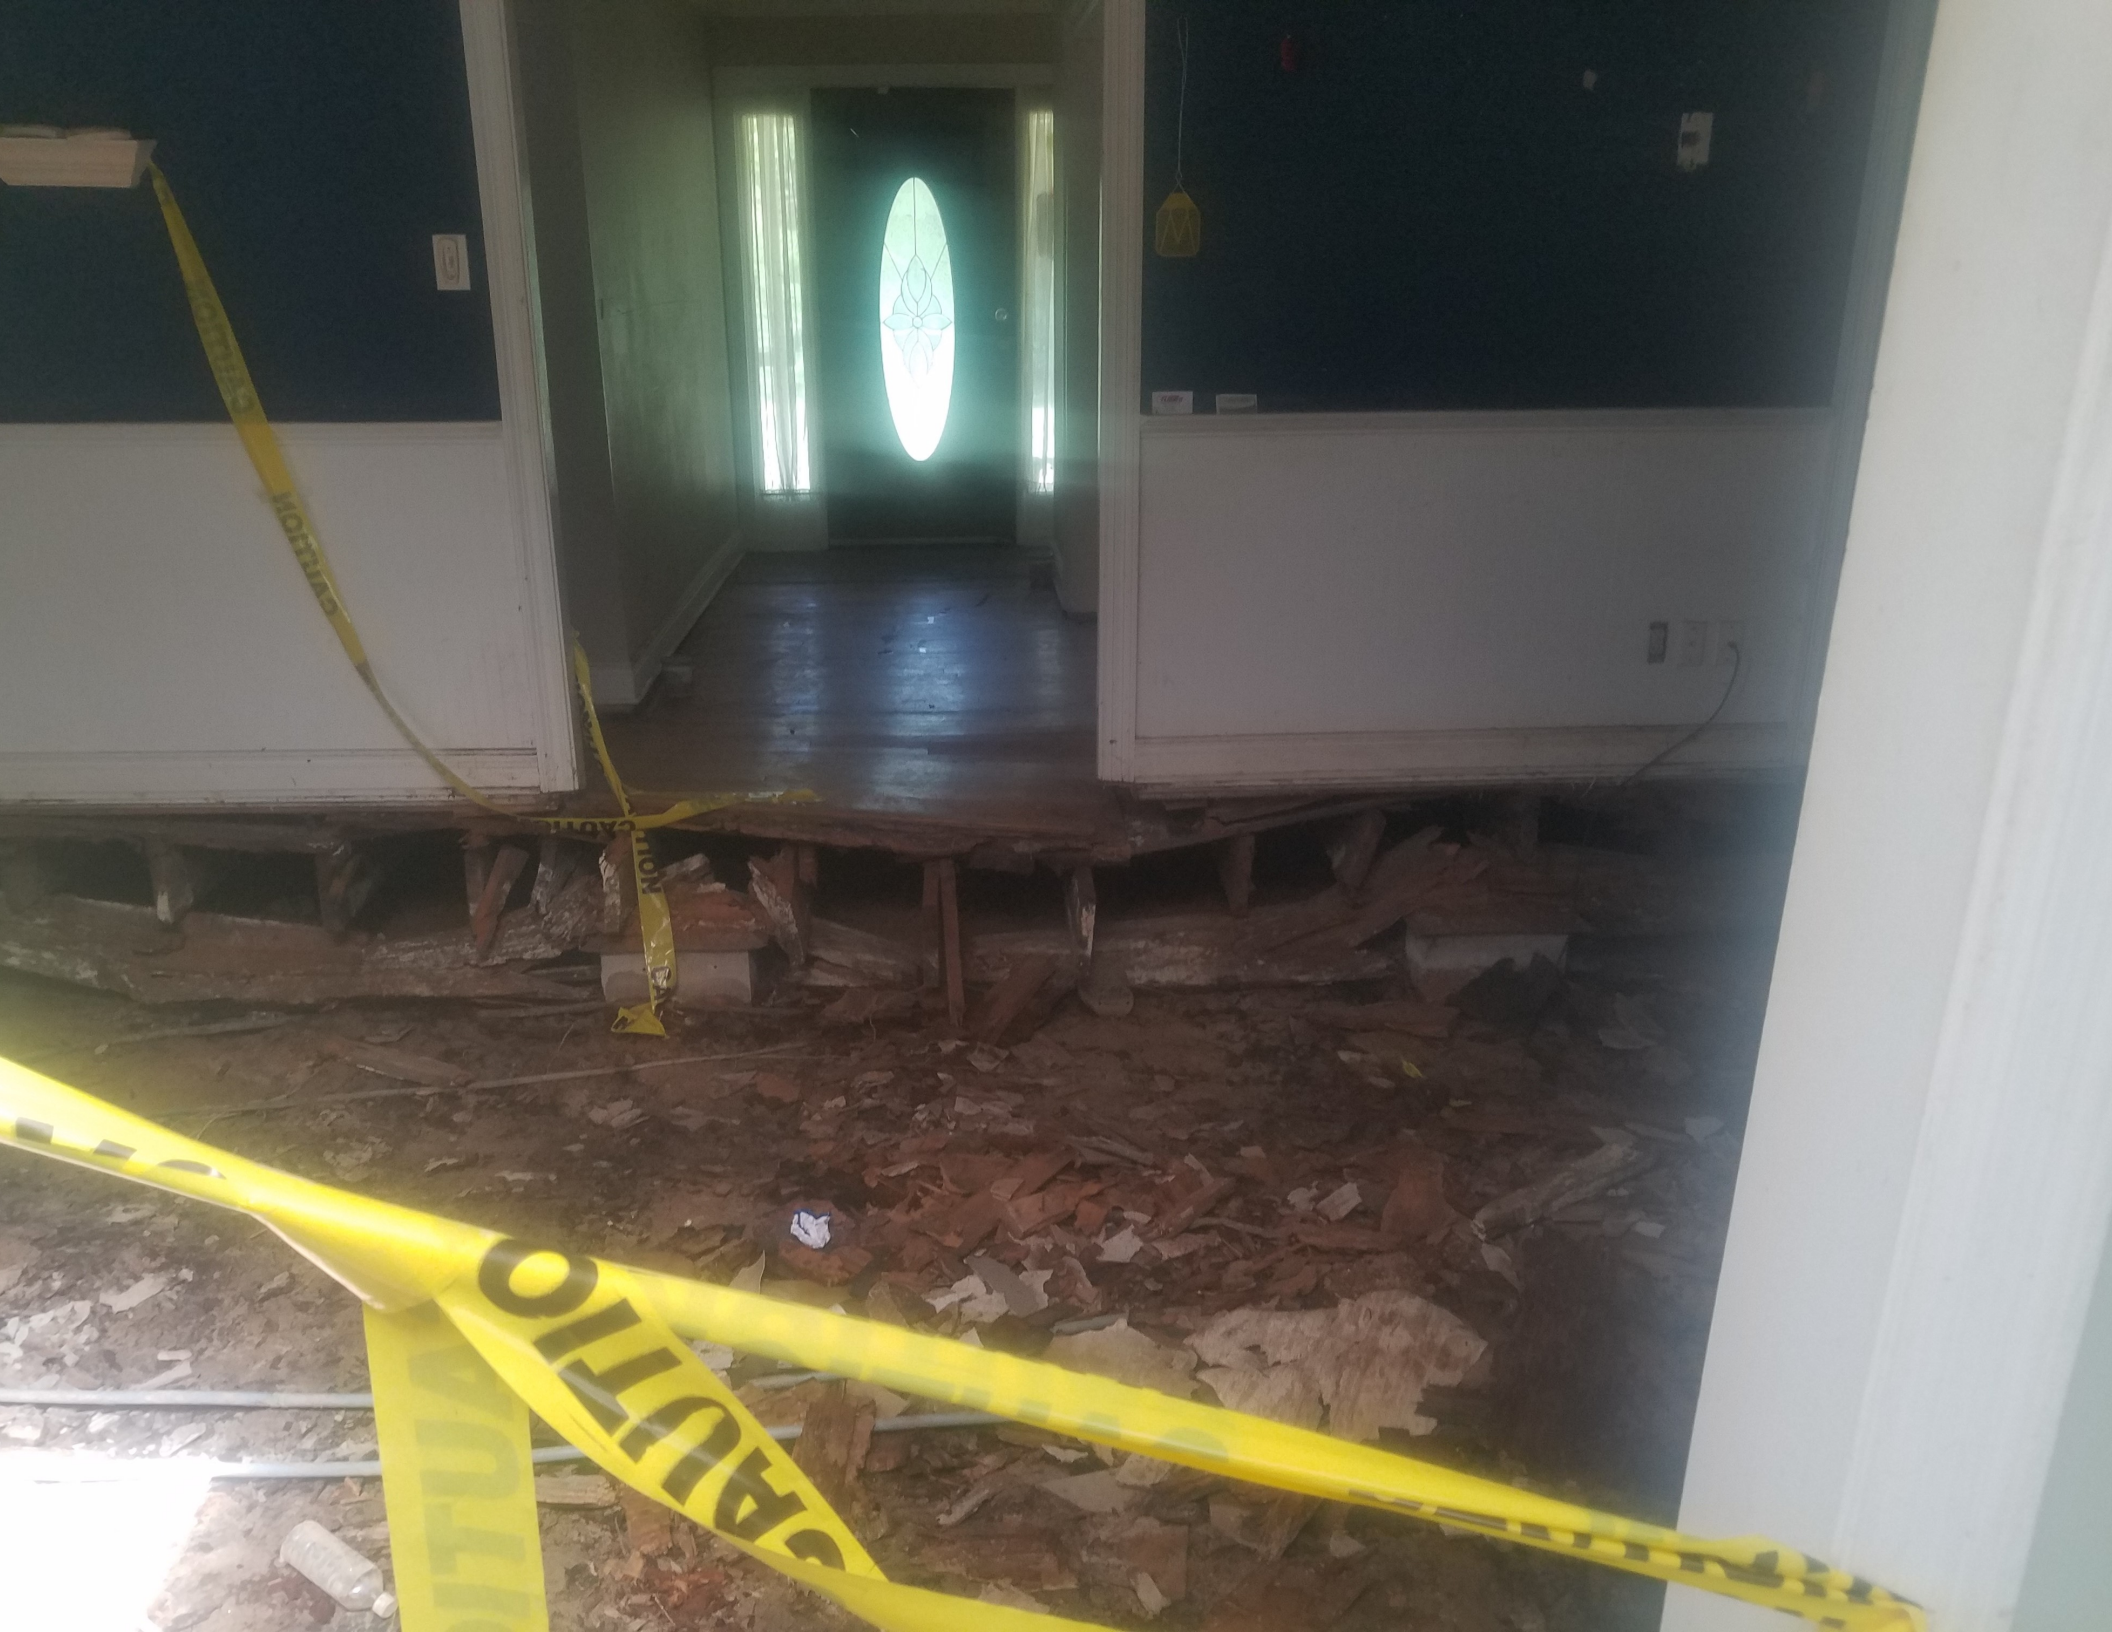
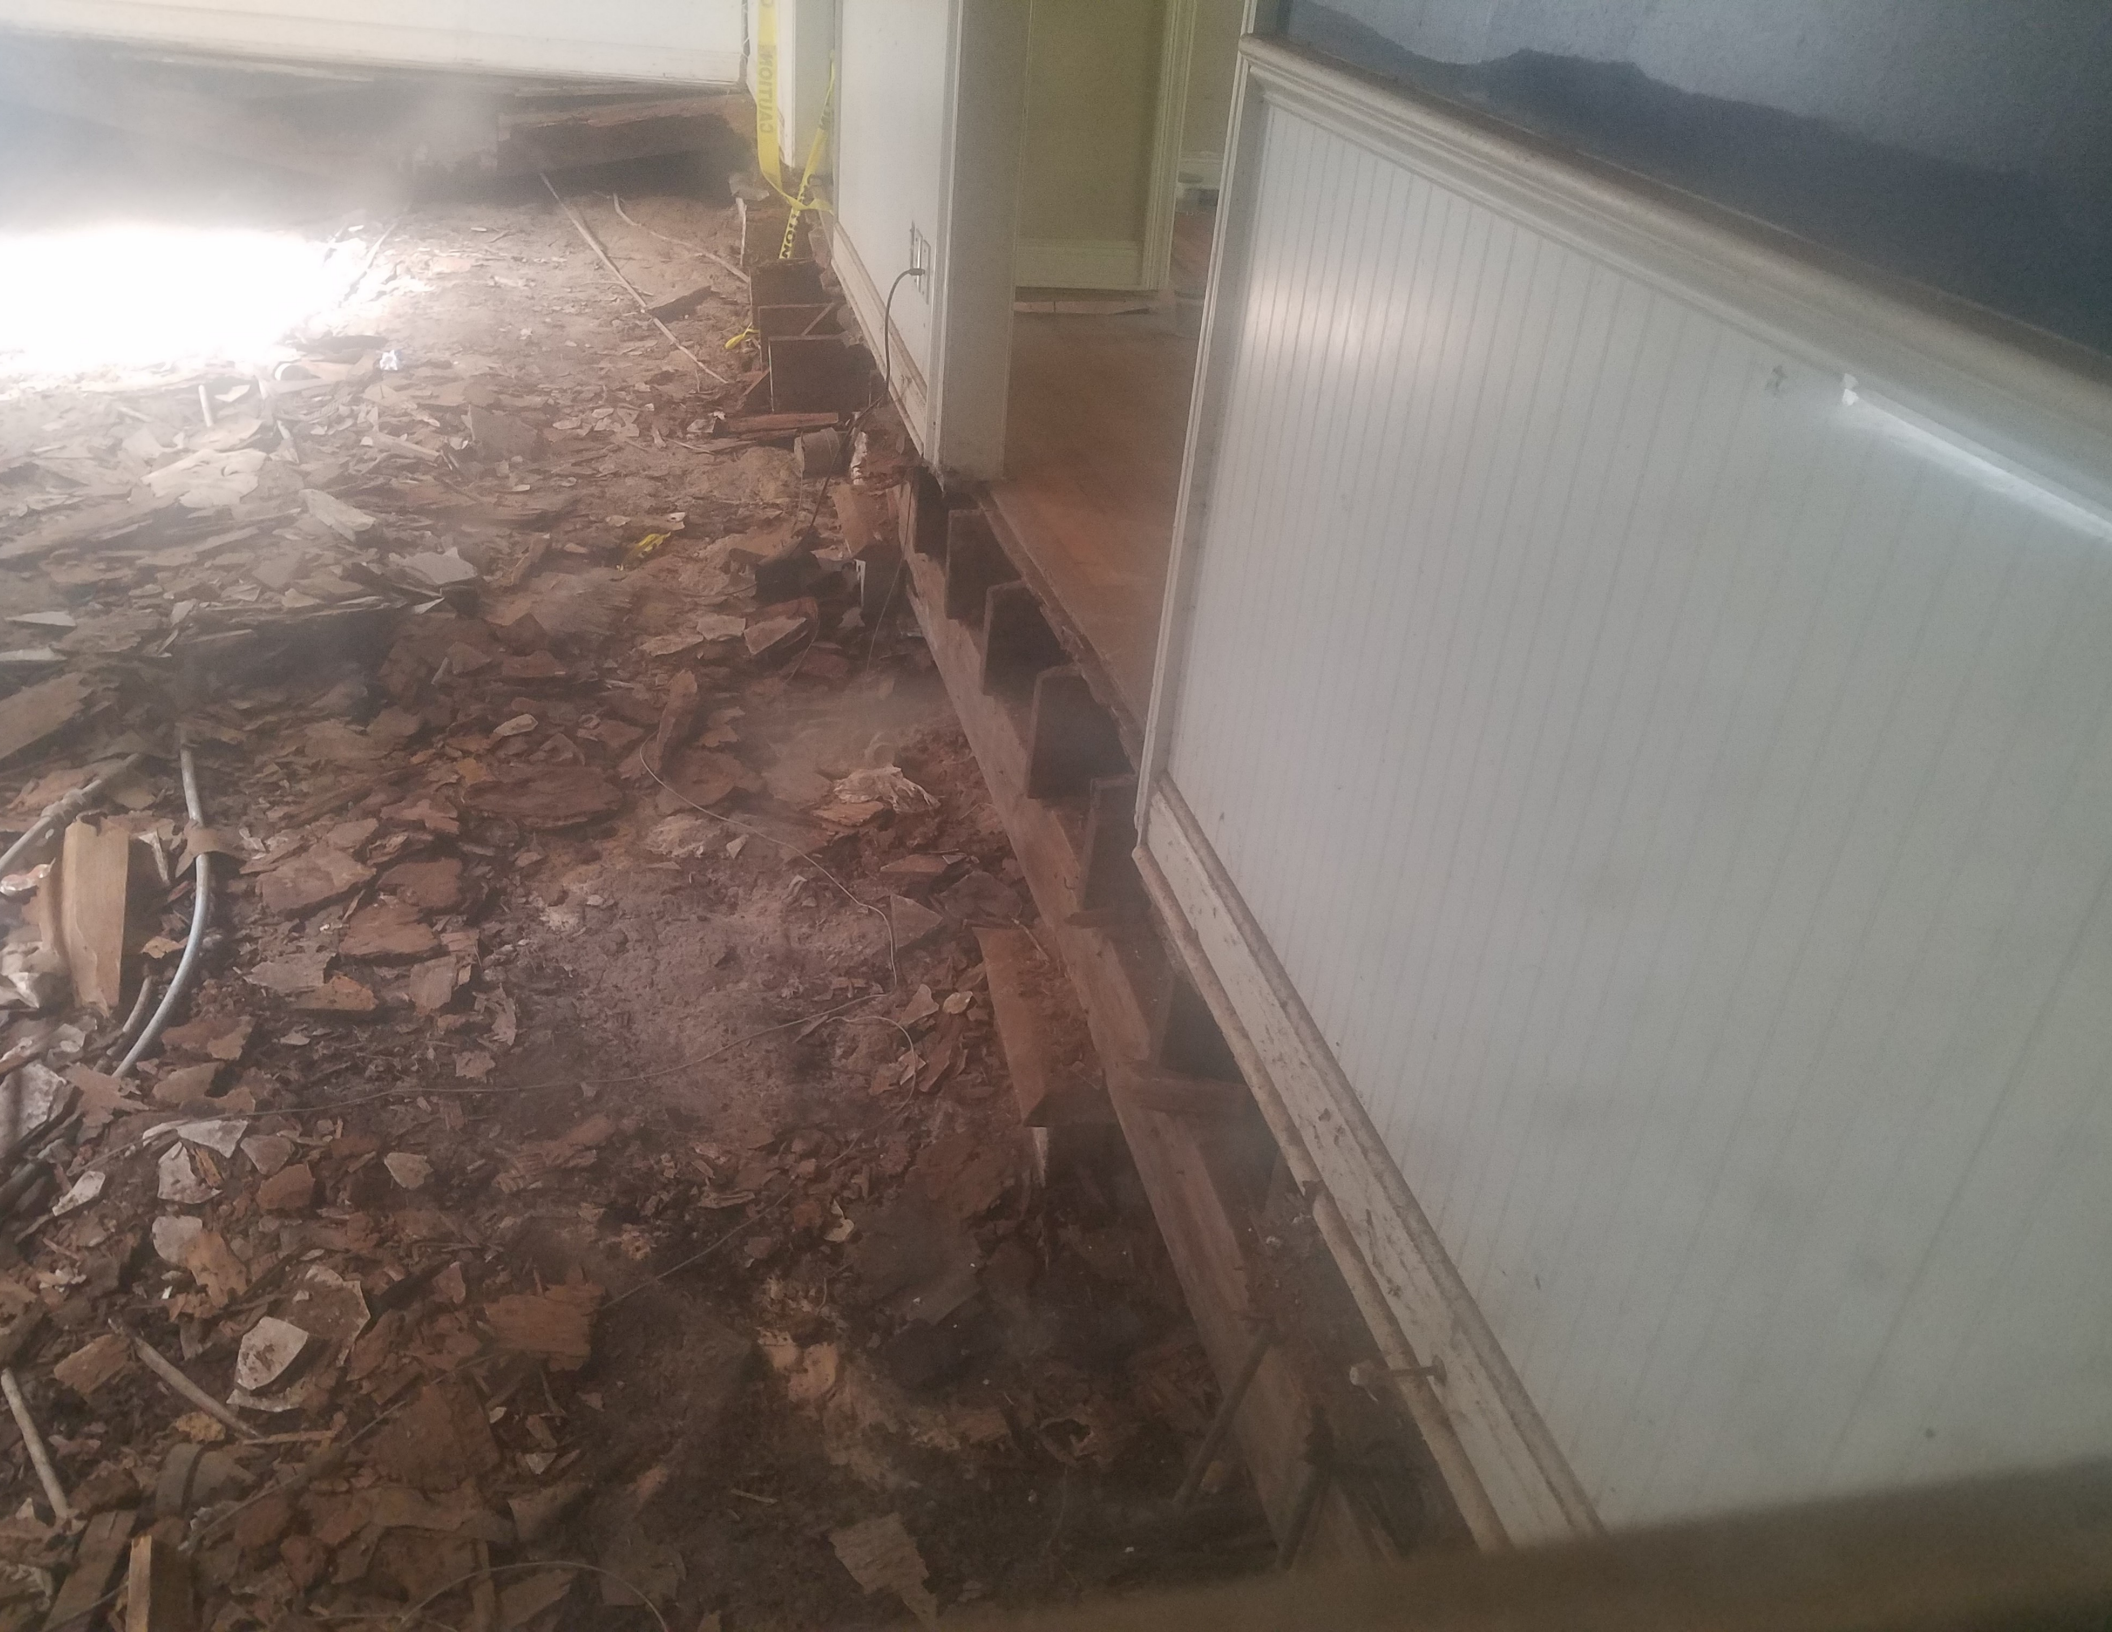
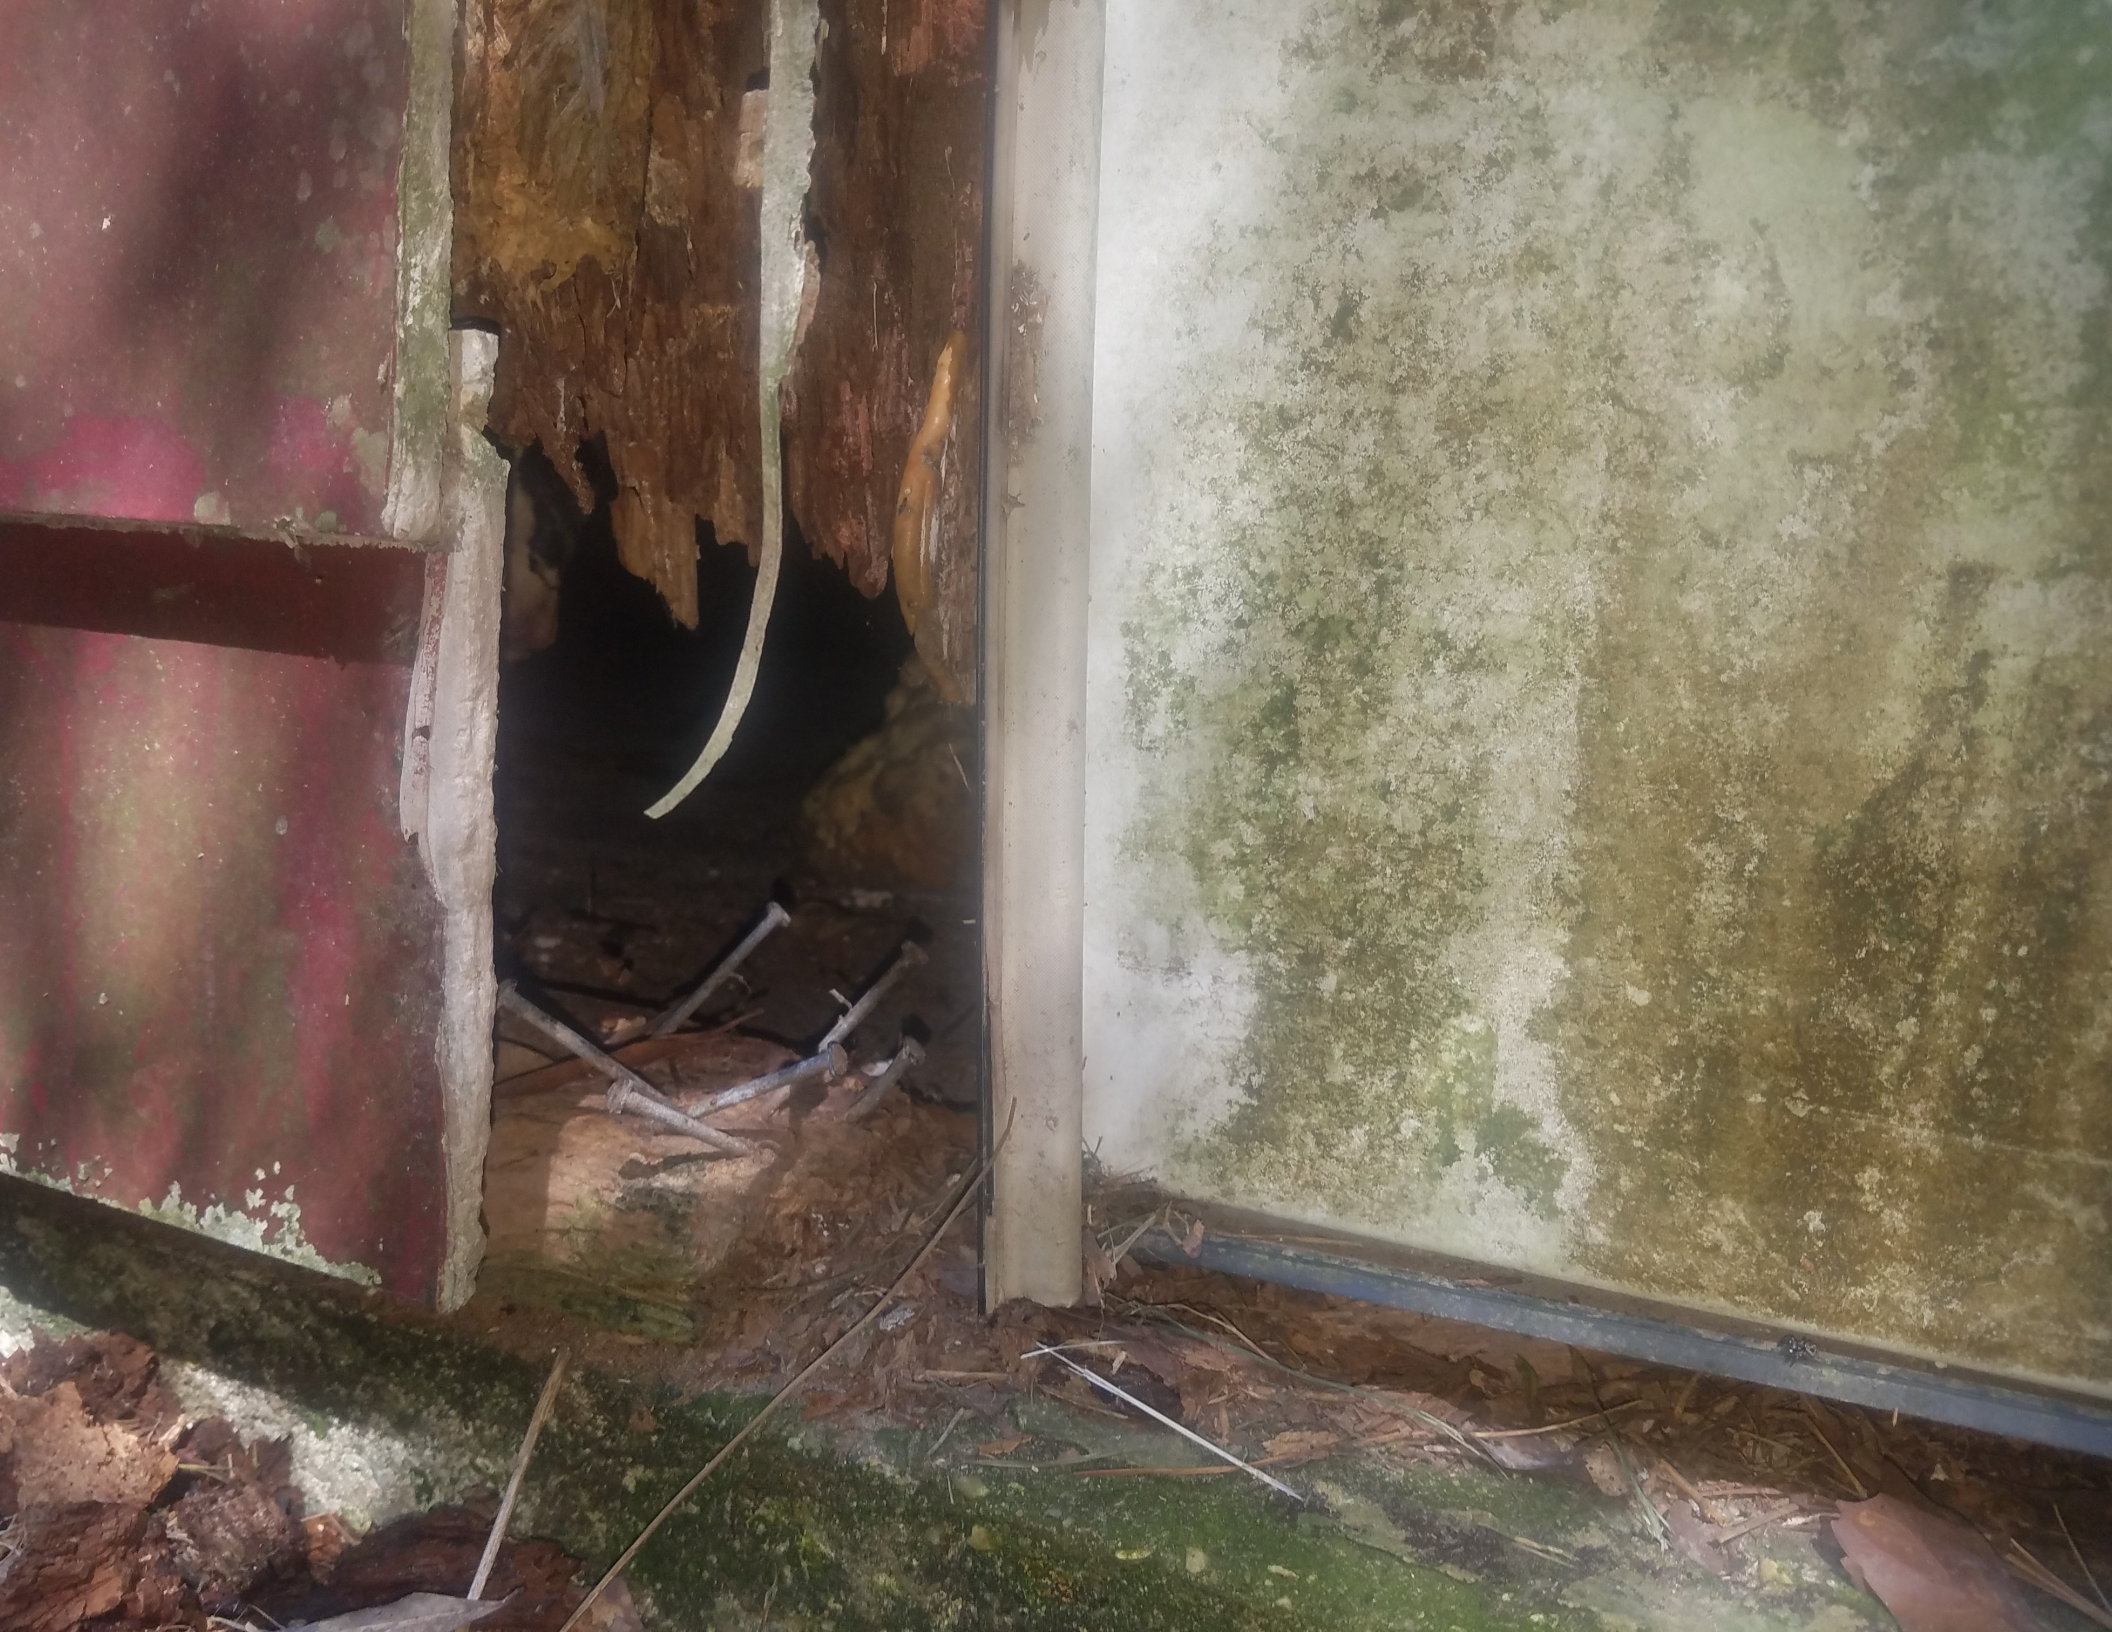
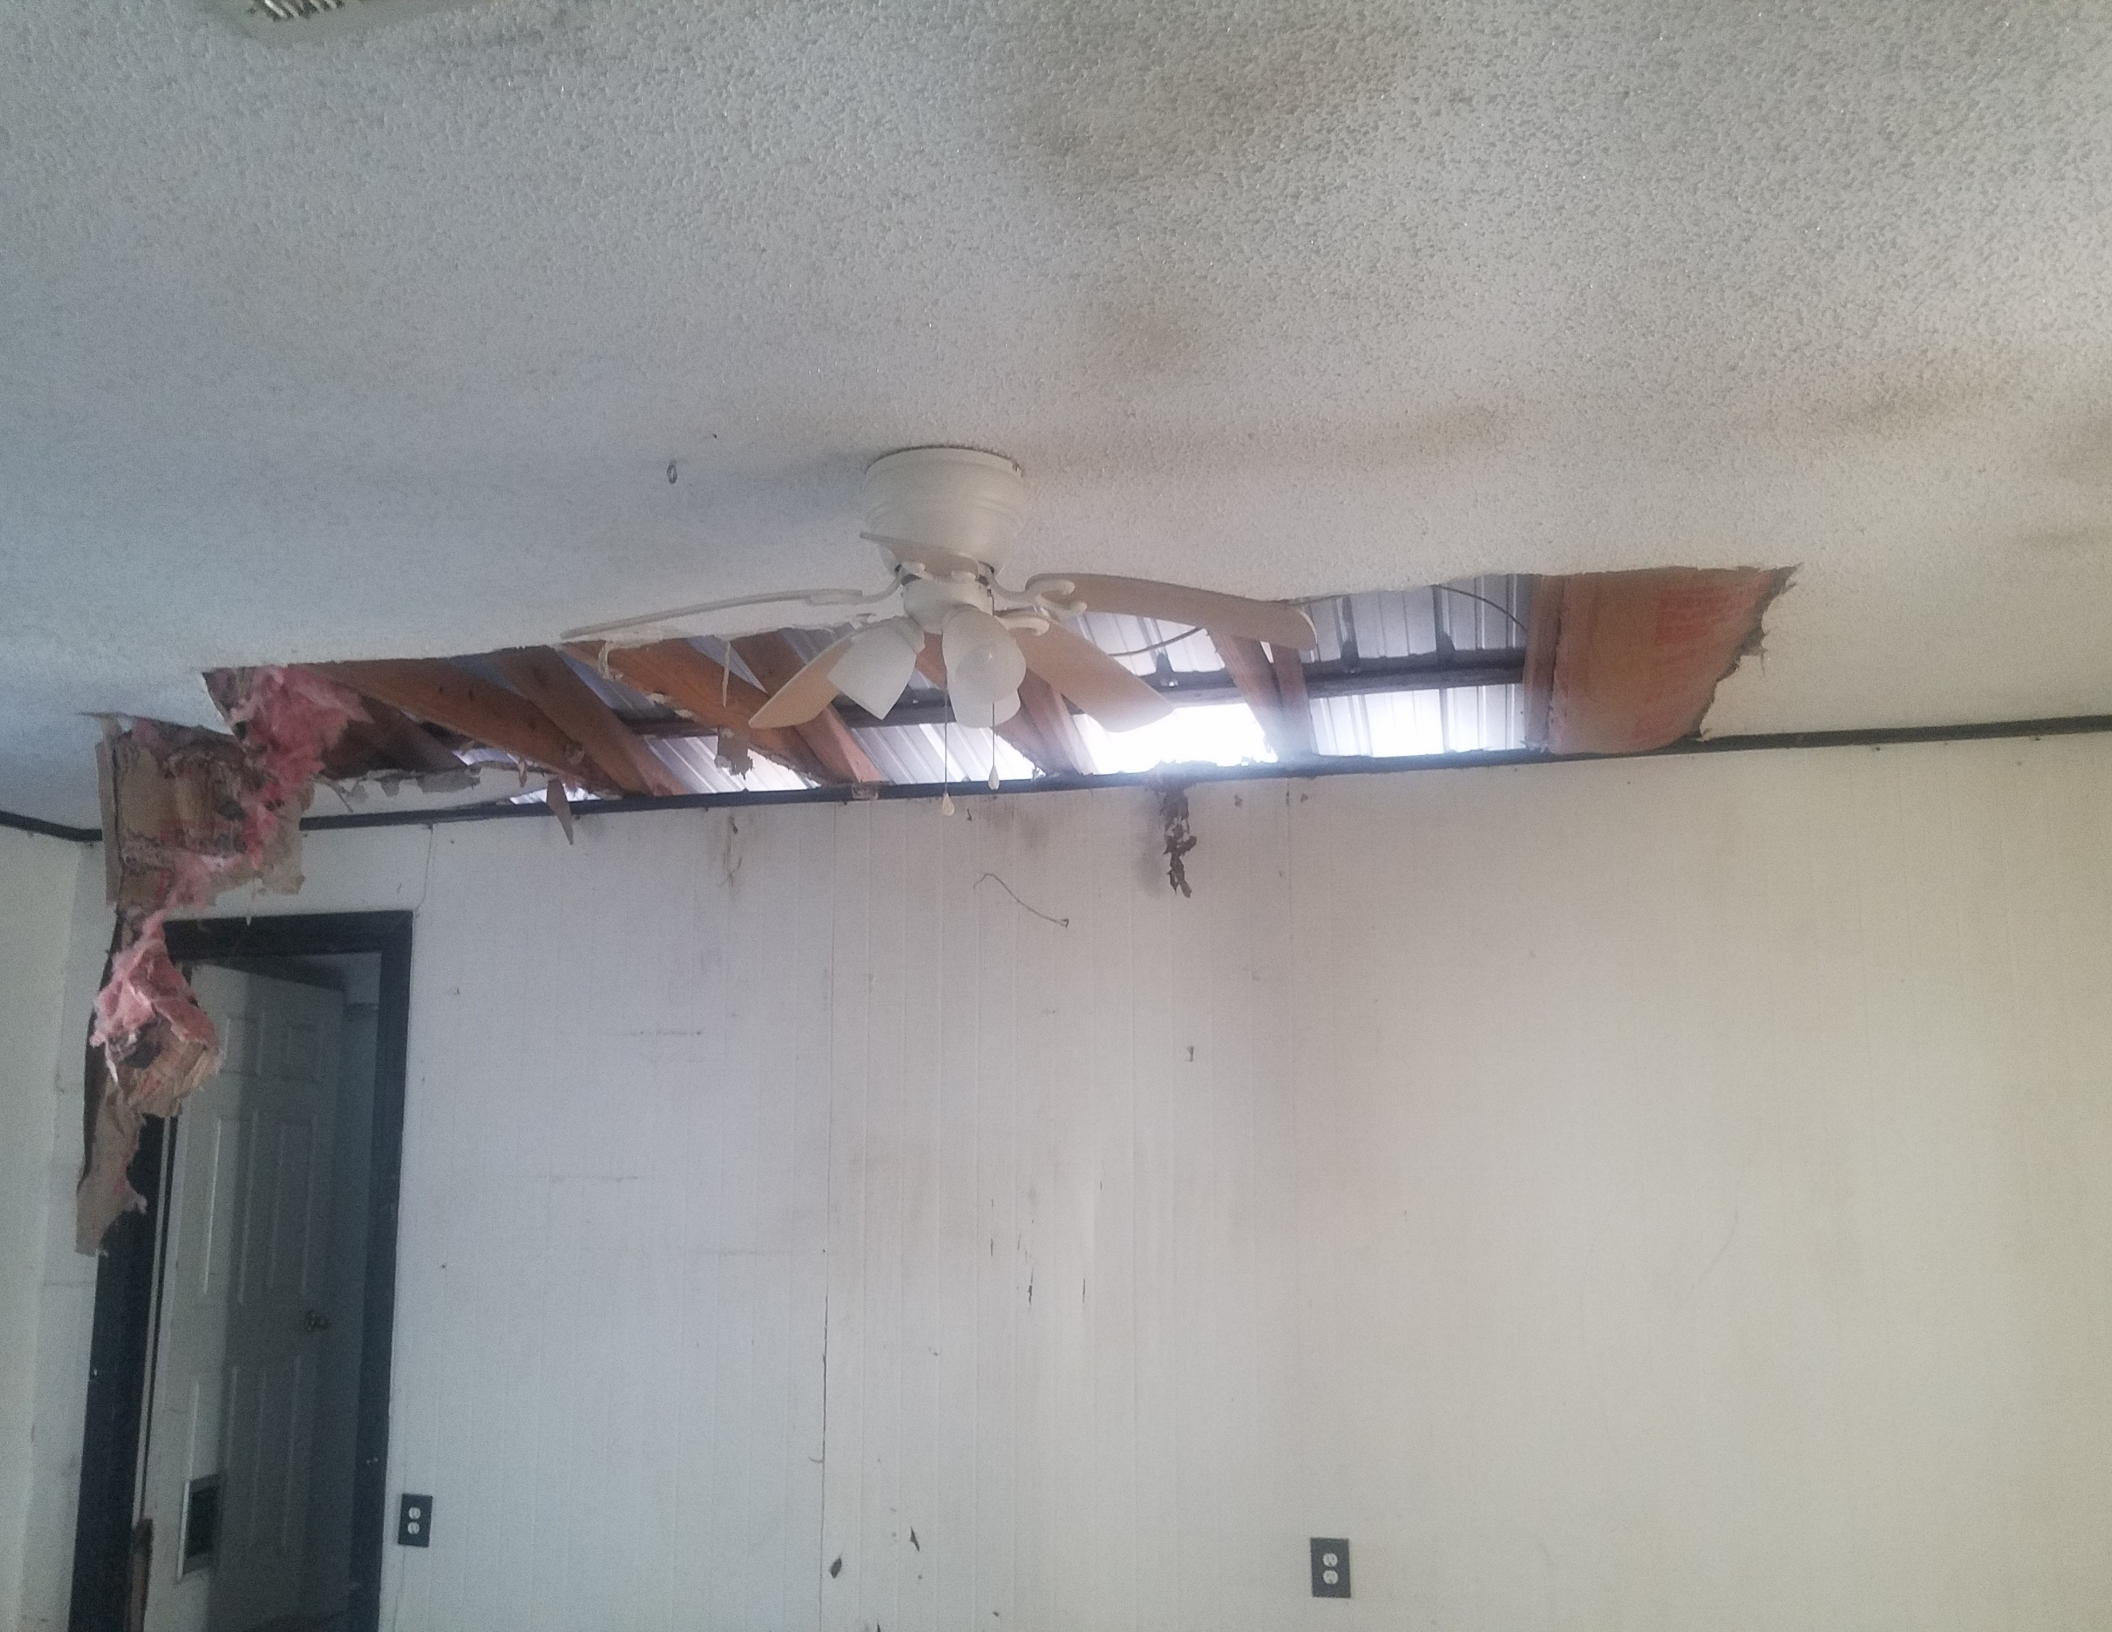
See attachments;
Pictures

Upon inspection of the interior of the home, it was noted that there is major structural water & termite damage to all the wood floor joist and wood beams including the roof trusses. Due to the unsafe conditions of this home, it is recommended that it be demolished.
