Amrize

Honey Island Sand and Gravel

Dammon Engineering was retained by Honey Island Sand and Gravel Inc. to investigate the structural integrity and repairability of the Sand and Gravel Separation Plant.

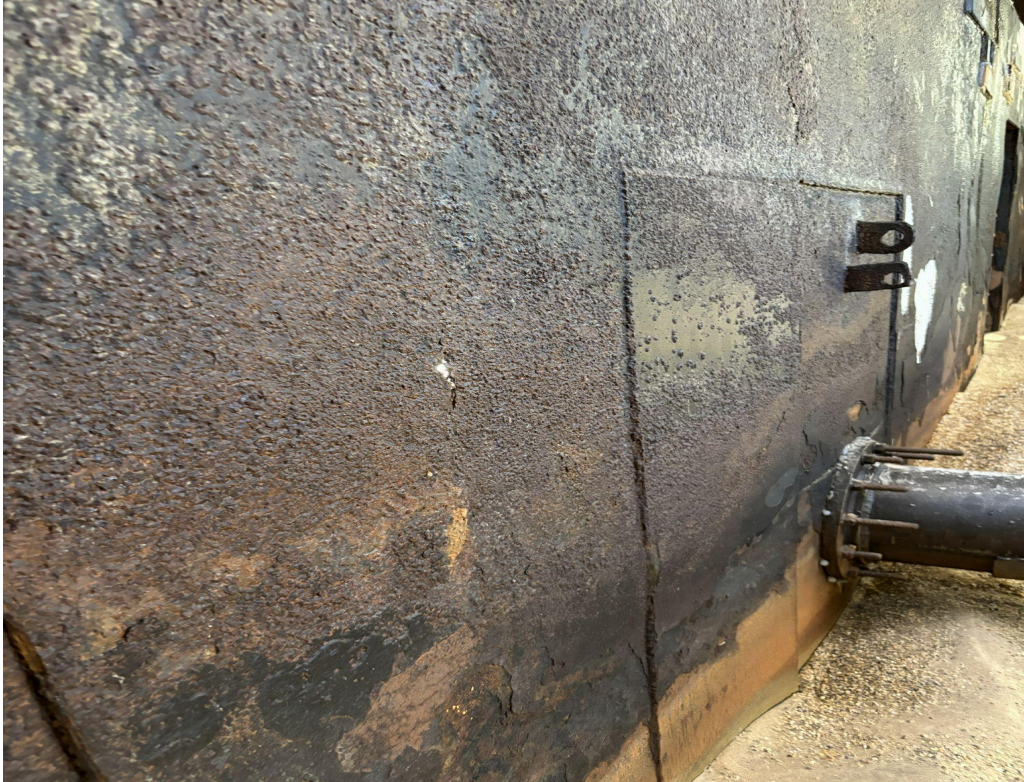
(Photo A) Exterior view level one looking northeast

Level one: This level exhibits moderate to severe corrosion on interior structural support. Additional framing has been added in the past to shore up original framing. Exterior plates (photo A) show moderate to heavy surface scaling and several areas have been replated at previous dates. Interior plates (photo B) show moderate to heavy surface scaling. Process Water inlet feed line flanges appear in good shape. Access hatches appear to be in good shape. Structural framing supporting the vibratory shaker exhibits moderate scaling and additional framing has been added in the past to shore up original framing.

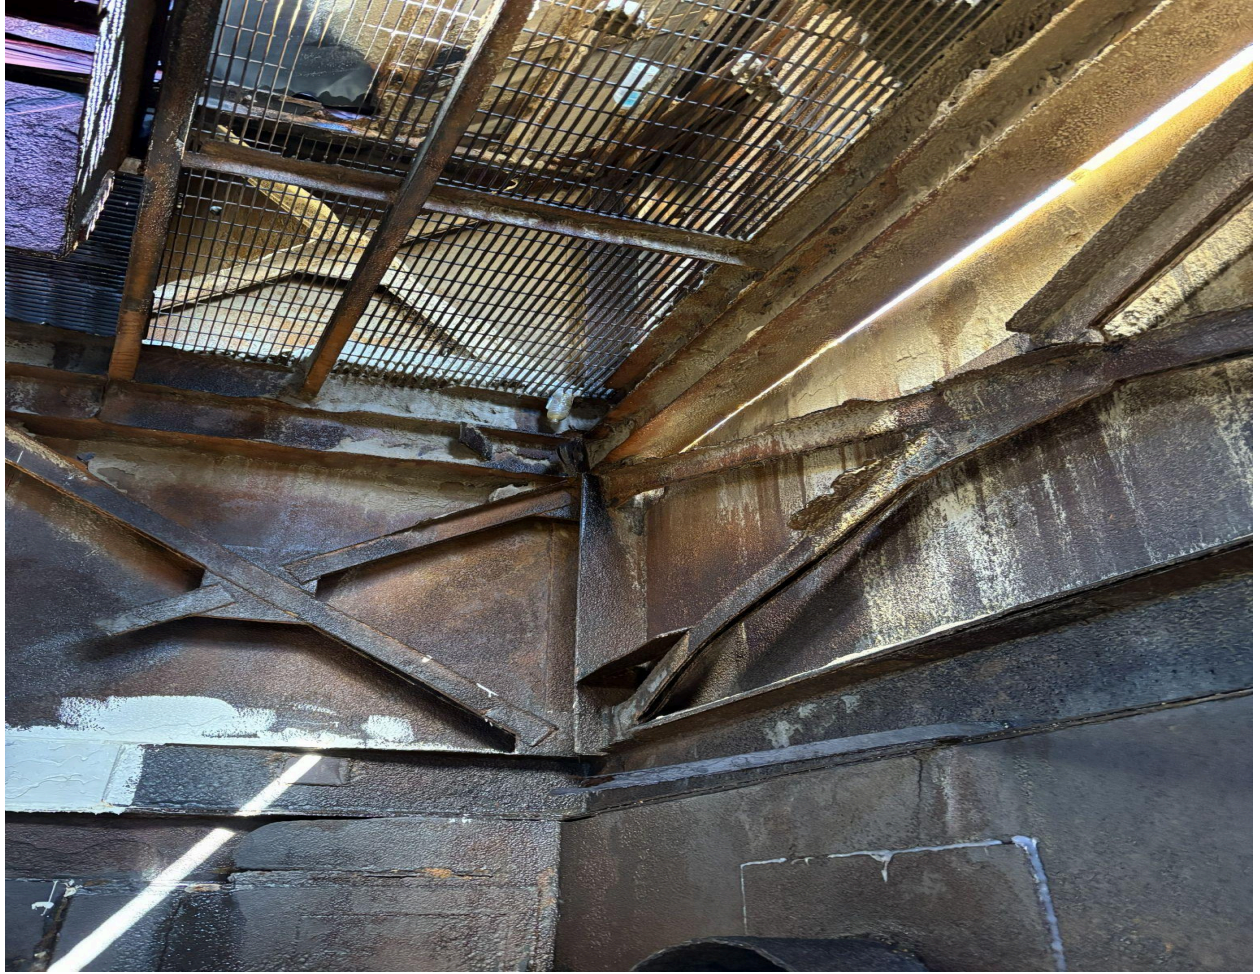
(Photo C) interior view level two looking northwest

Level two: This section exhibits severe corrosion and deteriorated structural support members. Several of the lateral X bracing is completely deteriorated and missing. (photo C and D) The bottom and top wide flange framing around the perimeter between level one and two and level 2 and three is severely deteriorated and in some areas non-existent. The south exterior plating has completely separated from the structural framing. The western vertical support shows buckling at the base. (Photo E)

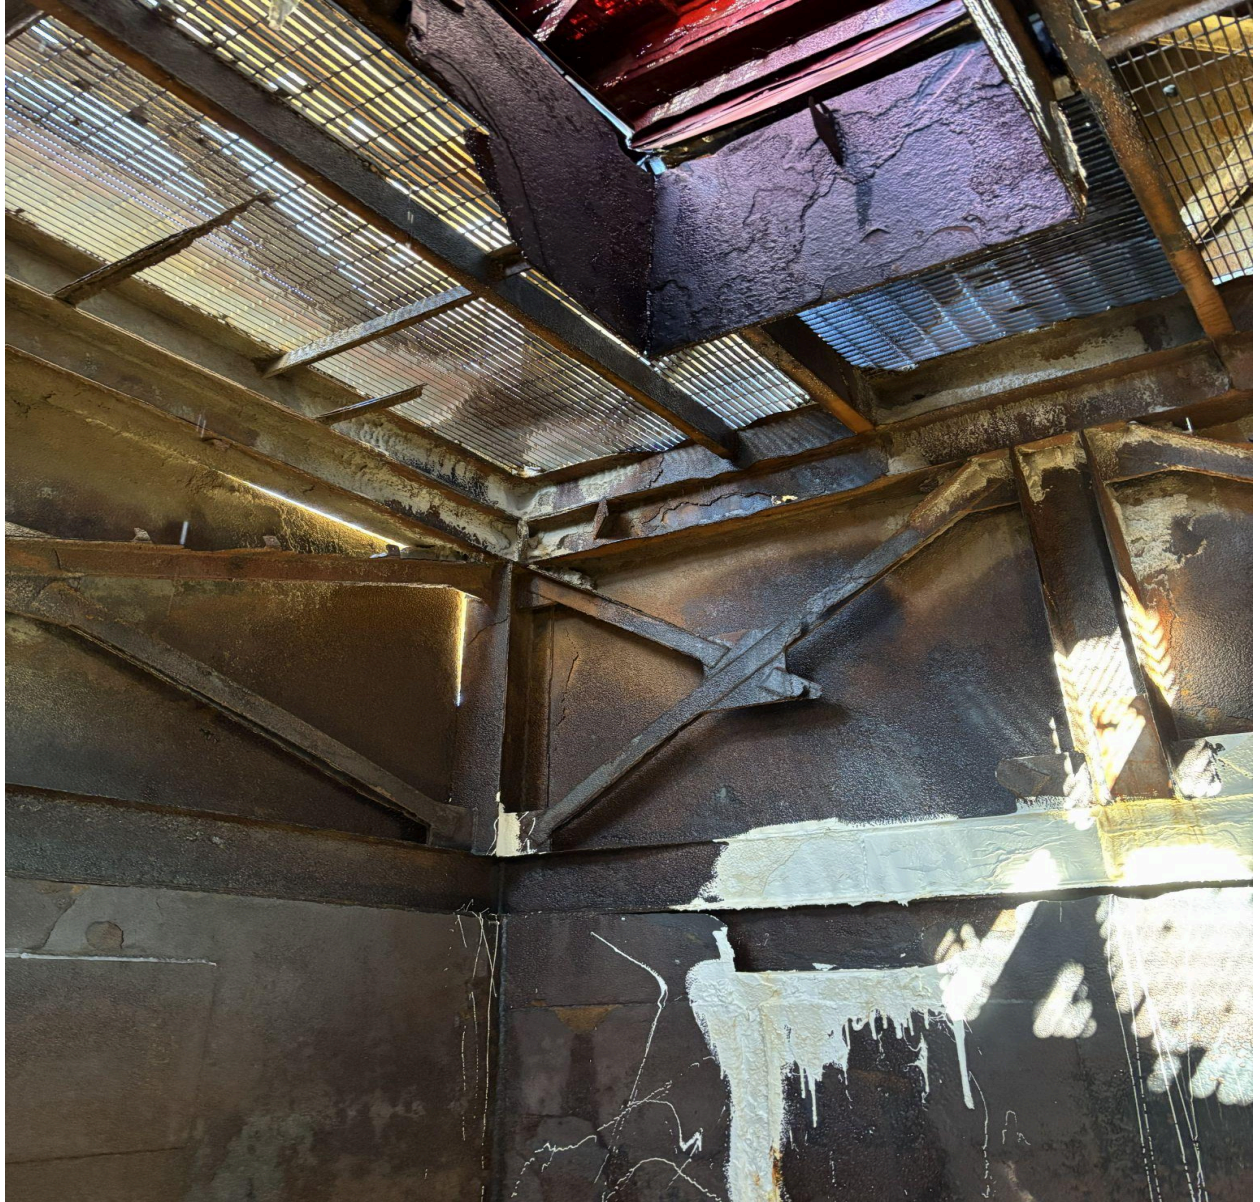
(Photo D) Interior view level 2 looking southwest

Level three: This section exhibits moderate corrosion and deteriorated structural support members. (Photo D) Floor framing and bar grating appears to be generally intact. Some plates on the hopper are completely corroded thru and missing.

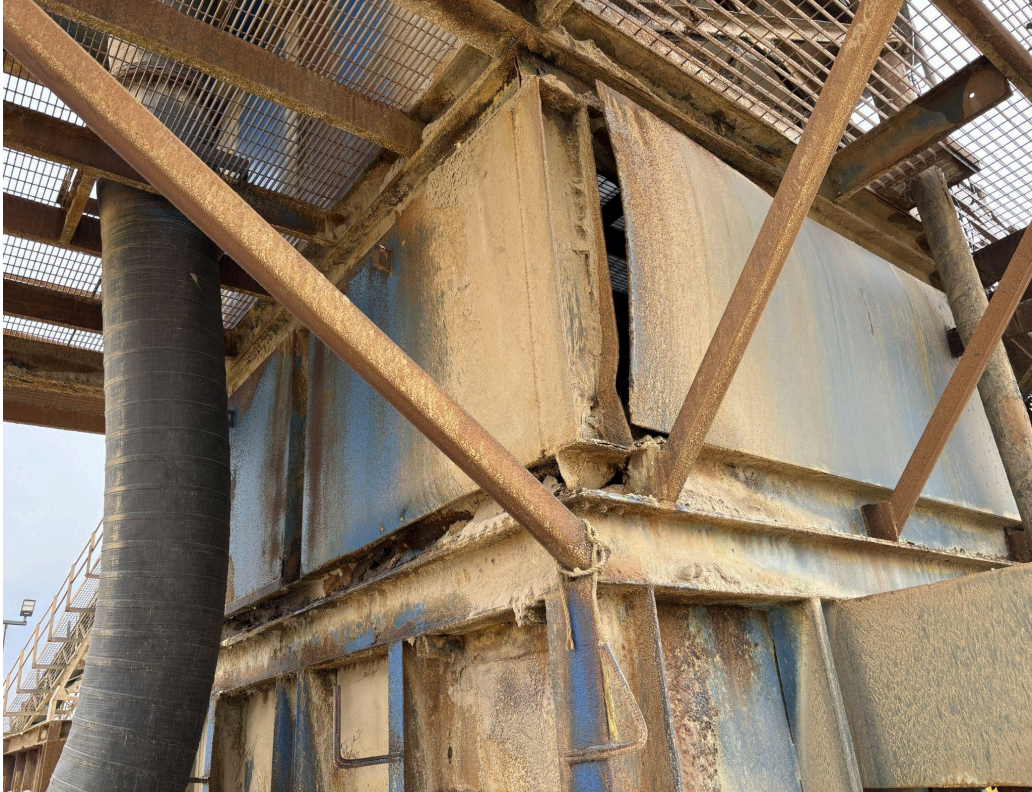
(Photo E) exterior view level 2 looking north east

Level four: This section exhibits moderate corrosion and deteriorated structural support members with one cross member completely corroded and missing. (photo E)
