## Structural Inspection

11-14-2023

Ref: NLP 25 Tractor Supply  
2083 Gause Blvd.  
Slidell, La. 70460

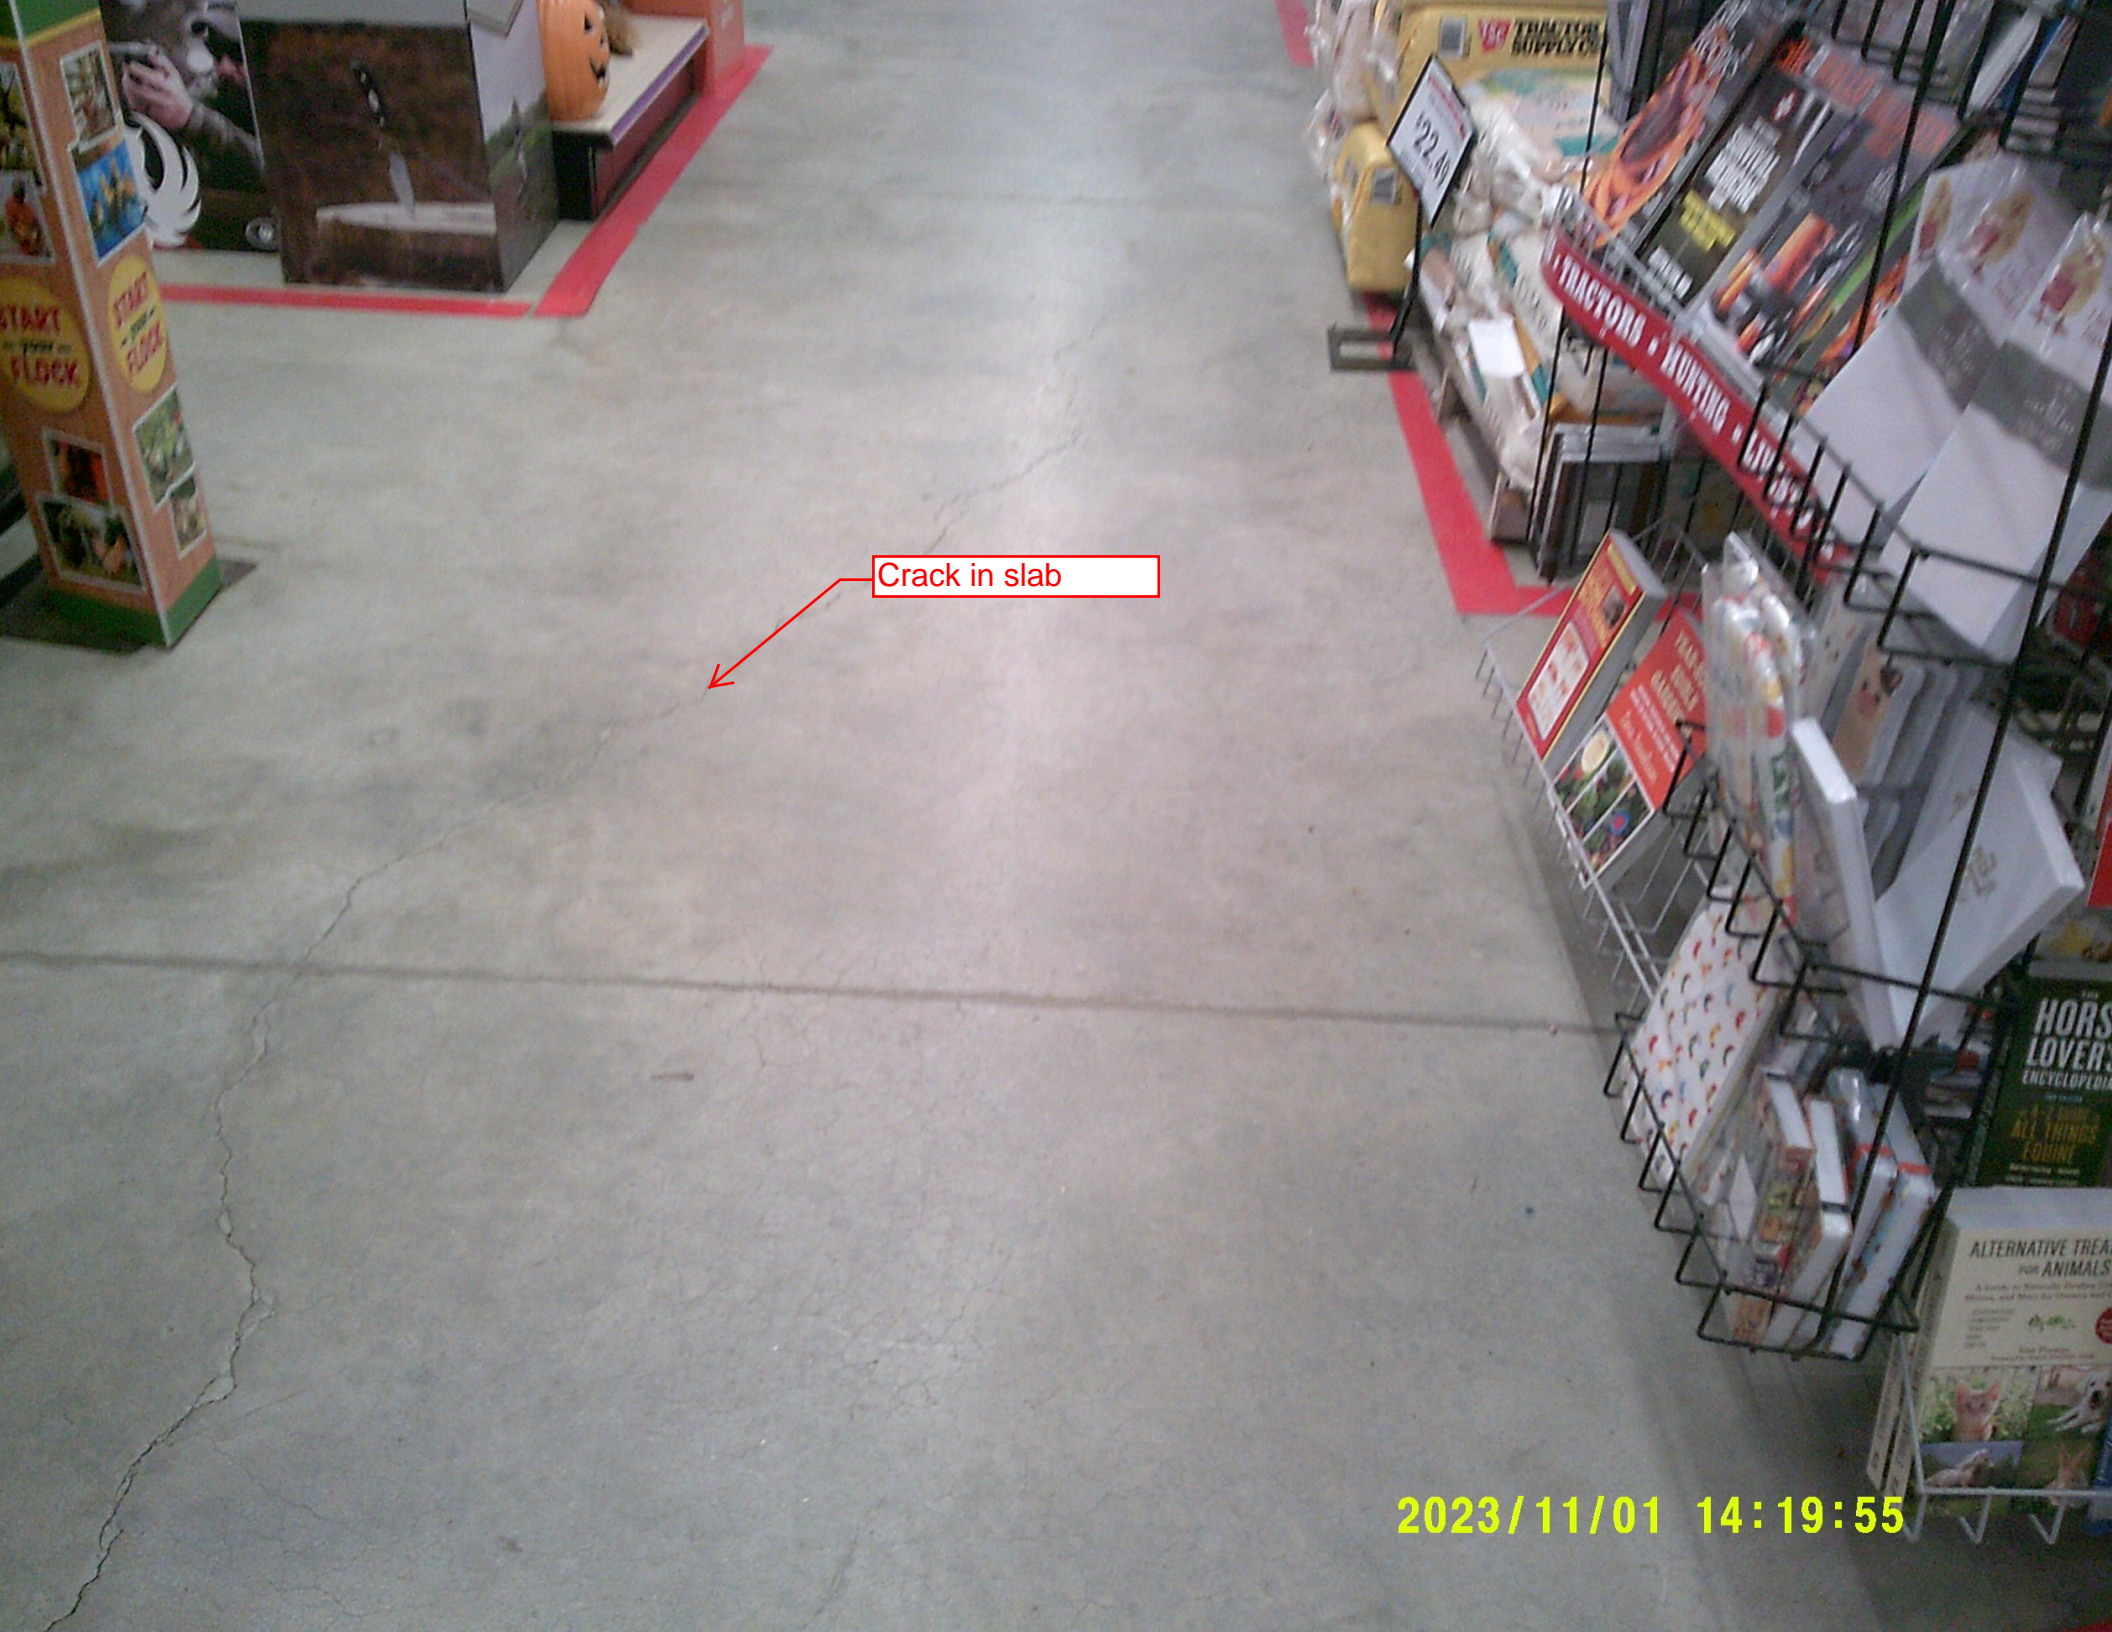
The slab/floor was also noted to have some small hairline cracks in the front left and right rear of the bldg including the area of the rear help desk.

Crack in slab

- 1) Remove and replace busted CMU blocks with more than 1/4" gap.
- 2) Verify bolts are tight where beams are attached to the columns.
- 3) Seal the cracks in the CMU block walls and floor with an elastic sealant for concrete to prevent insects from entering the Building.
- 4) Fix the one downspout that the elbow is off.
- 5) As an option, construct expansion joints @ each column.

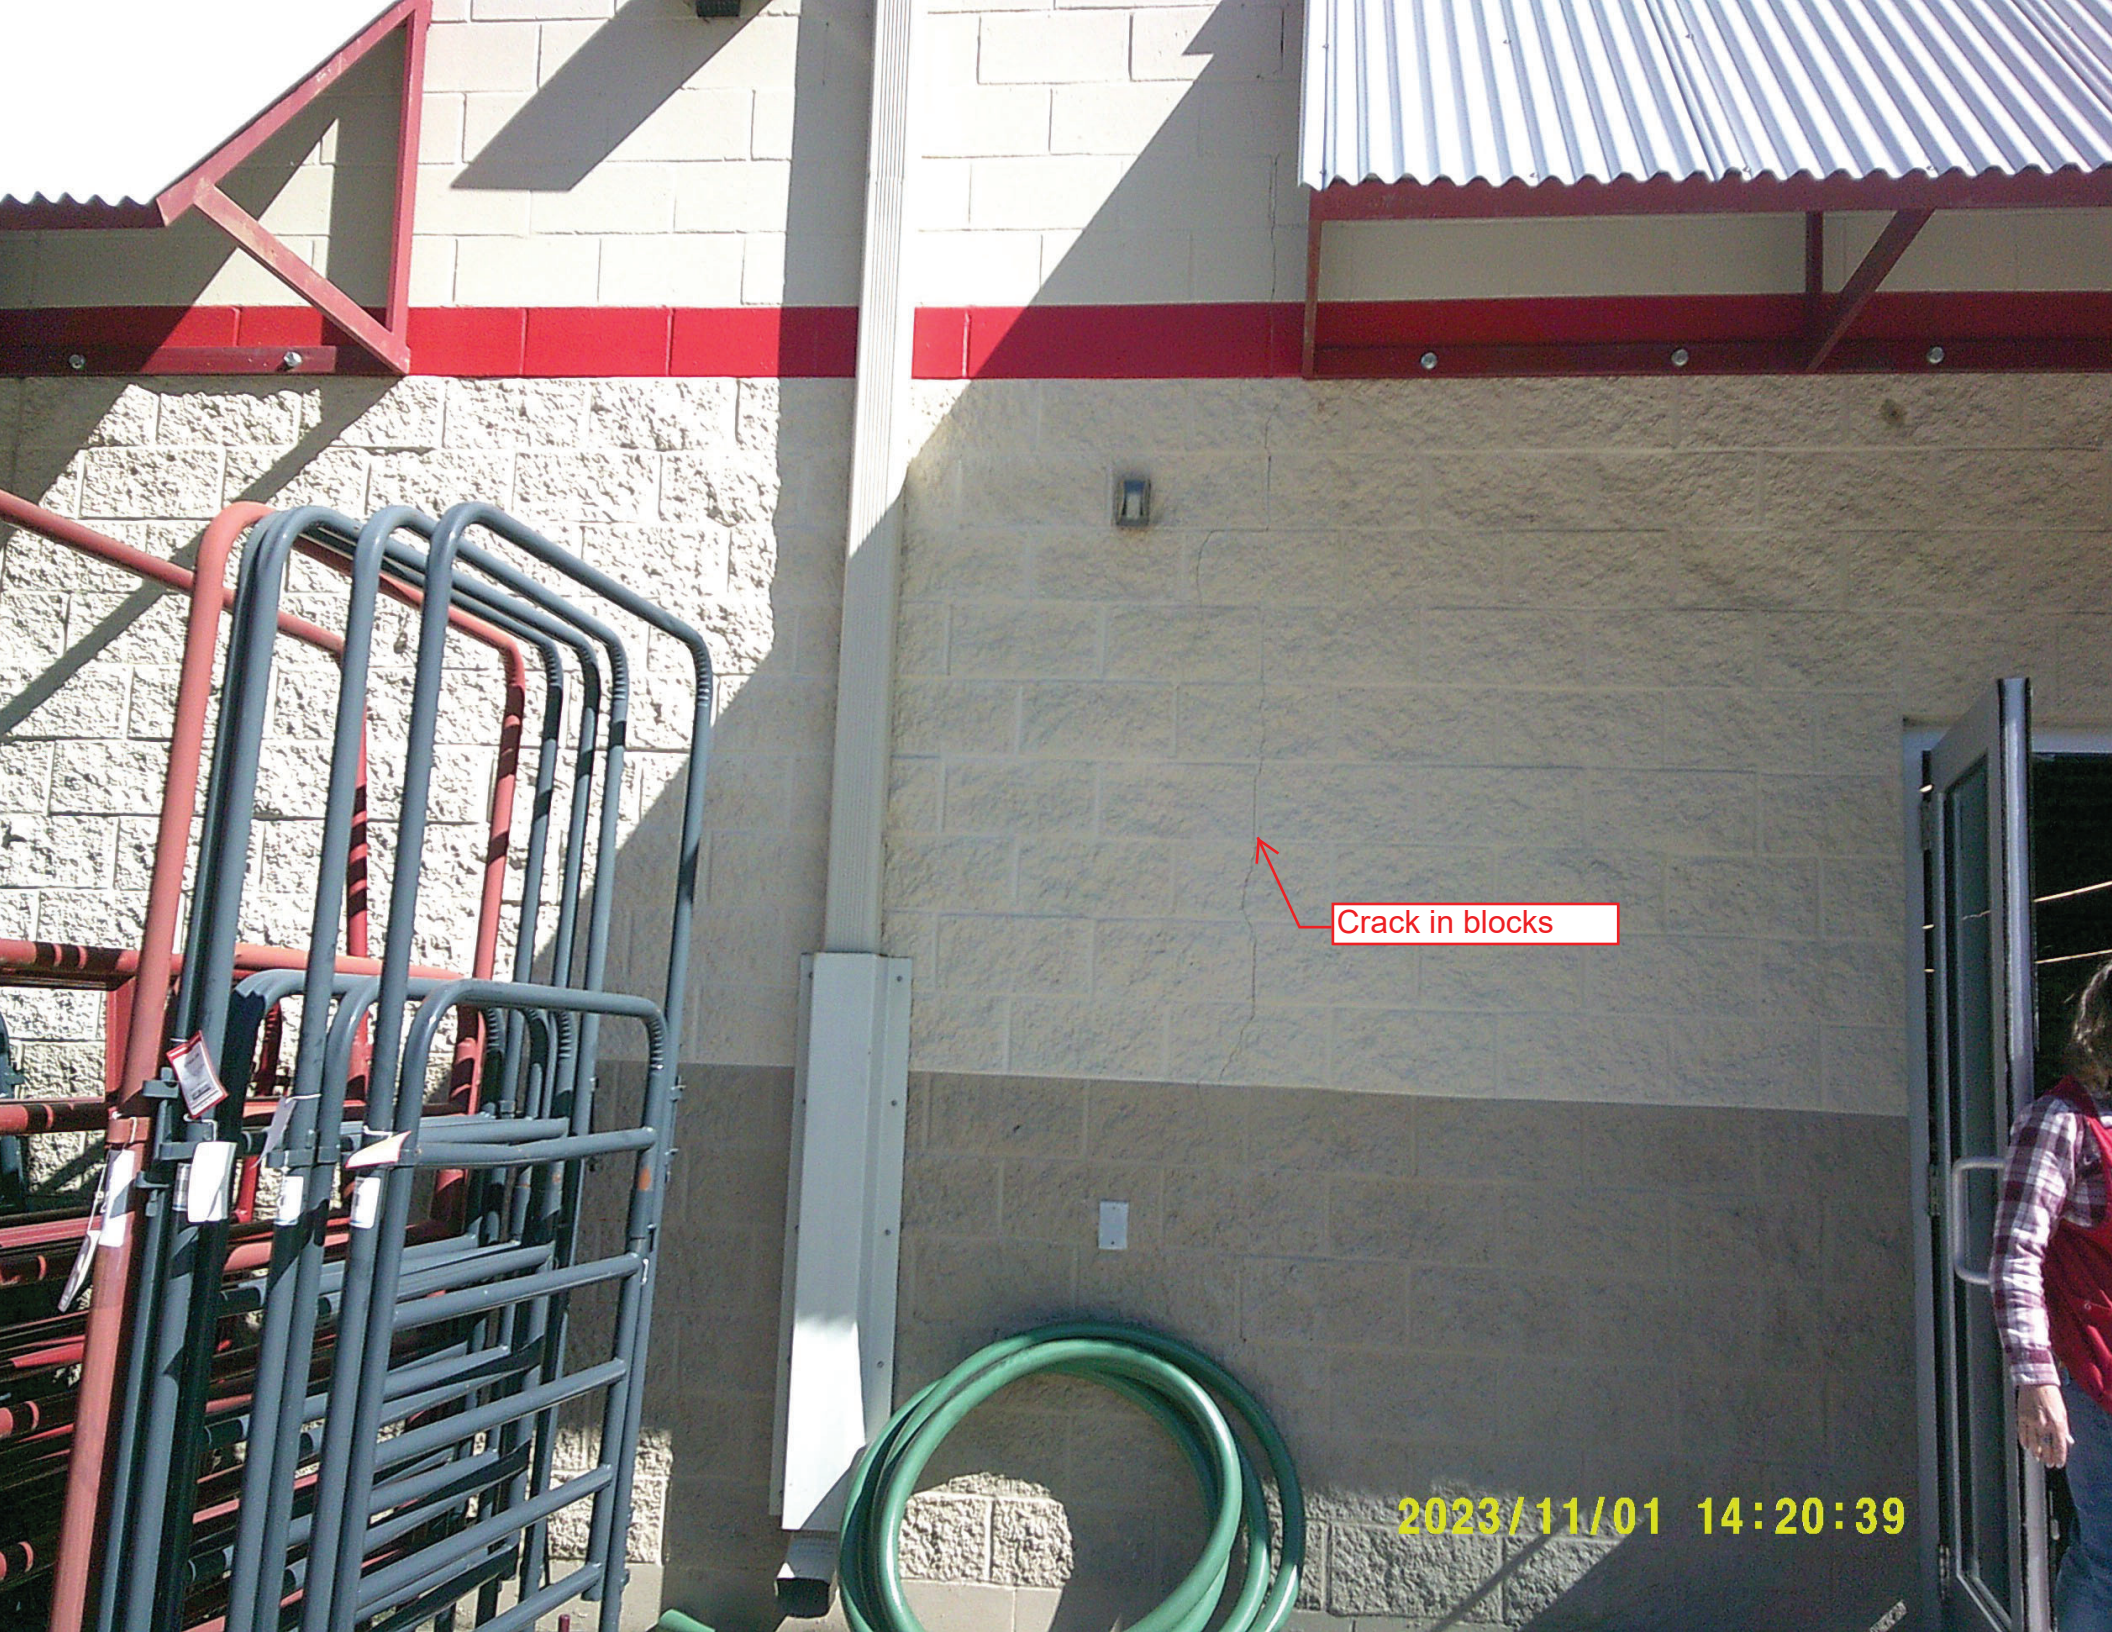
The exterior walls are made up of CMU blocks with vertical rebar @ 4' O.C. When the CMU blocks abut an exterior column, the CMU blocks are cut thin to enclose the exterior column with no rebar. When expansion and contraction occurs, these thin cut blocks are coming apart. There are some areas that the thin cut CMU blocks around the columns are falling out.

Crack in blocks
