INFRARED THERMOGRAPHY MARITIME VESSEL PROJECT

May 11, 2010

Our engineering firm, SAFETY ENVIRONMENTAL PROFESSIONALS, INC. (SEP-INC.), has been requested by Dammon Engineering, (Mr. Chuck Dammon) to perform an Infrared Analysis regarding a maritime vessel located at 332 Bayou Liberty Road, Slidell, LA. The purpose of this project was to determine the presence of moisture in the hull area of the vessel.

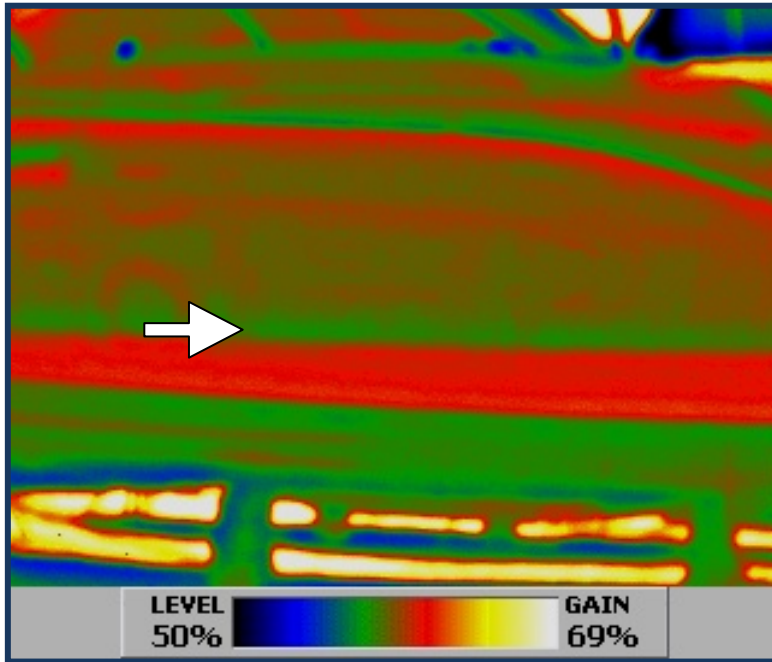
Image 1 Portside amidships: The pronounced red stripe is the hull coating; the area above this coating shows areas of uniformly cooler temperatures (green hue), indicating potential moisture (water) behind the hull (arrow).

The portside of the vessel shows eminent uniformity of cooler temperatures indicating potential moisture behind the hull. This is in comparison to the starboard side which denotes no significant temperature deduction as an image of moisture while facing the direct sunlight.

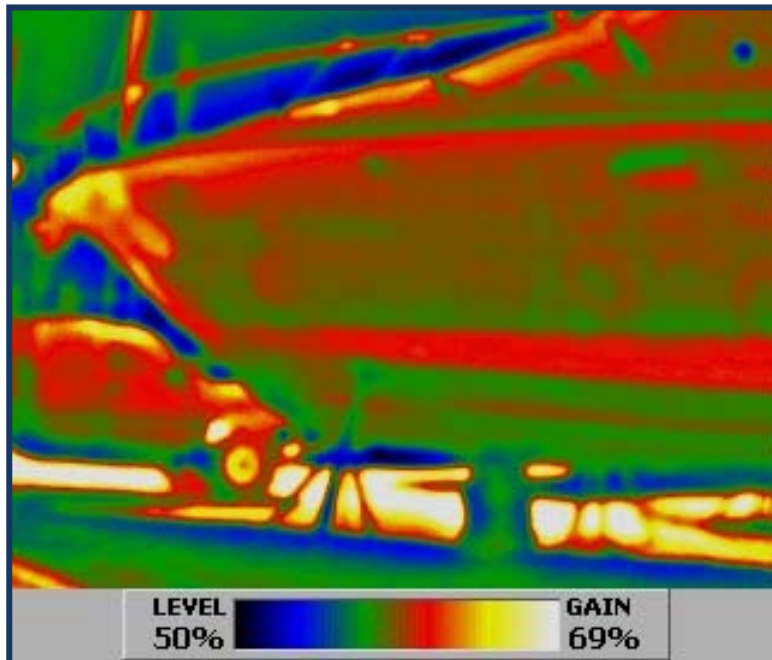
Image 2 Port Bow: Areas of high contrast indicate greater temperature fluctuation, indicating a lesser potential for moisture behind the hull.

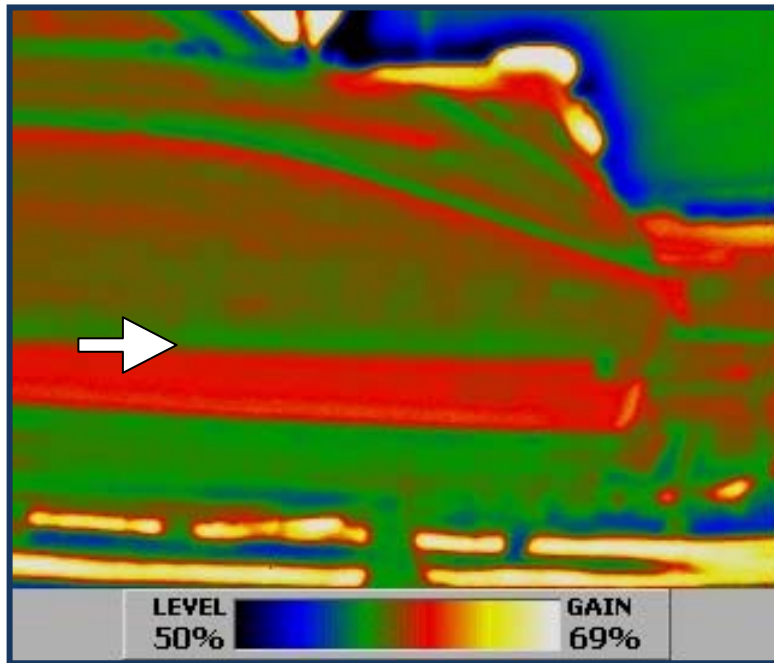
Image 3 Port Stern: As in Image 1, the cooler areas depict more uniformity, indicating a higher potential for moisture.

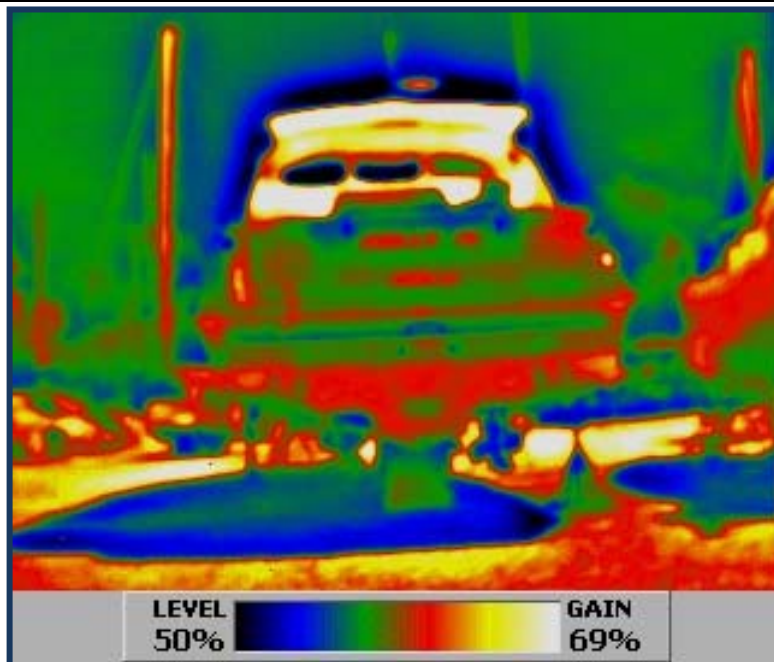
Image 4 Transom: The hull coating is shown as a uniform red color. No other information is evident in this view.

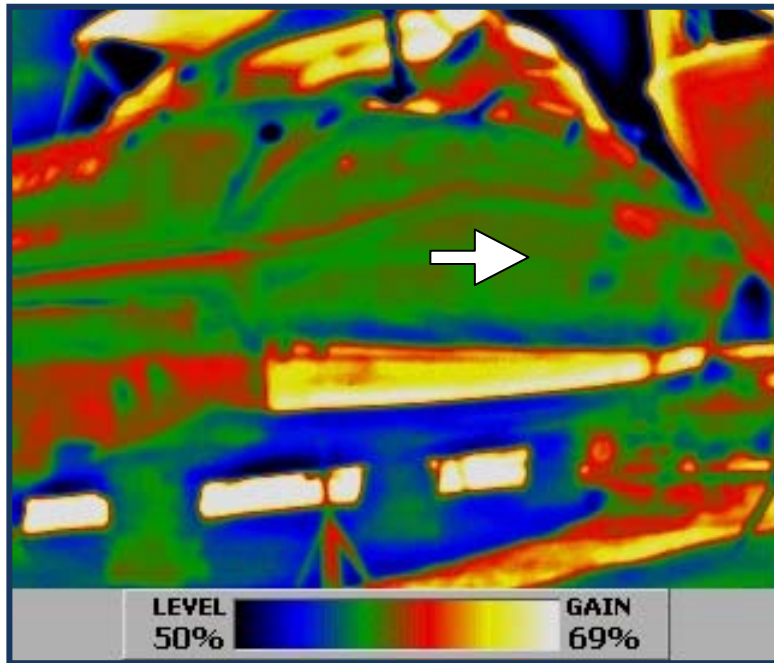
Image 5 Starboard Stern Quarter: This side is in direct sunlight. Note the significant temperature difference between the dark hull coating and the hull area above it. The upper hull (arrow) shows noticeable areas of temperature difference, indicating a lesser possibility of the presence of moisture.

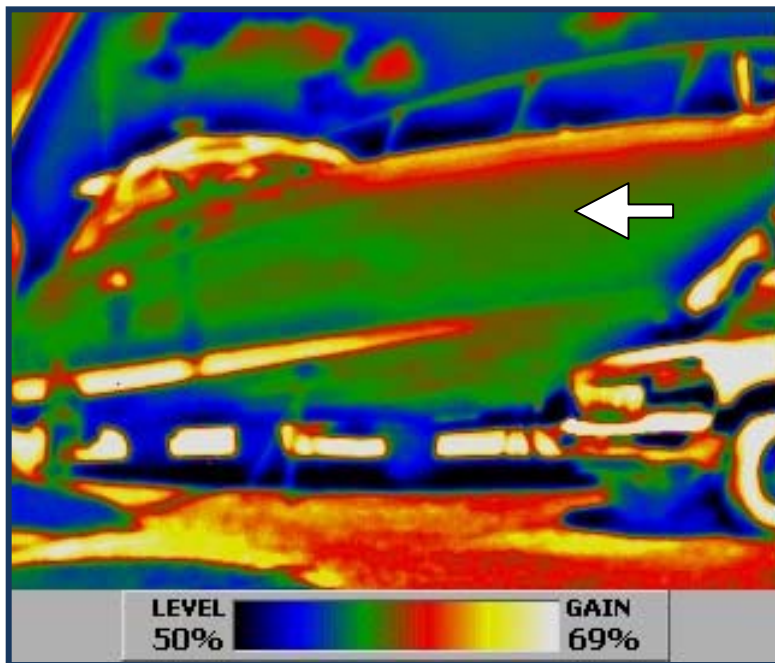
Image 6 Starboard Bow Quarter: This image shows characteristics similar to Image 5. The darker area on the bow (arrow) shows the bow is in a shadow.

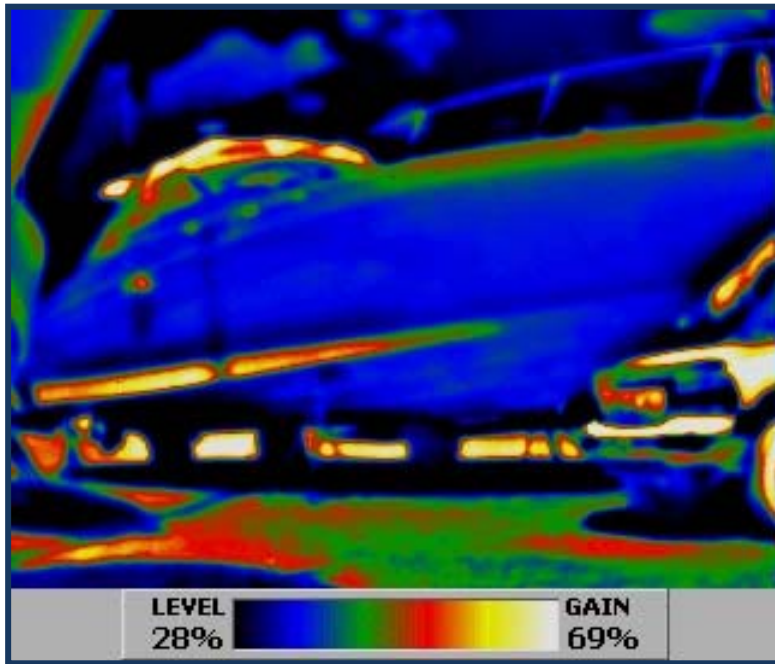
Image 7 Starboard Bow: This image uses a different color level for a contrasting view. No significant differences are noted from the previous image.

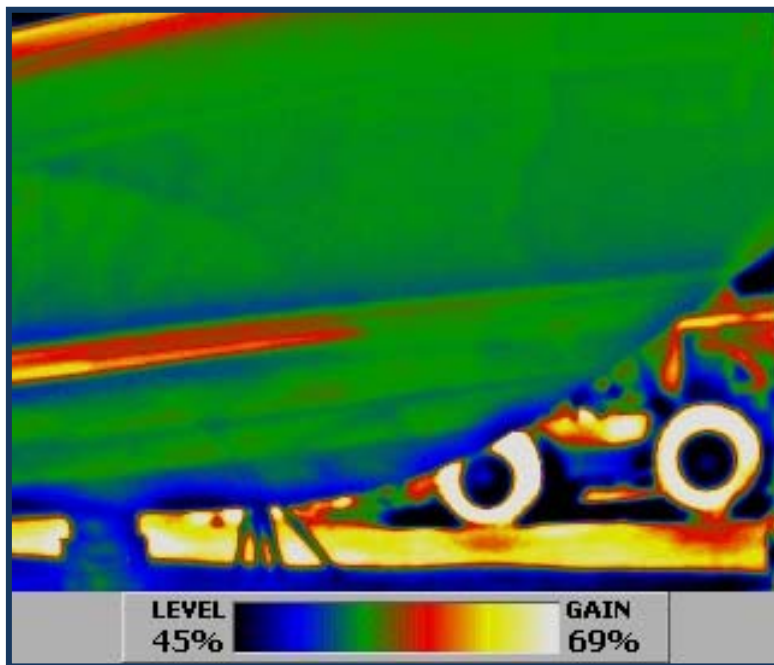
Image 8 Starboard Bow: This is a closer view of the bow. No indications of moisture. Note the effects of the sun's shadow.

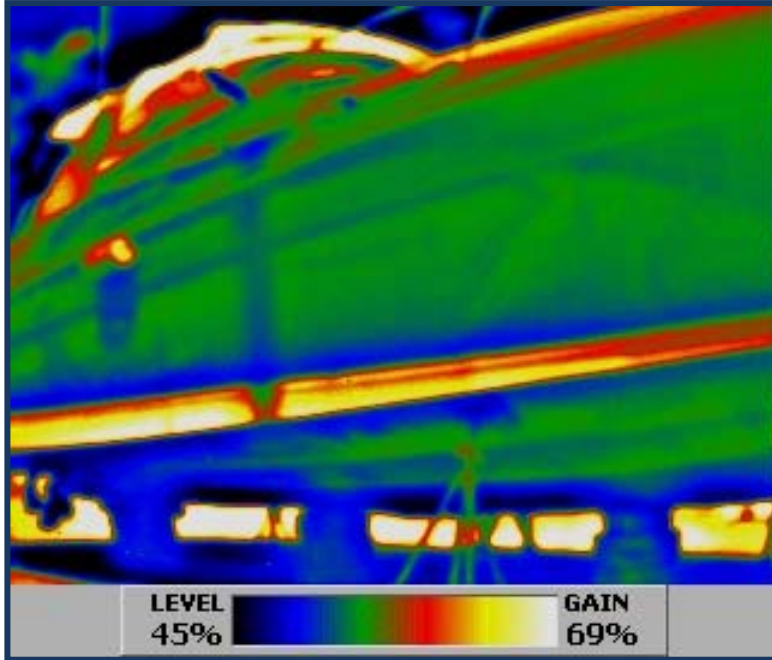
Image 9 Starboard Amidships: Notice the temperature differences where structural members adjoin the hull. These indications show a low potential for moisture behind the hull.

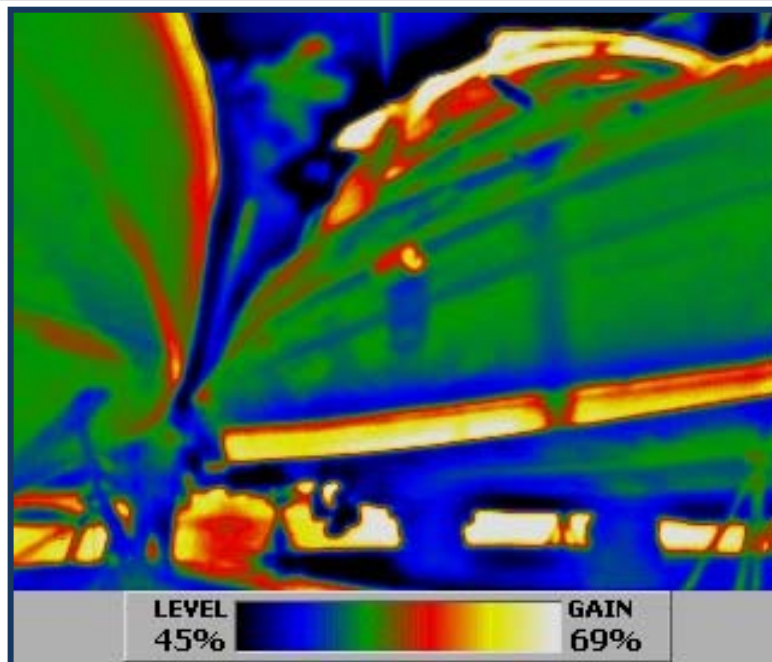
Image 10 A closer view from Starboard Amidships to the Stern. The presence of structural members behind the hull is evident, indicating further a low potential for the presence of moisture.
