## Sewer Treatment Specialist, LLC

On Friday, July 9<sup>th</sup>, 2010, Shane Ward and Gene Allison of Sewer Treatment Specialist, LLC aided Iqbal Properties, LLC with an ongoing treatment plant problem. The 25,000GPD extended aeration, activated sludge treatment plant has been experiencing an upset condition in the clarifier and chlorine contact chamber since the Winter of 2009.

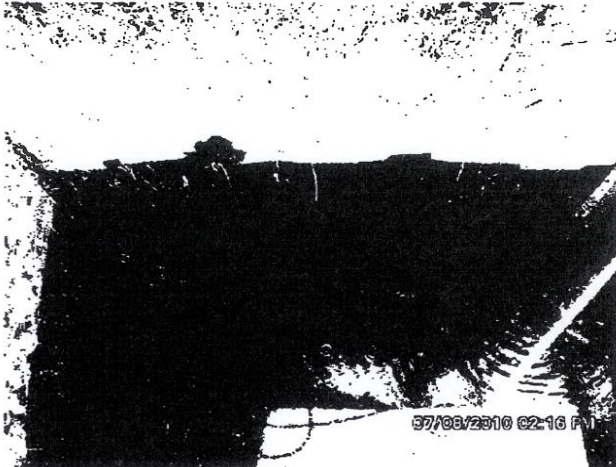
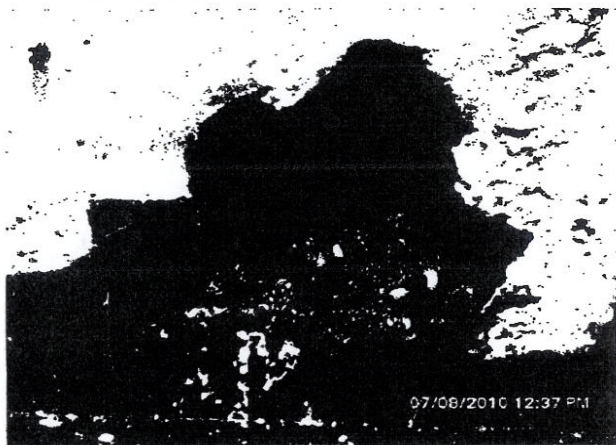
The treatment plant has experienced a pin flock condition in the clarifier, which was initially thought to be a low dissolved oxygen problem due to excess grease in the collection system and treatment plant. Sewer Treatment Specialist, LLC inoculated the plant with 10 pounds of Sewper-Rx bacteria – a bacteria used by the municipalities of Meridian, MS, Pass Christian, MS and Eagle Pass, TX with great results. The bacteria is a known digester of grease and performs well over a wide range of temperatures, DO and loading characteristics.

Besides the pin flock issue, the chlorine contact chamber was experiencing noticeable eddies and currents throughout the day. These currents would cause blooms of light-colored sludge to erupt from the bottom of the chlorine contact chamber. Sewer Treatment Specialist, LLC initially attacked the most obvious deficiencies – lack of controllable runtime on the blowers, lack of alternation on the blowers and improperly positioned skimmers in the clarifier and window.

The blower control panel was modified by installing a mechanical timer and alternating relay. This modification allowed the treatment plant to have rest times where the blowers did not run and the skimmers and sludge returns did not operate. Normally, we see almost instantaneous results but the overall effect was minimal at Chahta. All air drops were pulled and the diffusers were flushed and inspected. The diffusers were put back in service but only minimal improvements were noticed.

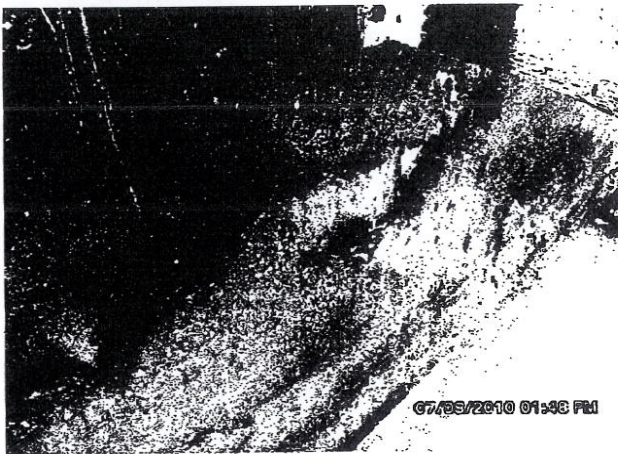
Once the clarifier was pumped down, we entered and inspected the entire length of the contact chamber for clues to the strange currents. We found several holes between the clarifier and the contact chamber, several of which were low enough to transport sludge. We measured the flow of all the cracks, fissures and holes and arrived at a rough figure of six gallons per minute entering the contact chamber – or ~6,000 gallons per day – 25% of the daily flow was entering the contact chamber without passing through the weir.

If the clarifier is receiving its' allotted flow through the weir but is also receiving an additional 6,000 gallon load through cracks and fissures, the net treatment in the clarifier is going to be greater than the designed loading. The currents caused by these flows will keep sediment stirred up and not allow it to drop out of suspension. The currents traveling from the clarifier to the contact chamber will not allow the solids to coalesce and settle.

This problem is compounded by an abnormally narrow weir that is set low in the water. This causes a rapid flow through the weir to the contact chamber. The baffles in the contact chamber are also inadequate to slow flow and allow for good mixing. Short circuiting can and does take place due to the improperly set, sized and fitted baffles.

The plant was installed by MoDad and carries a 20 year warranty against leaks. Since this plant is well within the warranty period (installed in 2005), the installer and engineer should be responsible for the construction and design deficiencies. Additionally, I recommend having an engineer review the paperwork associated with this installation and also write a professional opinion on the problems surrounding this installation.
