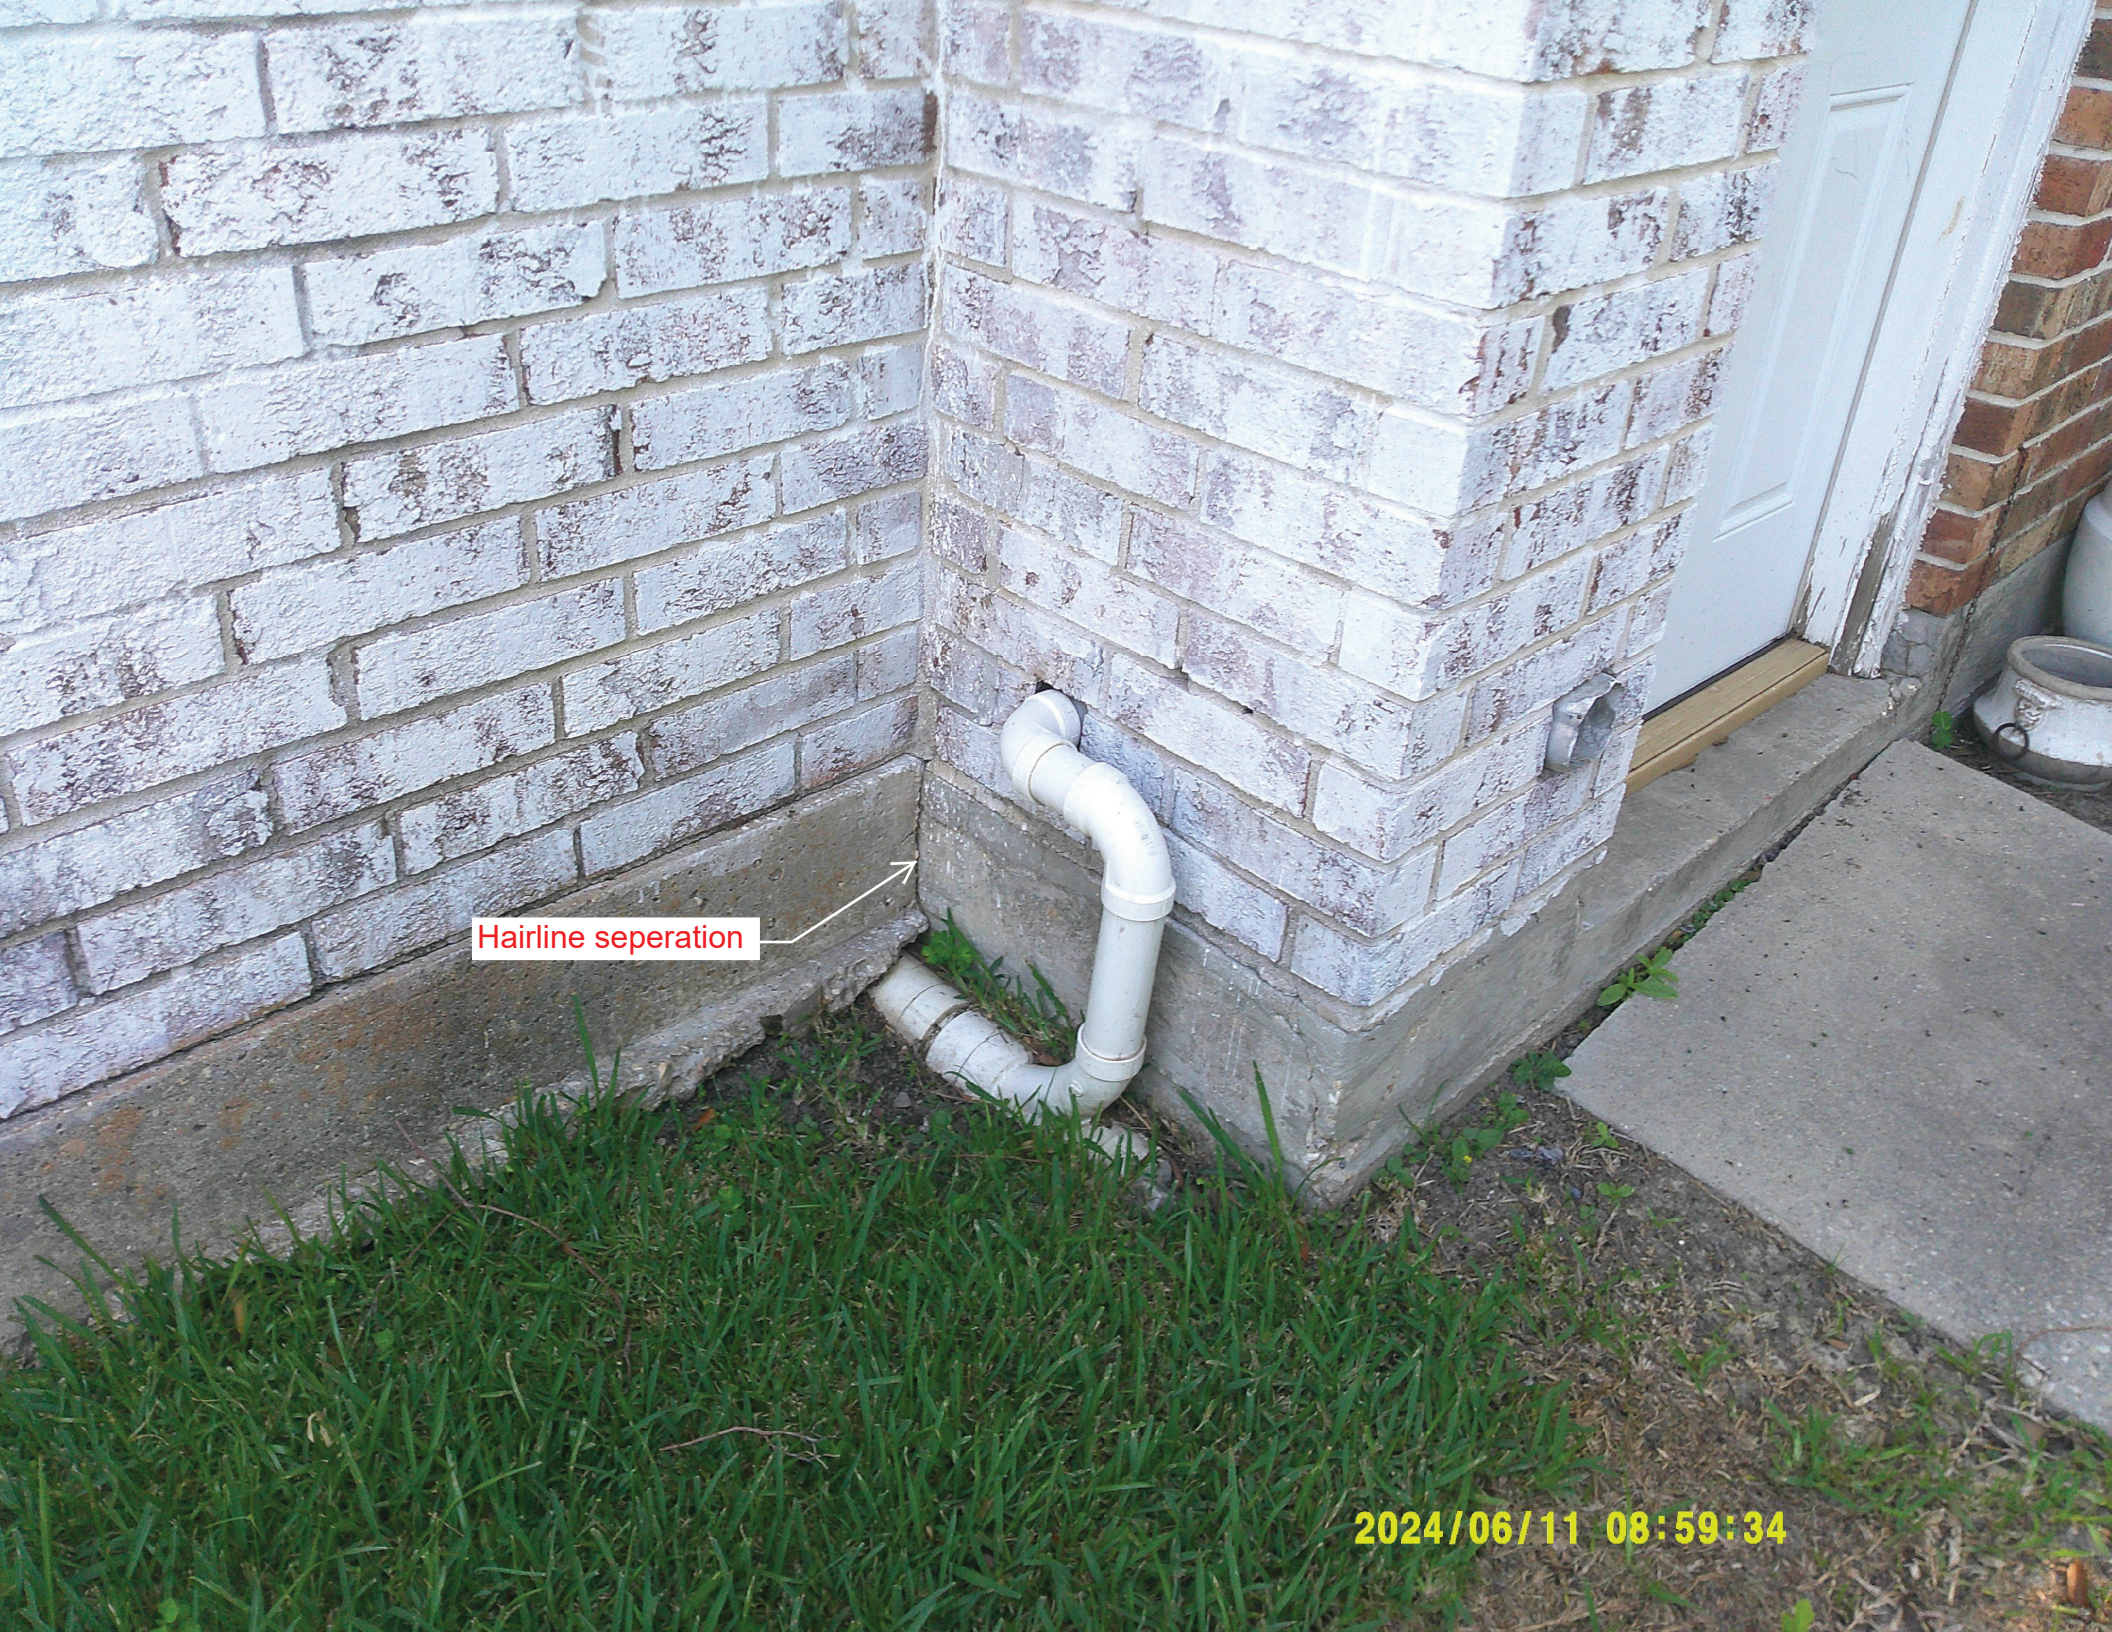
Hairline separation

No gutters or downspouts.

Brick Veneer that has been repointed and sealed.

Mold to be removed.

Hairline crack in
Brick Veneer

Hairline seperation
