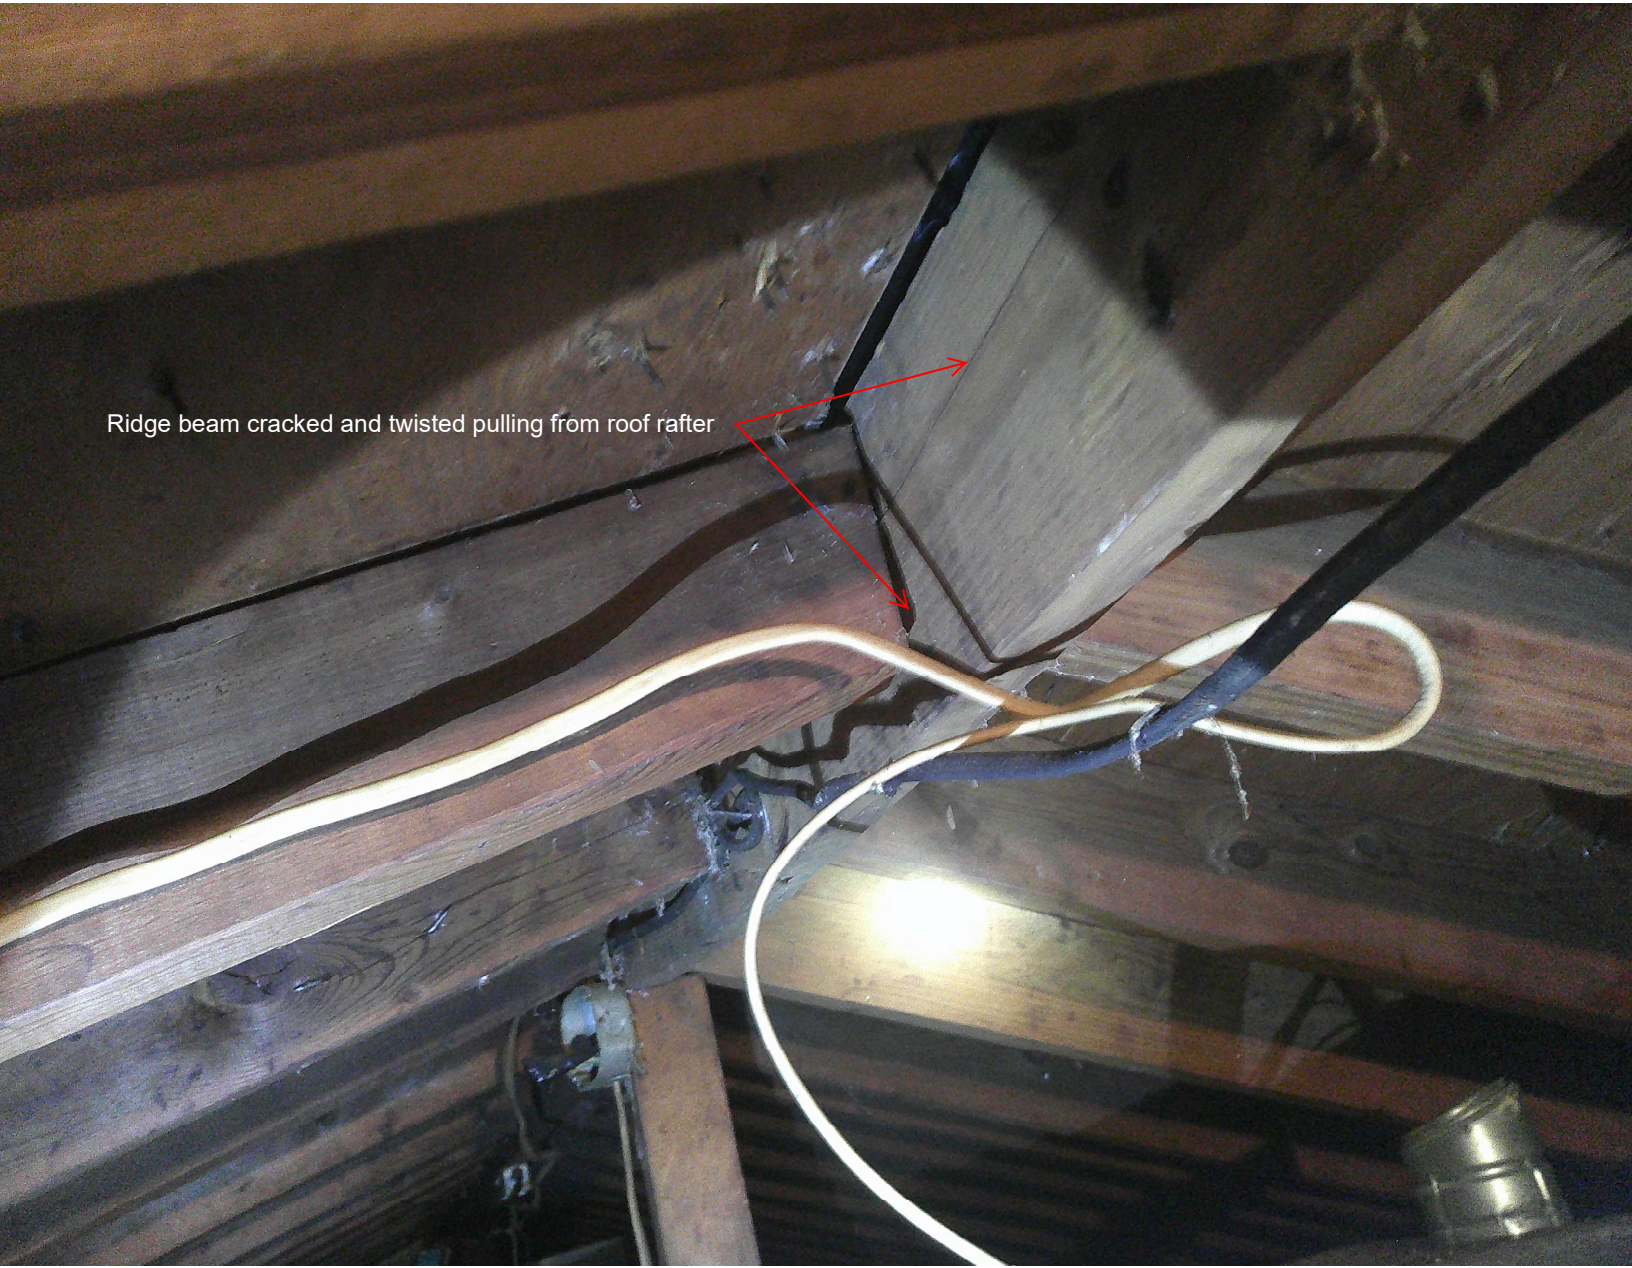
Ridge beam cracked and twisted pulling from roof rafter
