Structural Inspection

July 31, 2025

Ref: 400 Longleaf
Slidell, La. 70458

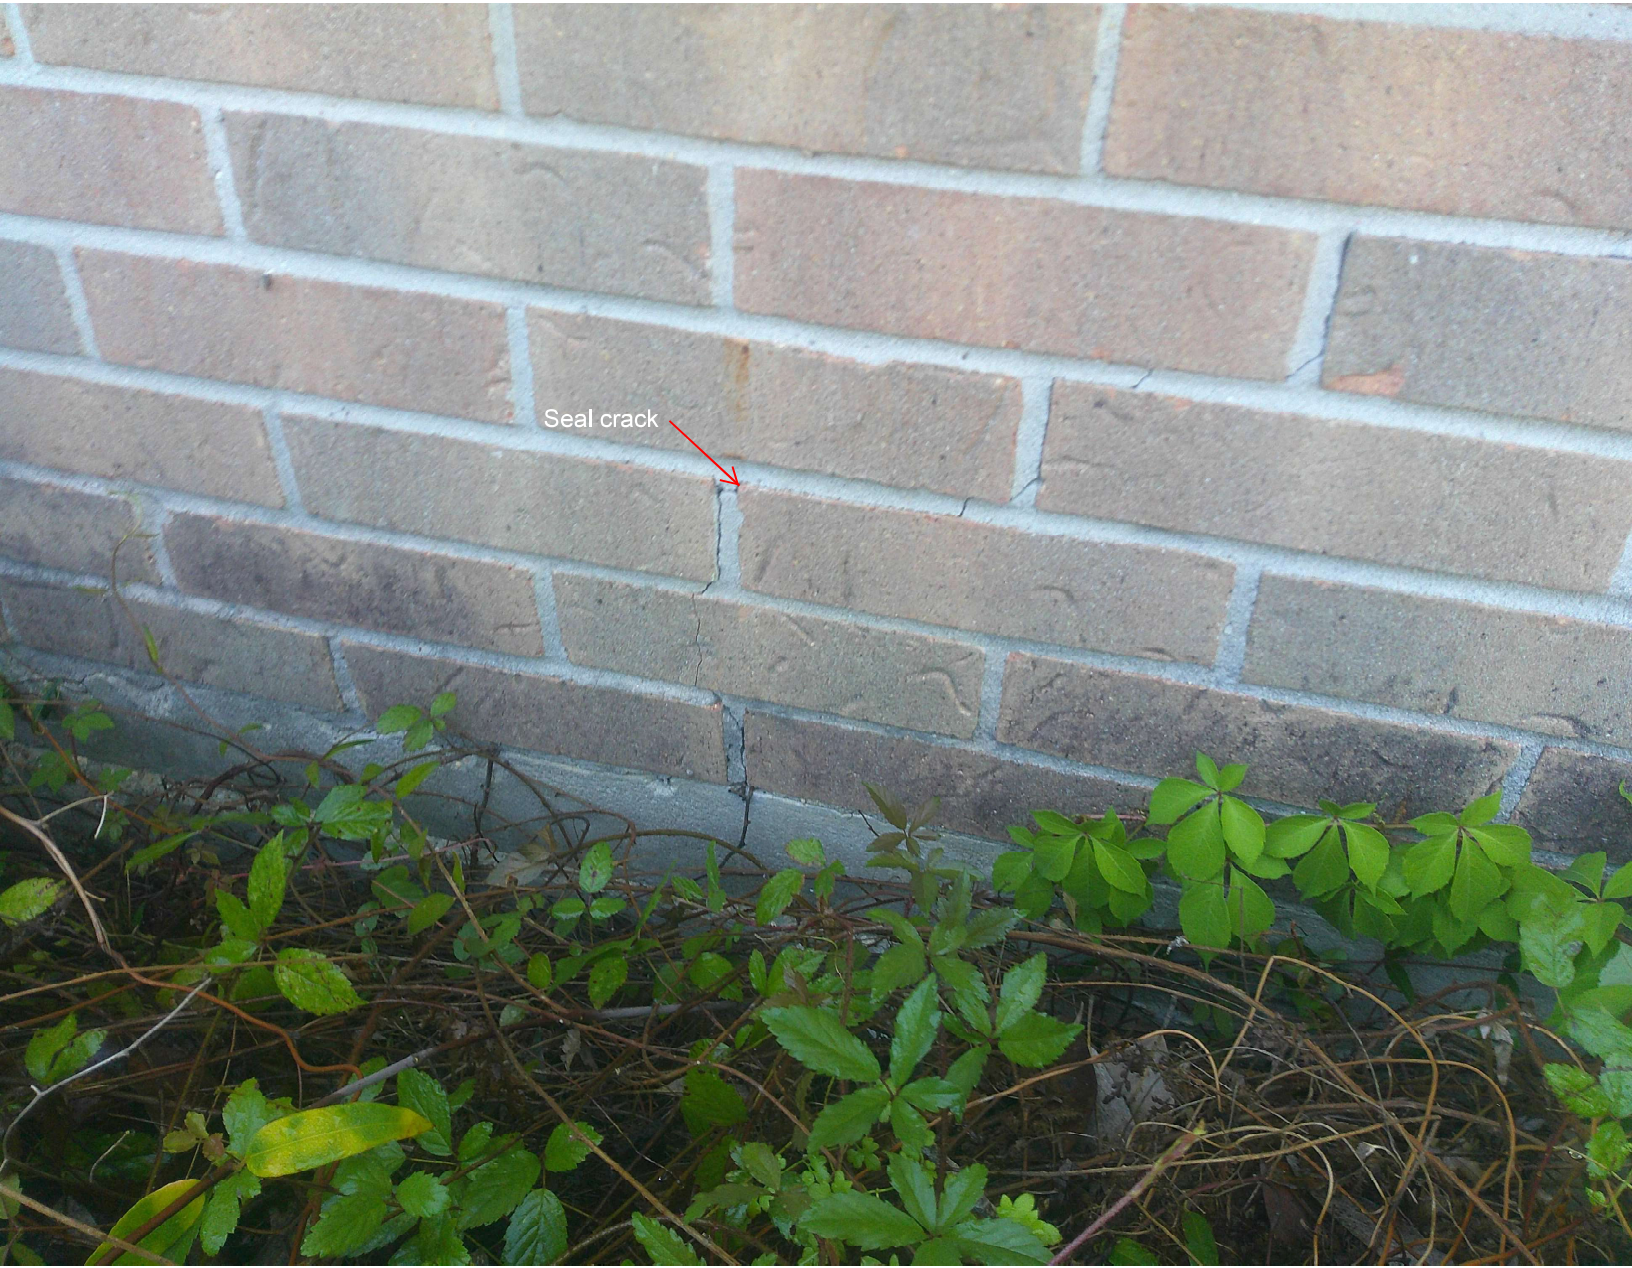
Upon inspection, on the right side of the home's brick veneer/mortar was noted to have cracks below the bathroom window down into the foundation. The brick veneer/mortar on the left side of the home below the kitchen window and kitchen sink window was noted to have cracks that run down to the foundation.

Seal crack

- 1) Seal all the cracks in the brick veneer and foundation with a non-shrinking grout, to prevent insects from entering the home.
- 2) Add gutters and down spouts around the whole home with subsurface drainage to the street.
- 3) Remove any trees and roots within 10' of the foundation.

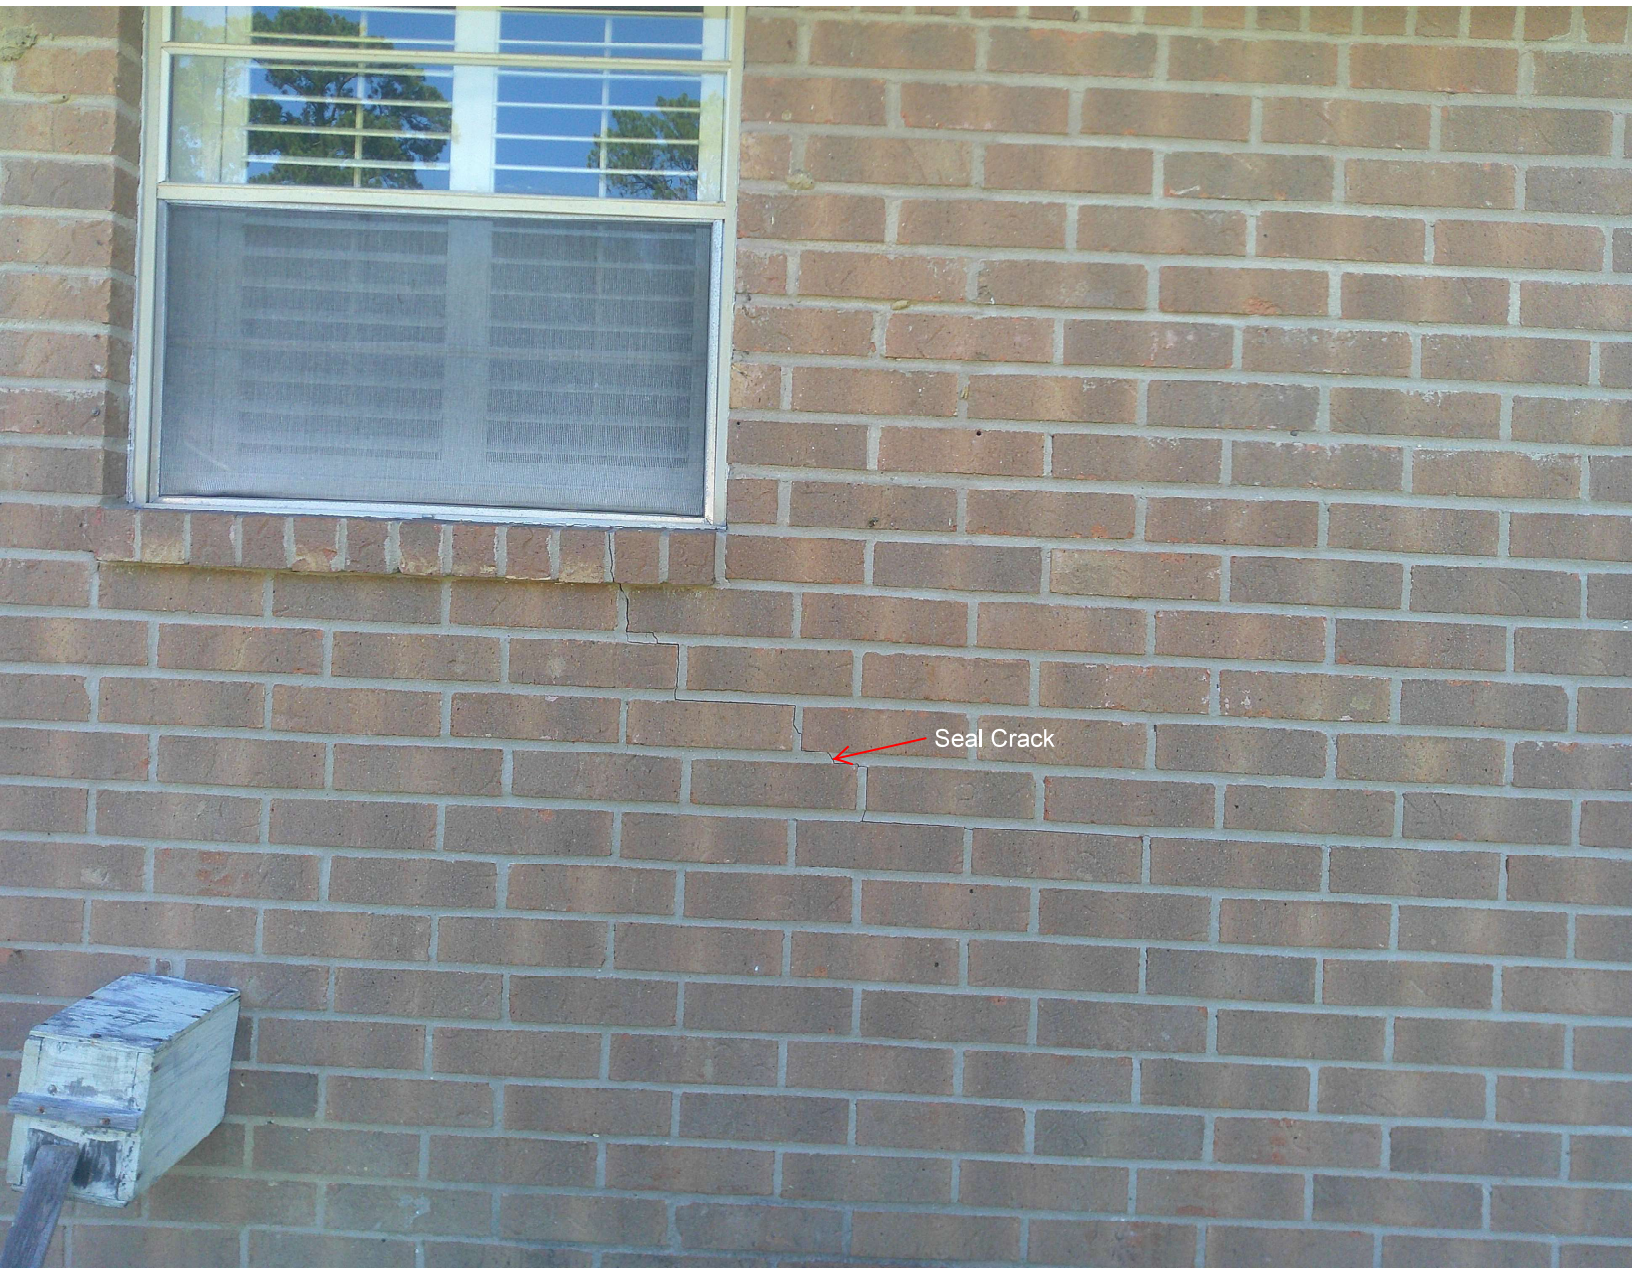
Seal Crack

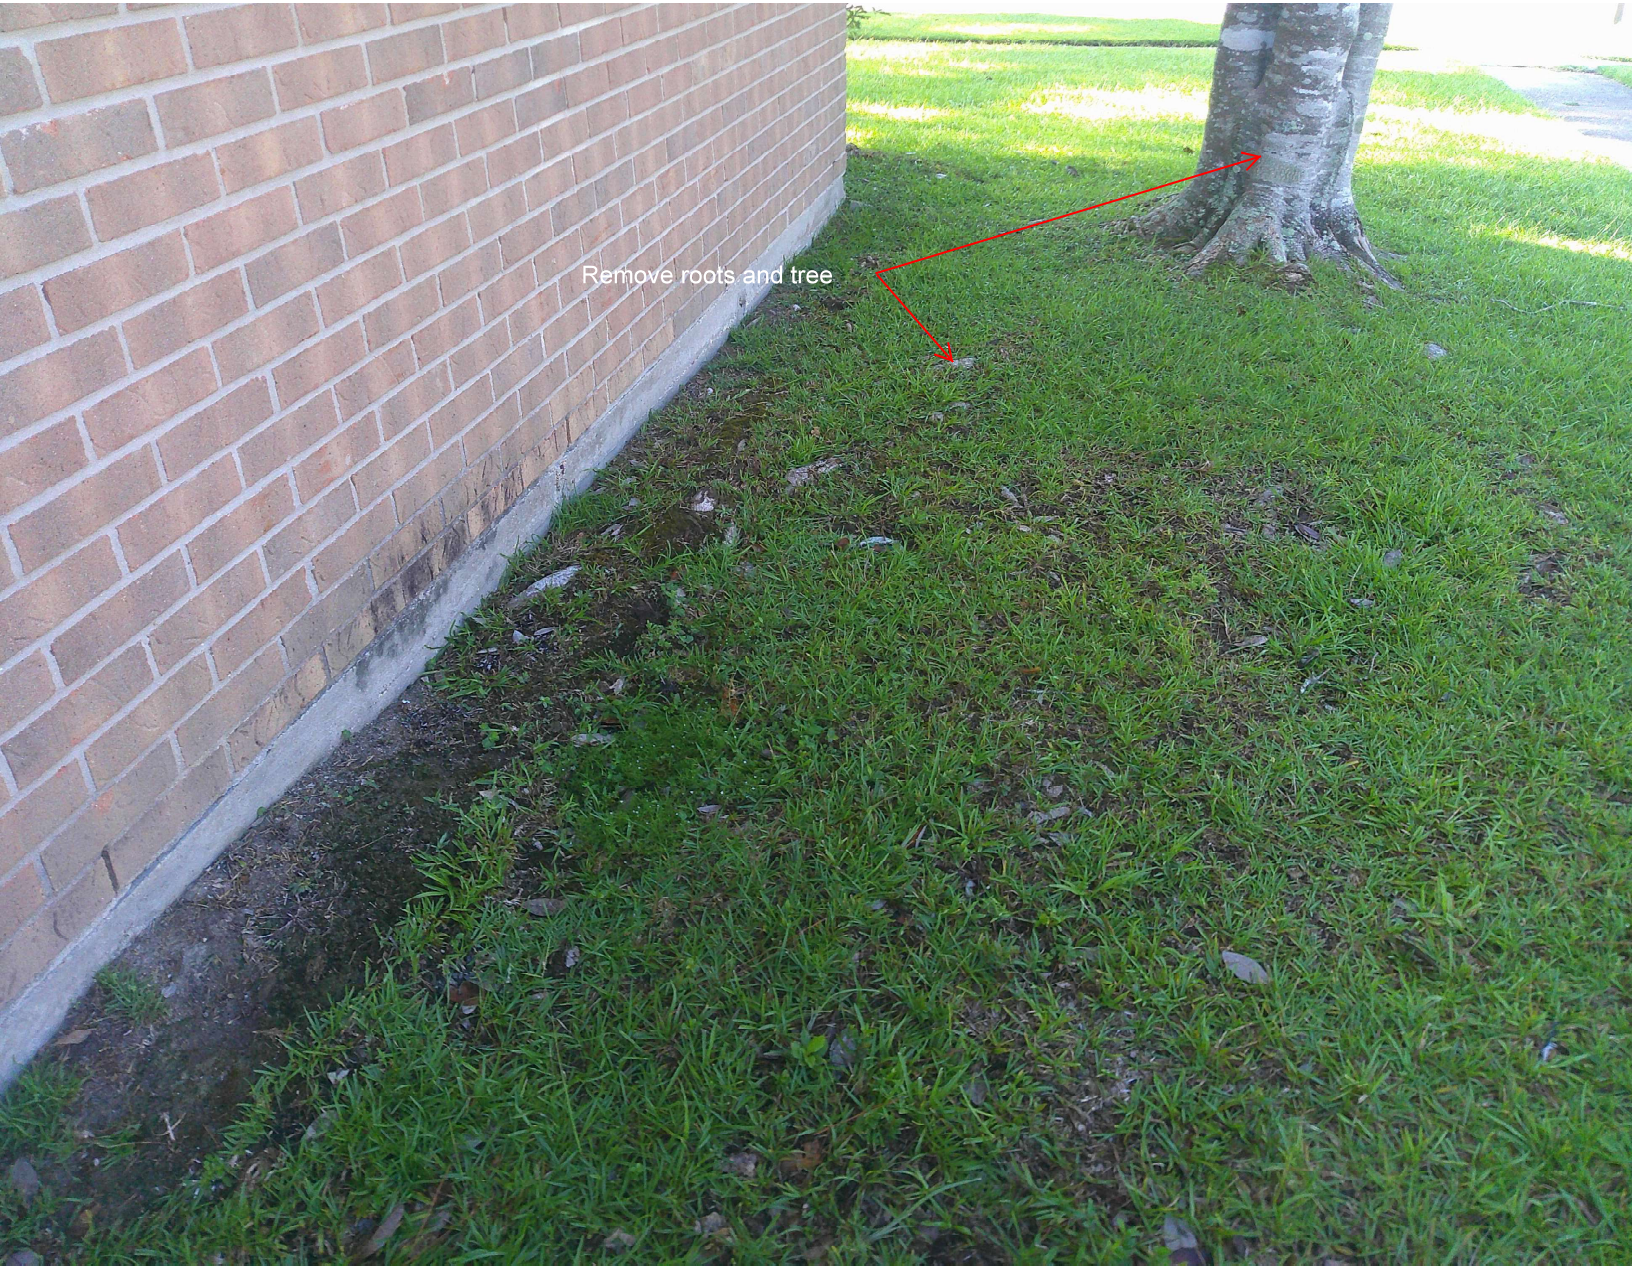
Remove roots and tree

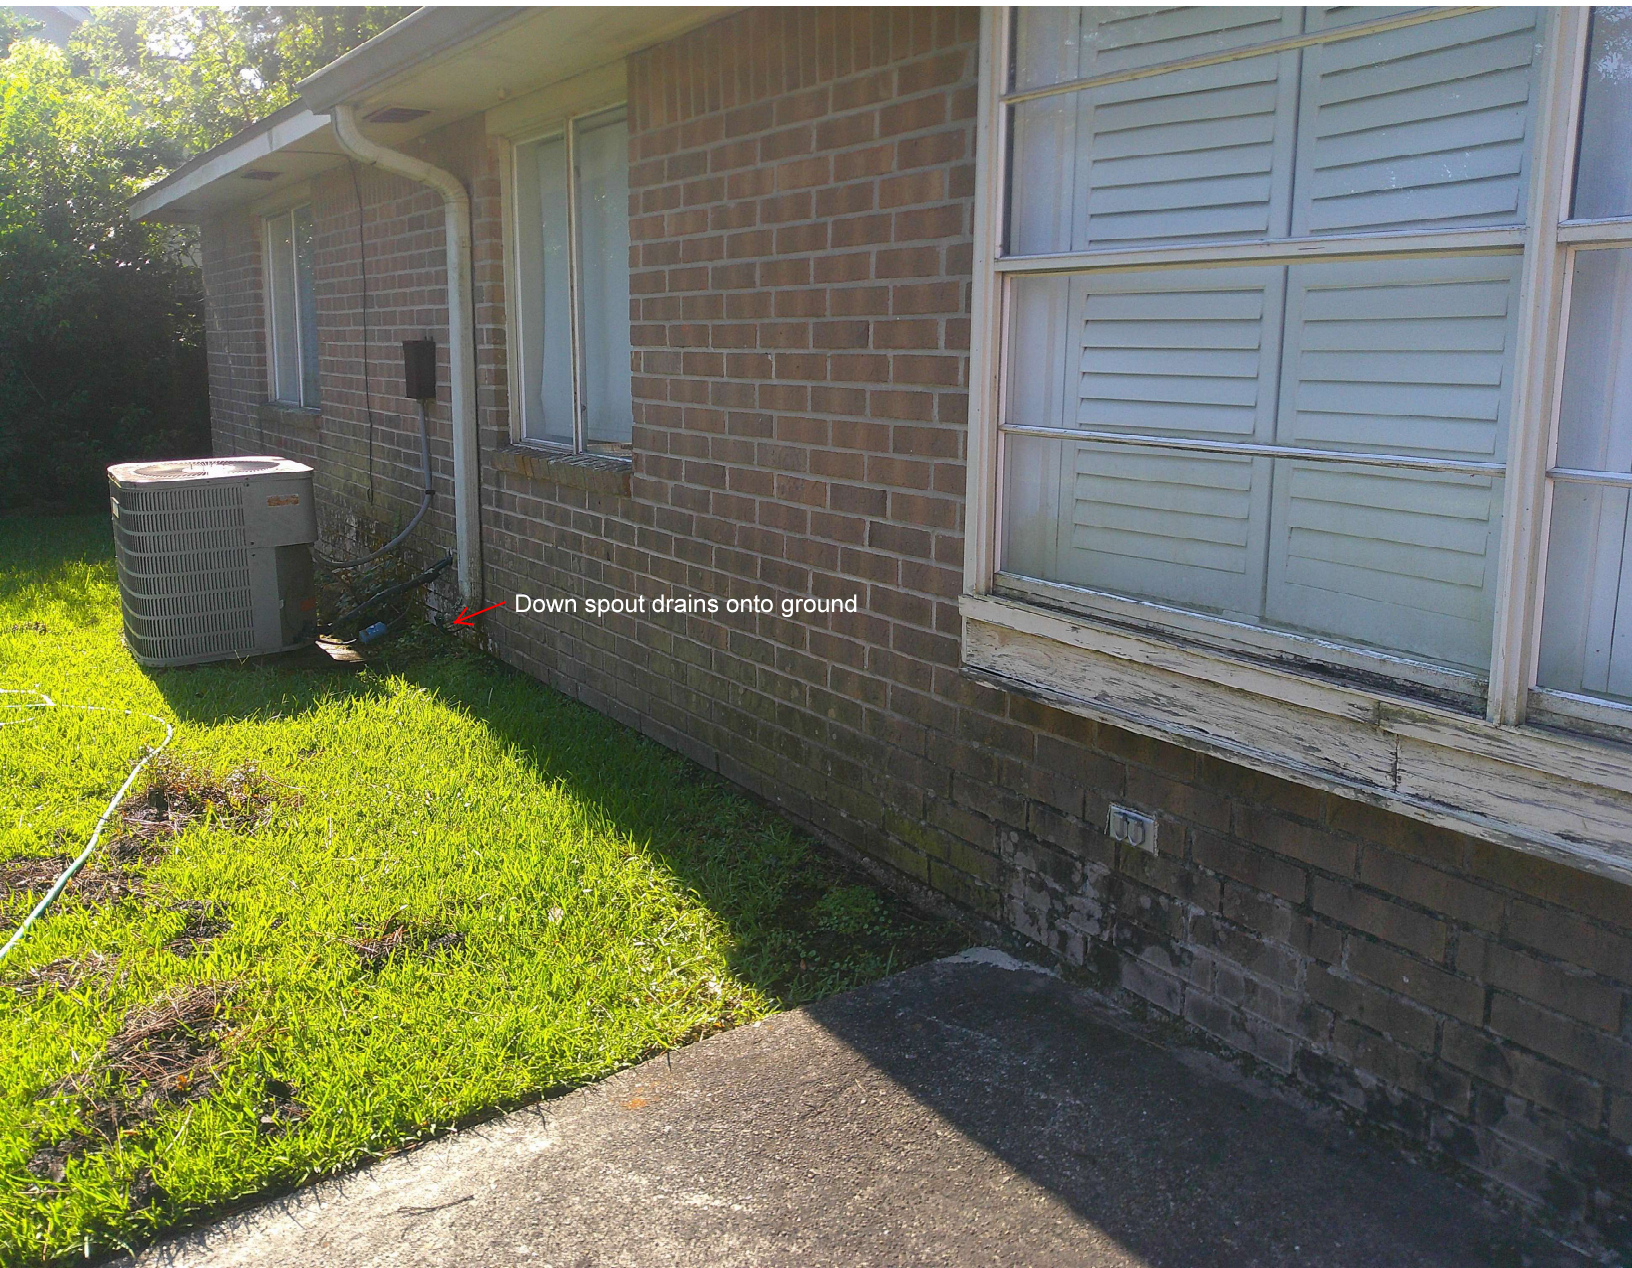
The gutters and downspouts on the rear of the home drain directly onto the ground and water is getting under the foundation causing washout and expansion and contraction of the ground.

Down spout drains onto ground

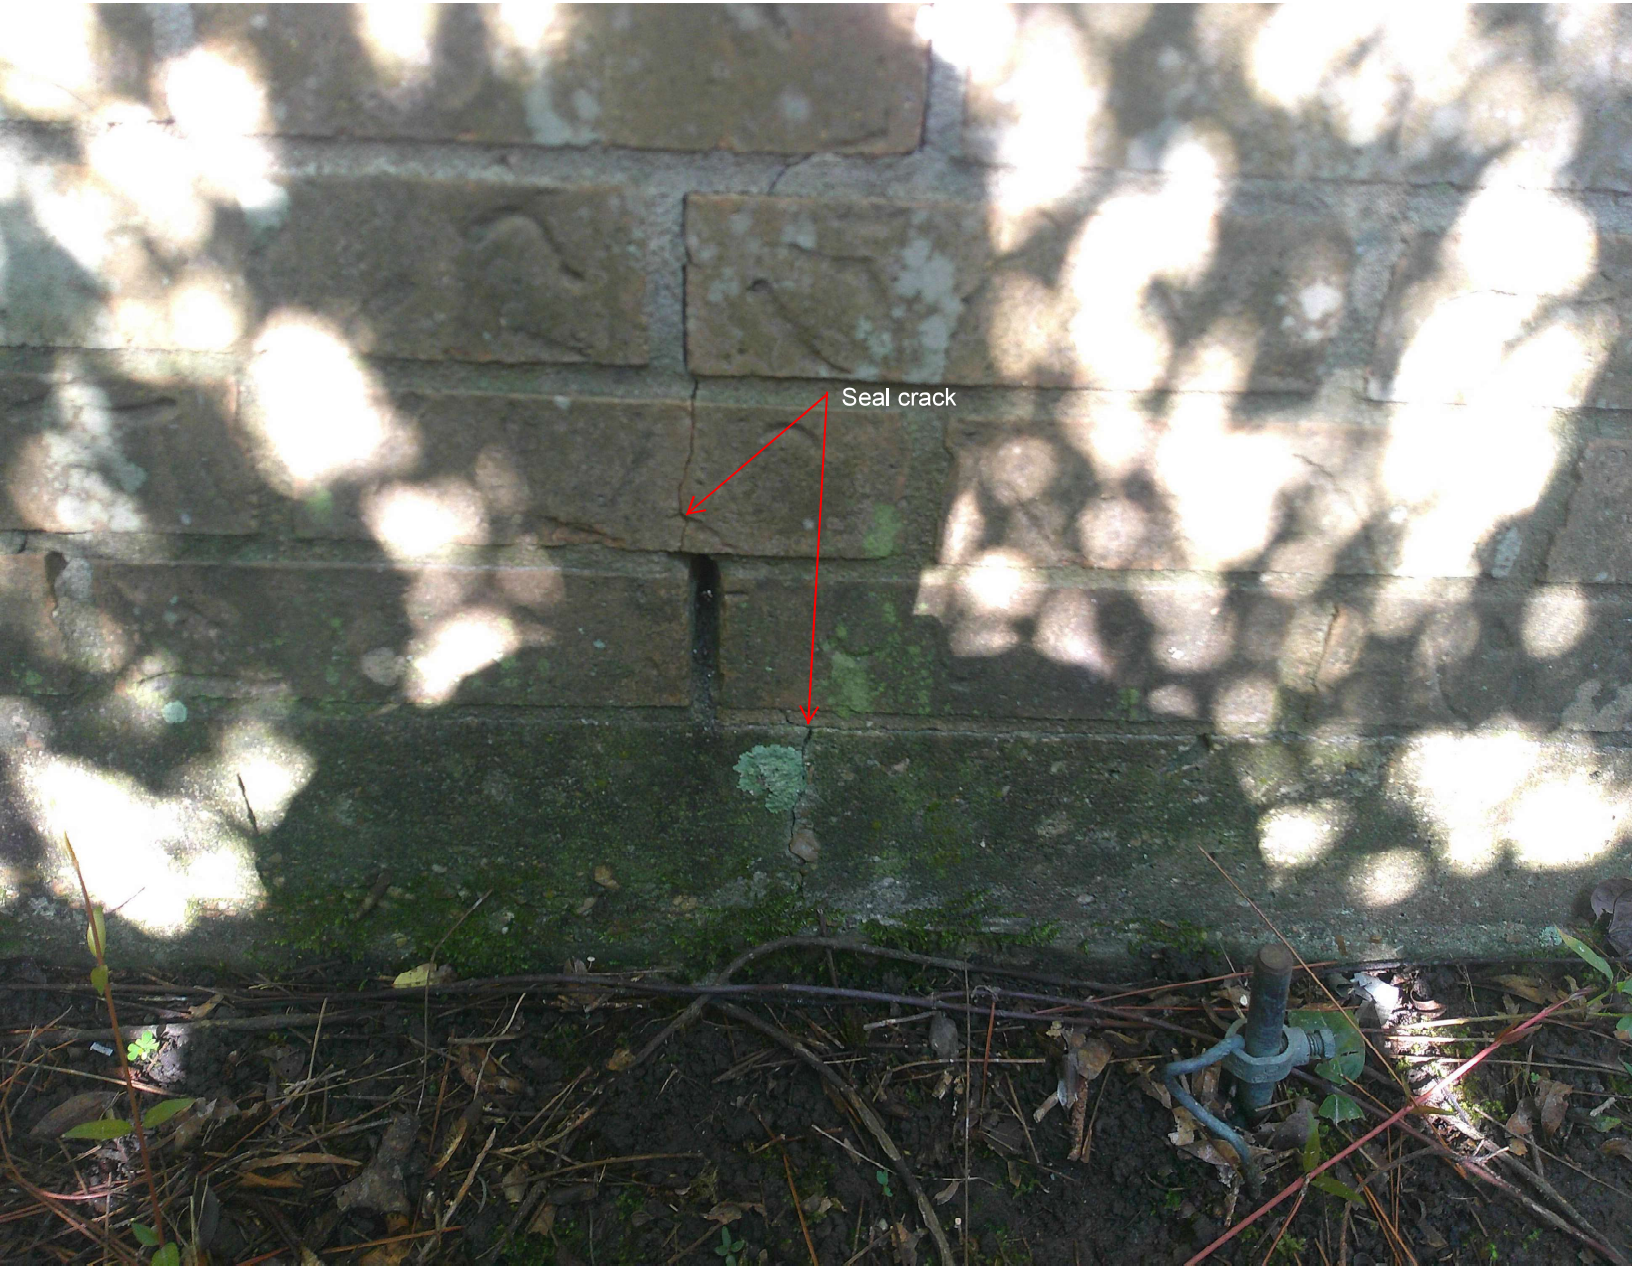
Seal crack
