Shingle to Slab Home Inspections, LLC  
(504) 723-5655  
shingletoslab.com

## Home Inspection Report

263 Audubon Dr  
Slidell, LA 70458

Prepared For Kimberly Tate, Salem Tate  
Inspected on Wed, May 27, 2026 at 1:00 PM

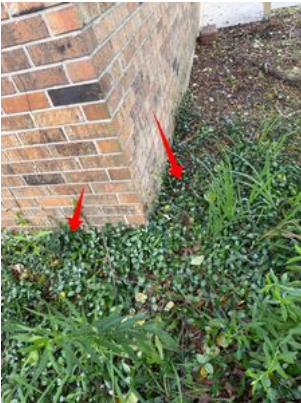
**Comment 1**

Slightly overgrown ground cover on front left corner under tree. Recommend maintaining a 12" clearance of all vegetation from structure.

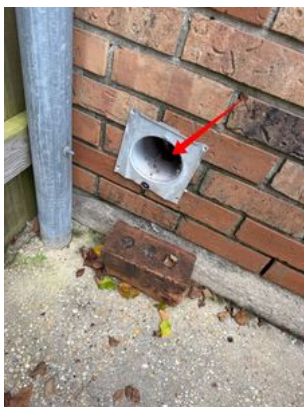
### Comment 2

Dryer vent termination is missing. Recommend replacement with a non-screened vent termination cap.

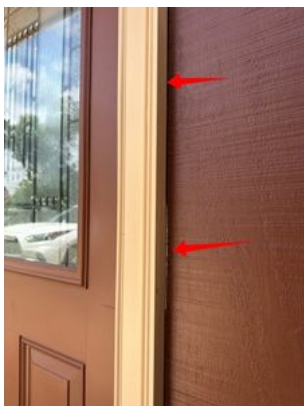
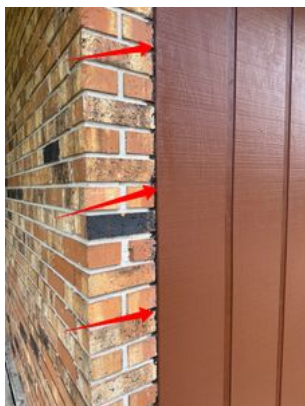
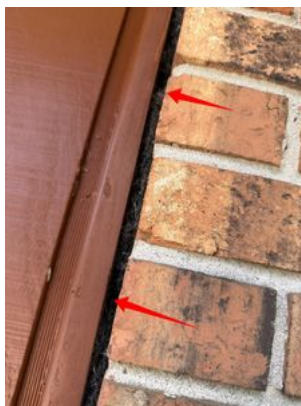
### Comment 3

Recommend sealing right side of side door and brick-wood transition on right side of right wall where sealing is missing, and resealing brick-wood transition on right side wall where sealant has failed.

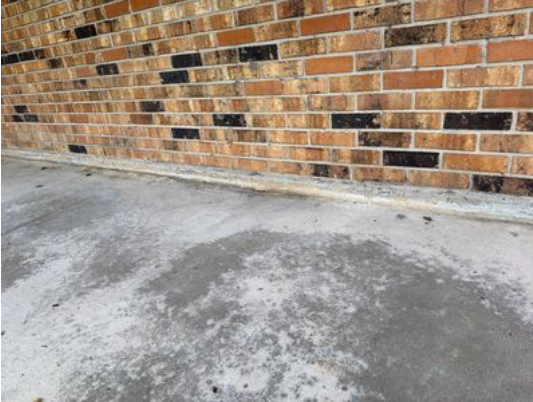
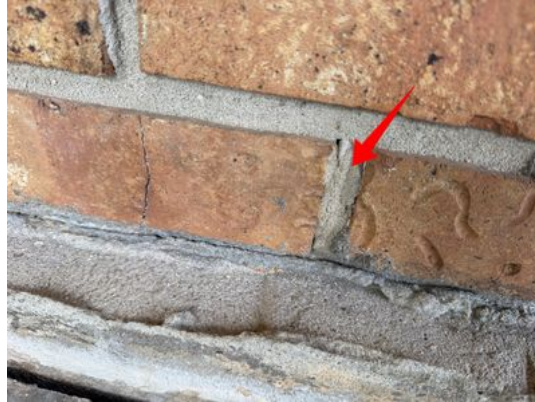
**Comment 4**

Weep-holes are not present along front porch/patio. It appears some have been sealed with mortar. Recommend maintaining open weep-holes every 33” at a minimum.

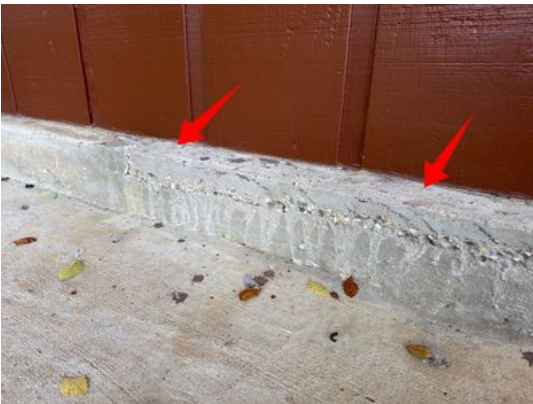
**Comment 5**

Lap wood at front wall should not be completely sealed at bottom. This should be flashed and have a gap to allow moisture to drain away from wall.

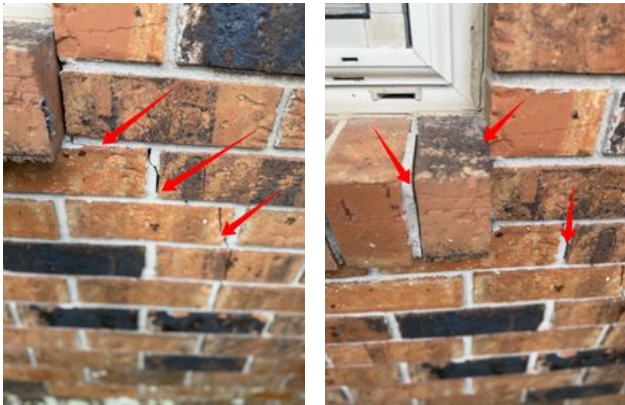
**Comment 6**

Step crack present at left wall under window in right side. This appears to be from a structural settlement. Recommend tuckpointing wall and sill and monitor for additional movement.

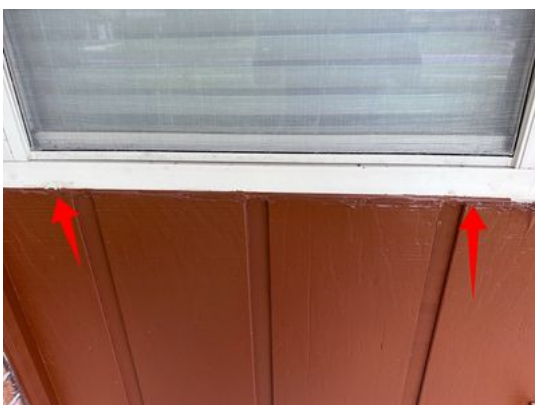
**Comment 7**

Front window has weep-holes sealed with sealant. Recommend opening weep-holes.

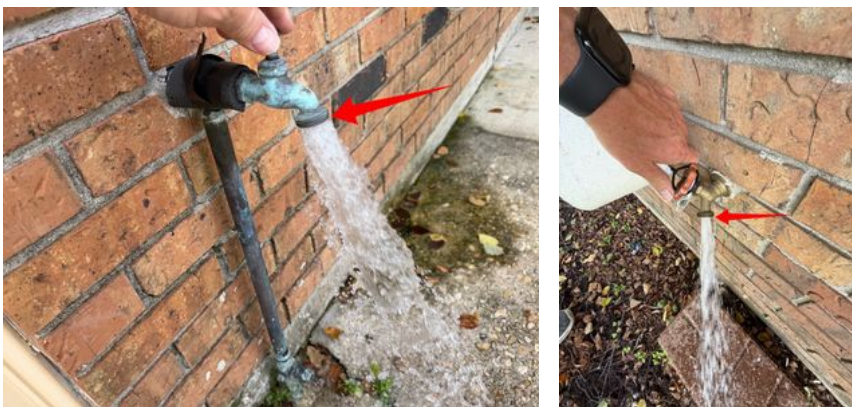
**Comment 8**  
**Safety Concern**

Exterior hose bibs should be fitted with an anti-siphon device. An anti-siphon device is a safety device on outdoor faucets (also known as hose bibs or sillcocks) that prevents backflow of contaminated water into the home's water supply.

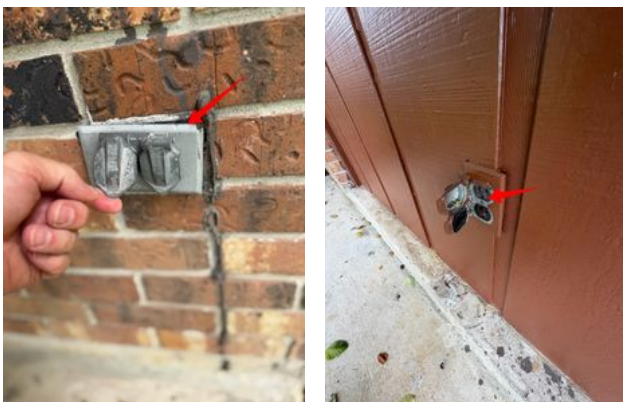
**Comment 9**  
**Safety Concern**

Right wall electrical receptacle is not GFCI protected. Rear wall electrical receptacle is loose, not GFCI protected, and has open ground. Front wall electrical receptacle is not GFCI protected and has open ground. Recommend correction by a licensed electrician.

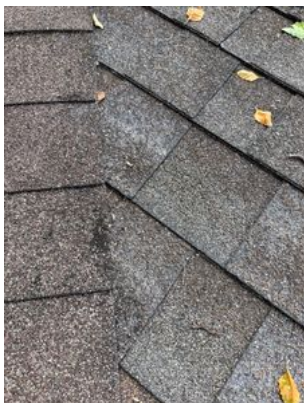
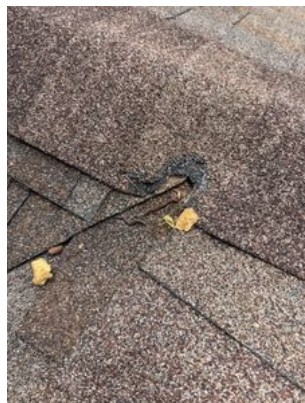
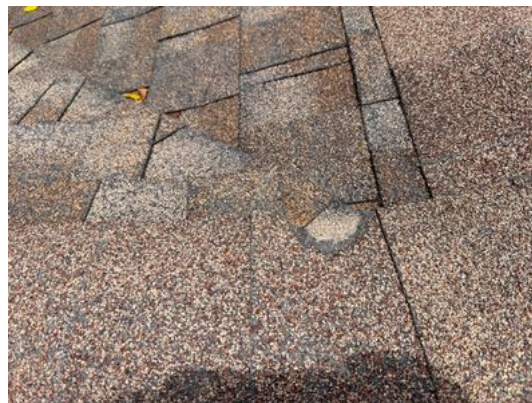
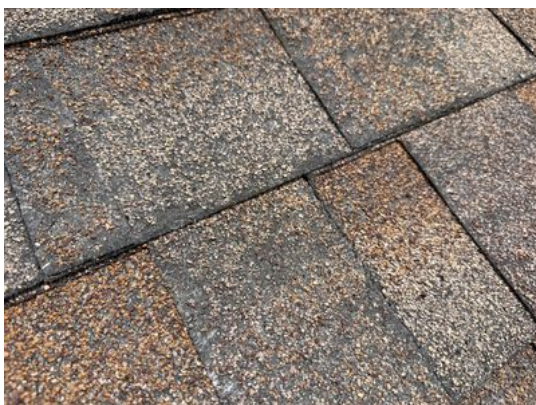
### Comment 10

Roof covering is beyond its useful life and has damaged shingles. Appears to be watertight at this time but needs replacement in the very near future.

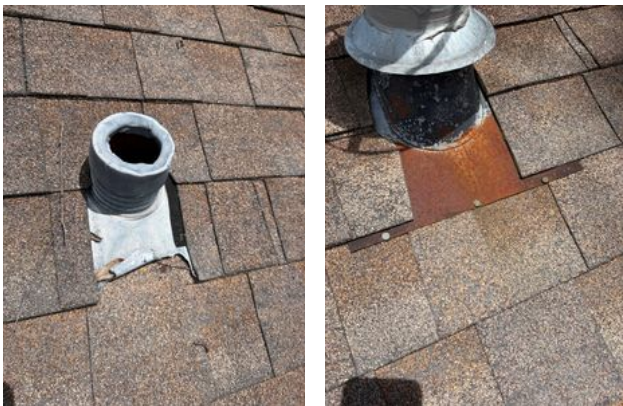
**Comment 11**

Flashings are damaged with exposed fasteners. Recommend replacement with roof replacement.

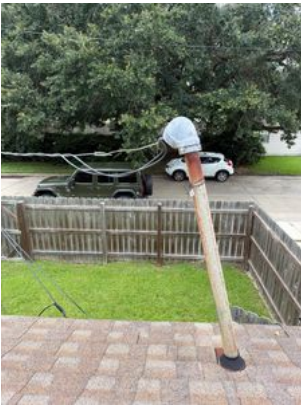
Overhead mast is bent/displaced. Recommend correction by a licensed electrician.

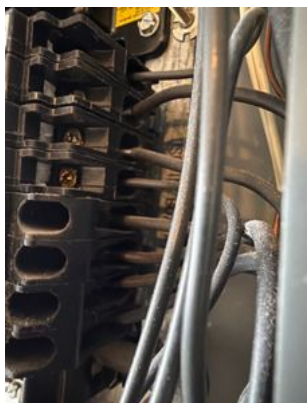
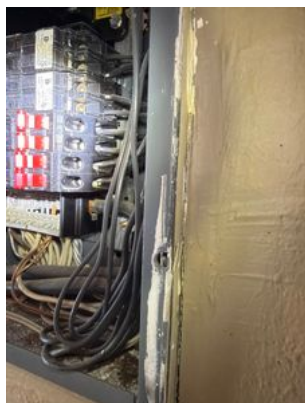
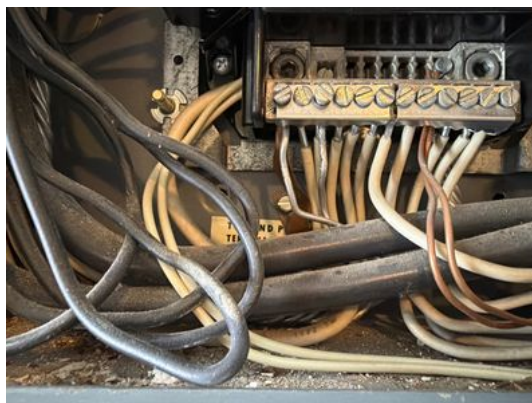
**Comment 14**

Solid aluminum wiring. Recommend evaluation by a licensed electrician.

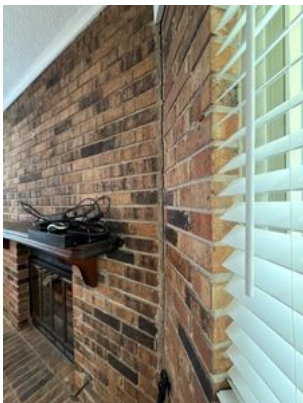
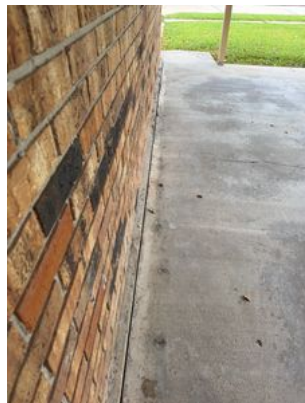
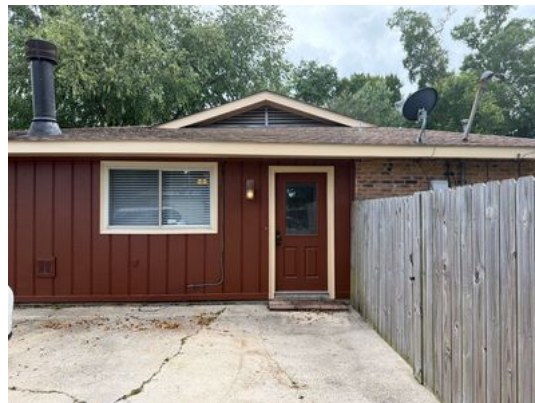
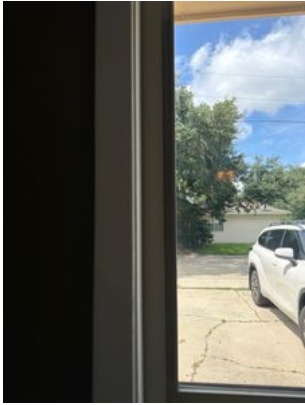
There is evidence of substantial movement at the front brick wall, the fireplace brick, and the exterior right wall. Separation of fireplace from wall, an obvious dip in the roof on the right wall, bowing of window in right wall, and separation of the slab from the adjacent front patio. Recommend evaluation by a structural engineer to determine integrity of walls and any corrective action required.

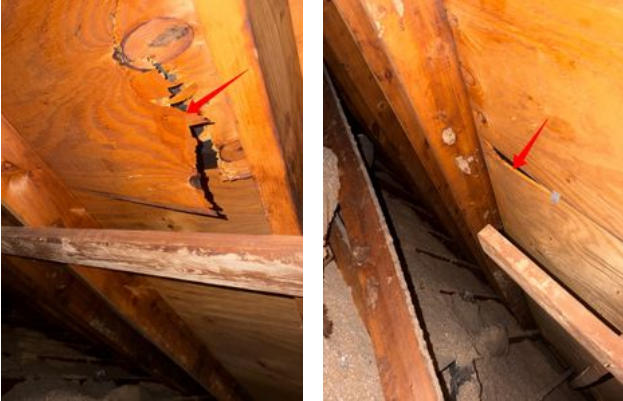
Several damaged deck boards. Recommend repair/replacement in conjunction with roof replacement.

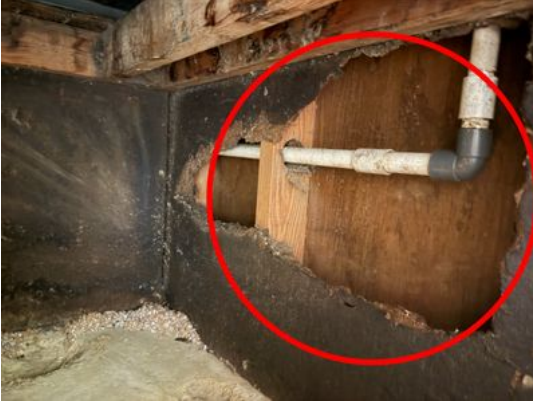
Return chase appears to be sealed at one time but seal has been compromised. Recommend resealing return chase.

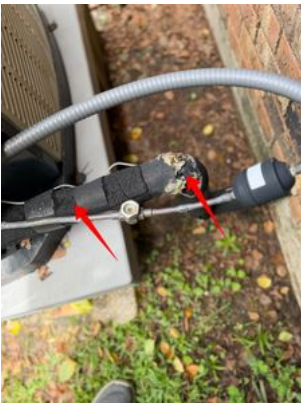
**Comment 21**  
**Repair or Replacement Needed**

The insulation of the suction line on the exterior is degraded. Recommend re-insulating to maintain efficiency of the system.

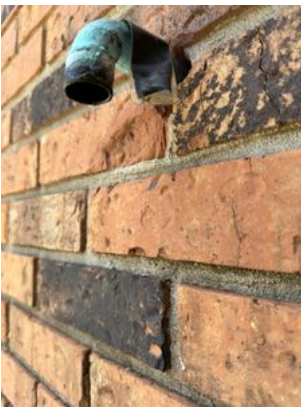
Valve is discharging water continuously. This indicates a faulty TPRV. Recommend d repair/replacement by a licensed plumber.

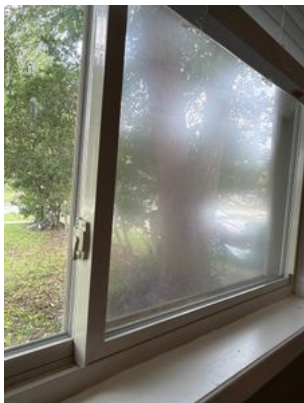
Right sash appears to have lost seal. Recommend evaluation and repair/replacement by a qualified window contractor.

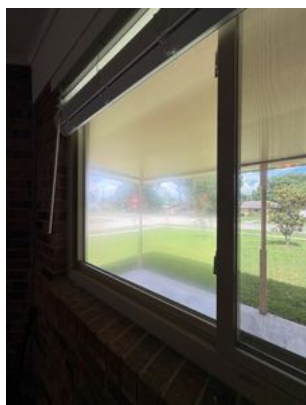
Left sash appears to have lost seal. Recommend evaluation and repair/replacement by a qualified window contractor.

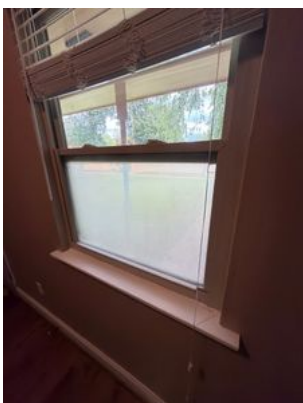
### Comment 34

Foyer window bottom sash appears to have lost seal. Recommend repair/replacement.

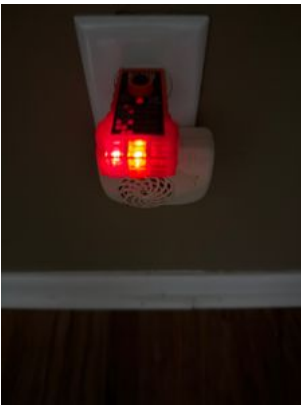
Receptacle in pantry has hot/neutral reverse. Recommend correction by a licensed electrician.

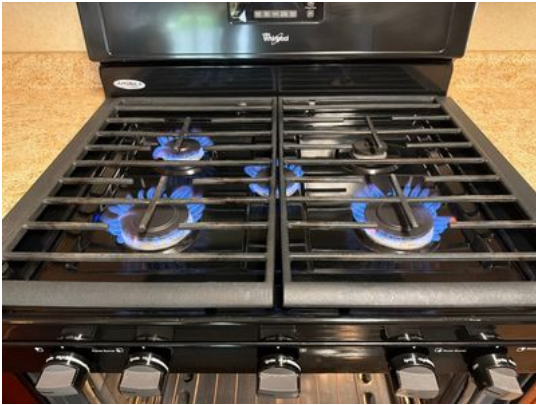
#### Comment 36

Right rear burner does not ignite. Recommend evaluation by a qualified appliance technician.

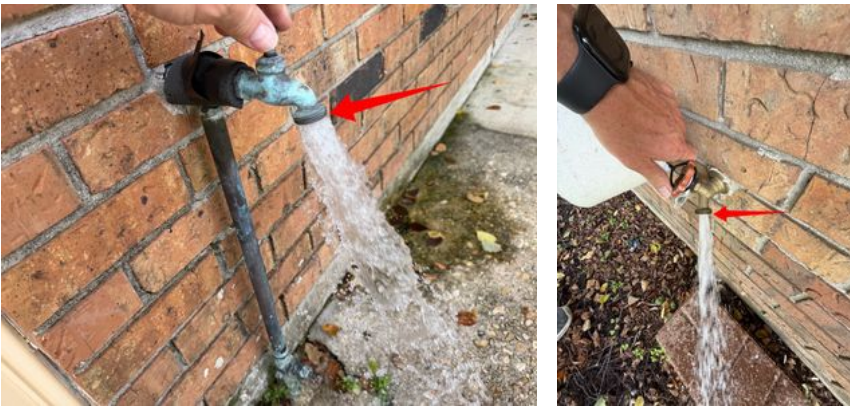
Exterior hose bibs should be fitted with an anti-siphon device. An anti-siphon device is a safety device on outdoor faucets (also known as hose bibs or sillcocks) that prevents backflow of contaminated water into the home's water supply.

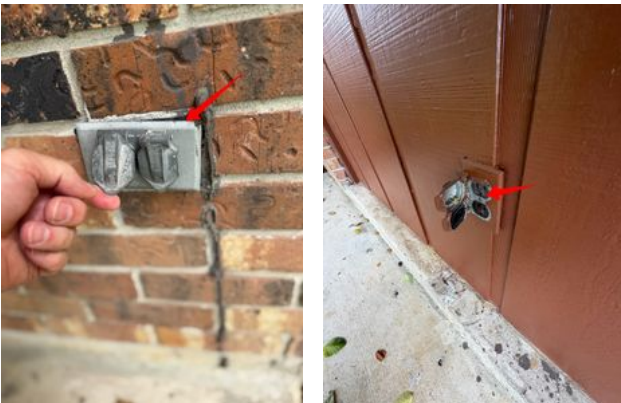
Right wall electrical receptacle is not GFCI protected. Rear wall electrical receptacle is loose, not GFCI protected, and has open ground. Front wall electrical receptacle is not GFCI protected and has open ground. Recommend correction by a licensed electrician.

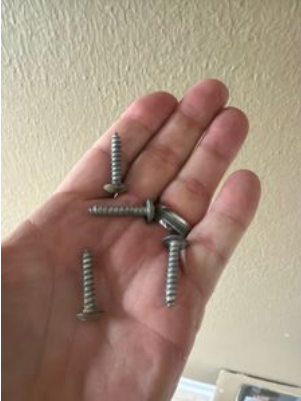
Sharp tipped screws are securing panel. This is a safety concern and they can pierce conductors within panel and electrify the panel. Use only blunt-tipped screws to secure dead front cover to panel.

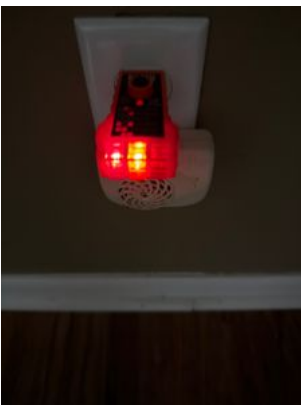
Receptacle in pantry has hot/neutral reverse. Recommend correction by a licensed electrician.

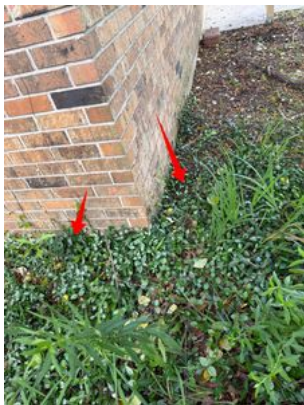
Slightly overgrown ground cover on front left corner under tree. Recommend maintaining a 12" clearance of all vegetation from structure.

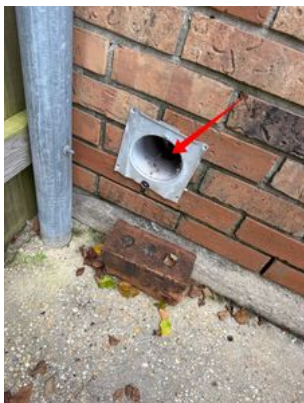
Dryer vent termination is missing. Recommend replacement with a non-screened vent termination cap.

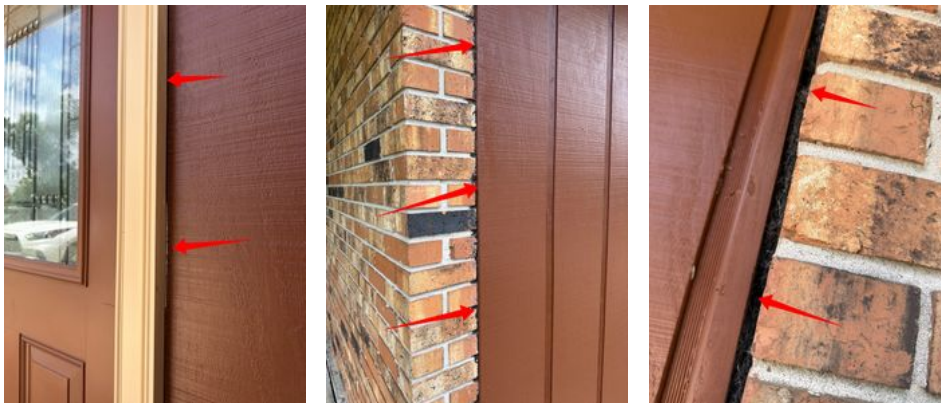
Recommend sealing right side of side door and brick-wood transition on right side of right wall where sealing is missing, and resealing brick-wood transition on right side wall where sealant has failed.

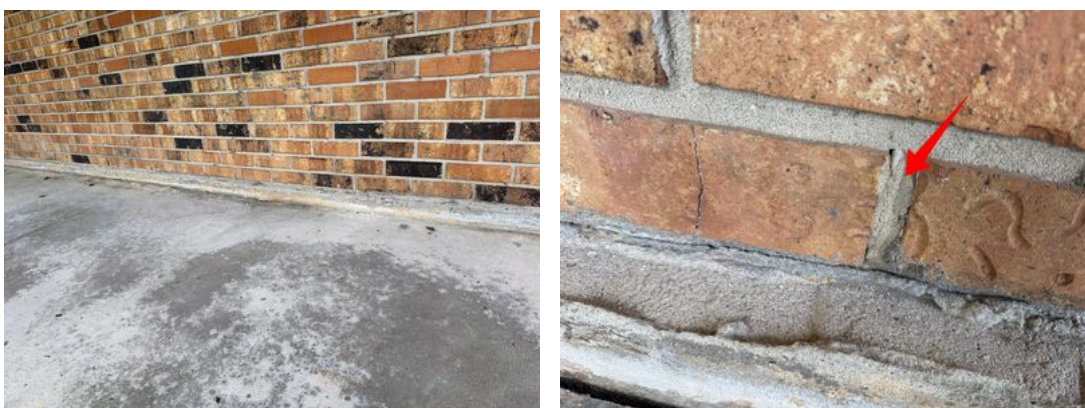
Weep-holes are not present along front porch/patio. It appears some have been sealed with mortar. Recommend maintaining open weep-holes every 33" at a minimum.

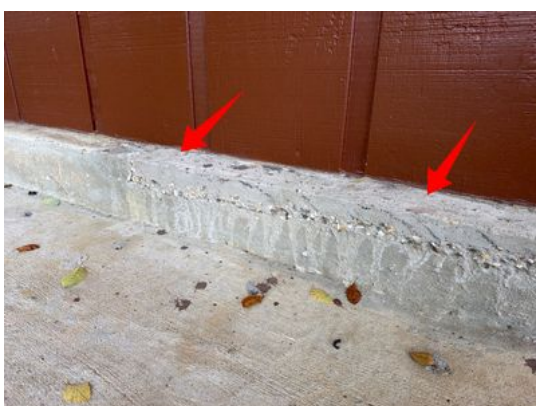
Lap wood at front wall should not be completely sealed at bottom. This should be flashed and have a gap to allow moisture to drain away from wall.

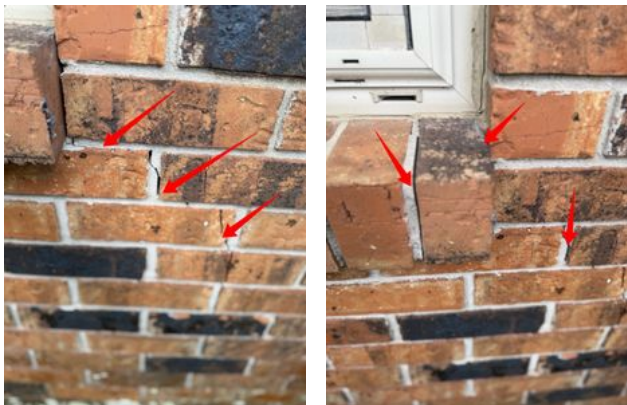
Step crack present at left wall under window in right side. This appears to be from a structural settlement. Recommend tuckpointing wall and sill and monitor for additional movement.

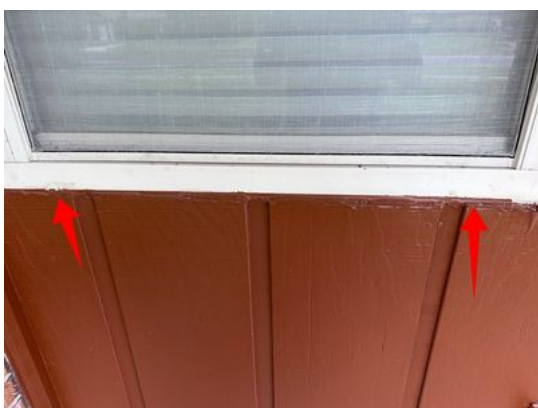
Front window has weep-holes sealed with sealant. Recommend opening weep-holes.

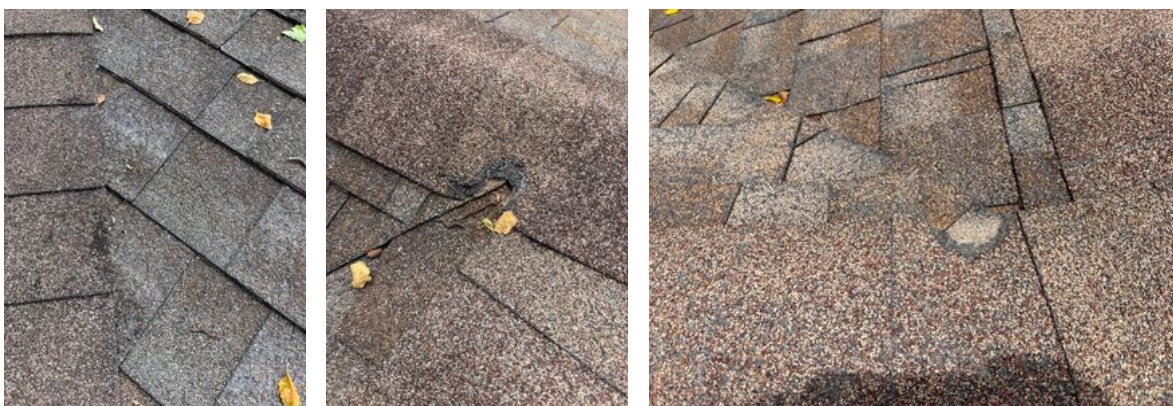
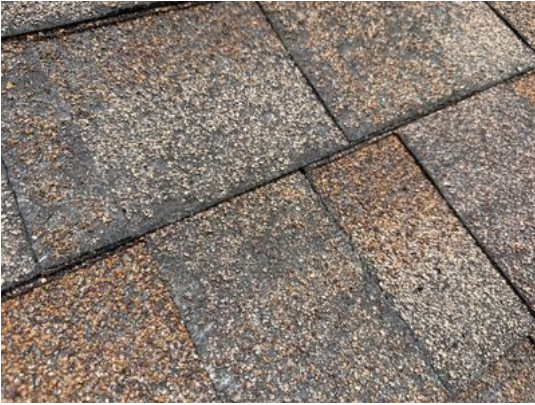
Roof covering is beyond its useful life and has damaged shingles. Appears to be watertight at this time but needs replacement in the very near future.

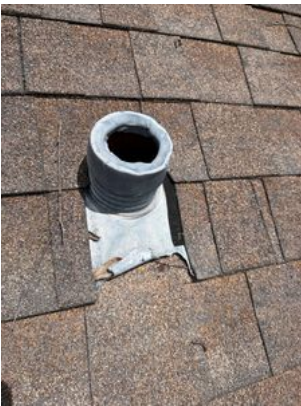
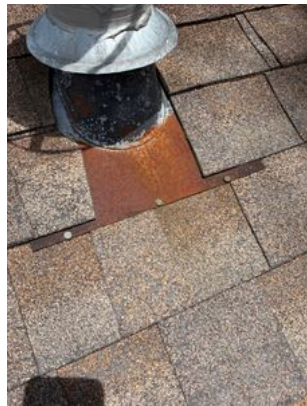
Flashings are damaged with exposed fasteners. Recommend replacement with roof replacement.

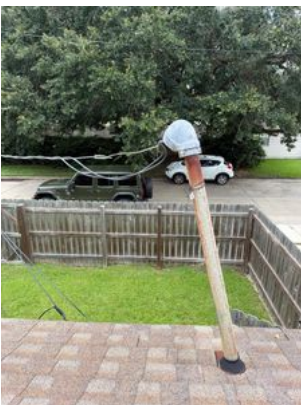
Overhead mast is bent/displaced. Recommend correction by a licensed electrician.

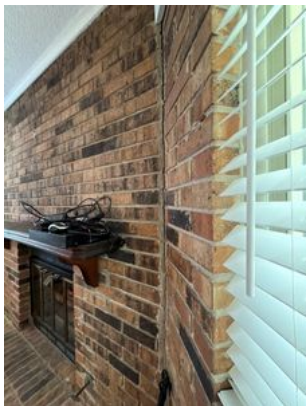
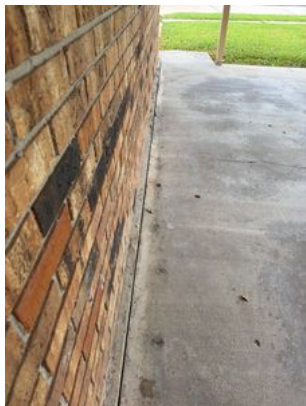
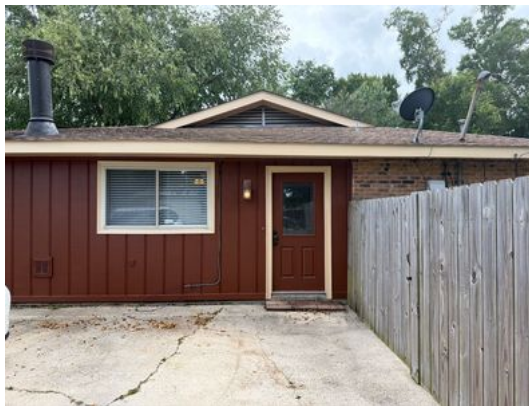
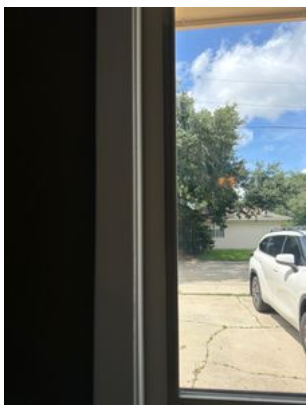
There is evidence of substantial movement at the front brick wall, the fireplace brick, and the exterior right wall. Separation of fireplace from wall, an obvious dip in the roof on the right wall, bowing of window in right wall, and separation of the slab from the adjacent front patio. Recommend evaluation by a structural engineer to determine integrity of walls and any corrective action required.

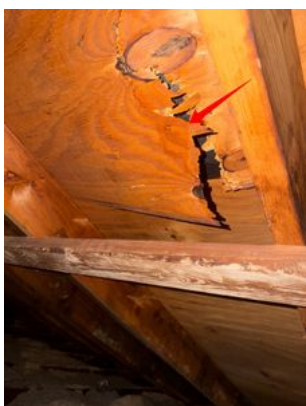
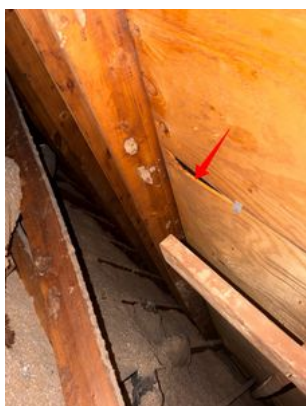
Several damaged deck boards. Recommend repair/replacement in conjunction with roof replacement.

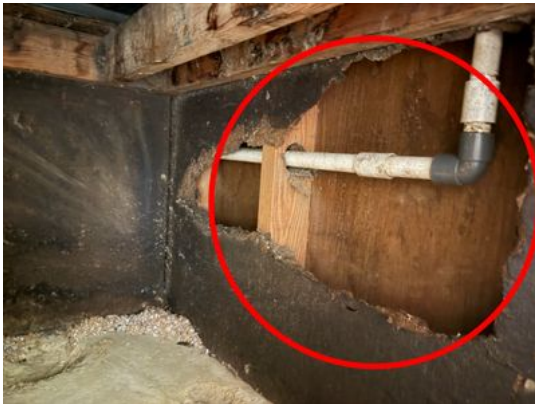
Return chase appears to be sealed at one time but seal has been compromised. Recommend resealing return chase.

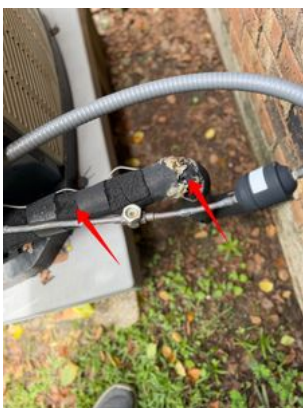
The insulation of the suction line on the exterior is degraded. Recommend re-insulating to maintain efficiency of the system.

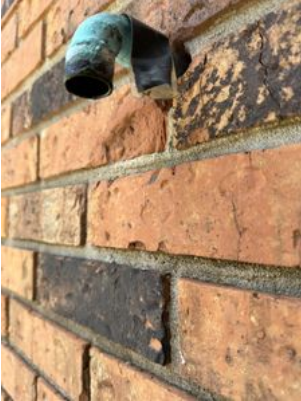
Valve is discharging water continuously. This indicates a faulty TPRV. Recommend d repair/replacement by a licensed plumber.

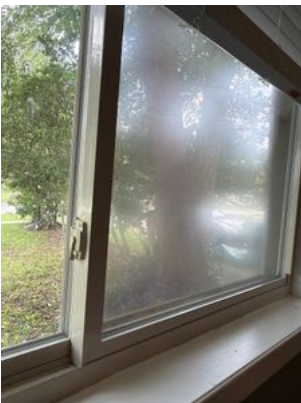
Right sash appears to have lost seal. Recommend evaluation and repair/replacement by a qualified window contractor.

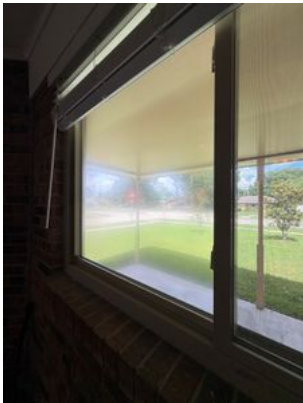
Left sash appears to have lost seal. Recommend evaluation and repair/replacement by a qualified window contractor.

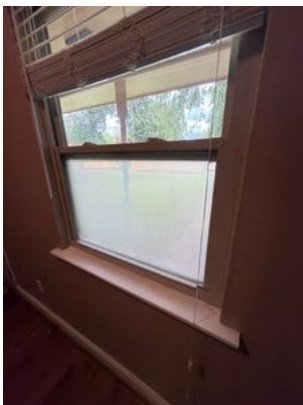
Foyer window bottom sash appears to have lost seal. Recommend repair/replacement.
