Structural Inspection

May 12, 2026

Marlin Ford
5453 Iris Hollow Rd.
Slidell, La. 70461

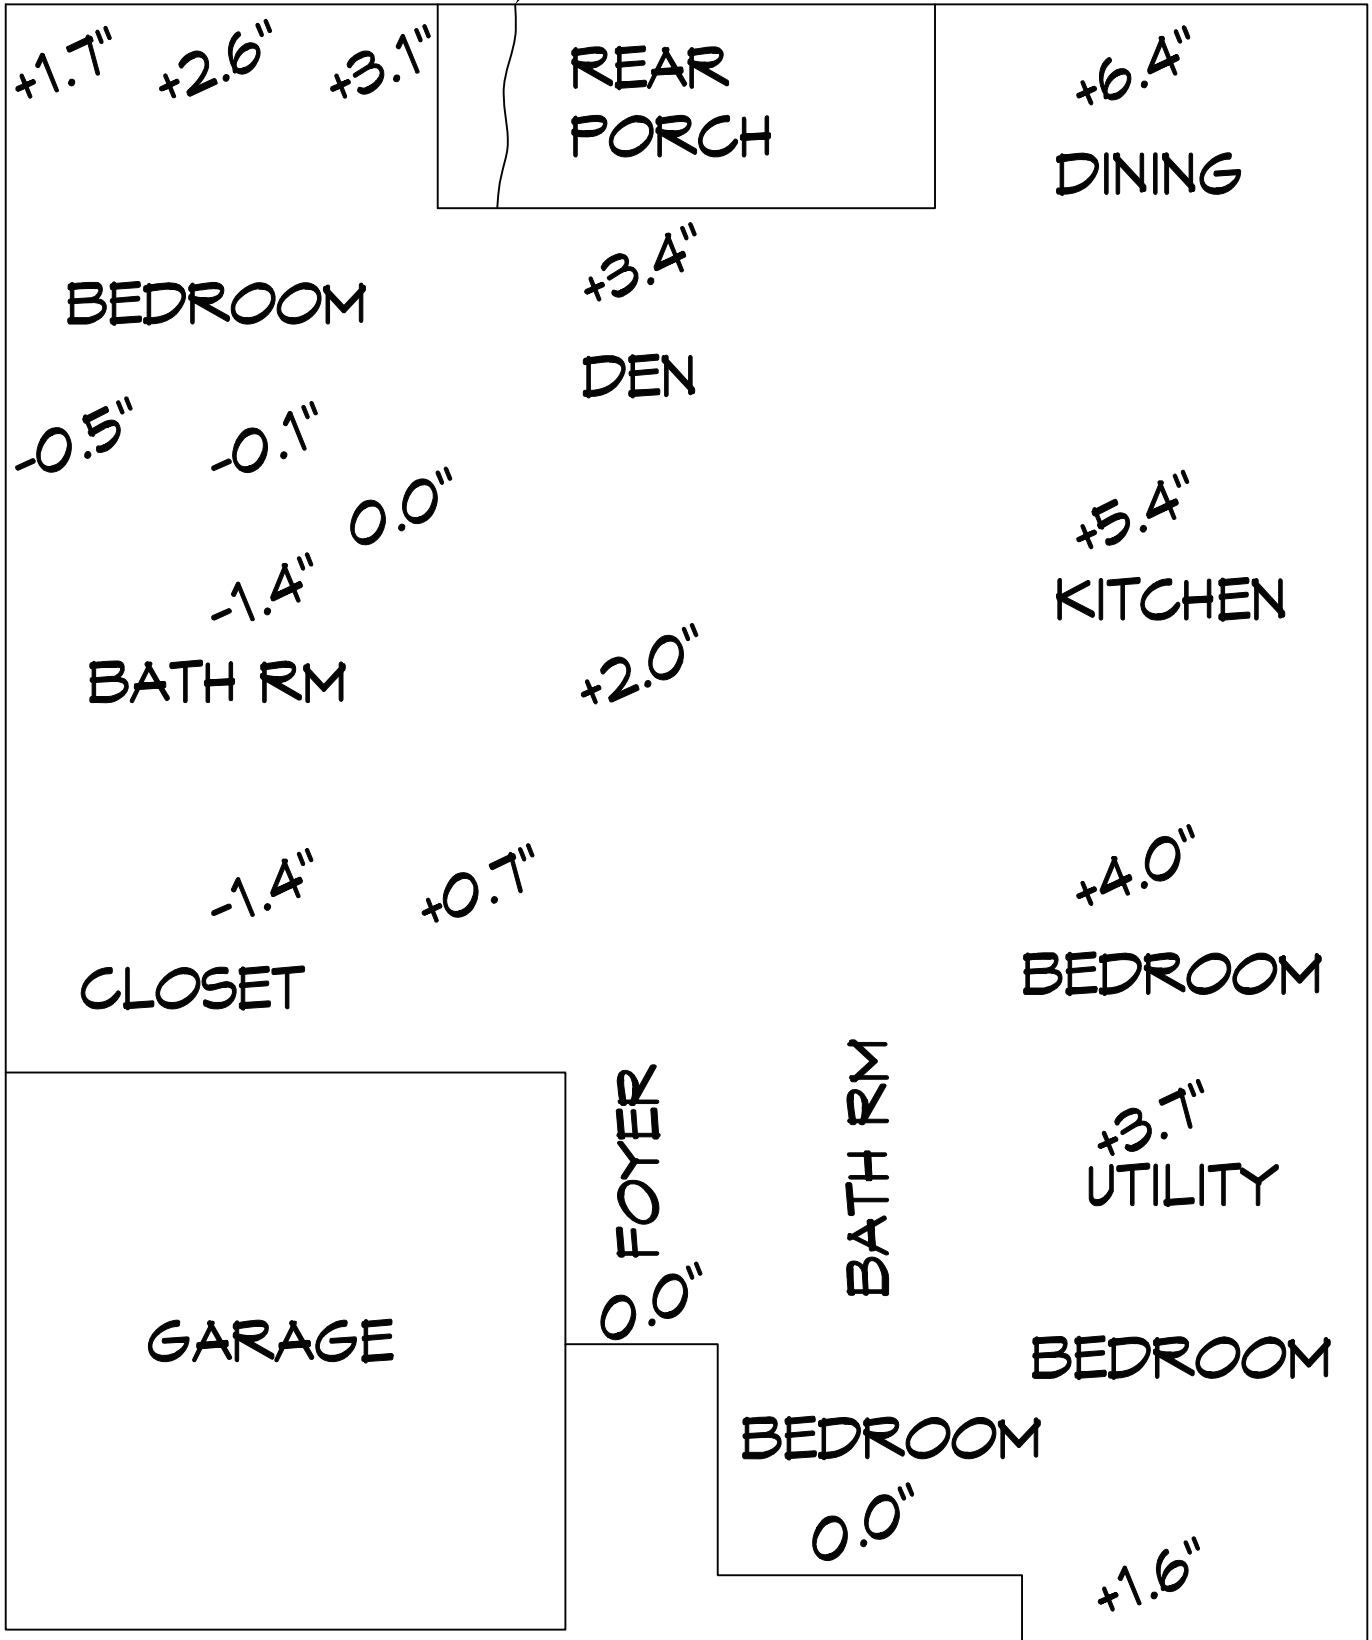
There is one small hairline crack in the foundation noted in the rear porch area and runs up the foundation to inside. There are no signs of stress in the sheet rock ceilings or walls. All interior doors open and close, the garage door swings closed by itself. All ceilings and walls appear visually straight.

HAIRLINE CRACK

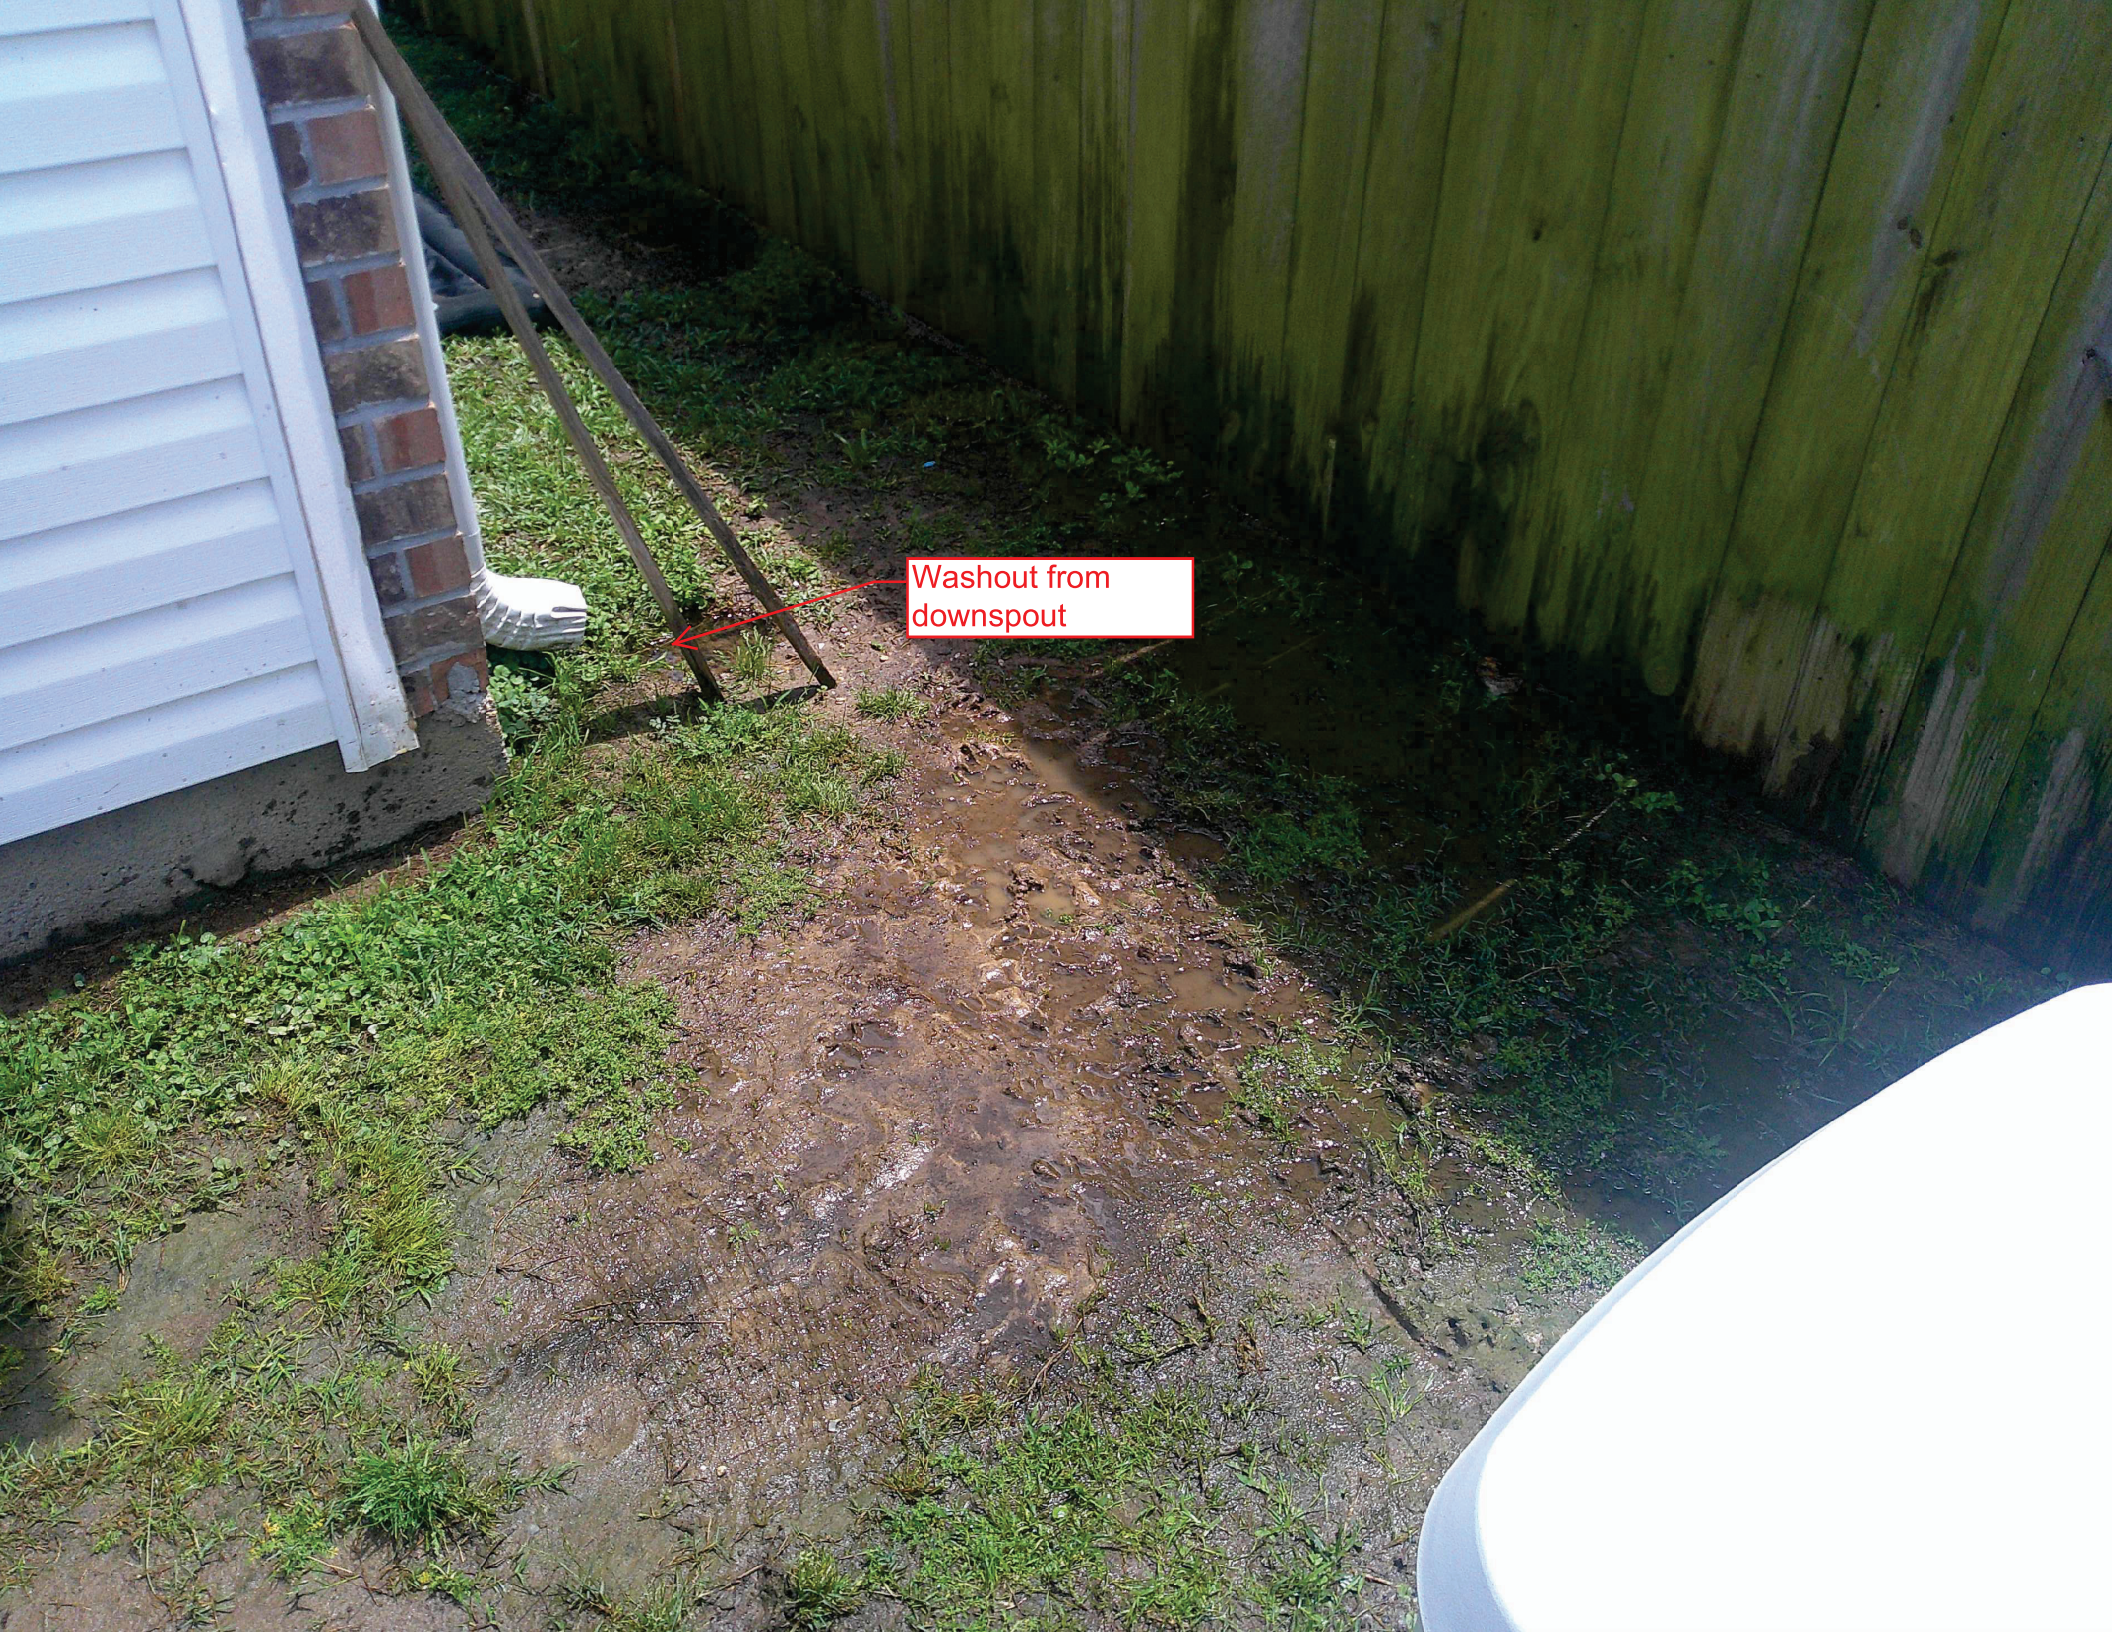
The exterior of the home was noted to have gutters and downspouts that drain directly onto the ground. The downspouts on the left side of the home drain directly onto the ground and have caused a washout of the ground. This area stays wet.

Washout from
downspout

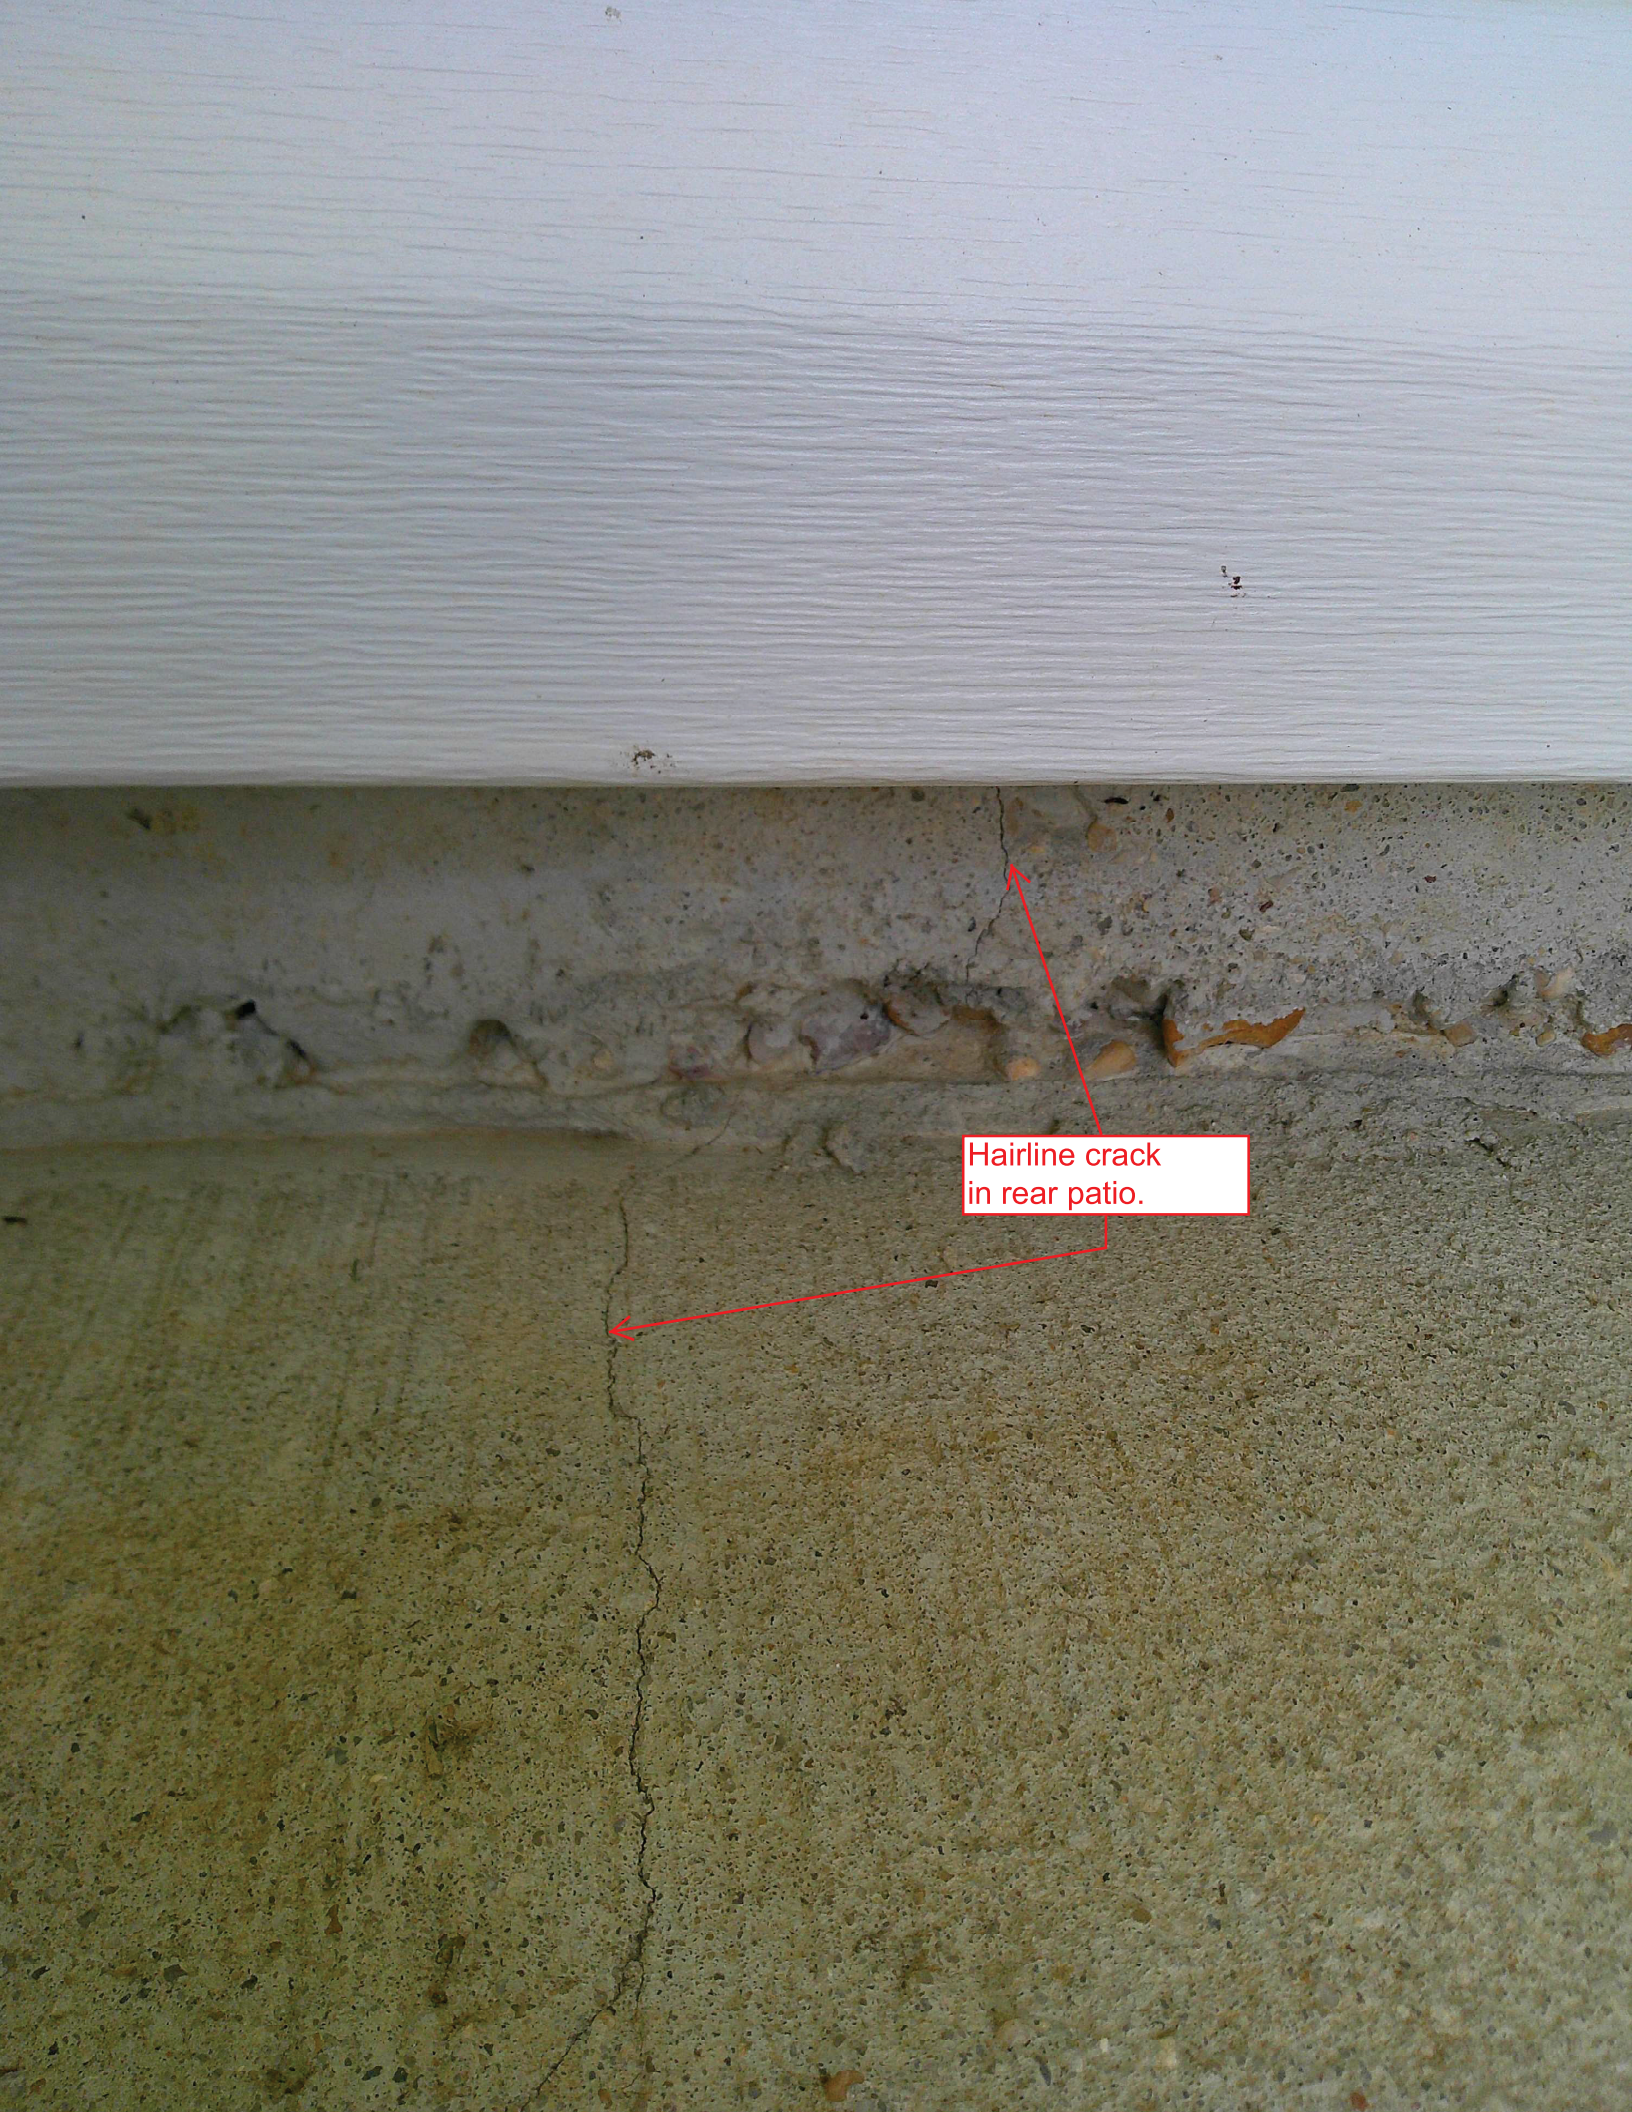
Hairline crack
in rear patio.
