Structural Inspection

July 30, 2024

Jack Tolley
228 St Mary Ct
Abita Springs, La. 70420

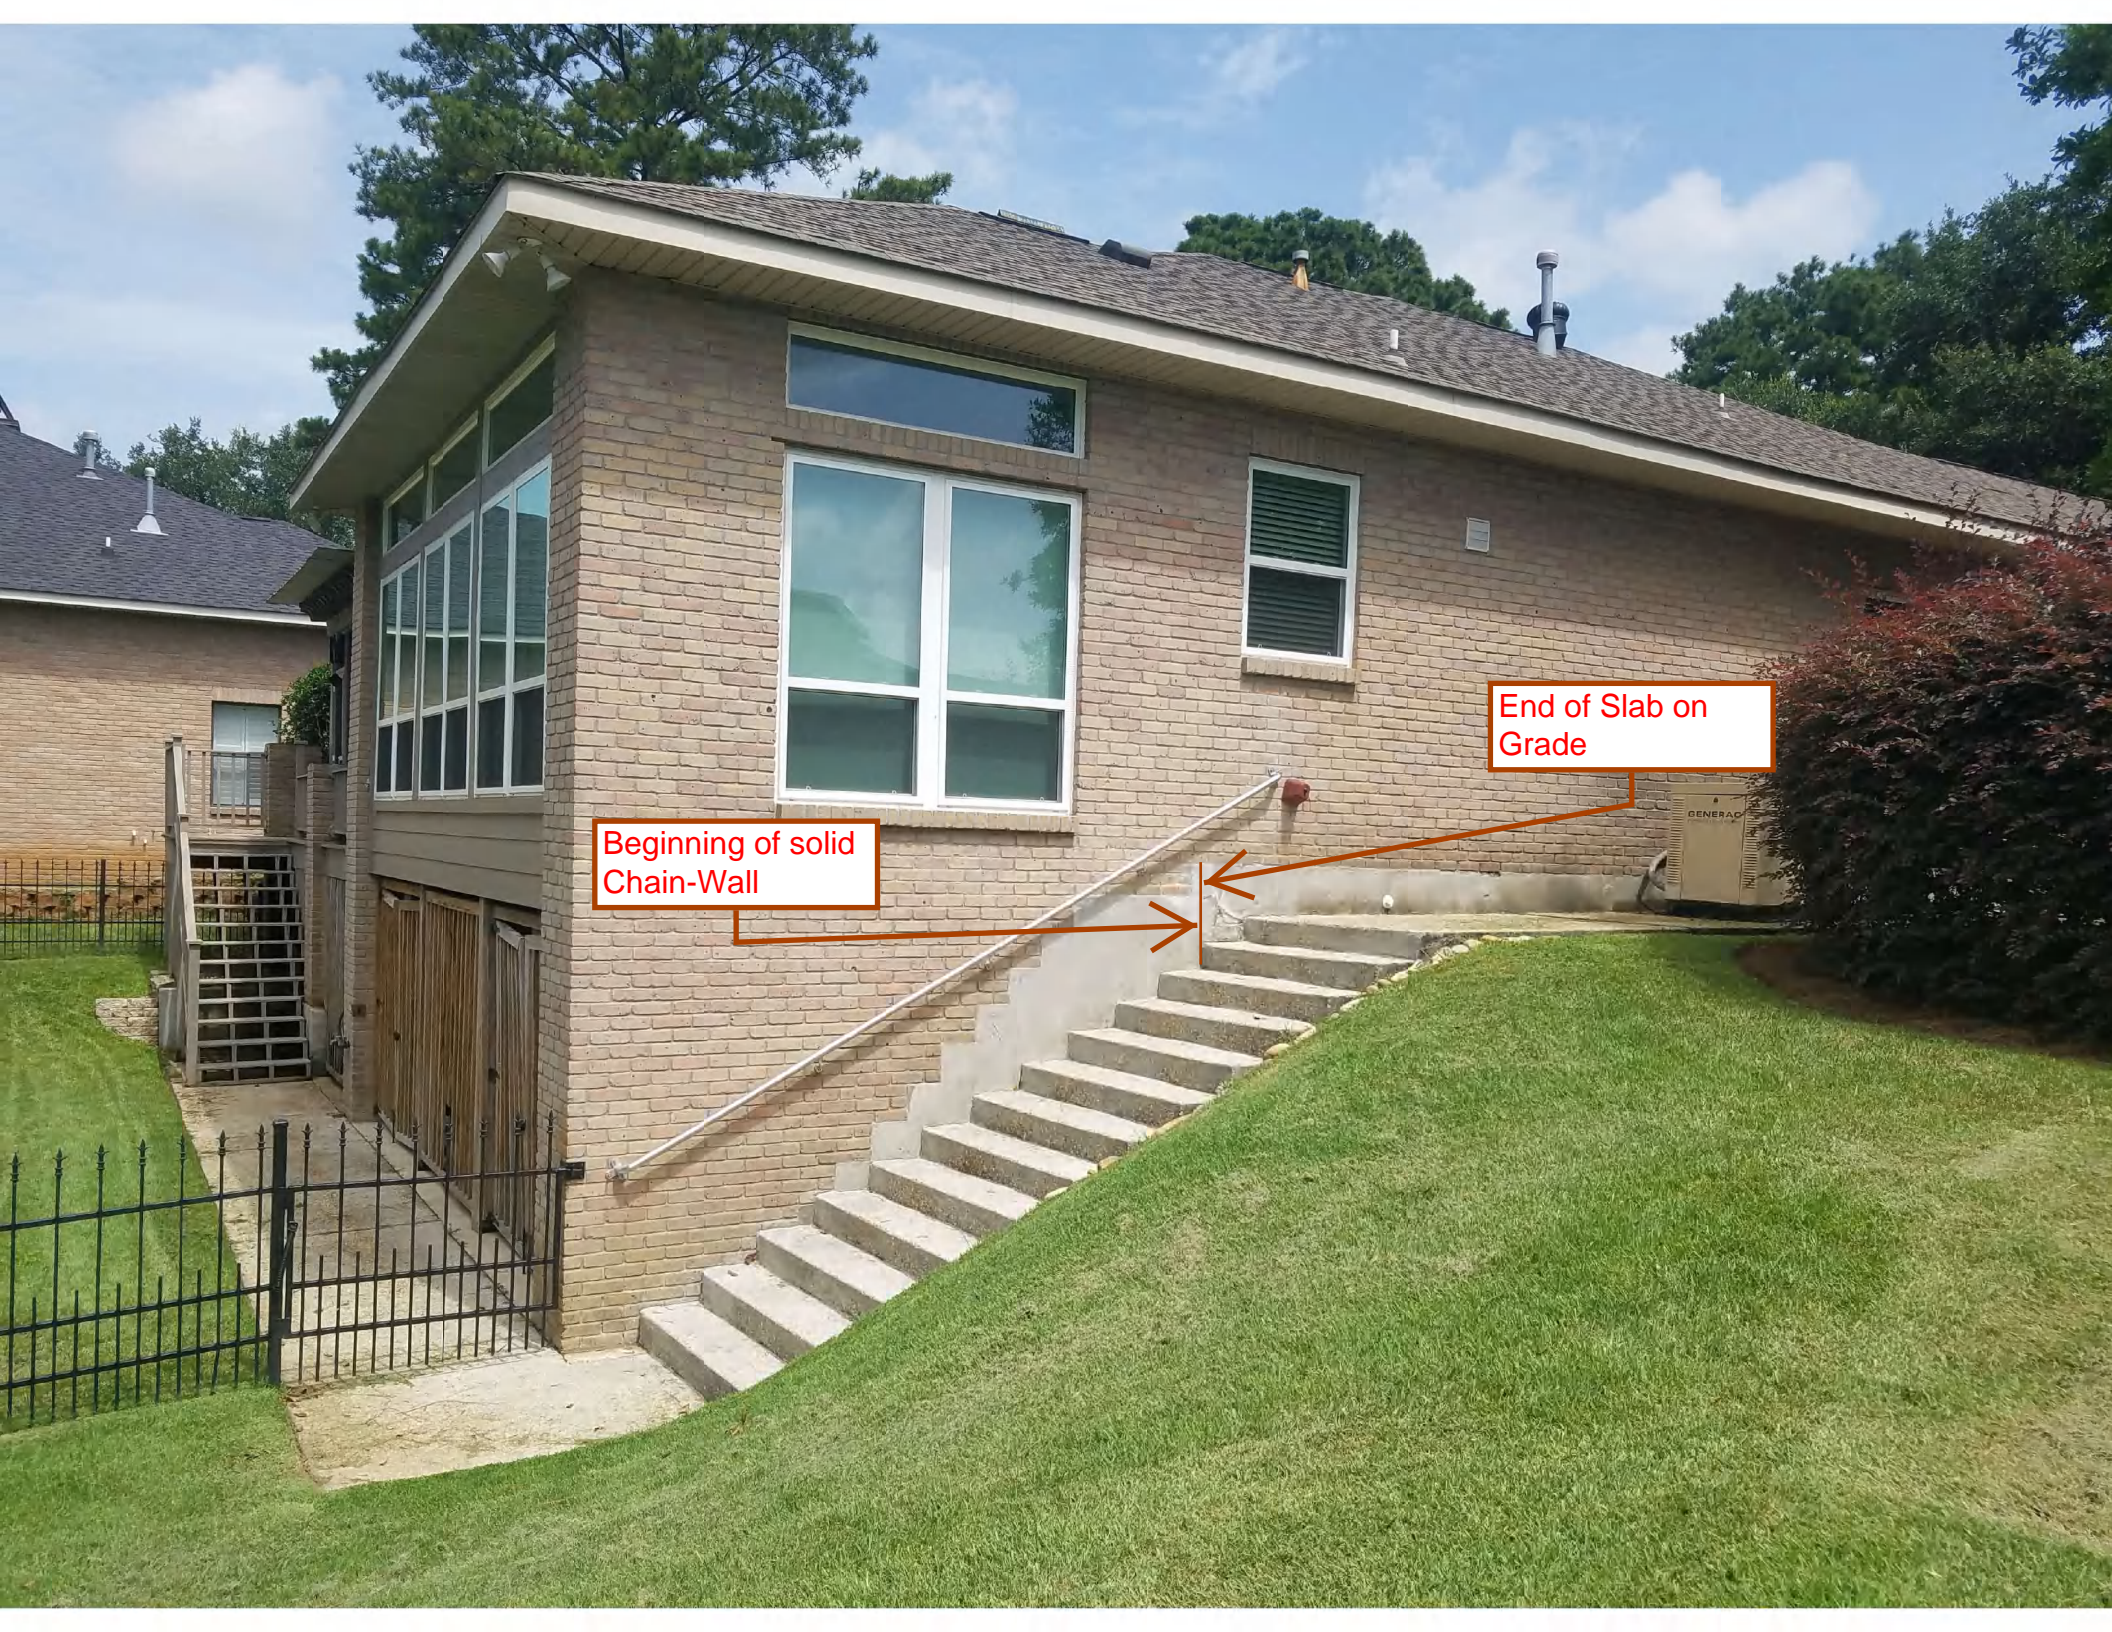
Beginning of solid Chain-Wall

End of Slab on Grade

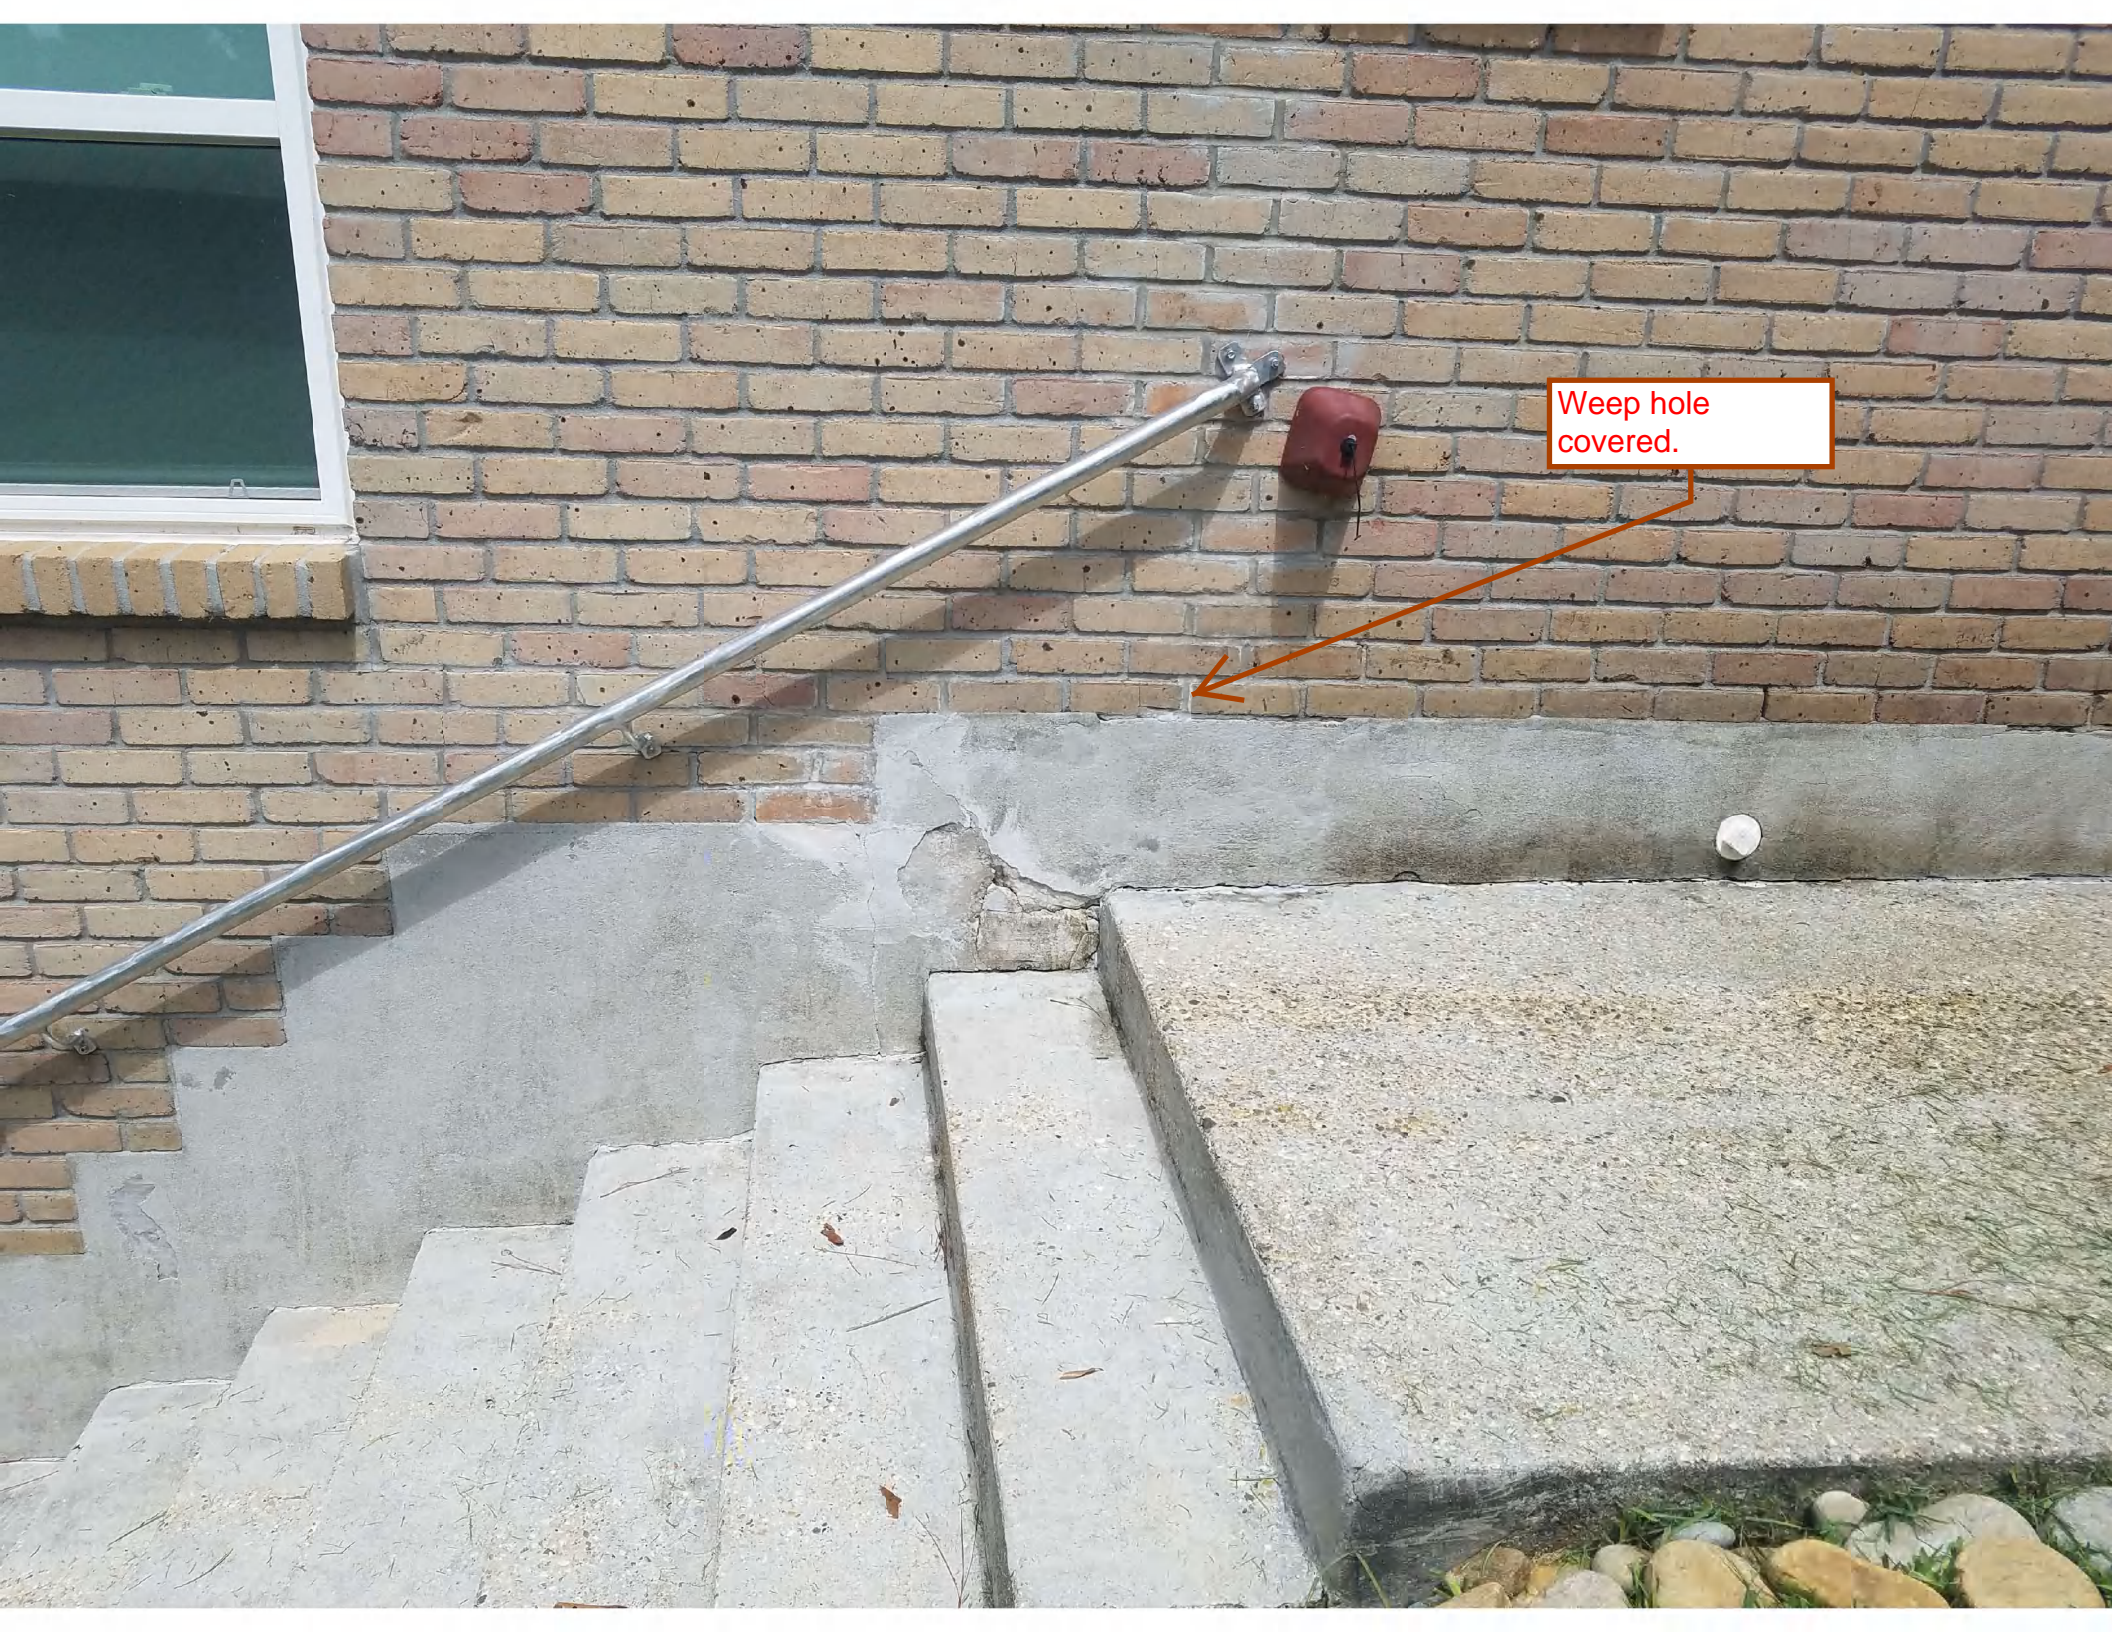
Weep hole covered.

- 1) Install gutters and downspouts to move rainwater away from the house foundation.
- 2) Install a long-term durable moisture resistant expansion joint material between the sidewalk and the house.
- 3) Repair the cracked concrete at the top step using non-shrinking grout.
- 4) Remove the concrete that was placed into the brick façade weep hole(s).

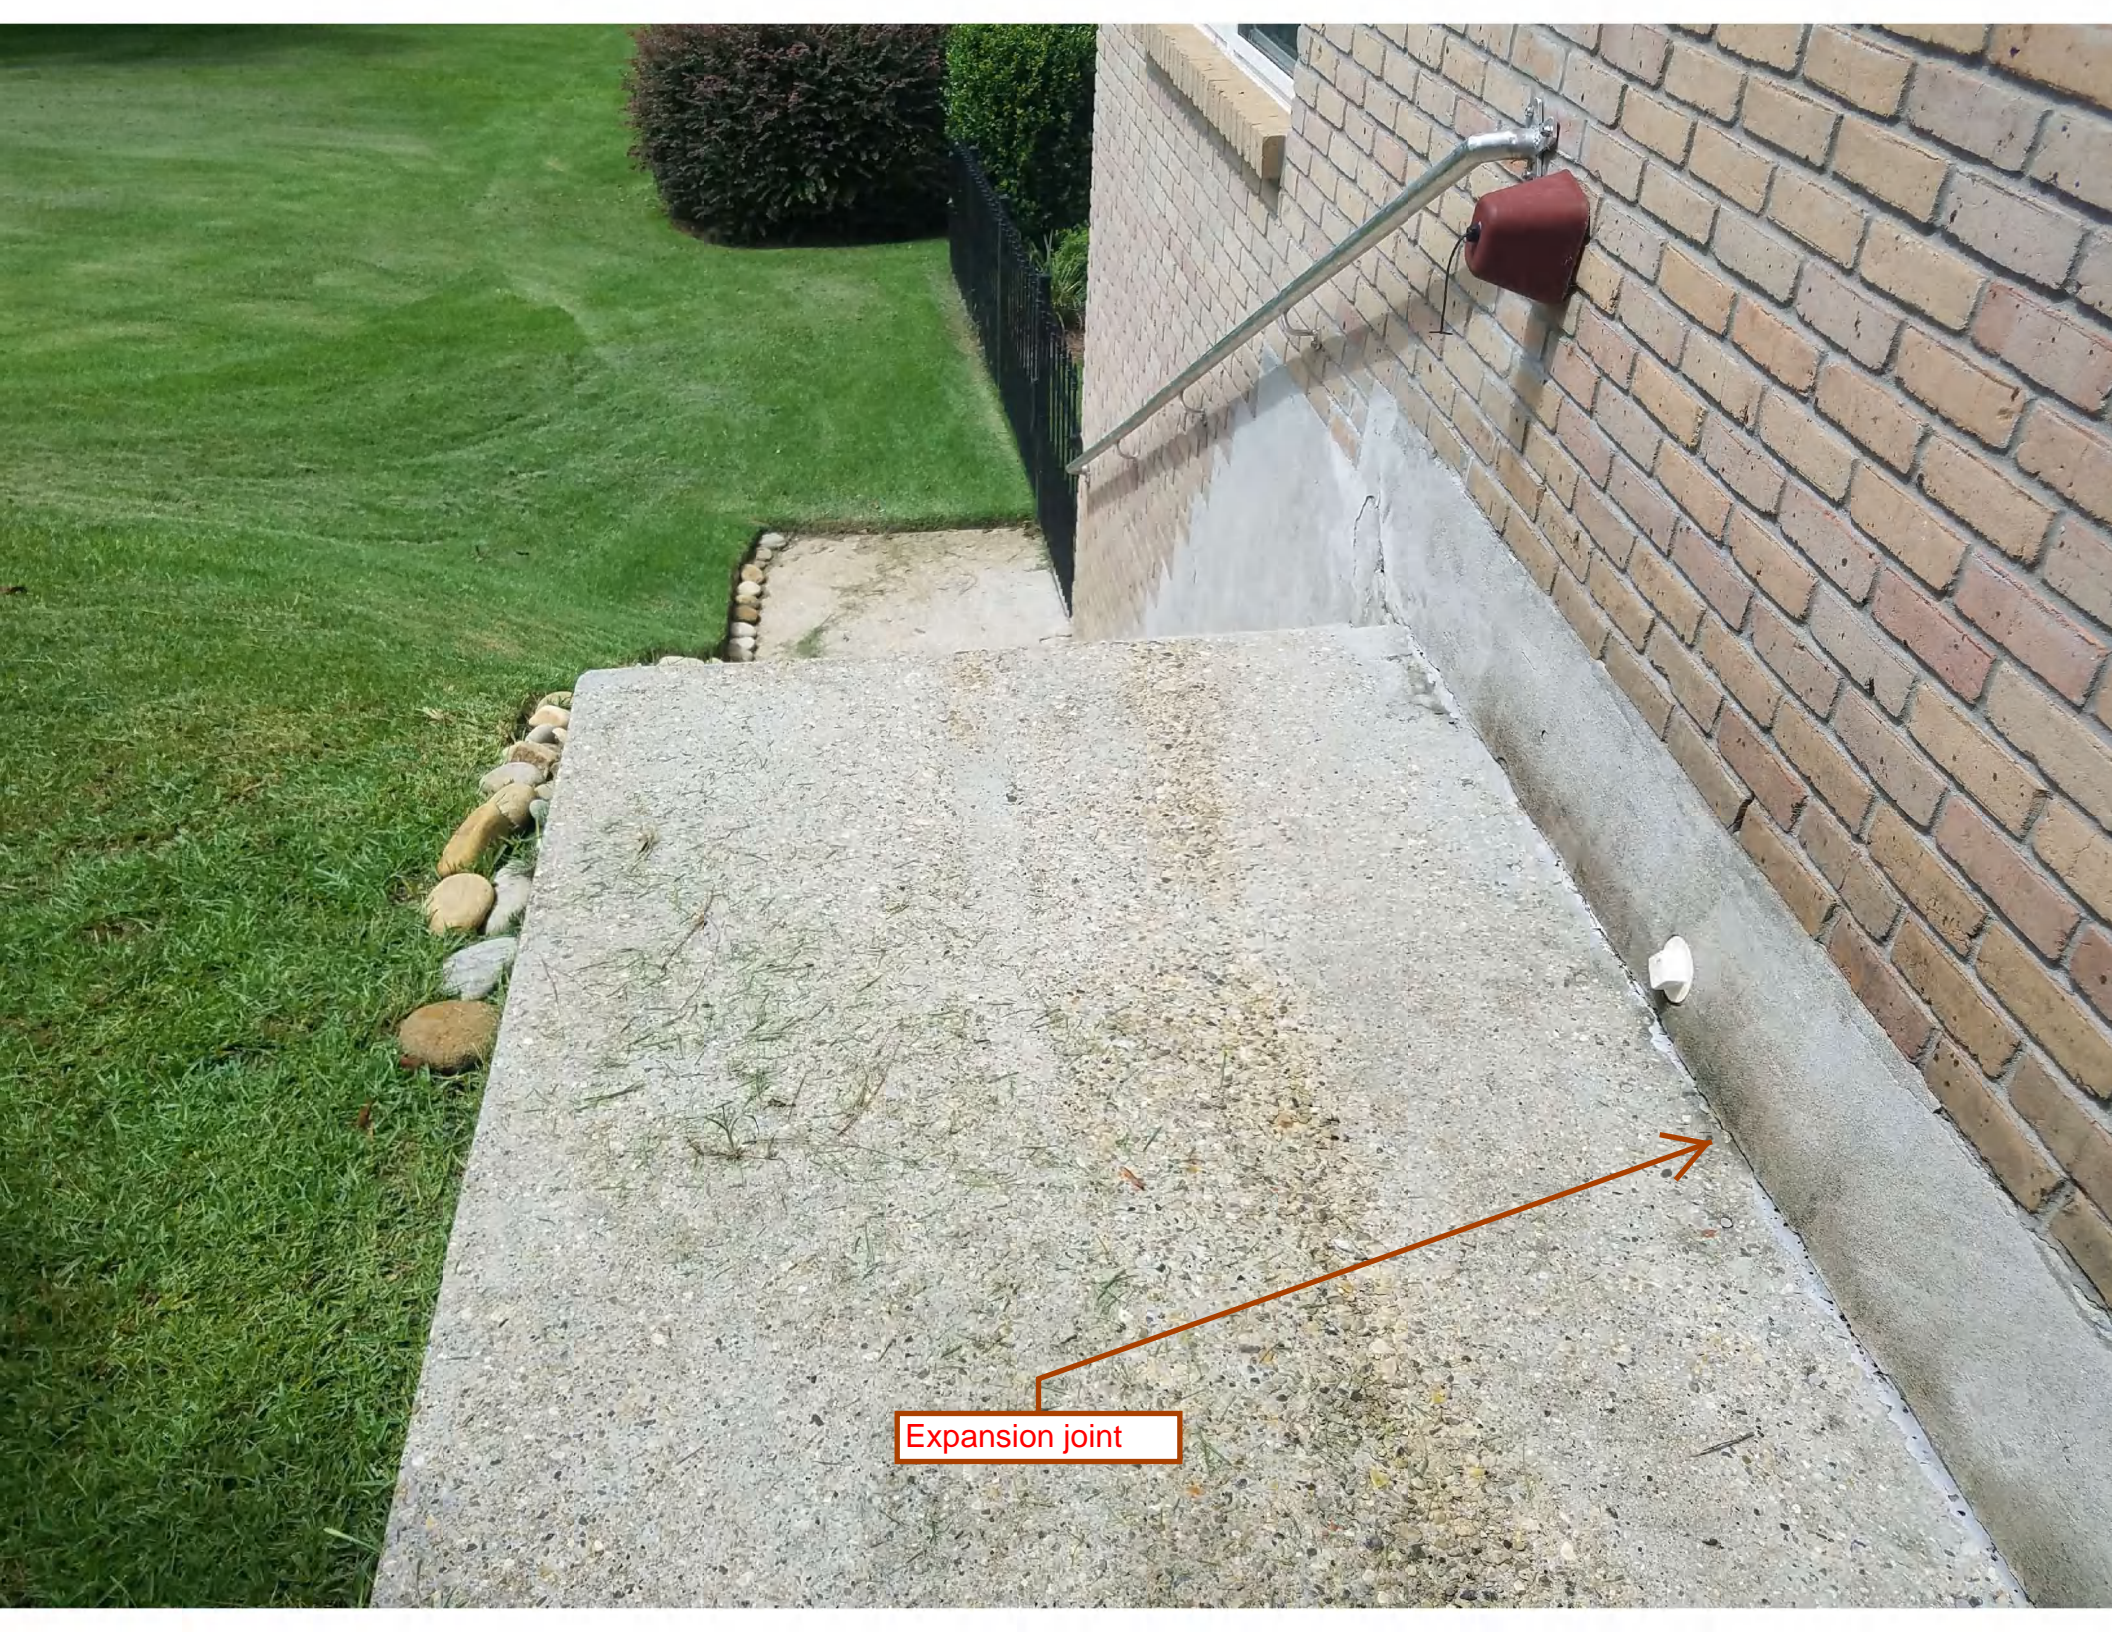
This house does not use gutters and rainfall hits the sidewalk next to the house, on this side of the house. There are stains and growth on the foundation where the water appears to have collected. The connection between the sidewalk and the foundation appears to have been caulked in the past but needs to be repaired.

Expansion joint
