**BUILDING INSPECTION AUTHORIZATION AND AGREEMENT**  
**THIS IS A TWO PAGE, LEGALLY BINDING CONTRACT. PLEASE READ IT CAREFULLY.**

**SUBJECT:** Inspector agrees to conduct a limited, visual inspection of the property located at \_\_\_\_\_ 125 Ayshire, Slidell La 70461 \_\_\_\_\_. This inspection shall be conducted on or about \_\_\_\_\_ April 6, 2016 \_\_\_\_\_ for a fee of \_\_\_\_\_ \$435 (\$510 w/pool) \_\_\_\_\_.

## INSPECTION CONDITIONS

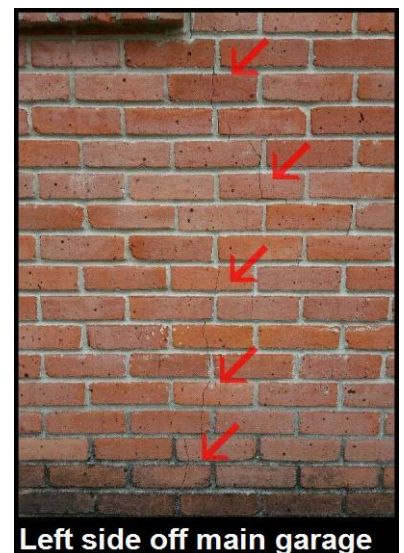
The following concerns were noted at the exterior walls: Cracks noted. Some cracking is to be expected in all exterior surfaces as the property settles with age. Recommend monitoring for any future changes, Significant cracks were noted, Pest entry points noted. Recommend sealing all penetrations to prevent access, Recommend making necessary repairs, Recommend caulking/sealing intersections between dissimilar building materials. Recommend evaluation by a qualified licensed structural engineer.

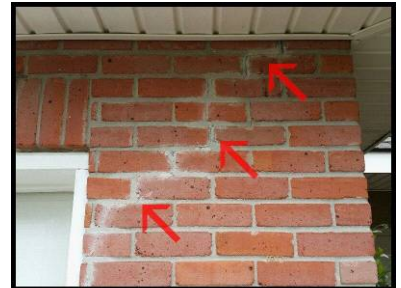
**By garage**

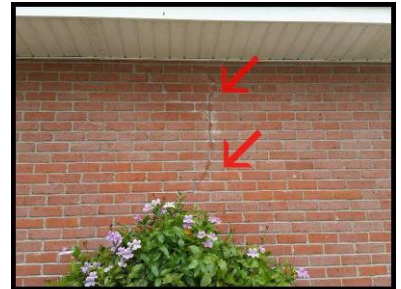
**Left side of house**

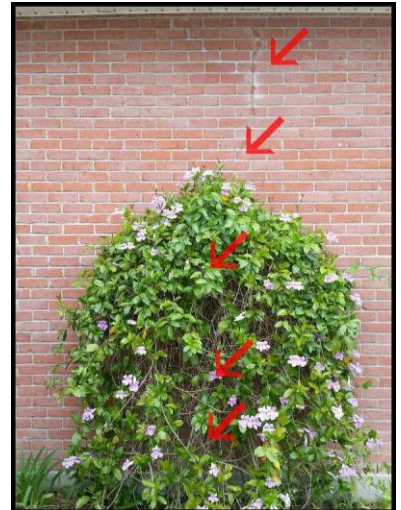
**Runs all the way down the wall**

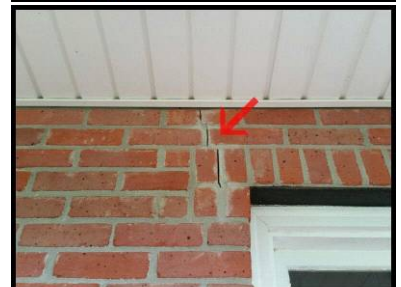
**By front door**

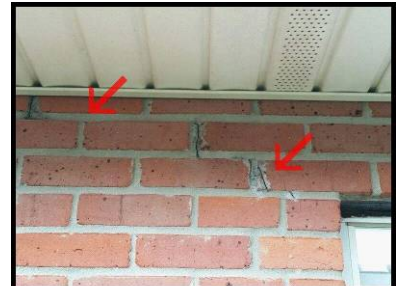
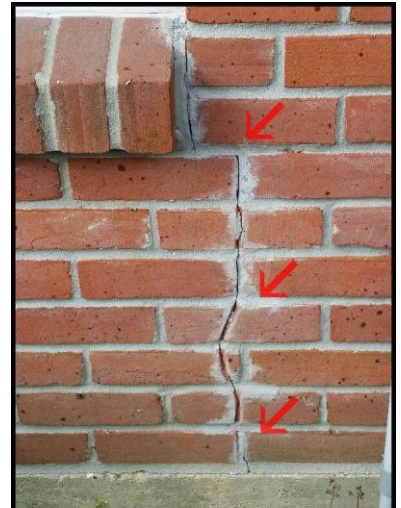
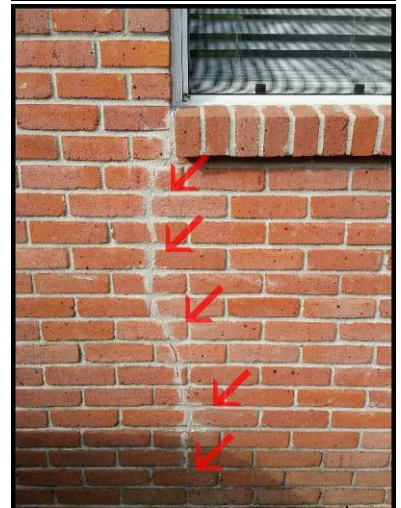
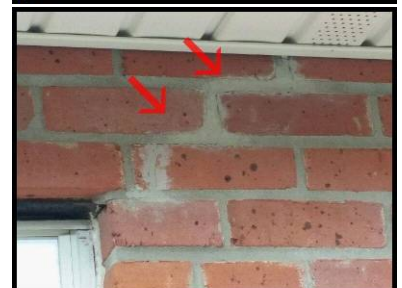
Right side of house

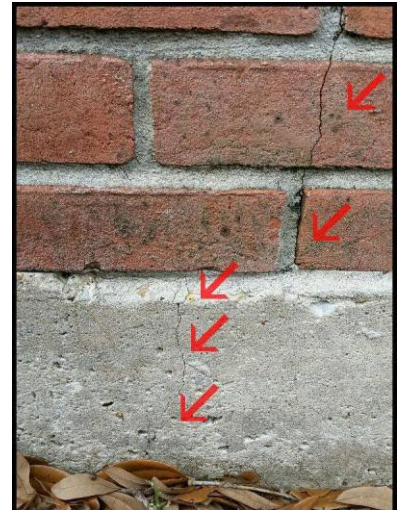
Zoomed in look of last pic

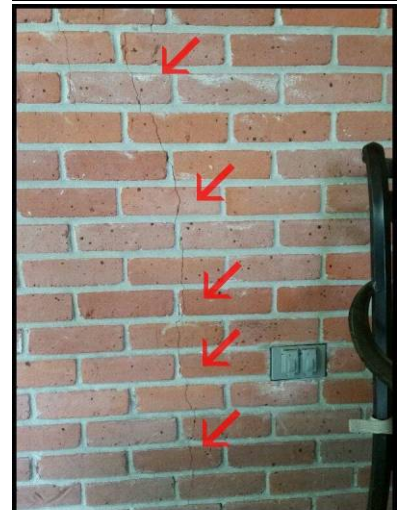
Side wall below patio

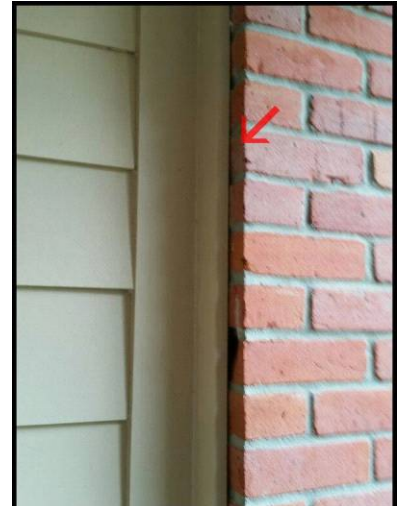
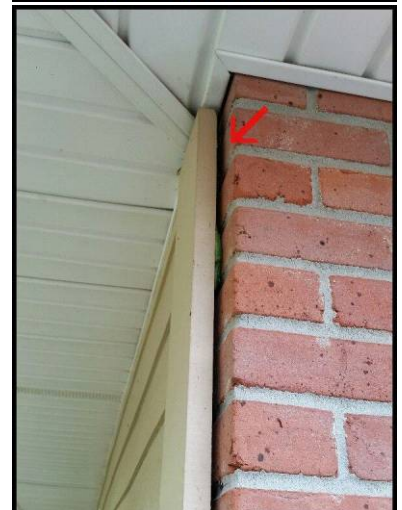
The following concerns were noted at the exterior trim: Pest entry points noted. Recommend sealing all penetrations to prevent access, Caulking recommended at intersections between dissimilar building materials, Loose or deteriorated material.

**Caulk between all dissimilar material**

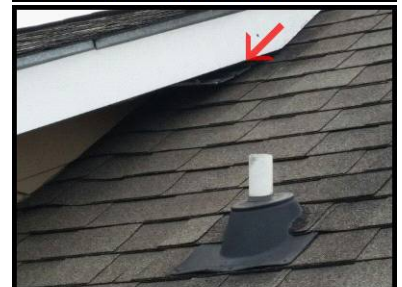
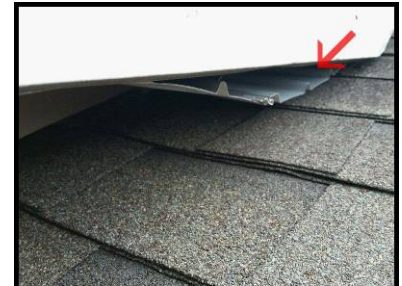
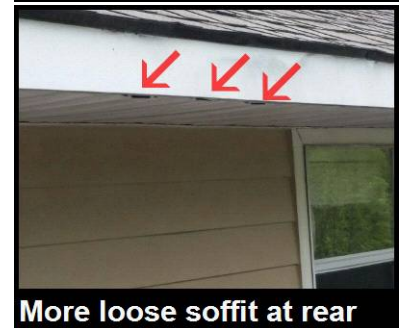
**Loose soffit at rear**

**Zoomed in pic of loose soffit**

**More loose soffit at rear**

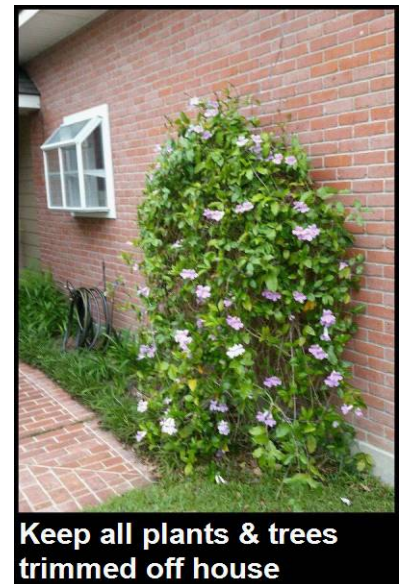
**LANDSCAPING CONCERNS:** The following concerns were noted at the landscaping: Keep plants trimmed away from structure to help prevent moisture damage and pest intrusion. Trees planted close to structure, Trees are touching or over-hanging the roof. Damage is possible.

**Keep all plants & trees trimmed off shed**

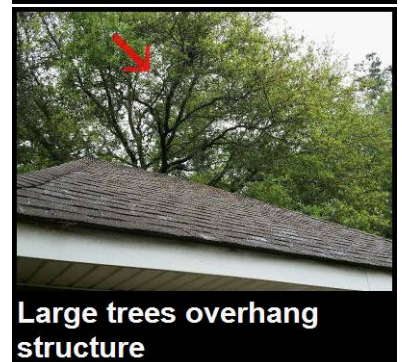
**Large trees overhang structure**

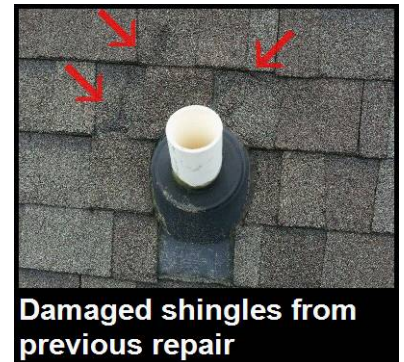
| <b>ROOF COVERING CONCERNS:</b> | Damaged or missing shingles noted. Repair/replacement recommended. Damage/Deterioration/Defects noted, Nails/Fasteners are exposed. Sealing is recommended, Nails/Fasteners are protruding from the roof surface, Rusting fasteners noted. Repair/replacement recommended. Non-professional repairs noted. |

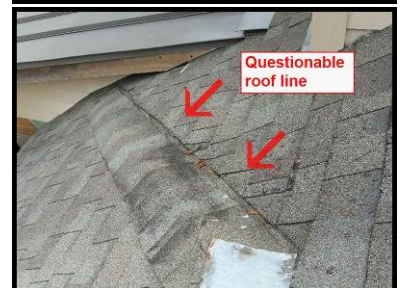
**House appears to have an add-on**

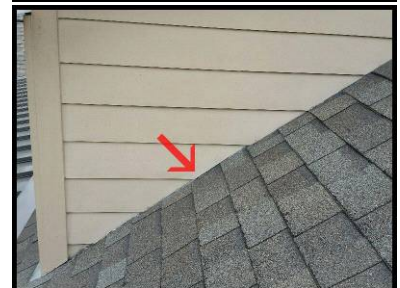
**Missing moisture break at intersection**

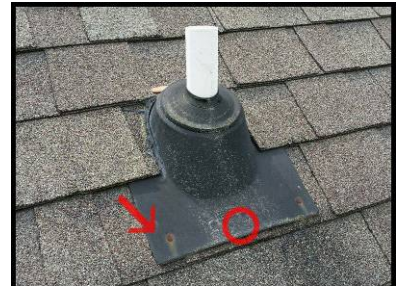
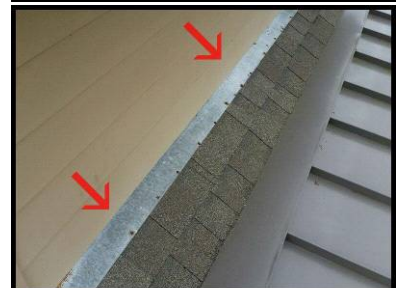
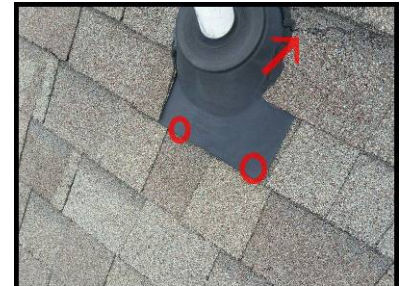
**Seal ALL nails / Missing Face nails**

**Seal ALL exposed nails**

**Missing face nails /  
Cracked shingle**

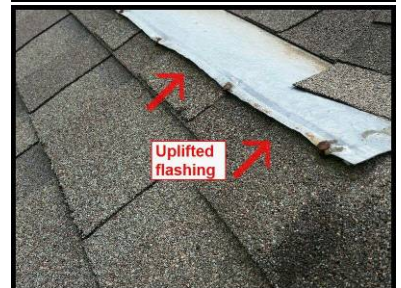
**House appears to have an add-on**

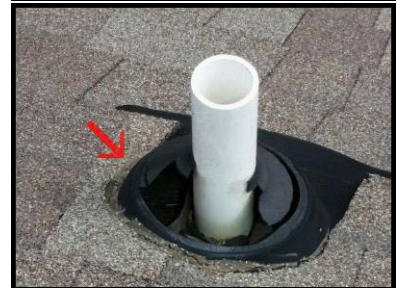
The following concerns were noted at the flashings: Rusty flashing is noted, Damaged flashing is noted in the following areas: at the plumbing vent covers, The potential for water entry is present, Damage/openings noted at sealant on flashing.

**Damaged vent boot over master area**

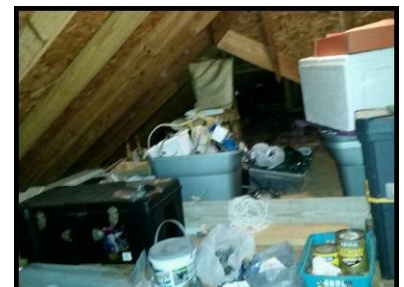
Attic is mostly accessible/was entered for inspection. However, due to the inherent design of attic spaces, some areas are not conducive to inspection. Restricted access to attic due to personal belongings. Only partially entered/partially inspected.

**Personal items in garage  
attic**

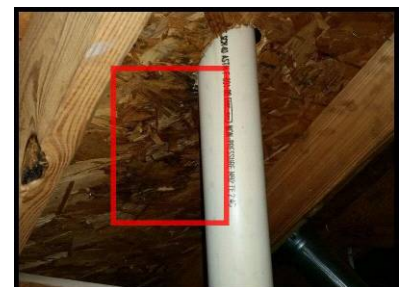
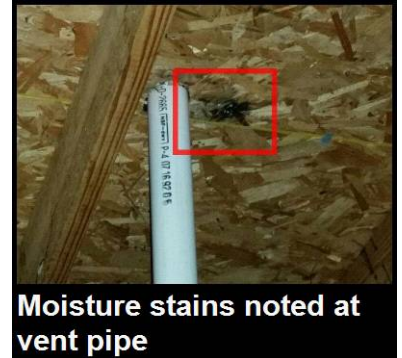
The following concerns were noted at the attic: Viewing of the attic areas was limited: due to personal belongings. Recommend thorough inspection, before closing on the property, when attic is cleared. The following concerns were noted at the attic flooring: Minimal amount of walk boards were provided. Recommend additional boards be installed for ease of access. Staining is noted.

**Moisture stains noted at  
vent pipe**

**Moisture stains noted at vent pipe**

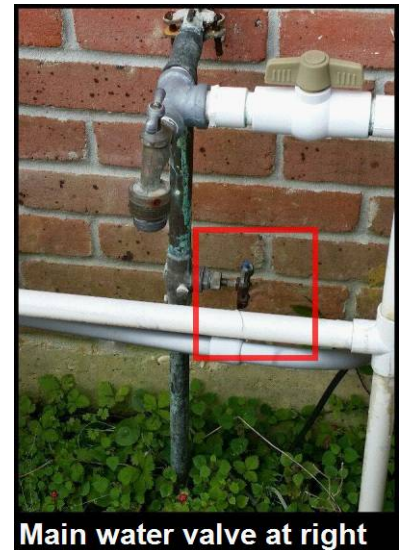
Main water shut off valve is located: at the right side of the house.

Appears serviceable, Valve is operational, Water pressure appears adequate.

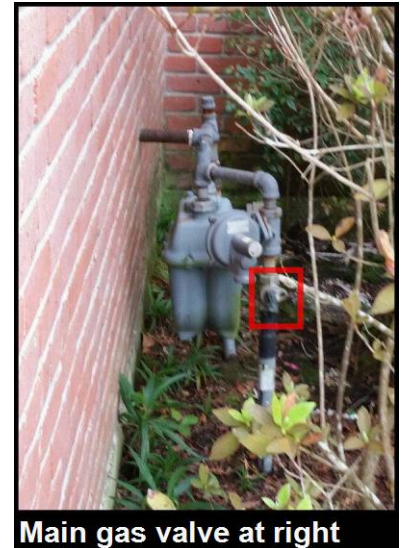
**Main gas valve at right**

**FUEL SYSTEM CONCERNS:** The following concerns were noted on the fuel system: restricted access due to landscape.

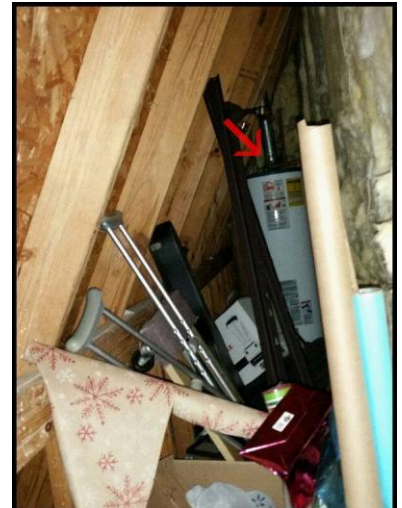
**WATER HEATER CAPACITY:** Data plate is not accessible/not visible. Unable to determine.

**Unable to access left water heater**

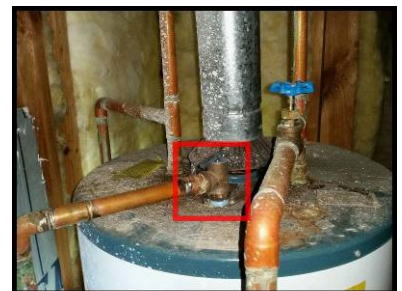
**TPR safety valve**

**WATER HEATER CONCERNS:** The following concerns were noted at the water heater: Rust flakes/corrosion noted, Older model appliance. Unit appears to be nearing the end of its useful life. The following concerns were noted with water heater TPR valve: Pressure relief valve drain line ends prematurely. This is a SAFETY HAZARD. We recommend this drain line be extended to a safe location/pointing toward and terminating within 6" of the ground. TPR valve piping improperly terminates in the overflow drain pan. This is not advisable by current safety standards. Correction is recommended.

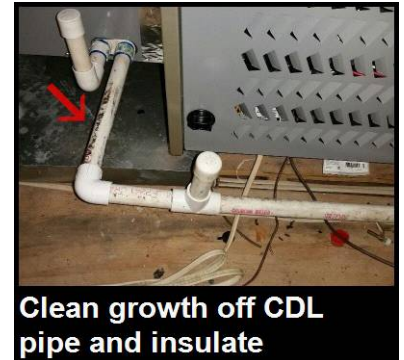
**CONDENSATE LINE/PAN CONCERNS:** The following concerns were noted at the condensate drain line: Recommend insulating drain line to guard against condensation on exterior of piping.

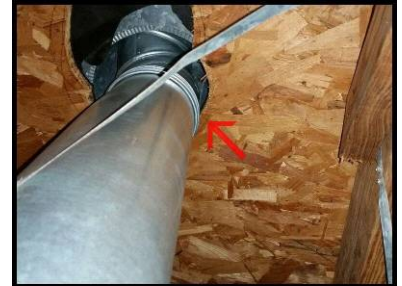
**VENTING CONCERNS:** The following concerns were noted at the heater vent: Inadequate vent pipe clearance- Combustibles are nearby/touching vent pipe.

**Improper clearance to combustibles**

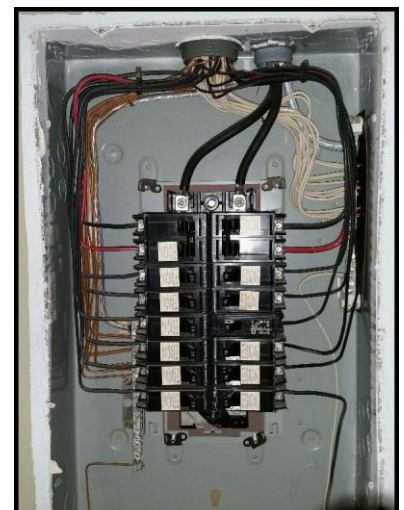
The following concerns were noted at the electrical sub-panel: Panels are without the benefit of complete labeling, The following concerns were noted at AFCI/GFCI breakers: No AFCI (arc fault circuit interrupter) breakers were visible. Recommend installing AFCI breakers to comply with current safety standards. Electrical system appears to be outdated by today's standards. Upgrade should be considered. The following wiring concerns were noted: More than one neutral wire connected at a single terminal lug on the neutral bus bar.

**Panel at laundry / No AFCI circuits**

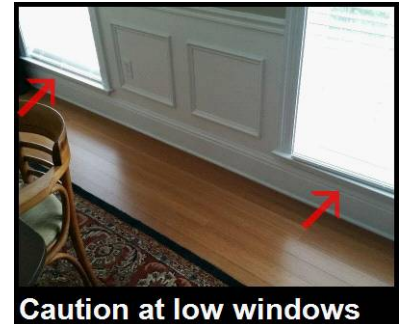
**WINDOW CONCERNS:** The following concerns were noted at the windows: Rusting lintels noted at exterior. Damaged/Missing exterior screens noted, Unable to determine if glass is tempered safety type glass at the following locations: Large windows with more than 9 sq ft area, closer than 18" from floor, top edge over 3' from floor and within 3' of a walking surface should be tempered safety glass.

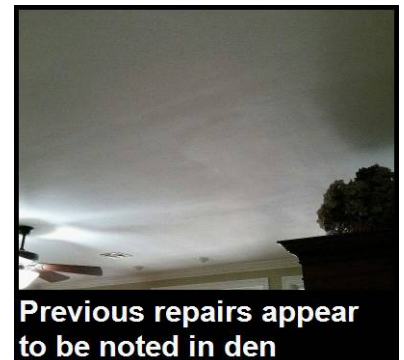
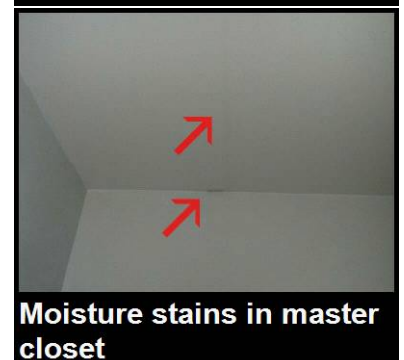
**CEILING CONCERNS:** The following concerns were noted at the ceilings: Typical cracks noted. Some cracking is to be expected in all interior surfaces as the property settles with age. Recommend monitoring for any future changes, Nail pops noted, Moisture stains noted, Previous repairs noted. Verify reason with seller and monitor the area for on-going or future problems.

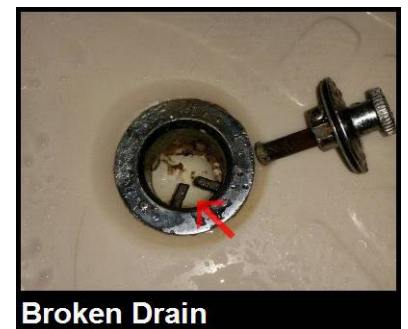
The following concerns were noted at the tub/shower drain: Stopper is damaged.

**Broken Drain**

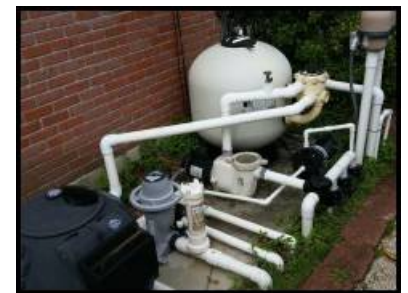
**PUMP/MOTOR MANUFACTURER (MAIN):** Century/Centurion brand pump.

**PUMP/MOTOR HP RATING (MAIN):** 1.5 HP motor.  
**PUMP/MOTOR CONDITION (MAIN):** Appears serviceable, but signs of wear and aging noted. Monitor for problems.  
**PUMP/MOTOR MANUFACTURER (CLEANER):** Century/Centurion brand pump, Polaris.  
**PUMP/MOTOR HP RATING (CLEANER):** 3/4 HP motor.

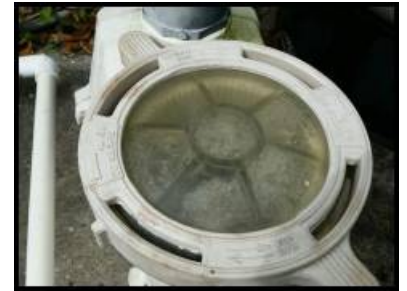
**LEAF BASKET CONCERNS:** Major air bubbles noted. This may indicate a leak in the supply piping or leaf basket gasket that may need repair.

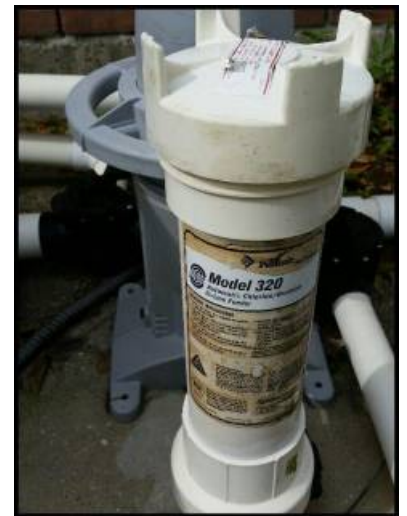
**POOL/HOT TUB WATER TREATMENT SYSTEM TYPE:** In-line chlorinator type.

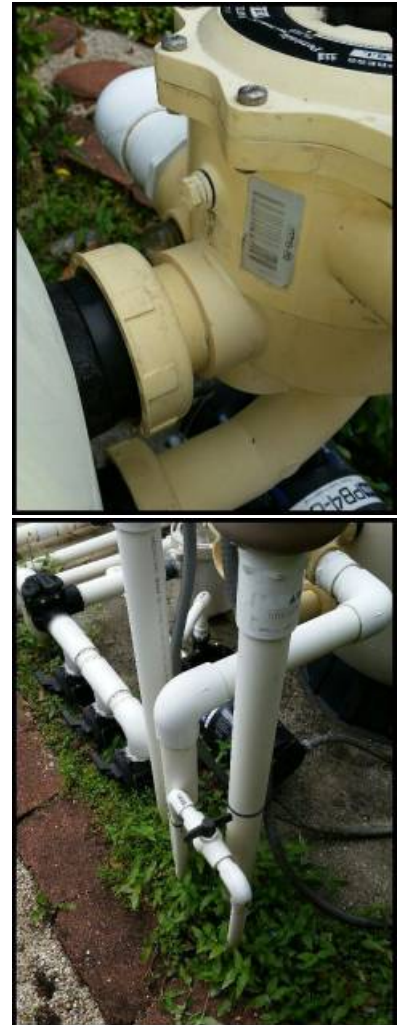
**VISIBLE POOL/HOT TUB PLUMBING LINES CONCERNS:** Leakage noted at piping at the following area(s): control valve side plug. May be loose or needs new o-ring. Valve is off. Not certain what this valve controls. Verify with sellers.

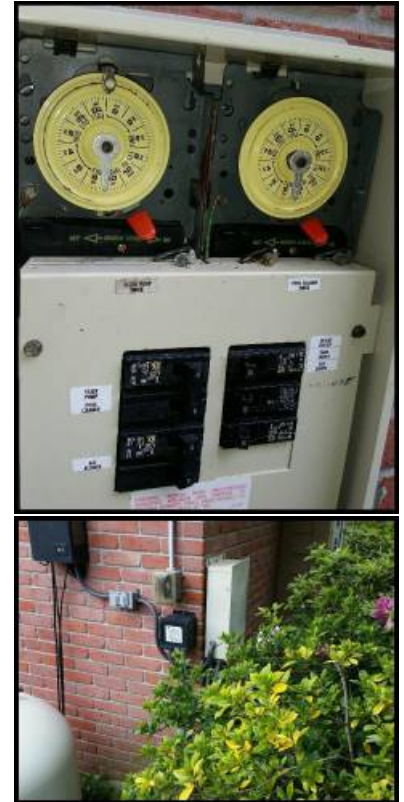
The following concerns were noted at the electric controls: Timer control tabs are not installed. It appears that the timer is not currently in use. Recommend verifying reason with sellers. Improper clearance to panel.

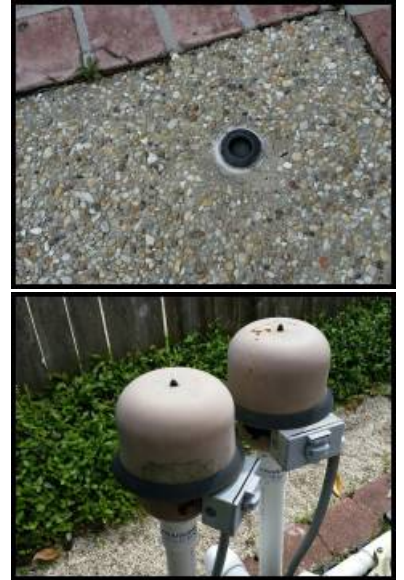
**SPA/HOT TUB CONCERNS:** The following concerns were noted at the spa/hot tub: Controls were damaged. Unable to operate spa. Blower motors for jets would not respond to testing. Verify proper operation with sellers and repair or replace as needed.
