A  
Glossary of  
Historic  
Masonry  
Deterioration  
Problems  
and  
Preservation  
Treatments

Compiled by Anne E. Grimmer

Department of the Interior  
National Park Service  
Preservation Assistance Division

1984

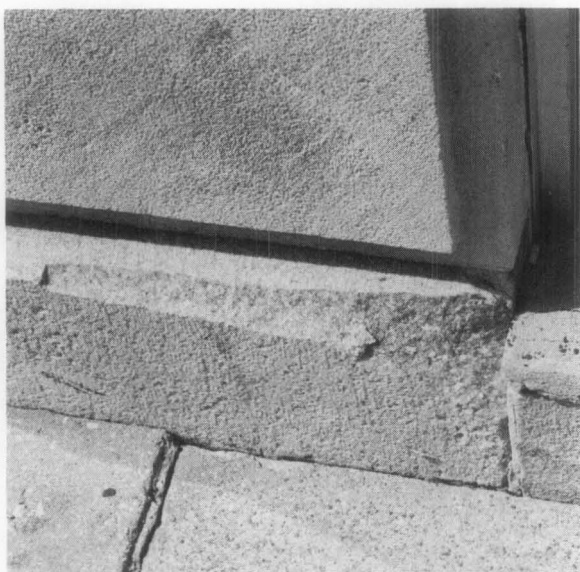
Small pieces or larger fragments of masonry separating from the masonry unit, often at corners or mortar joints. This may be the result of damage caused by later alterations or repairs, such as use of too hard a mortar, or by accident or through vandalism.

*Chipping of granite sill. Photograph: Anne E. Grimmer.*

*Preservation Treatment:* See Dutchman Repair, p.56; Replacement/Patching with Like or Compatible Substitute Materials, p.59.

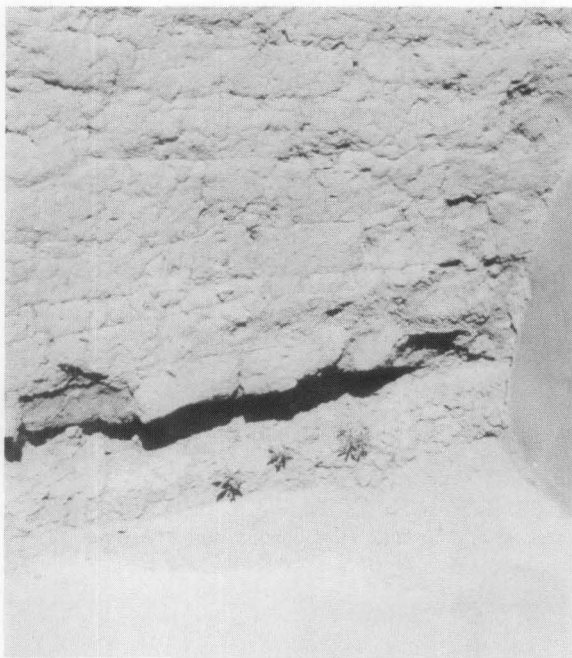
The hollowing out of an adobe wall just above grade level. Coving may be caused by standing rainwater or rainwater splash off the ground. It can also be caused by salts deposited in the adobe by the evaporation of water.

*Coving of adobe wall. Photograph: National Park Service.*

*Preservation Treatment:* See Replacement/Patching with Like or Compatible Substitute Materials, p.59.

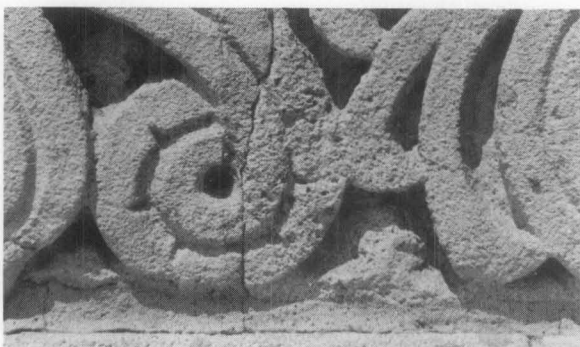
A term describing narrow fissures from 1/16 to 1/2 inch wide in a block of masonry. Cracking may result from a variety of conditions, such as structural settlement of a building, too hard a repointing mortar, or it may be an inherent characteristic of the masonry itself, such as unfired brick or adobe. Small cracks within a single block of masonry may not be serious, but longer and wider cracks extending over a larger area may be indicative of structural problems, and should be monitored.

*Cracking of limestone. Photograph: John H. Myers.*

*Preservation Treatment:* See Mechanical Repair, p.58; Replacement/Patching with Like or Compatible Substitute Materials, p.59.

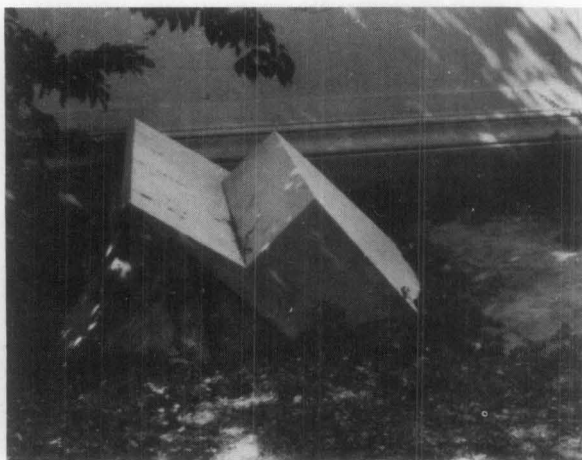
The result of a complete break (or failure of an original construction joint) in which the detached portion of masonry survives intact.

*Detachment of section of marble pediment. Photograph: Walter Smalling.*

*Section of marble lying on the ground at base of building after it had separated from pediment above. Photograph: Walter Smalling.*

*Preservation Treatment:* See Mechanical Repair, p.58.

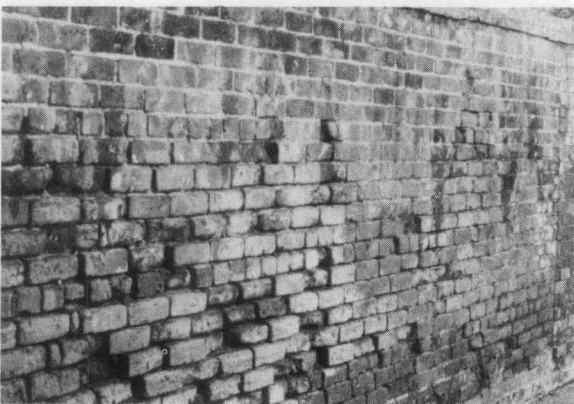
A whitish haze of soluble salts on masonry generally caused by excessive "pulling" of soluble salts into the masonry and out through the surface. Capillary action may pull soluble salts which result in efflorescence from the ground into the masonry, such as chlorides from salting of streets and sidewalks in winter and nitrates from fertilizers. In addition, carbonates from lime mortar and air-borne or water-deposited pollutants in the atmosphere may cause sulfates to be deposited on the surface of the masonry. Sulfates resulting from the curing and firing process are a common source of efflorescence in brick. Finally, efflorescence may be a combined salt residue left on the masonry surface by chemical cleaning, too strong a chemical solution, or improper rinsing.

Efflorescence itself may be more unsightly than harmful, but its presence on an older or historic masonry building often serves as a warning, indicating that water has found a point of entry into the structure. Once this has occurred, more serious damage can usually be predicted. Efflorescence may also indicate salt accumulations under the surface of the masonry (subflorescence) which are potentially damaging to the masonry, and are most definitely a matter of concern.

*Efflorescence and spalling on brick wall. Photograph: Anne E. Grimmer.*

*Preservation Treatment:* See Poulticing, p.44; Water Washing, p.46.

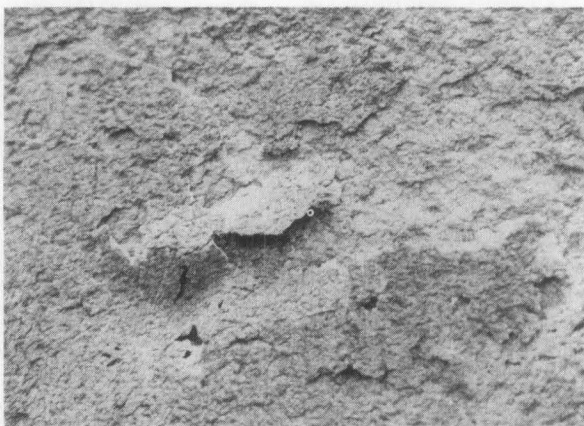
Flaking is an early stage of peeling, exfoliation, delamination or spalling, and is best explained as the detachment of small, flat, thin pieces of the outer layers of stone from a larger piece of building stone. Flaking is usually caused by capillary moisture or freeze-thaw cycles that occur within the masonry. The application of a water-repellent coating may result in flaking of the masonry when trapped moisture is forced to the surface.

*Flaking of granite. Photograph: Baird M. Smith, AIA.*

*Preservation Treatment:* To date, no completely effective treatment has been developed for this condition.

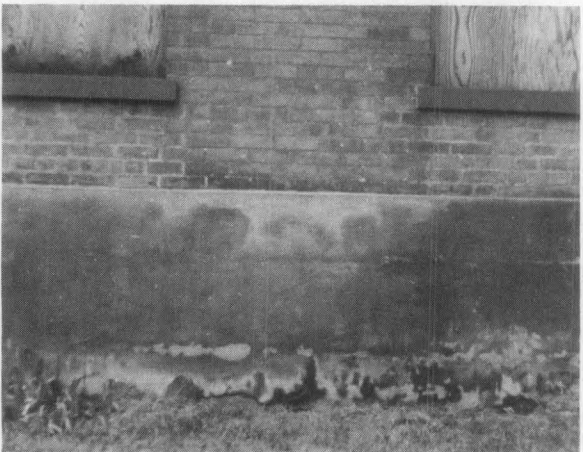
The suction of groundwater into the base of masonry walls through capillary action is called rising damp. Moisture is drawn up into the building walls and released at the interior and exterior surfaces where a horizontal wet stain or tidemark is left. The moisture often carries with it salts in solution, which can result in efflorescence and lead to deterioration of masonry, plaster, wood and paint. Rising damp, often the result of improper drainage, is a problem common to many older masonry structures, and one that is difficult to solve completely.

*Rising damp evidenced on parged foundation.  
Photograph: John Stubbs.*

*Preservation Treatment:* See Dampproof Course, p.54.

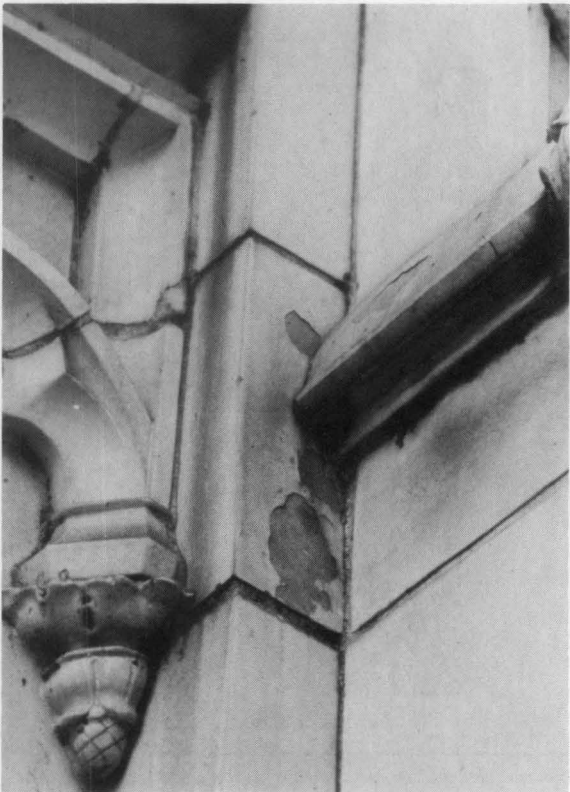
*Glaze spalling of glazed terra cotta. Photograph: John H. Myers.*

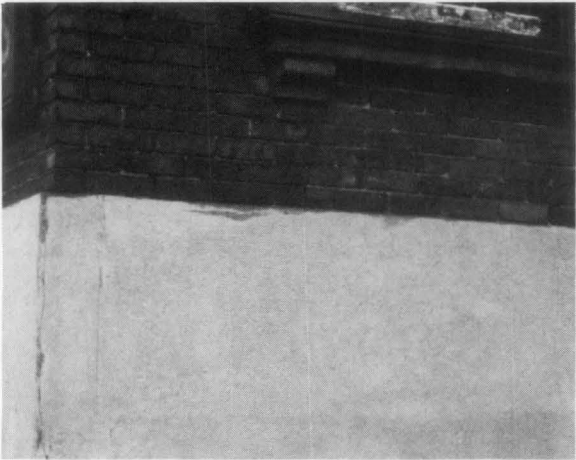
In masonry construction, a thin coat of cement mortar (often containing dampproofing ingredients) applied to provide a smooth surface for rough masonry, or as a dampproofing measure for rough masonry, foundation and basement walls. In Great Britain, parging or pargeting describes the traditional decorative plastering of the exterior, including timbers, with a tough lime plaster reinforced with ox-hair and decorated with impressions or patterns made with a mold or comb.

*Parging over brick. Photograph: National Park Service.*

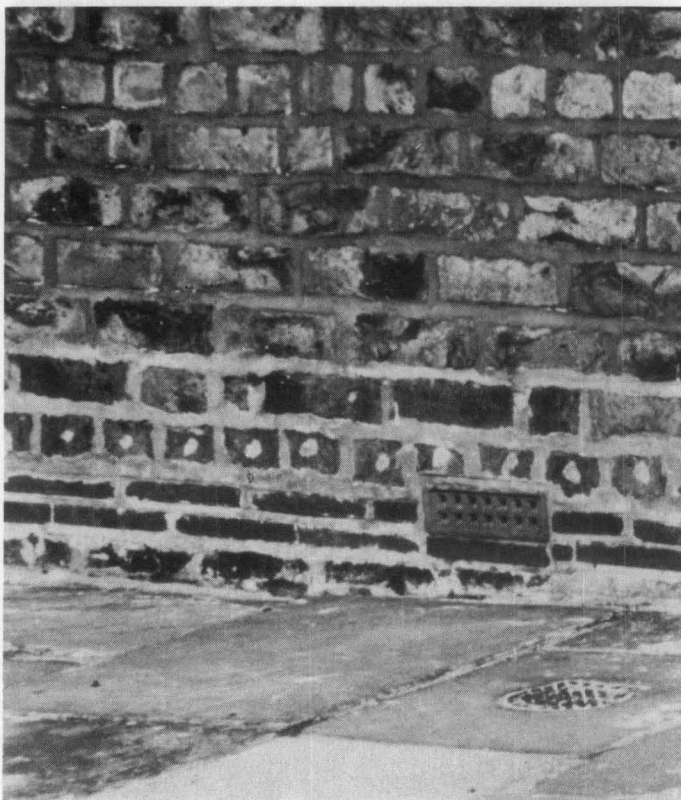
Installation in masonry of a horizontal layer of material which is impervious to water, such as tile, slate, lead-cored bituminous sheet or bituminized felt, polyethylene sheeting, or metal, to prevent the capillary rise of moisture—**rising damp**—from the ground into the masonry wall. Historically, some masonry buildings were constructed with a dampproof course, but usually dampproof courses must be added later as a remedial measure to correct problems caused by rising damp. A traditional dampproof course is not installed without difficulty, as a continuous horizontal course must be cut out of the mortar or brick at a level just above the ground and below first floor joists, and the dampproofing material inserted in an uninterrupted horizontal course. This system

*The horizontal row of white dots in the brick headers indicates that a chemical dampproof course has been injected. Photograph: Baird M. Smith, AIA.*
