The Secretary of the Interior's Standards  
for the Treatment of Historic Properties

with Guidelines for  
Preserving, Rehabilitating  
Restoring & Reconstructing  
Historic Buildings

Kay D. Weeks and Anne E. Grimmer

U.S. Department of the Interior  
National Park Service  
Cultural Resource Stewardship and Partnerships  
Heritage Preservation Services  
Washington, D.C.  
1995

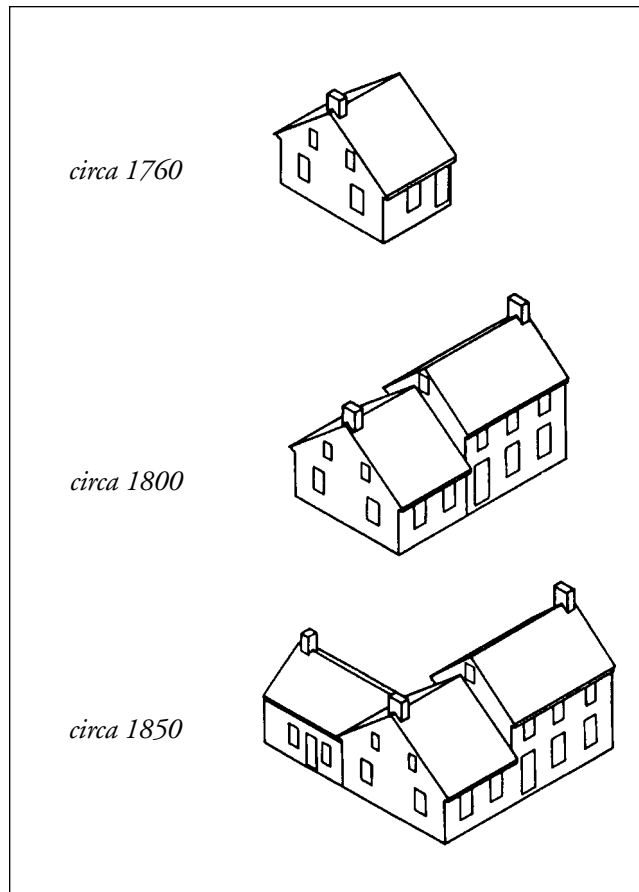
*This three-part drawing shows the evolution of a farm house over time. Such change is part of the history of the place and is respected within the treatment, Preservation. Drawing: Center for Historic Architecture and Engineering, University of Delaware (adapted from Preservation Brief 35: Understanding Old Buildings).*

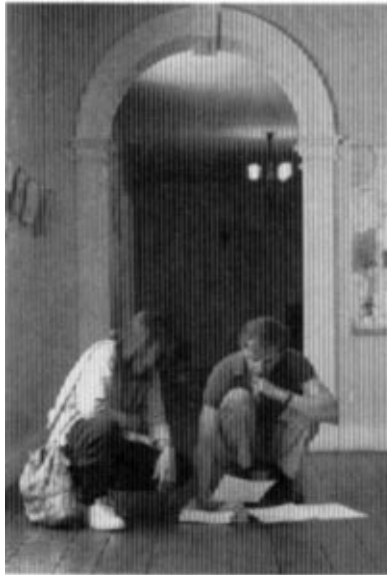
*Careful documentation of a building's physical condition is the critical first step in determining an appropriate level of intervention. (a) This may include relating the historical research to existing materials and features; or (b) documenting a particular problem such as this cracked ceiling. Photo (a): Jean E. Travers; Photo (b): Lee H. Nelson, FAIA.*

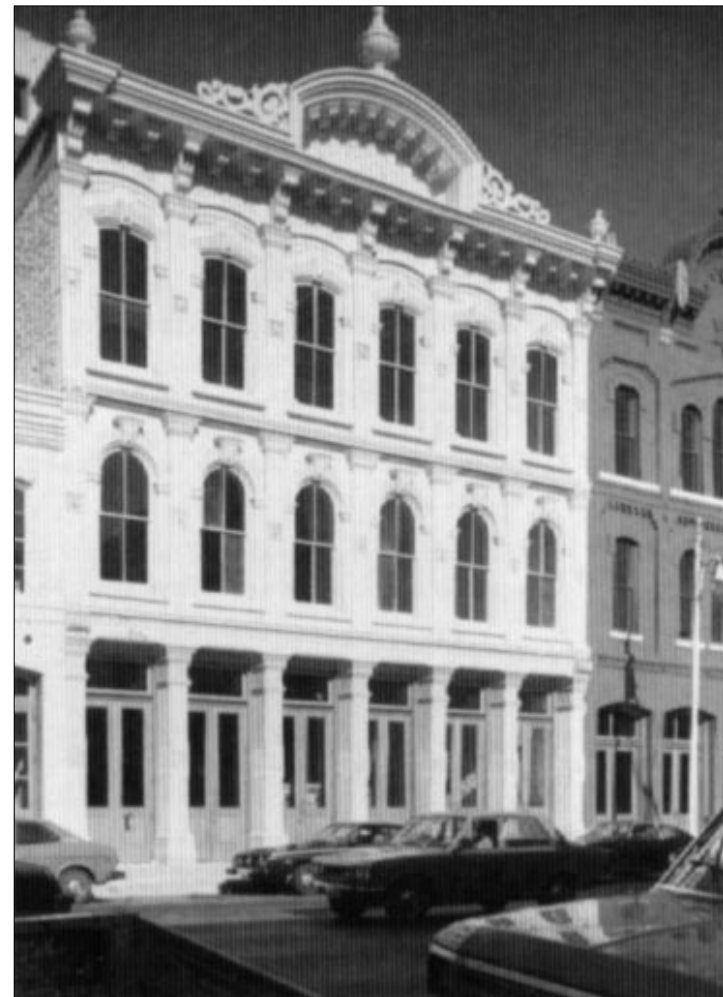
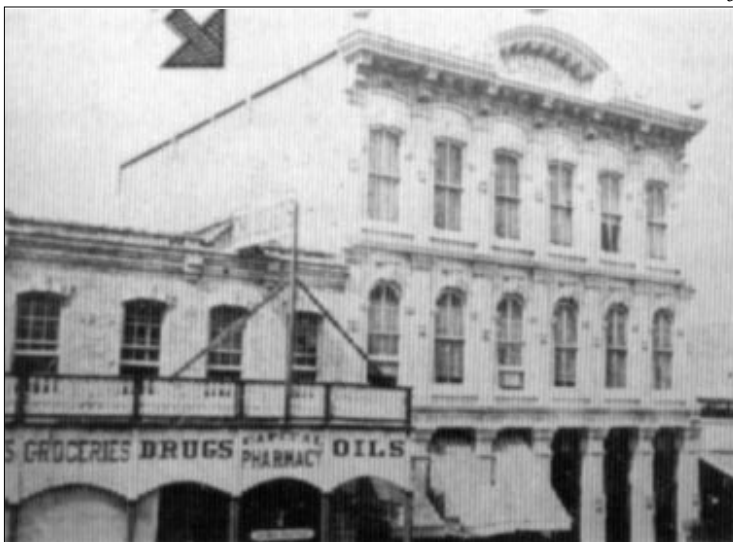
*In the treatment, Rehabilitation, one option for replacing missing historic features is to use pictorial documentation and/or physical evidence to re-create the historic feature. (a) In this example, the ornamental cornice of an 1866 limestone building was missing; and the ground level storefront had been extensively altered. (b) and (c) Based on the availability of photographic and other documentation, the owners were able to accurately restore the cornice and storefront to their historic configuration. A substitute material, fiberglass, was used to fabricate the missing pressed metal cornice, an acceptable alternative in this project. All work met the Standards.*

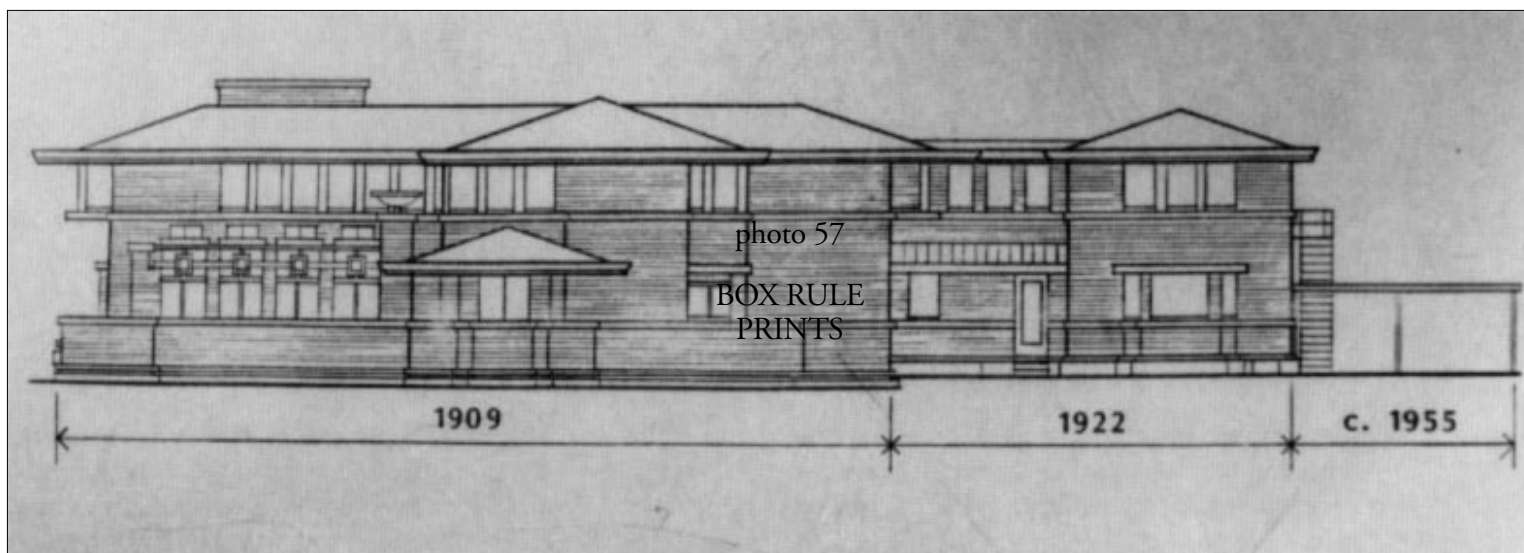
*The Meyer May House in Grand Rapids, Michigan, was designed by Frank Lloyd Wright and built in 1909. In 1922, May added to the house for an expanding family. After the May occupancy, the house was altered for use as apartments, with a carport added in 1955. In the 1980s restoration, the Wright's original design was deemed more significant than May's later changes, and, as a result, the additions were removed and the house returned to its 1909 appearance. Drawing: Martha L. Werenfels, AIA.*

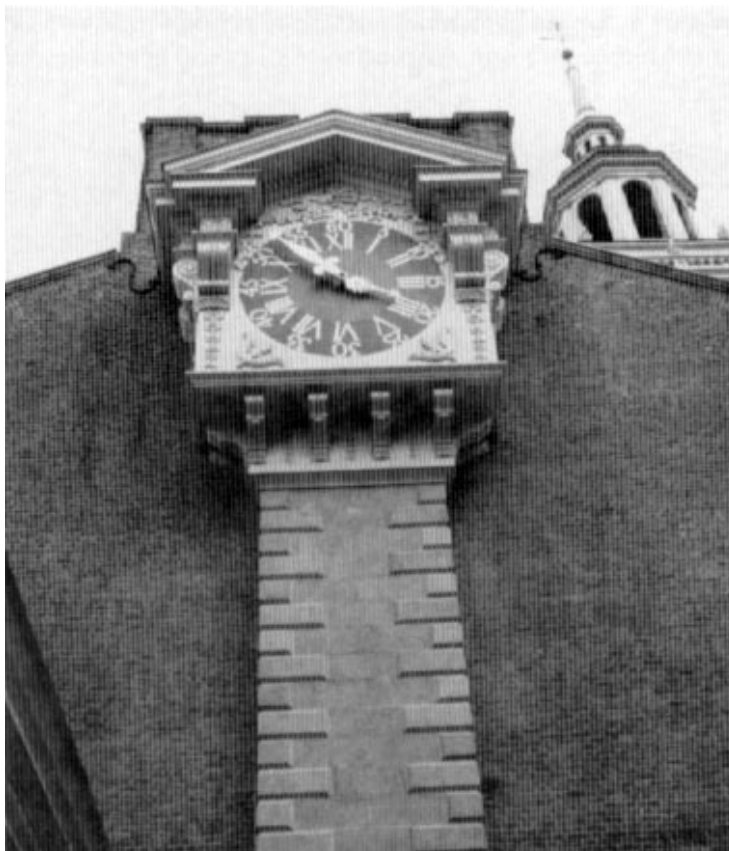
*The Standards for Restoration call for the repair of existing features from the restoration period as well as the re-creation of missing features from the period. In some instances, when missing features are replaced, substitute materials may be considered if they convey the appearance of the historic materials. In this example at Philadelphia's Independence Hall, the clock was re-built in 1972-73 using cast stone and wood with fiberglass and polyester bronze ornamentation. Photo: Lee H. Nelson, FAIA.*

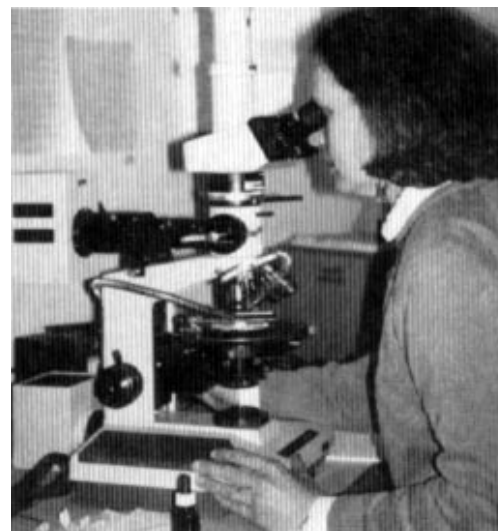
*A complete paint investigation often needs to be conducted during Restoration. Paint samples are carefully collected onsite. In the laboratory, an ultra violet light is used to identify pigment and binding media. Paint samples are then photographed. Physical evidence documented through laboratory research provides a sound basis for an accurate restoration of painted finishes, such as the complex stencilling pictured here. Photo left: Courtesy, Alexis Elza; Photo right: Courtesy, Andrea Gilmore.*

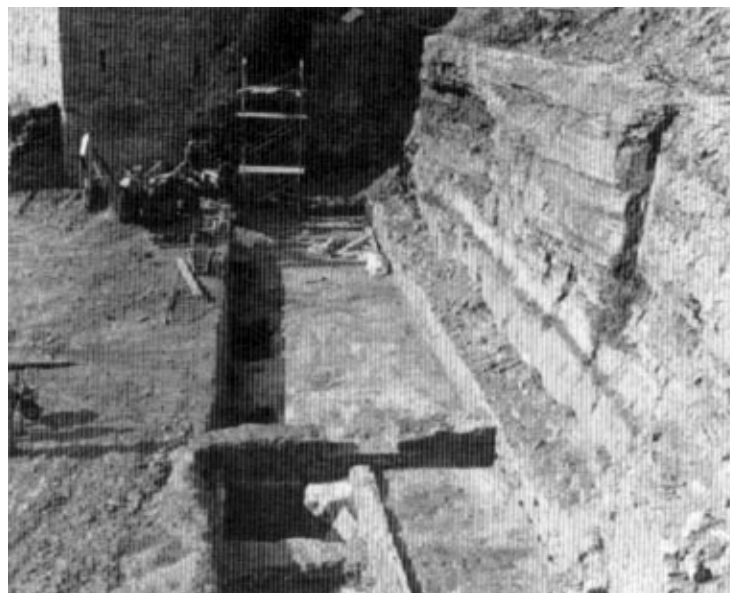
*Reconstruction should generally be based on an extensive archeological investigation, as was done here to re-create a non-surviving commissary building at Fort Snelling.*
