**BOARD OF COMMISSIONERS OF THE PORT OF NEW  
ORLEANS**

**ASBESTOS DAMAGE ASSESSMENT  
MECHANICAL EQUIPMENT CO. INC.  
(MECO)**

**3855 FRANCE ROAD  
NEW ORLEANS, LOUISIANA**

**APRIL 2008**

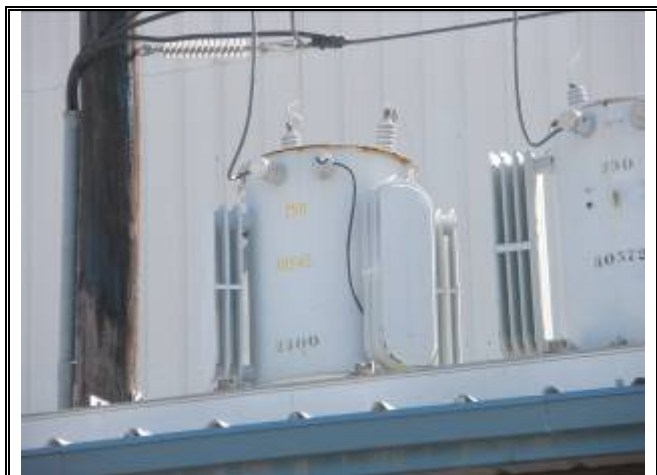
Photograph No. 079: transformers

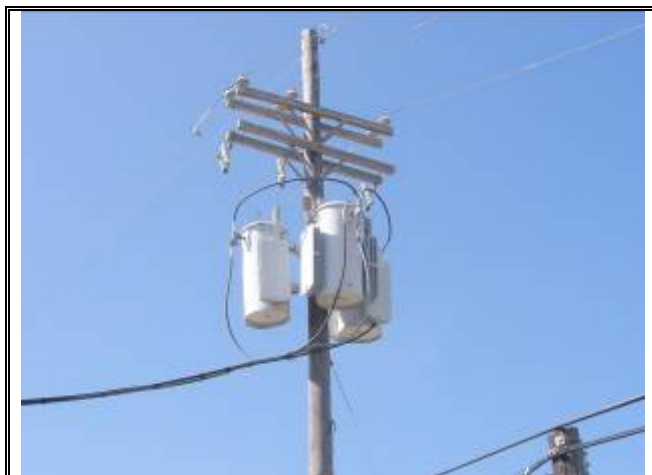
Photograph No. 082: transformers

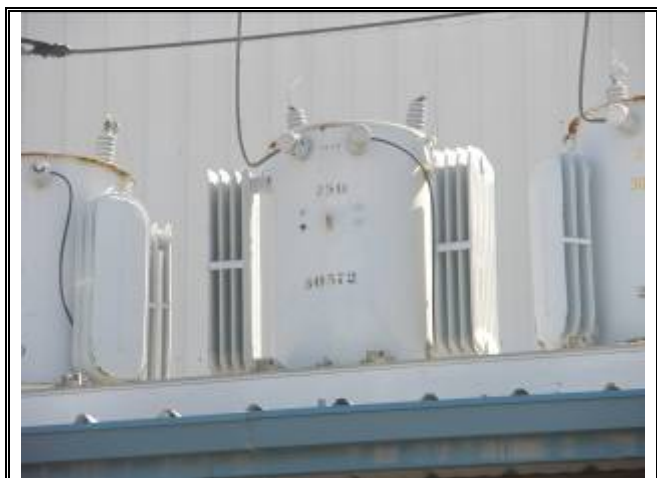
Photograph No. 080: transformers

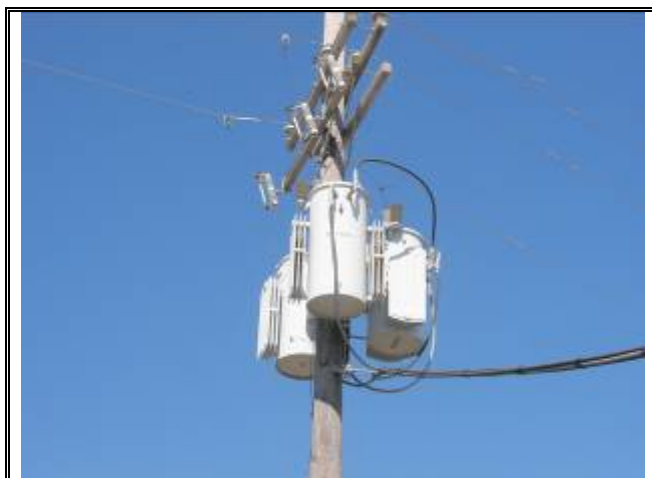
Photograph No. 083: transformers

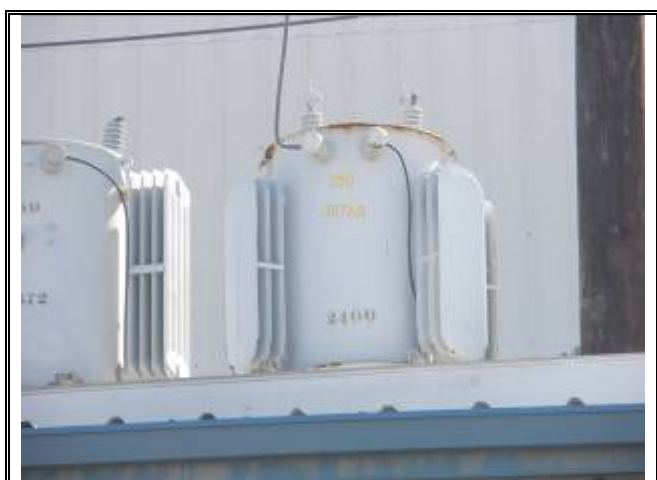
Photograph No. 081: transformers
