Structural Inspection

July 15, 2020

Ref: Village at Northshore – JoAnn – Building Damage

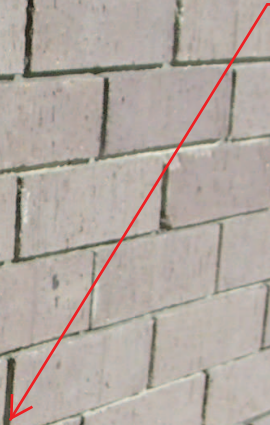
An exterior inspection of the southeast corner of the building noted busted and cracked bricks extending 36" high. The eastern corner side of the building was noted to have a hairline crack in three bricks. The foundation below the crack does not appear to have been comprised.

Damage

- 1) Remove all damaged bricks in that area on both the southeast and eastern side of the building and replace with new to match existing.
