# Inspection Report

**Property Address:**  
139 Everest Drive  
Slidell La. 70458

**DTM Building Inspection Serv.,LLC**

<b>Date:</b> 5/12/2017	<b>Time:</b> 02:30 PM	<b>Report ID:</b> 03649
<b>Property:</b> 139 Everest Drive Slidell La. 70458	<b>Customer:</b> Mr. Ryan Dey Ms. Briana Davis	<b>Real Estate Professional:</b> Lloyd Clark III

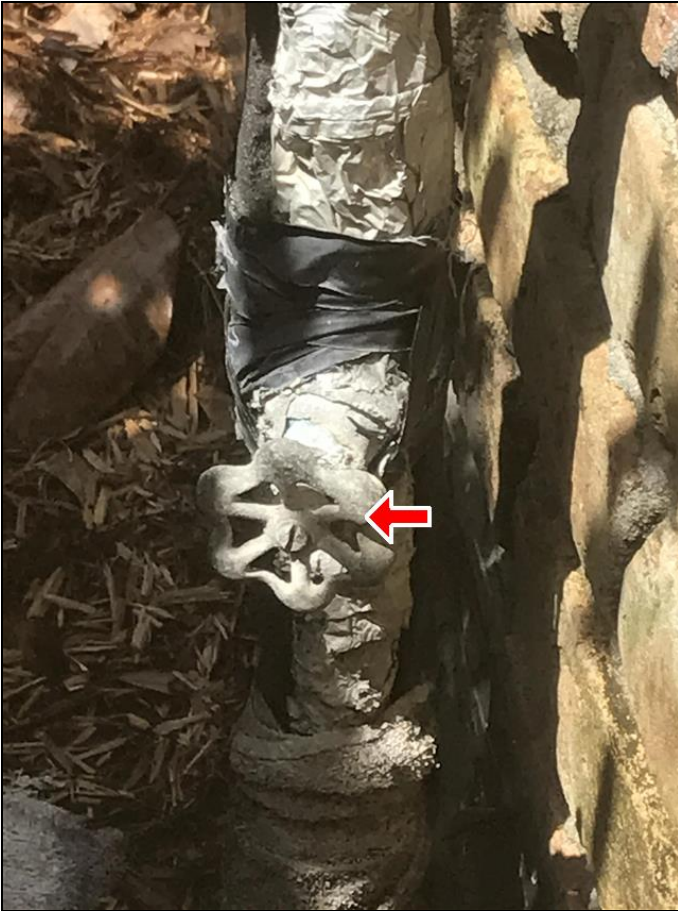
**6.3** The main shut off is the knob located outside on the front wall. This is for your information.

6.3 Item 1(Picture) main water shut off

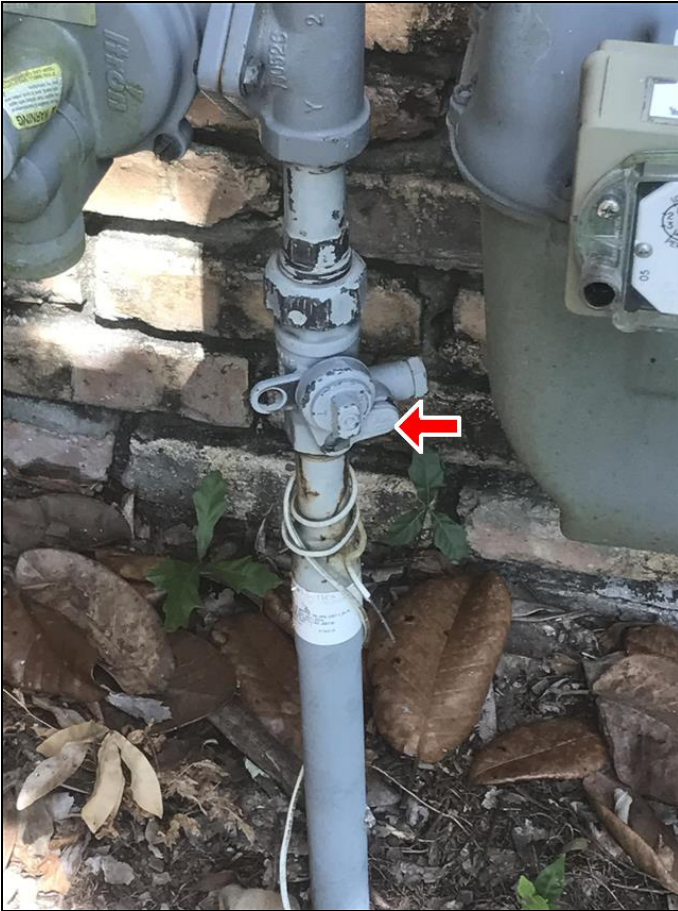
6.5 The main fuel shut off is at gas meter outside at the front right side of the home.

6.5 Item 1(Picture) main gas shut off valve

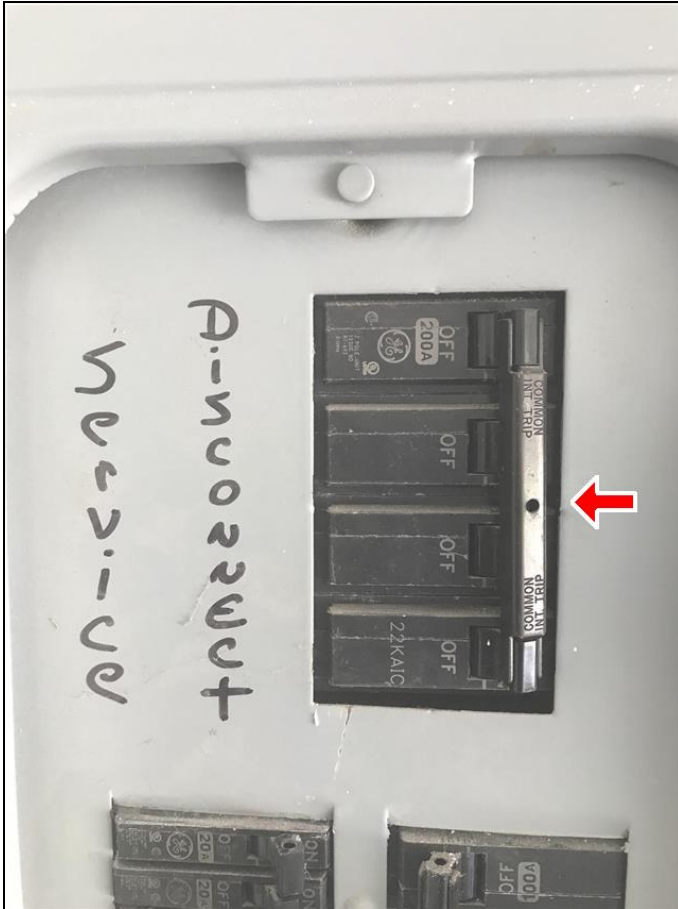
**7.6 The main panel box is located on the (garage) of the home. To kill all power to the home, simply flip the top main breaker (200) amps into the off position.**

7.6 Item 1(Picture) main electrical disconnect
