Acutec Home Inspectors  
PO Box 93  
Slidell, La 70459

336 Cape Breton  
Slidell La 70458

**Inspector Name** Shawn Gregg  
**Company Name** Acutec Home Inspectors  
**Address** PO Box 93  
**City** Slidell **State** La **Zip** 70459  
**Phone** Acutec Home Inspectors  
**E-Mail** Shawn@AcutecLLC.com  
**Report Name** Masker081016  
**Payment Amount:** 600.00  
**Payment Method:** Check

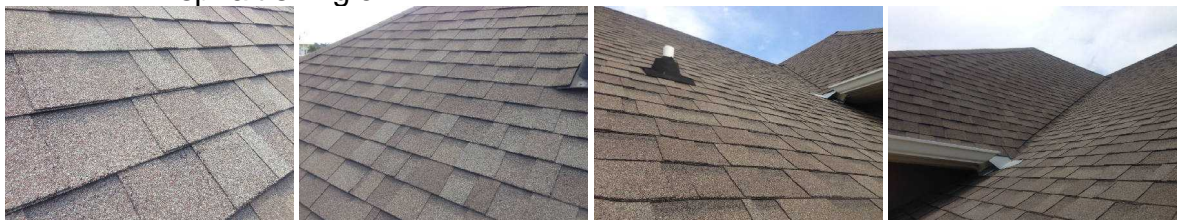
3. **Material:** Asphalt shingle

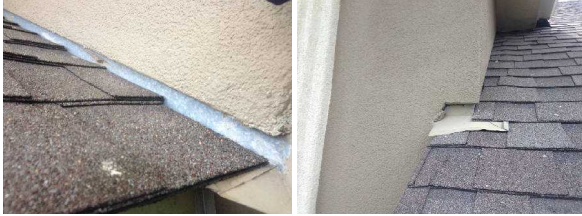
7. Defective **Plumbing Vents:** PVC, Rubber boots, Lead boots-- Flashing does not rest tight to roof below. This area is prone to leak as water may travel up and under flashing. This metal should not be raised. There is daylight visible from underside in attic. Repairs should be made.

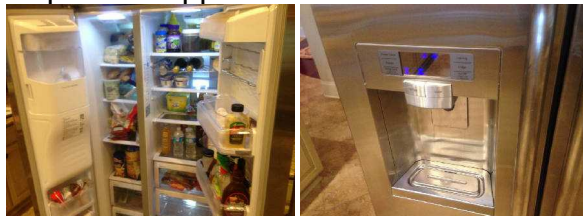
4. Defective **Refrigerator:** There was no ice at the door during the evaluation. The water dispenser appeared functional.
