**BOARD OF COMMISSIONERS OF THE PORT OF NEW  
ORLEANS**

**ASBESTOS DAMAGE ASSESSMENT  
MECHANICAL EQUIPMENT CO. INC.  
(MECO)**

**3855 FRANCE ROAD  
NEW ORLEANS, LOUISIANA**

**APRIL 2008**

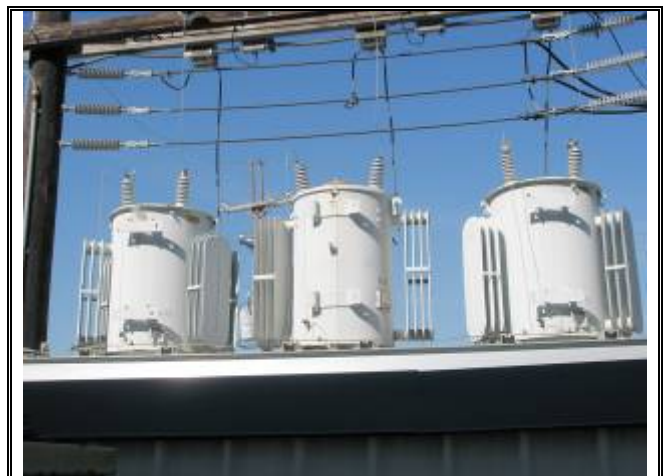
Photograph No. 078: transformers

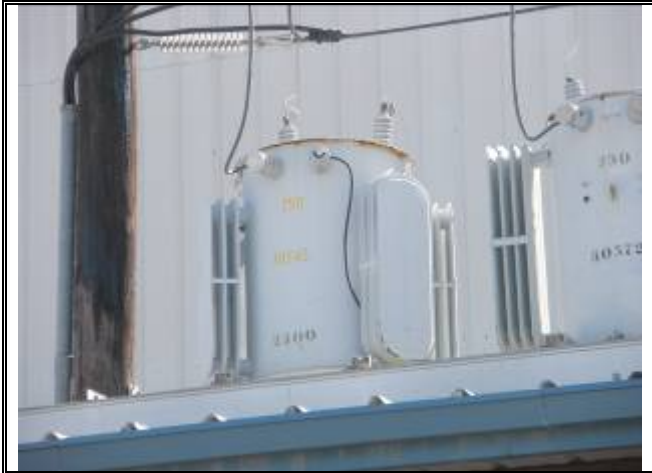
Photograph No. 079: transformers

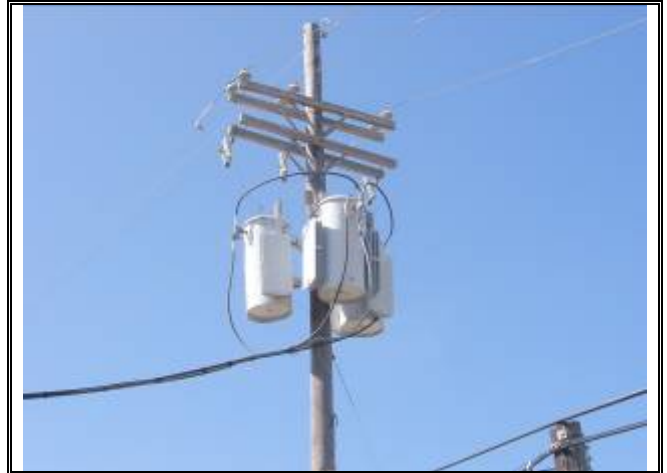
Photograph No. 082: transformers

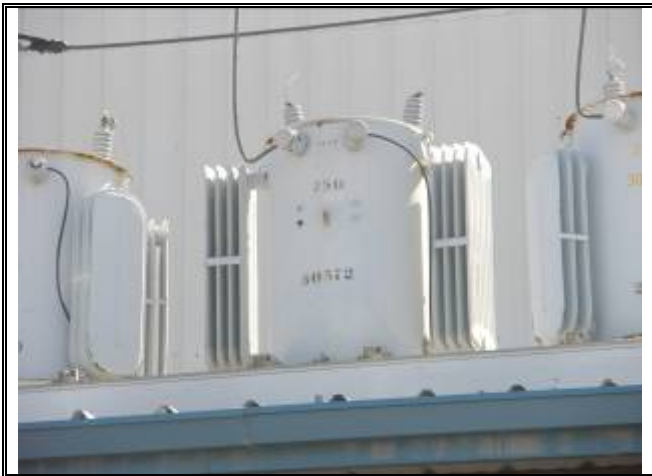
Photograph No. 080: transformers

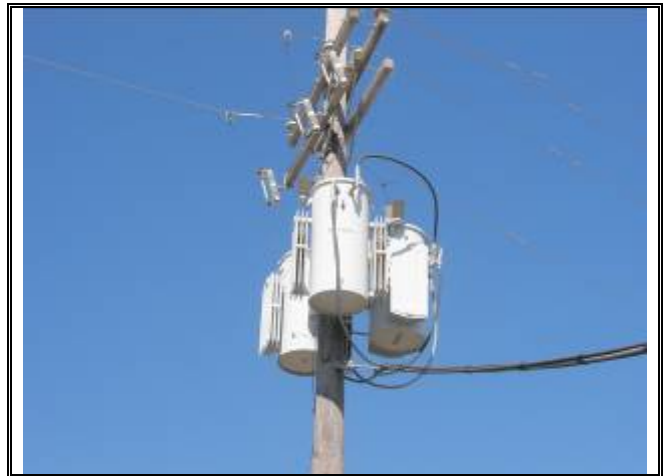
Photograph No. 083: transformers

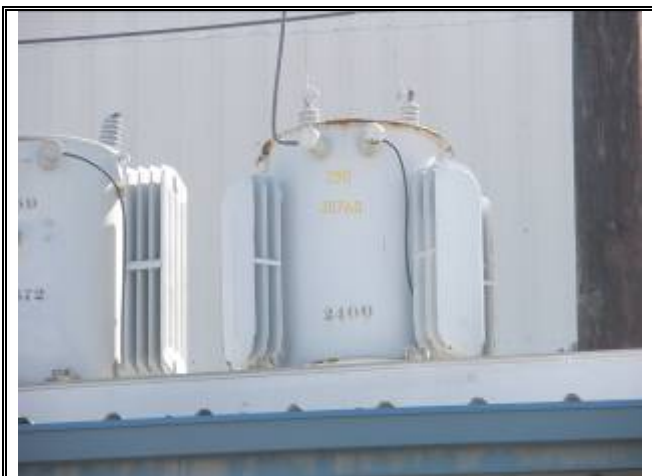
Photograph No. 081: transformers
