February 8, 2017

Re 112 Rue D'Azur.
Slidell LA 70461

REPORT SUMMARY

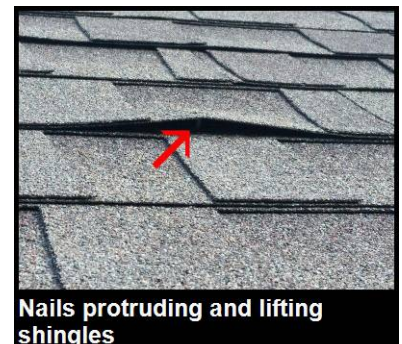
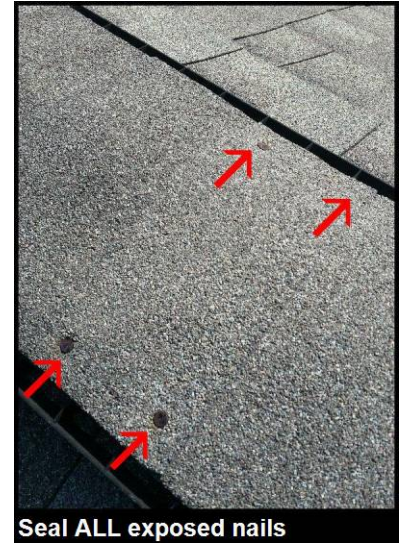
- AGE OF ROOF IN YEARS:** Unknown.
- ROOF STYLE:** Gable, Hip.
- ROOF TYPE:** Composition Shingles.
- ROOF ACCESS:** Walked on roof.
- ROOF COVERING CONDITION:** Appears serviceable/within useful life.
- ROOF COVERING CONCERNS:** The following concerns were noted at the roof: Nails/Fasteners are exposed. Sealing is recommended, Nails/Fasteners are protruding from the roof surface, Lifted shingles noted, Rusting fasteners noted. Repair/replacement recommended.

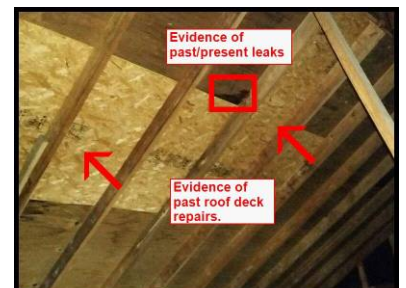
Main house attic

The following concerns were noted at the attic: The following concerns were noted at the attic flooring: Minimal amount of walk boards were provided. Recommend additional boards be installed for ease of access. Loose flooring noted. Recommend securing before use, Staining is noted, Unable to determine the status of the stains. Active leakage may be present. Signs of past/present leakage, Recommend evaluation by a qualified licensed contractor and repair or replace as needed.

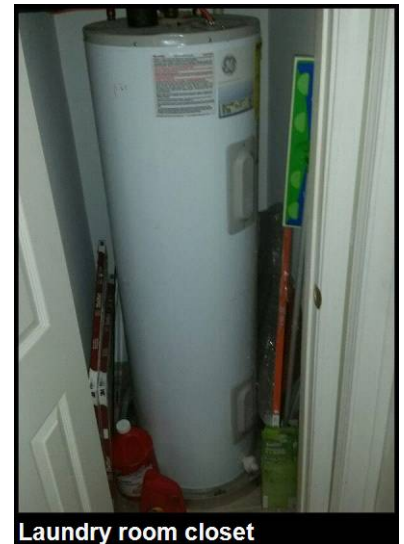
WATER HEATER CONCERNS: The following concerns were noted at the water heater: Overflow drain pan is installed, but no drain piping visible. Recommend installing drain line to exterior location to protect the home from water damage in the event of a leak. No visible electrical disconnect provided.

No outlet / disconnect

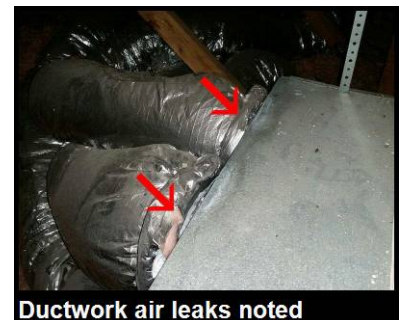
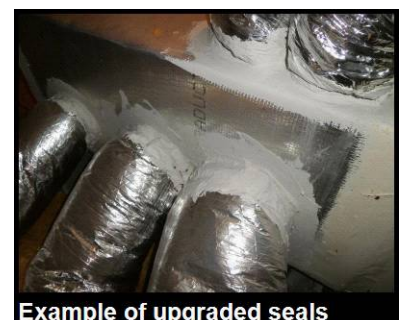
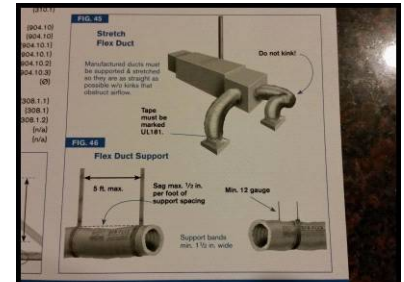
Ductwork is not suspended off the attic floor as required by today's standards. This is important to know because when it comes time to change the HVAC system, it will be required to properly install the ductwork as well. (see diagram and example pics for details)

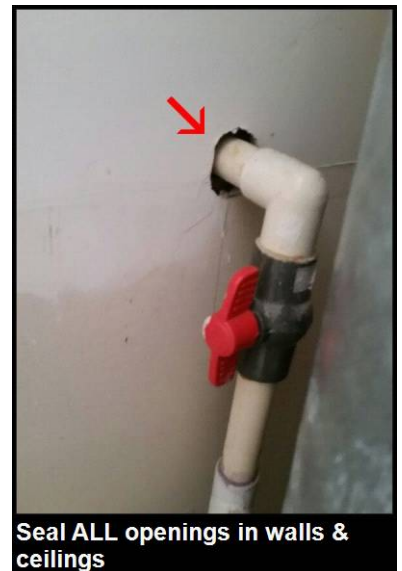
GARAGE FIRE WALL CONCERNS: The following concerns were noted with the fire wall: Repair any openings with approved materials to restore its fire rating, Attic access panel is not fire-rated. House entry door is not fire-rated. Recommend upgrades for safety.

Not fire-rated: attic & house entry door

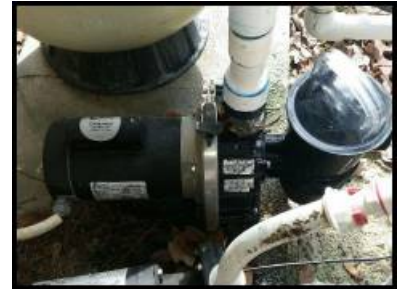
PUMP/MOTOR MANUFACTURER (MAIN): Century/Centurion brand pump.
PUMP/MOTOR HP RATING (MAIN): 1 HP motor.
PUMP/MOTOR CONDITION (MAIN): Appears serviceable, but signs of wear and aging noted. Monitor for problems.
PUMP/MOTOR CONCERNS (MAIN): The following concerns were noted at the pump/motor: Loose/missing wire clamp noted at motor wiring, Gasket between the pump and motor is leaking. Leakage noted where the return pipe is attached at the top of the pump. Motor is noisy while running. Worn bearings may be indicated.

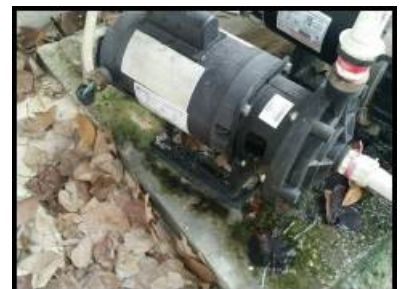
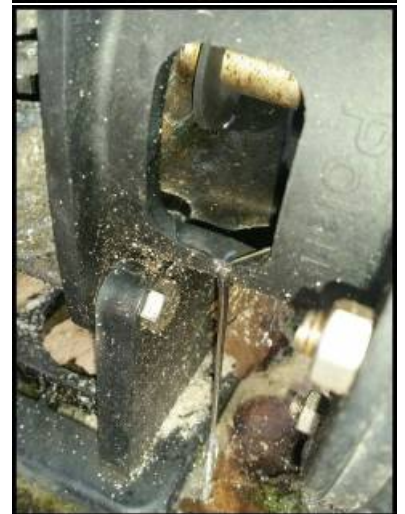
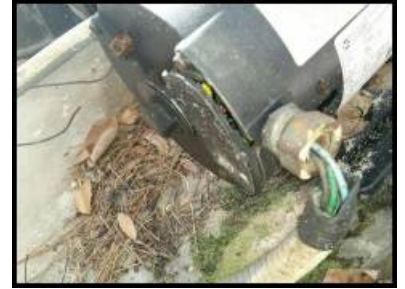
PUMP/MOTOR MANUFACTURER (CLEANER):	AO Smith brand pump.
PUMP/MOTOR HP RATING (CLEANER):	3/4 HP motor.
PUMP/MOTOR CONDITION (CLEANER):	Appears serviceable, but signs of wear and aging noted. Monitor for problems.
PUMP/MOTOR CONCERNS (CLEANER):	The following concerns were noted at the pump/motor: No visible electrical bonding was observed at the motor, Unprotected wires noted at motor, Loose/missing wire clamp noted at motor wiring, Leakage noted where the return pipe is attached at the top of the pump. Motor is extremely noisy while running. Bearings are likely worn and replacement is recommended. A qualified pool contractor should be called to make further evaluation and recommendations for repair or replacement.

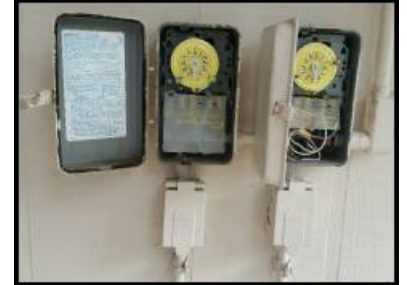
POOL/HOT TUB ELECTRIC CONTROLS CONCERNS: The following concerns were noted at the electric controls: GFCI protection is recommended for all electrical equipment serving the swimming pool. Recommend

upgrading current breakers to GFCI type for additional electrical protection.
