Structural Inspection

September 14, 2021

For: Todd Seal
1937 Grace Street
Slidell, La. 70458

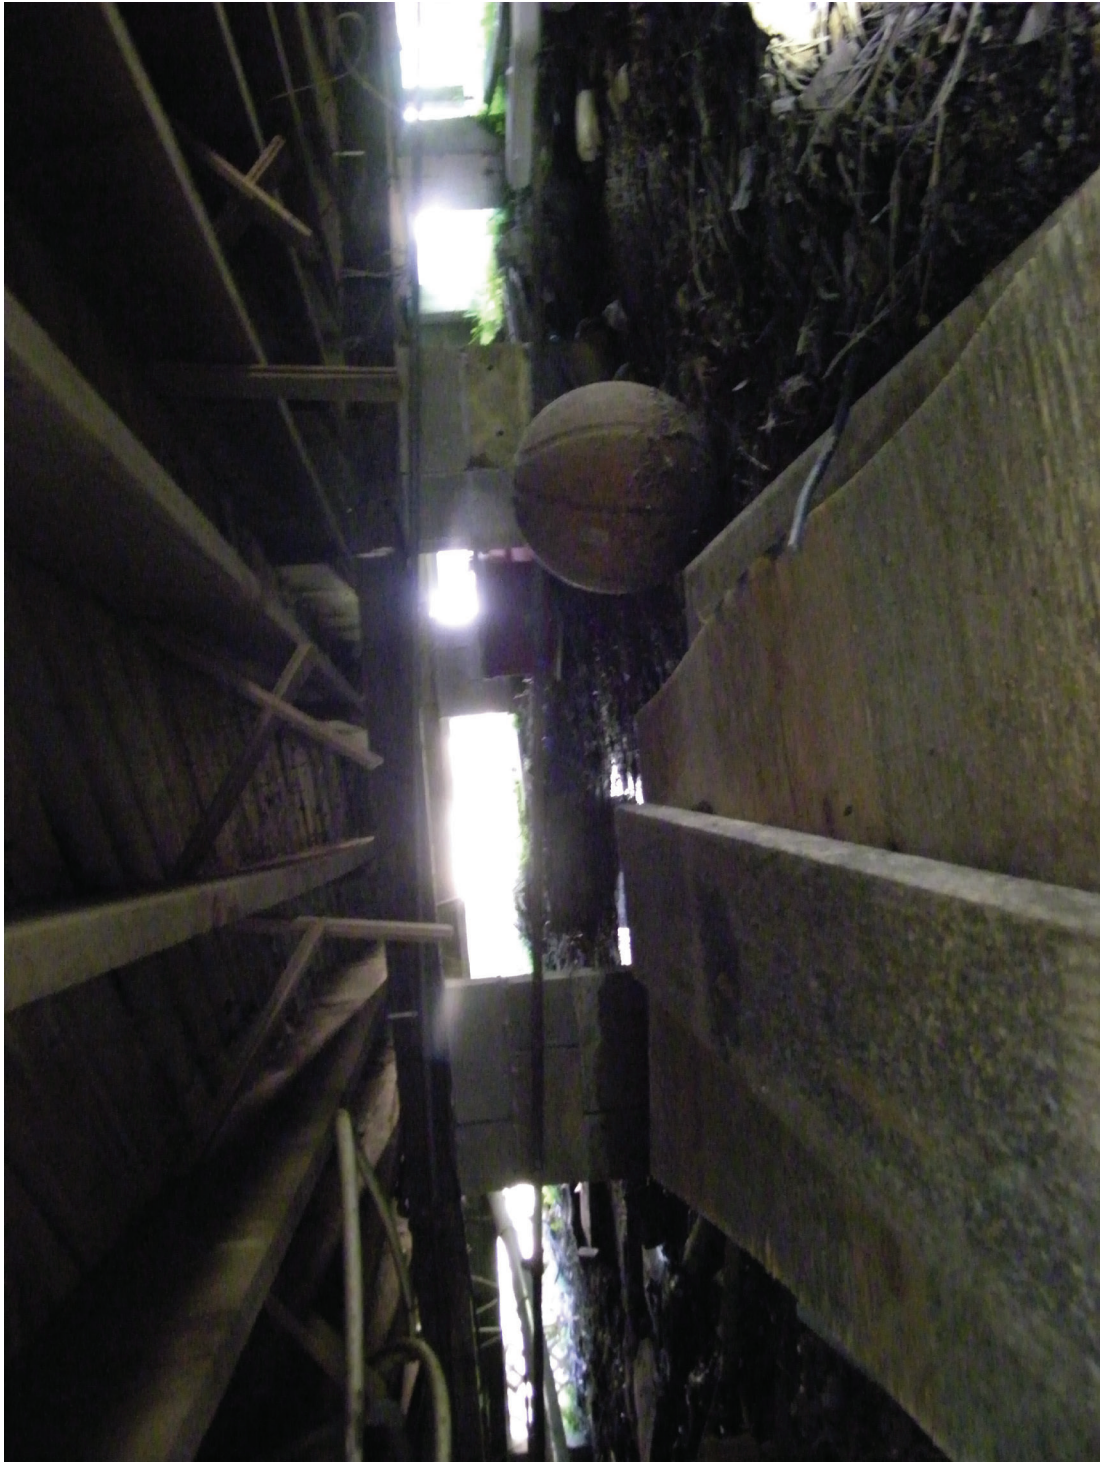
FRONT OF HOME

Upon inspection of the home, a pine tree fell on the left side of the home causing severe structural damage to the roof, roof rafters and ceiling joist. The damaged flooring and sheetrock are still in place and the house has not been gutted.
