Structural Inspection

February 17, 2017

Ref: 301 River Landing Road
Slidell, La. 70461

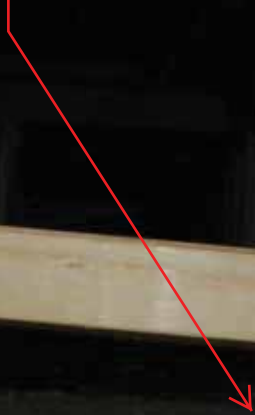
The construction of this room consisted of building a knee wall directly on top of OSB plywood decking that is covering the ceiling joist below. The knee wall is supporting the exterior load bearing walls of the media room. In most areas the knee wall is not supported properly over the OSB and is allowing the floor to sag.

No structural support

It is recommended that the media room be removed and utilized as the original design as an attic or totally rebuild it with proper construction means.
