# Your Inspection Report

443 Pine Cone Lane  
Slidell, LA 70458

**INSPECTION DATE:**  
Tuesday, September 26, 2017

RE: Report No. 1336  
443 Pine Cone Lane  
Slidell, LA  
70458

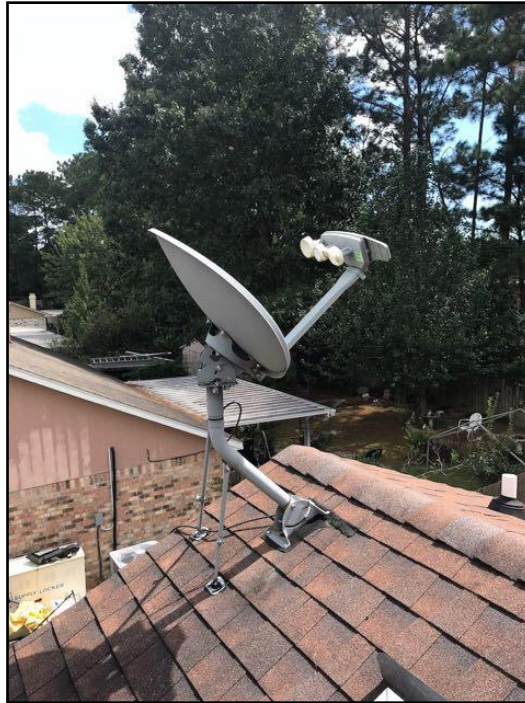
**1. Condition:** • Equipment mounted on the roofing surface. Recommend regular maintenance of sealant on mounting fasteners.

*3. Equipment mounted on the roofing surface....*

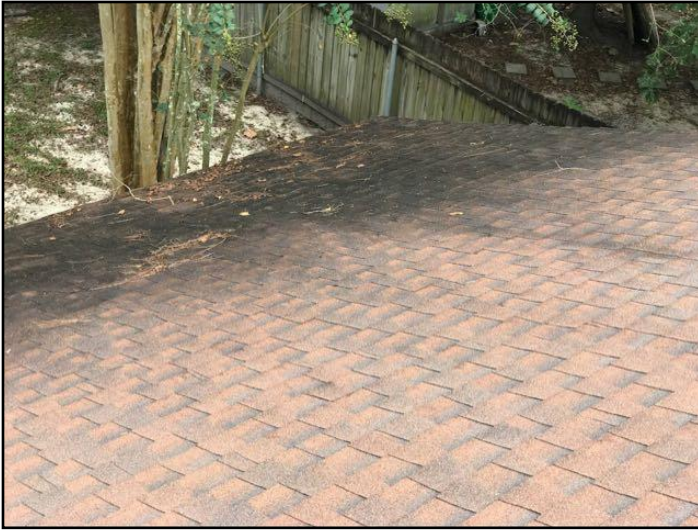
**Condition:** • Discoloration/algae observed at the roofing surface. Recommend professional cleaning by a qualified tradesman.

4. *Discoloration/algae observed at the roofing...*

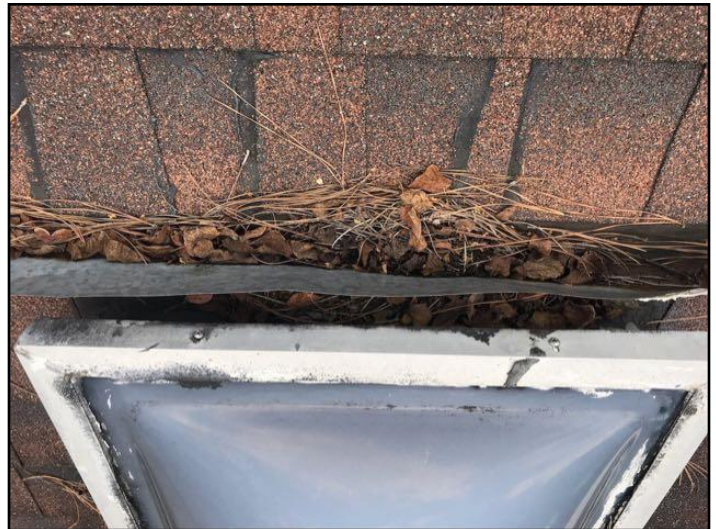
7. *Debris build-up at the roof surface may...*

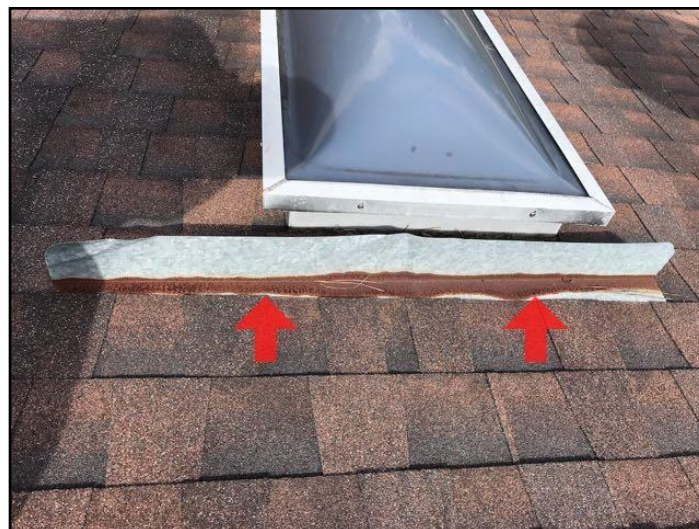
**8. Condition:** • Rusty flashing observed at the roof surface.

**8. Rusty flashing observed at the roof surface.**

**Task:** Repair or replace

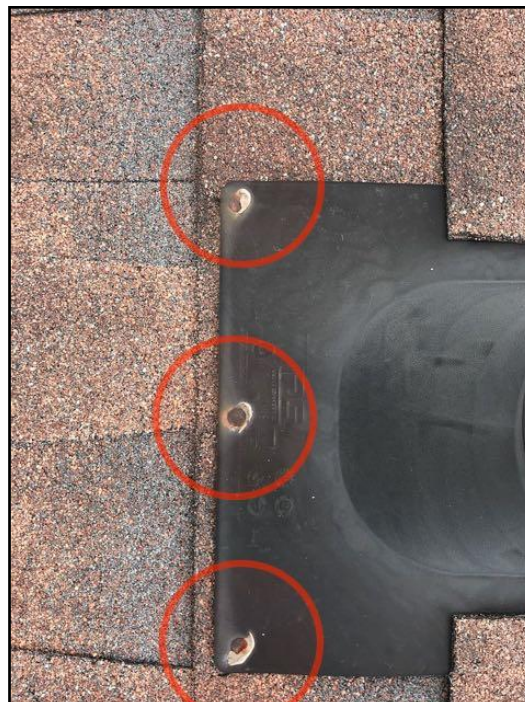
9. Exposed, missing fasteners

Task: Repair or replace, Further evaluation

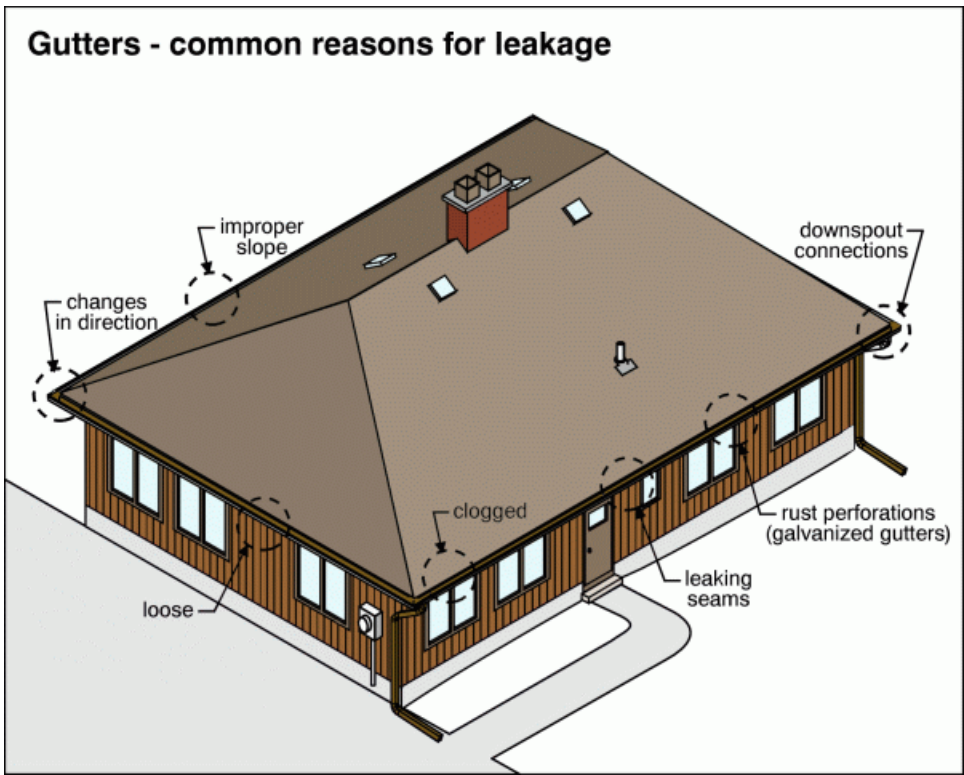
16. Leak

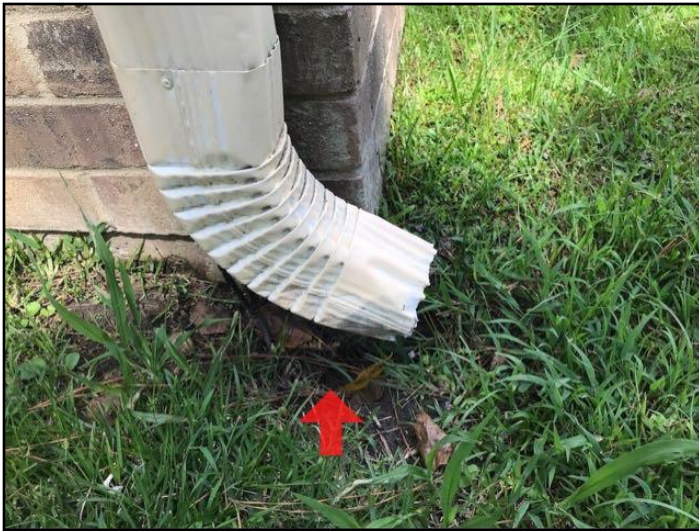
17. Soil erosion

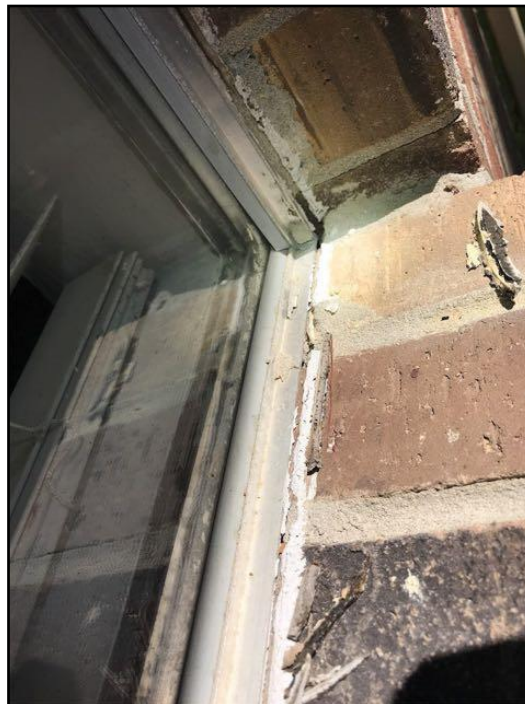
**17. Condition:** • Recommend caulking/sealing the intersections of dissimilar building materials.

20. Recommend caulking/sealing the intersection...

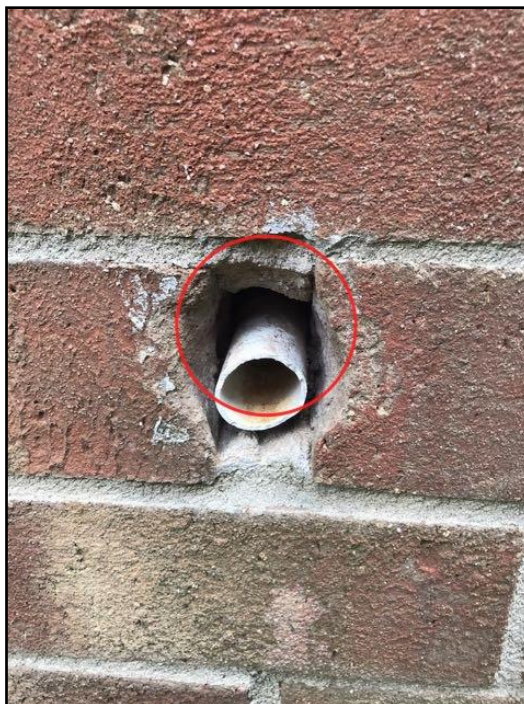
18. **Condition:** • Openings observed which may result in pest or water entry into the structure.

**Implication(s):** Chance of pest entering the building and water damage to contents, finishes and/or structure

21. Openings observed which may result in pest...

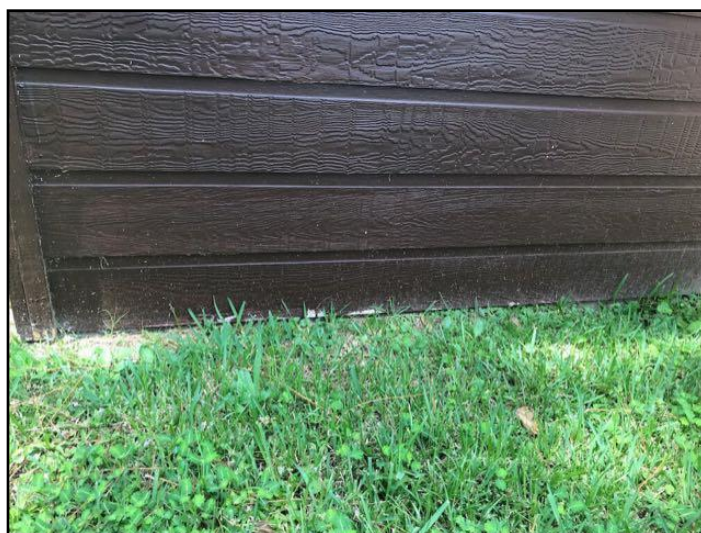
**Condition:** • [Too close to grade](#)

**Implication(s):** Chance of water damage to contents, finishes and/or structure | Material deterioration | Rot | Insect damage

22. Too close to grade

Task: Further evaluation

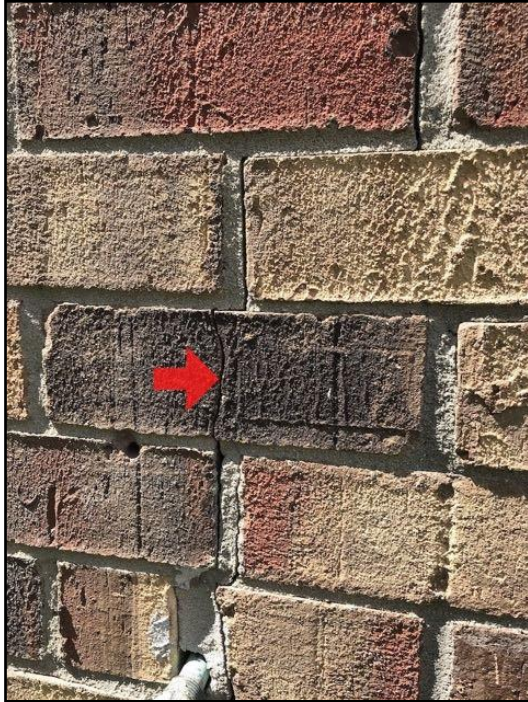
**Condition:** • [Cracked](#)

Cracking noted through mortar and face of brick. You may wish to seek further evaluation by a structural engineer. Monitor for any changes and/or problems.

23. Cracked

**Task:** Further evaluation

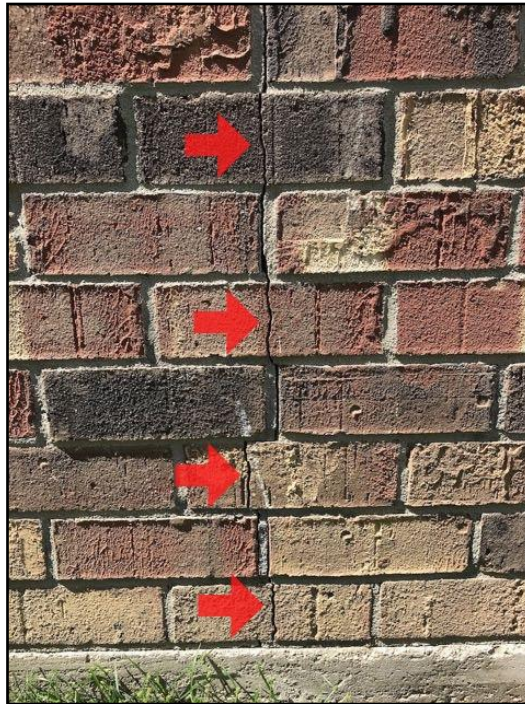
25. Cracked

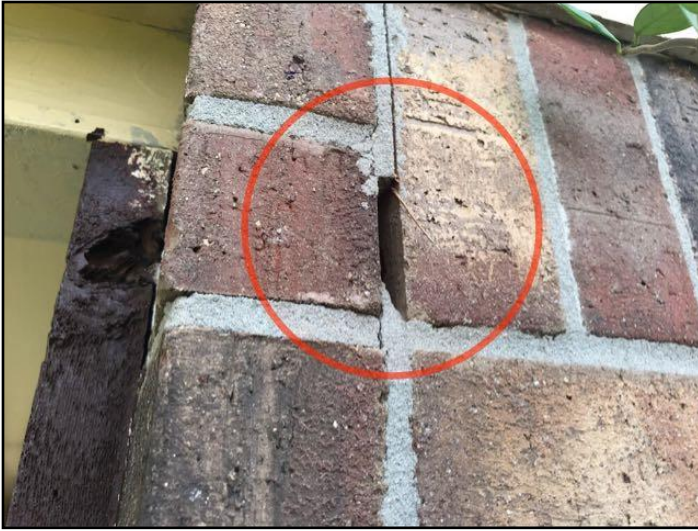
21. Condition: • [Mortar deterioration](#)

26. Mortar deterioration

Task: Repair or replace

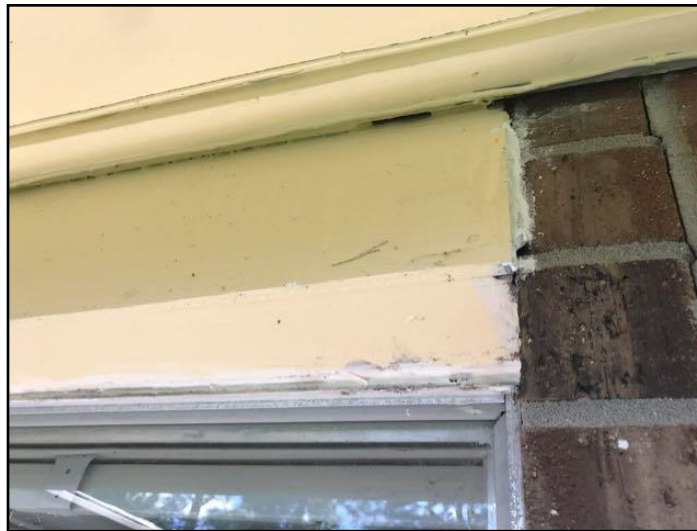
**Implication(s):** Chance of water damage to contents, finishes and/or structure

28. Damage

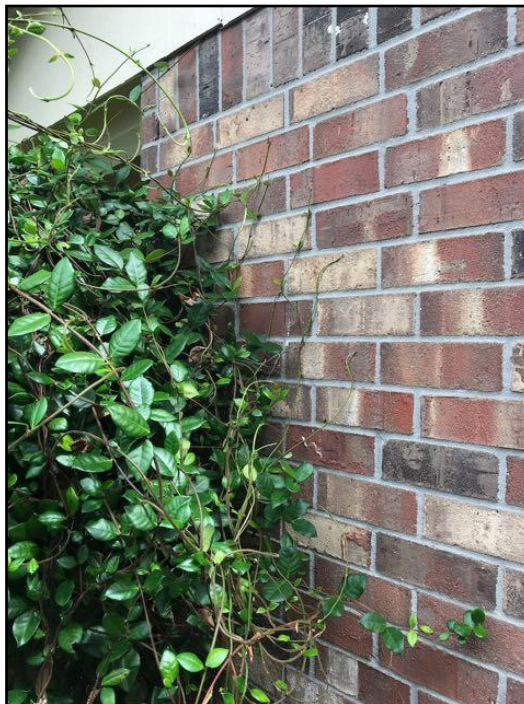
31. Vines on building

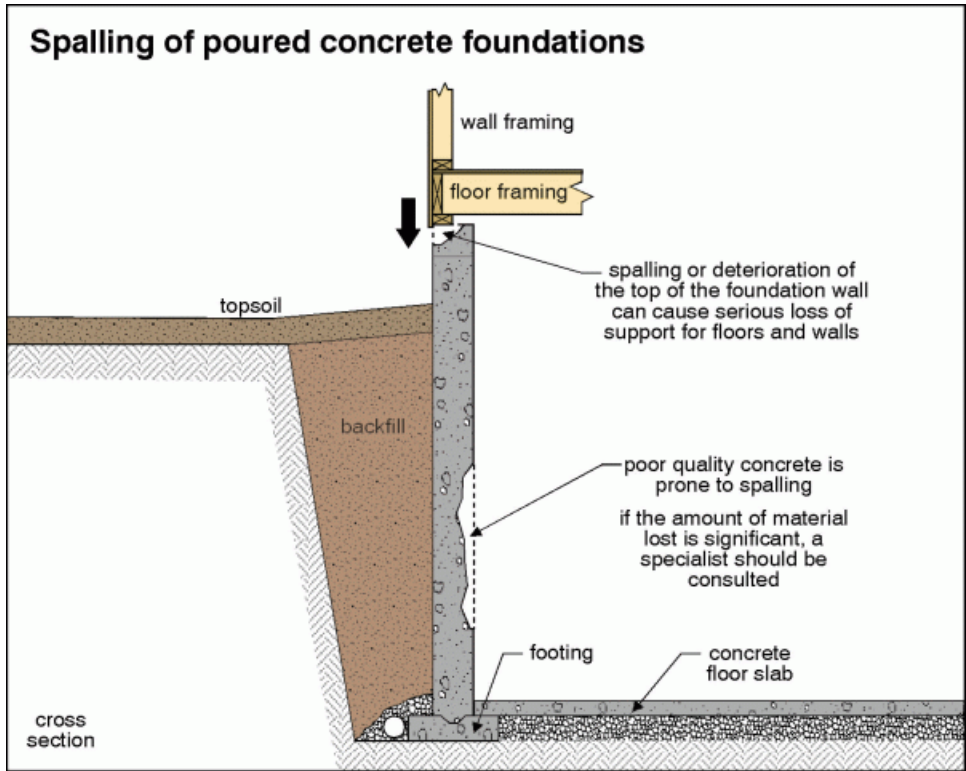
38. Spalling, crumbling or broken material

**Task:** Monitor

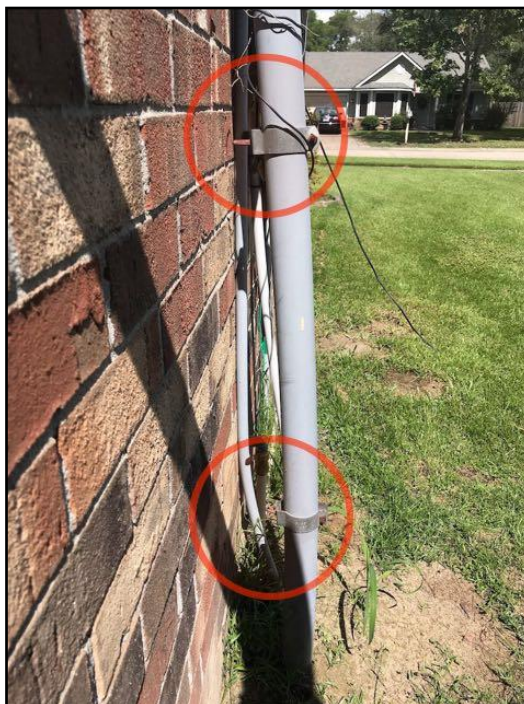
- 42. Condition:** • Conduit for service conductors is not properly secured to the exterior wall.
- Location:** Exterior Left
- Task:** Repair

42. Not secured

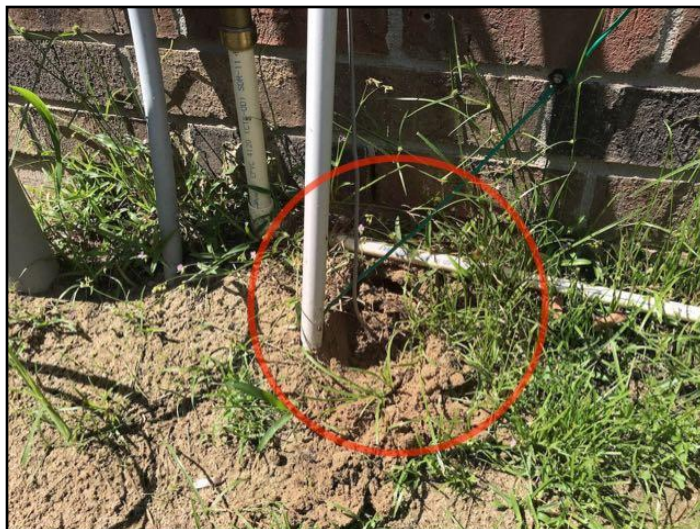
**Condition:** • Ground rod appears to be completely buried below grade level. Unable to verify proper installation and/or grounding type.

**43.** *Not accessible*

**Task:** Further evaluation

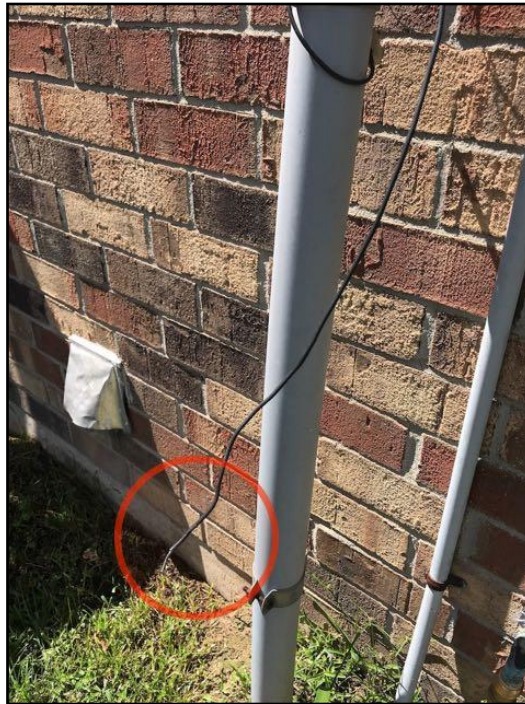
## **Condition:** • [Poor connections](#)

Loose ground wire noted

44. Poor connections

**Task:** Further evaluation

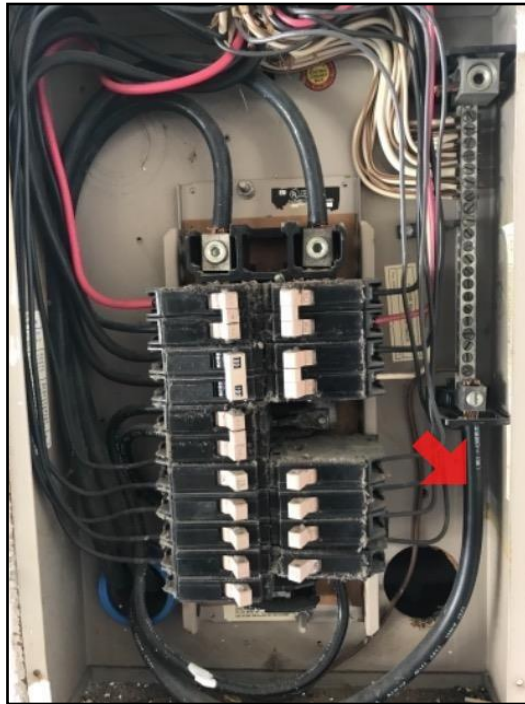
**51. Condition:** • Improper color-coding. White wire used at hot circuit inside the panel(s). Hot conductors should be marked black or red for proper identification.

47. Improper color-coding. Black wire used at...

**Task:** Correct

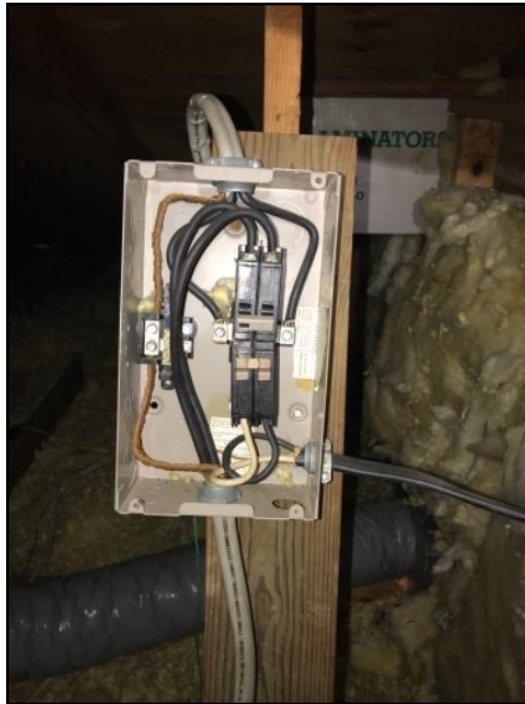
**Condition:** • Missing panel cover(s)

48. Missing cover

**Task:** Further evaluation

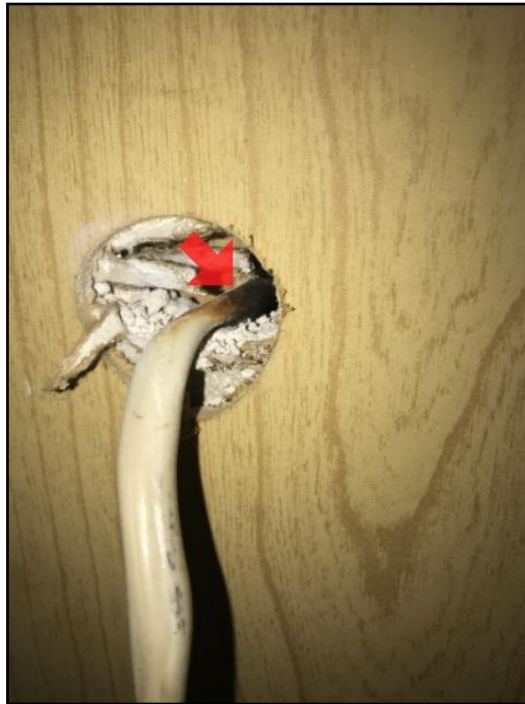
**Condition:** • Possible overheating/Discoloration noted at electrical wiring that is supplying the kitchen waste disposal.

49. Discoloration

**Task:** Further evaluation

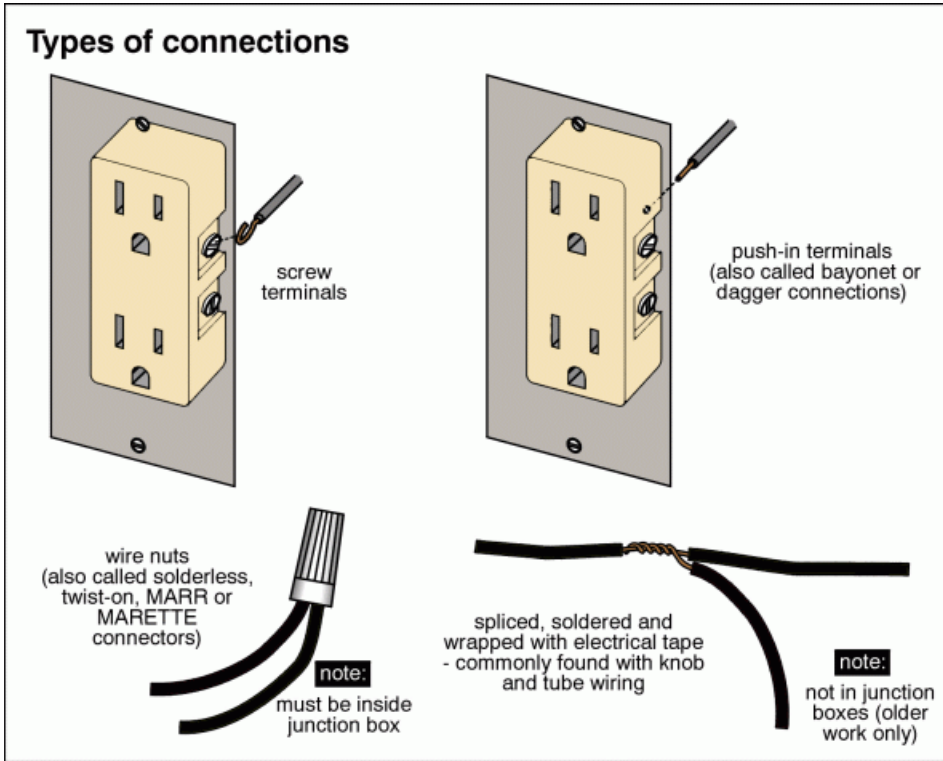
50. Missing

56. Condition: • [Missing, loose](#)

**Task:** Correct

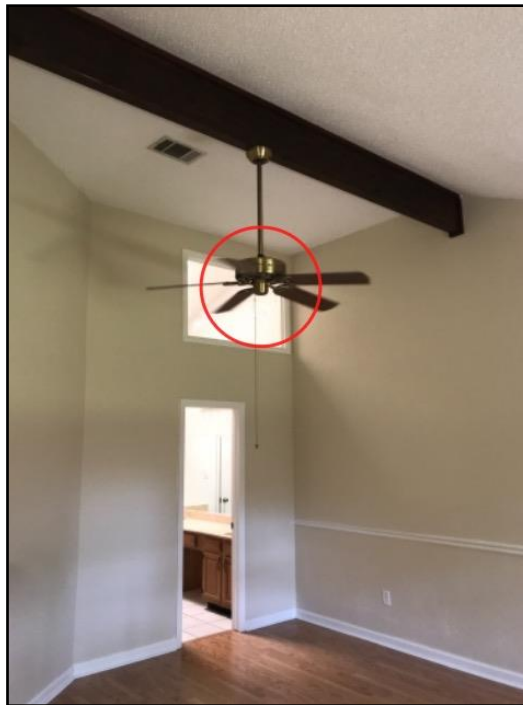
*52. Missing*

**58. Condition:** • [Missing](#)

**Implication(s):** Inadequate lighting

**Location:** Master Bedroom

**Task:** Improve

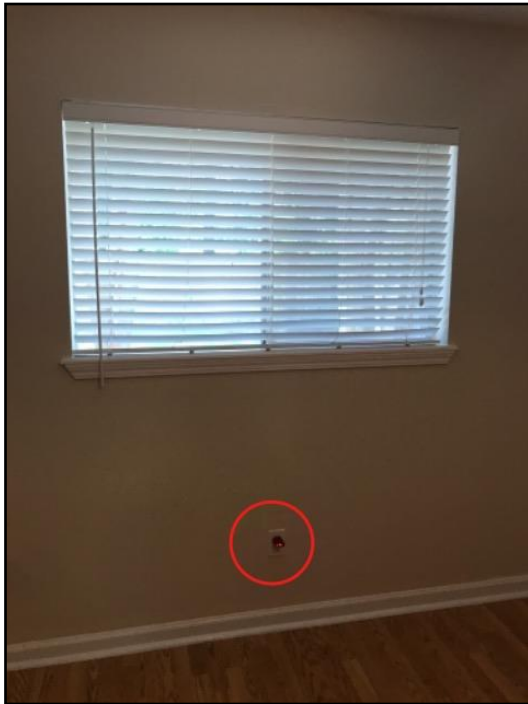
53. Reversed polarity

**60. Condition:** • [Reversed polarity](#)

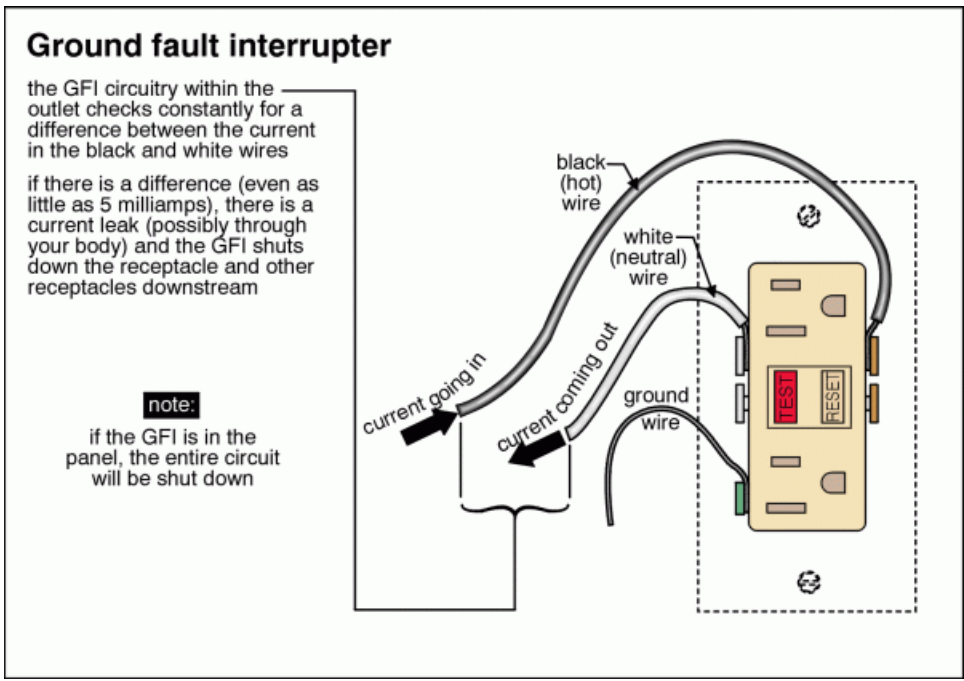
**61. Condition:** • [GFCI/GFI needed \(Ground Fault Circuit Interrupter\)](#)

**Implication(s):** Electric shock

Recommend installing GFCI outlets at all areas where water and electricity may come into contact.

**Task:** Further evaluation

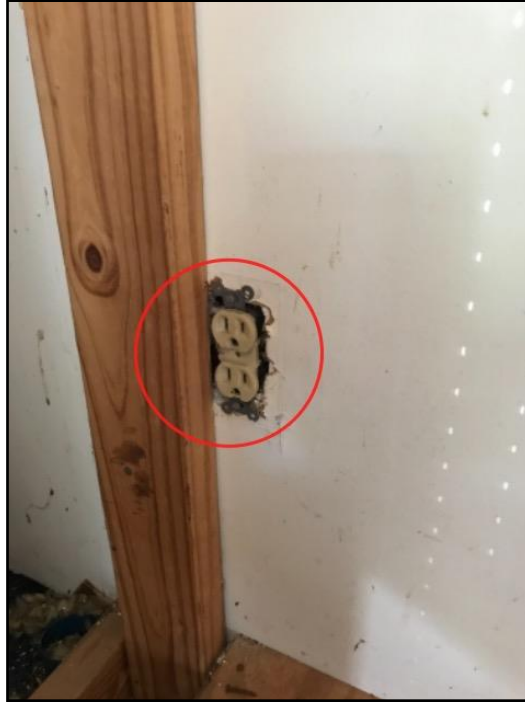
55. Missing

**62. Condition:** • [Missing](#)

**Location:** Garage

**Task:** Correct

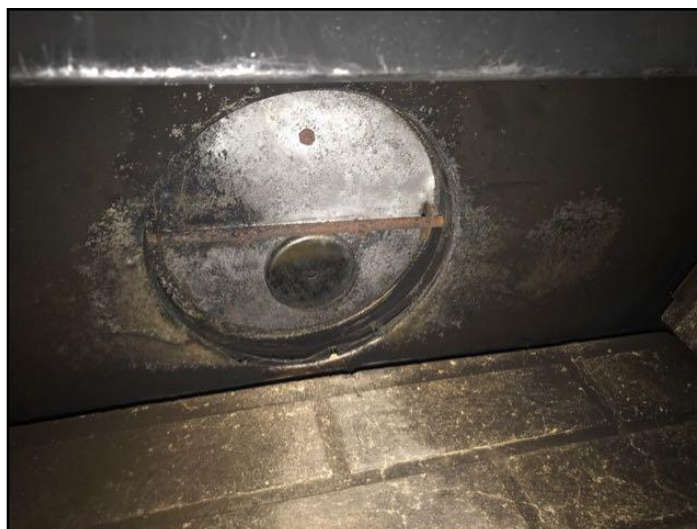
57. No damper arm

66. Condition: • Missing arm at damper for opening/closing.

Task: Repair or replace

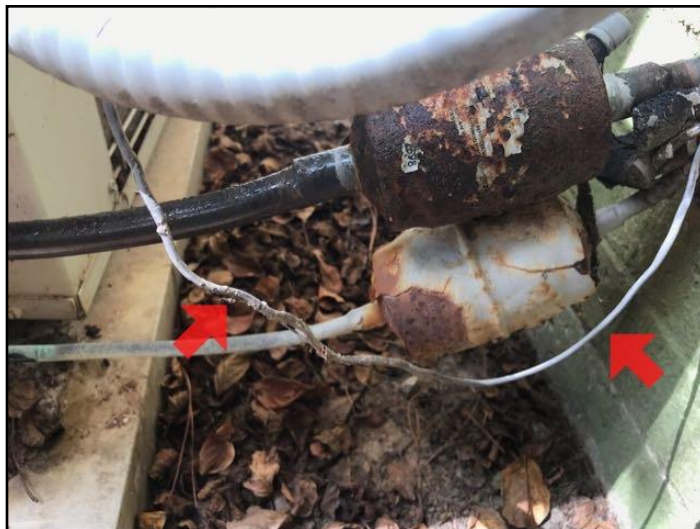
Damage noted to control wiring

**Location:** Exterior

**63.** Recommend properly protecting control wires.

**69. Condition:** • Recommend properly protecting control wires.

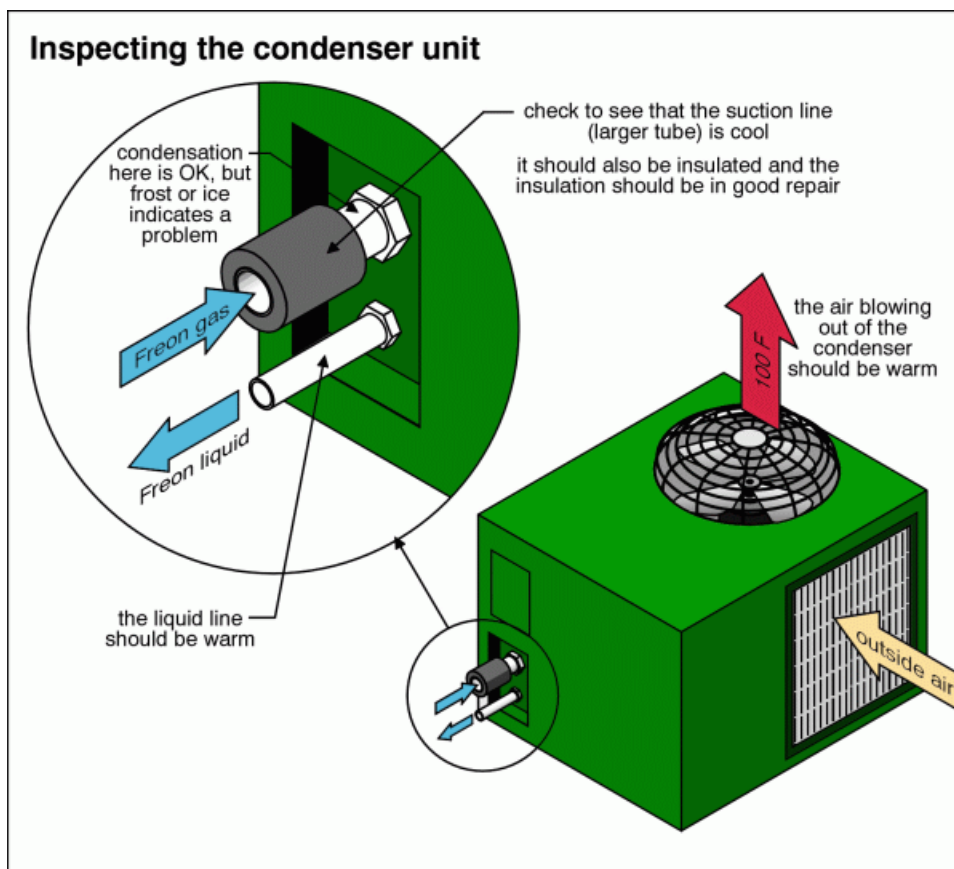
**72. Condition:** • [Dirty](#)

**Implication(s):** Reduced system life expectancy | Increased cooling costs | Reduced comfort

Recommend cleaning by licensed HVAC contractor.

Task: Clean

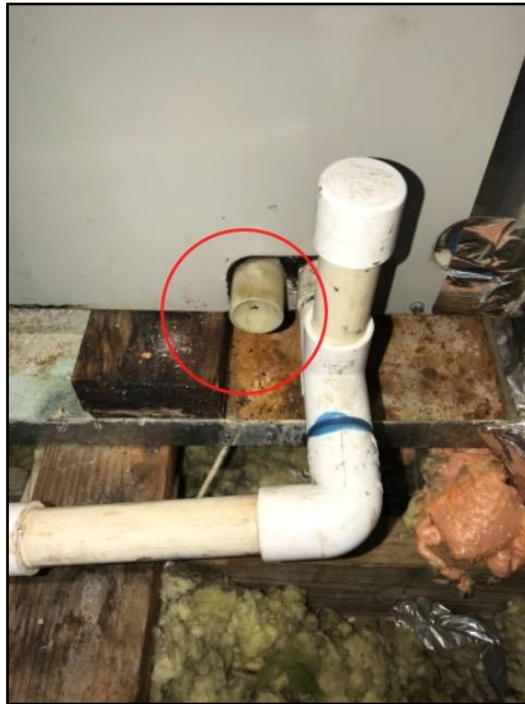
64. Poor termination

**75. Condition:** • Primary overflow drain line should be terminating down toward the secondary overflow drain pan.

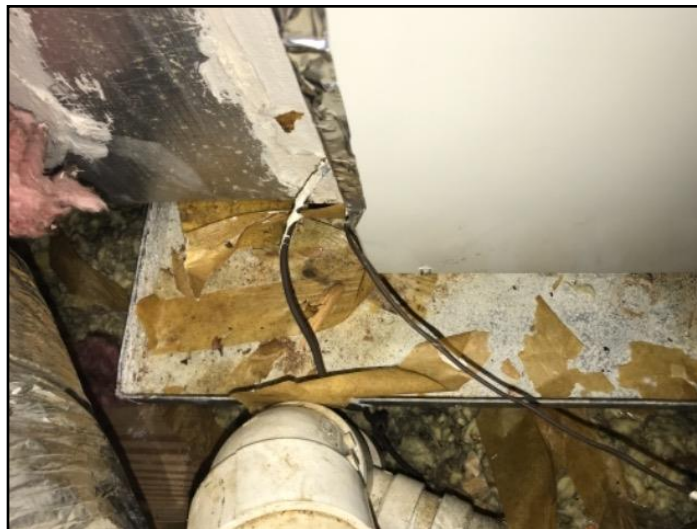
**76. Condition:** • Overflow drain pan needs cleaning. Recommend removing any insulation, trash, or debris from the drain pan to prevent clogging the overflow drain line in the event of a leak.

**Location:** Attic

65. Overflow drain pan needs cleaning. Recommen...

**Task:** Clean

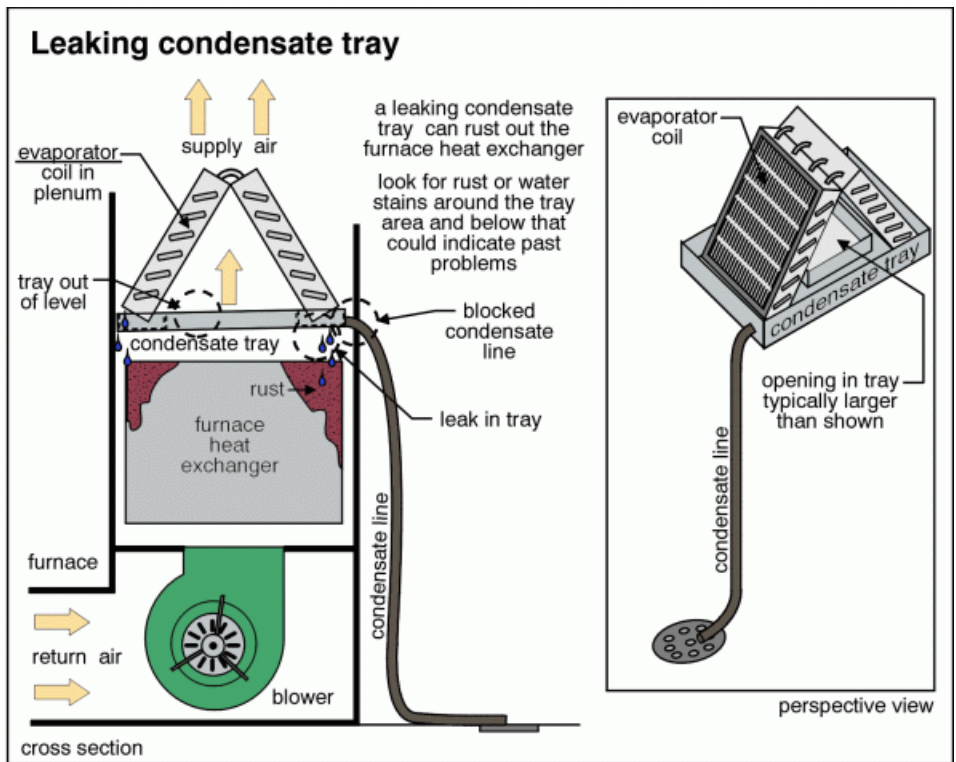
66. Rust in pan

**77. Condition:** • [Rust or holes in pan](#)

Rusting noted at the overflow drain pan.

**Implication(s):** Chance of water damage to contents, finishes and/or structure | Damage to equipment

**Location:** Attic

**Task:** Clean

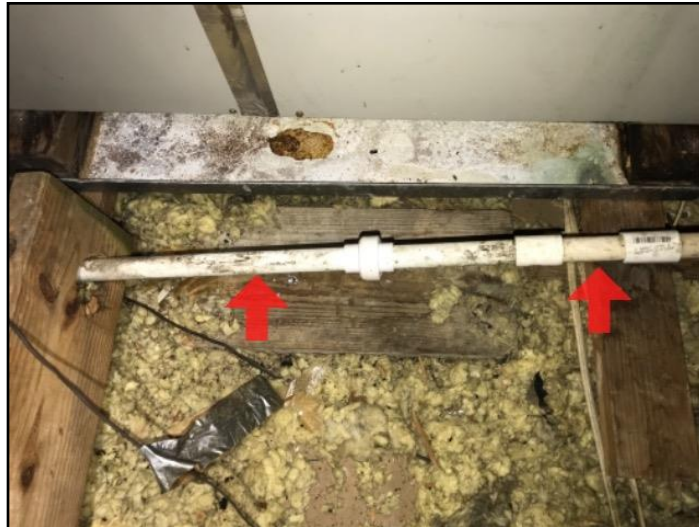
67. Missing insulation

**78. Condition:** • Missing insulation

**Location:** Attic

**Task:** Correct

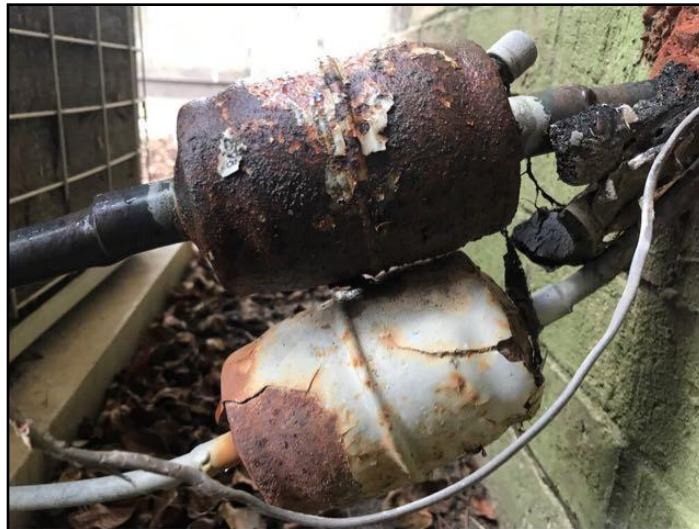
68. Rusting

**79. Condition:** • Rust damage noted

**Location:** Exterior

**Task:** Further evaluation

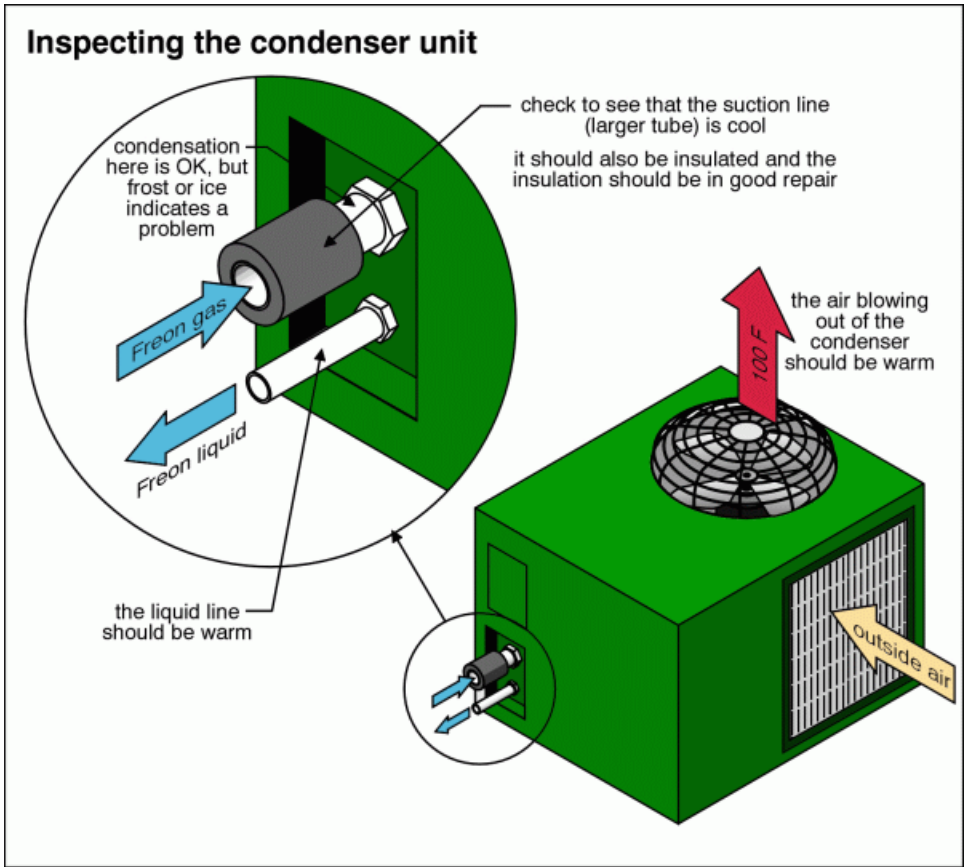
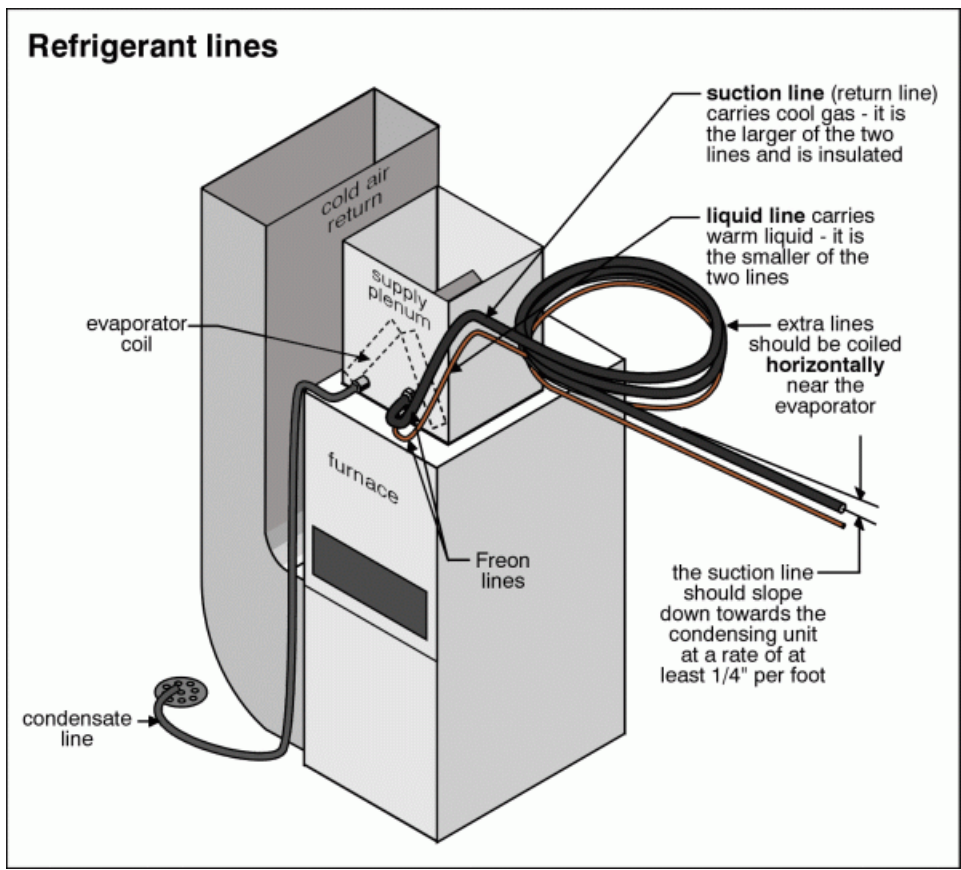
69. Insulation - missing

**80. Condition:** • [Insulation - missing](#)

**Task:** Provide

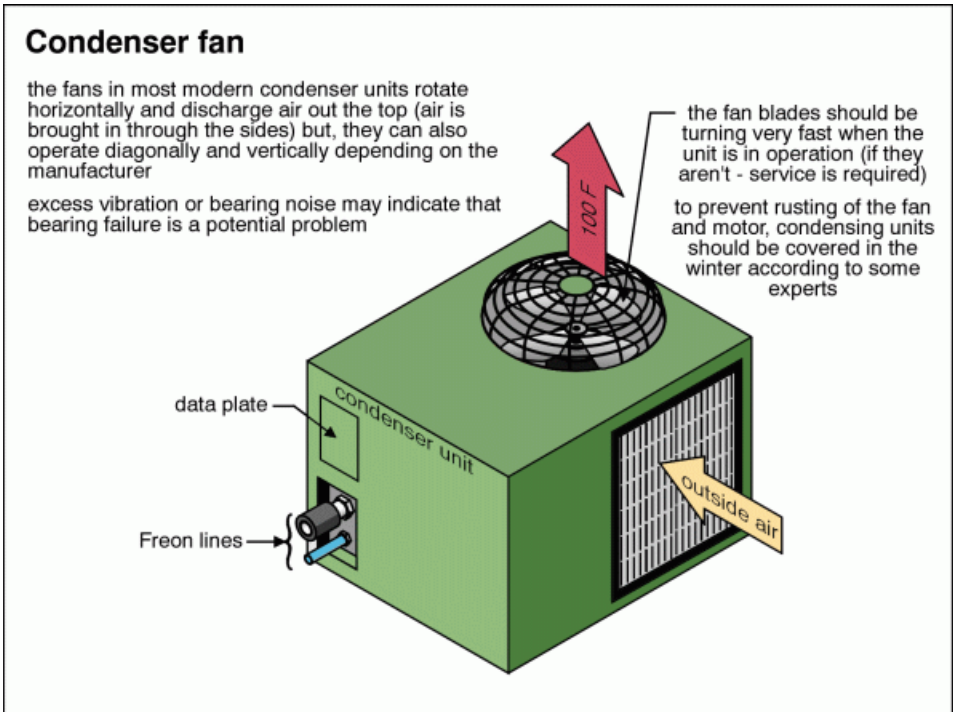
**83. Condition:** • [Dirty](#)

**Task:** Clean

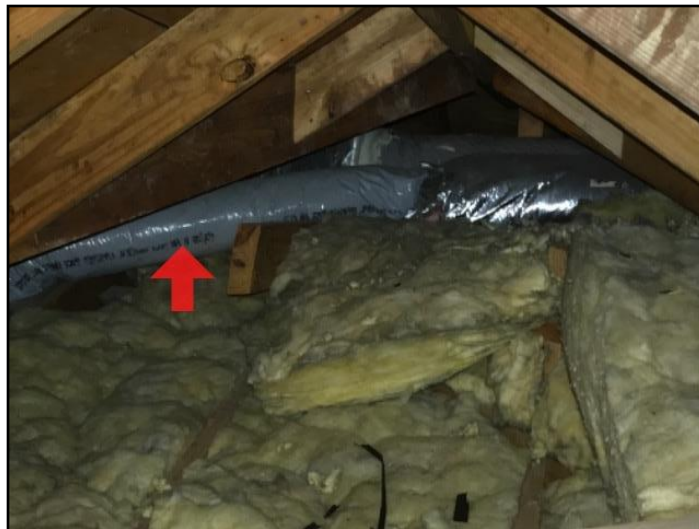
72. Gray vinyl ductwork

**84. Condition:** • Gray vinyl ductwork noted in some areas. These ducts are known to be ineffective at withstanding the heat of a residential attic. Damage and deterioration can be expected. Recommend replacing with approved ductwork.

**Location:** Attic

**Task:** Further evaluation

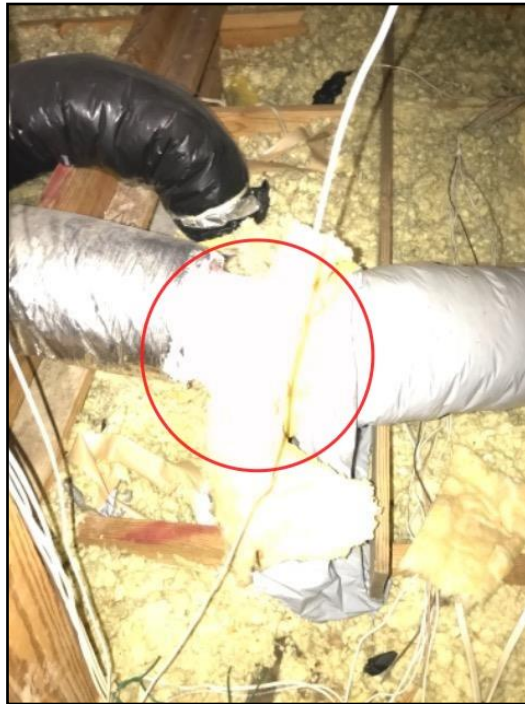
**76.** *Damaged insulation on ductwork*

**86. Condition:** • Damaged insulation on ductwork

**Task:** Repair or replace

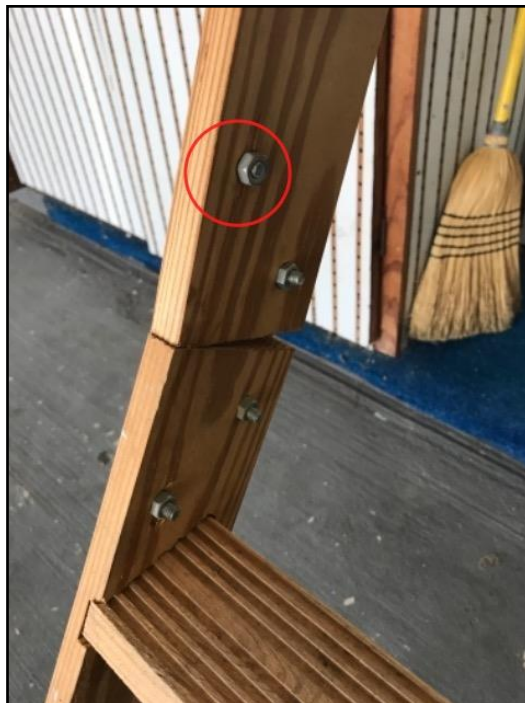
89. **Condition:** • Some attic ladder fasteners are unsecured. Repairs needed.

**Location:** Garage

78. Some attic ladder fasteners are unsecured....

**Task:** Correct

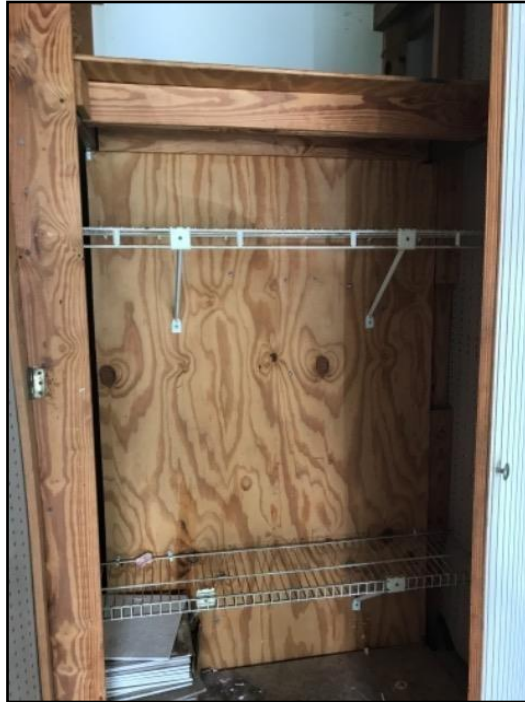
81. Water heater installed behind here

**Inspection limited/prevented by:** • Restricted access to the water heater. The appliance is installed in the garage behind closet/storage.

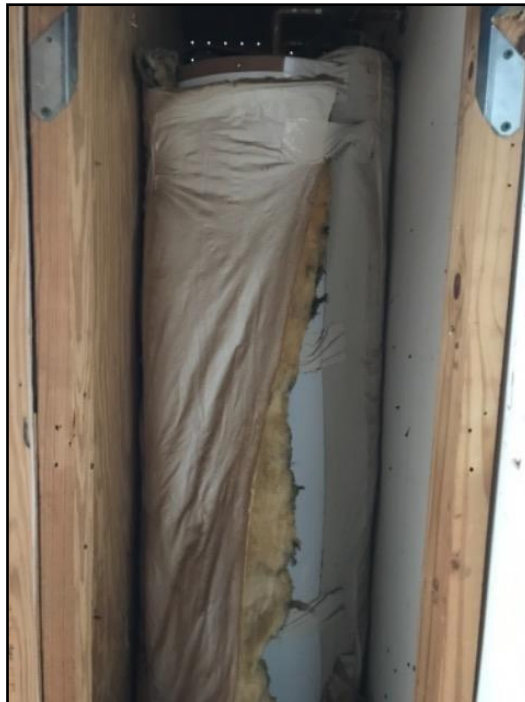
**Inspection limited/prevented by:** • Water heater is covered by an insulated thermal blanket. Limited access to the water heater as a result.

82. Water heater is covered by an insulated...

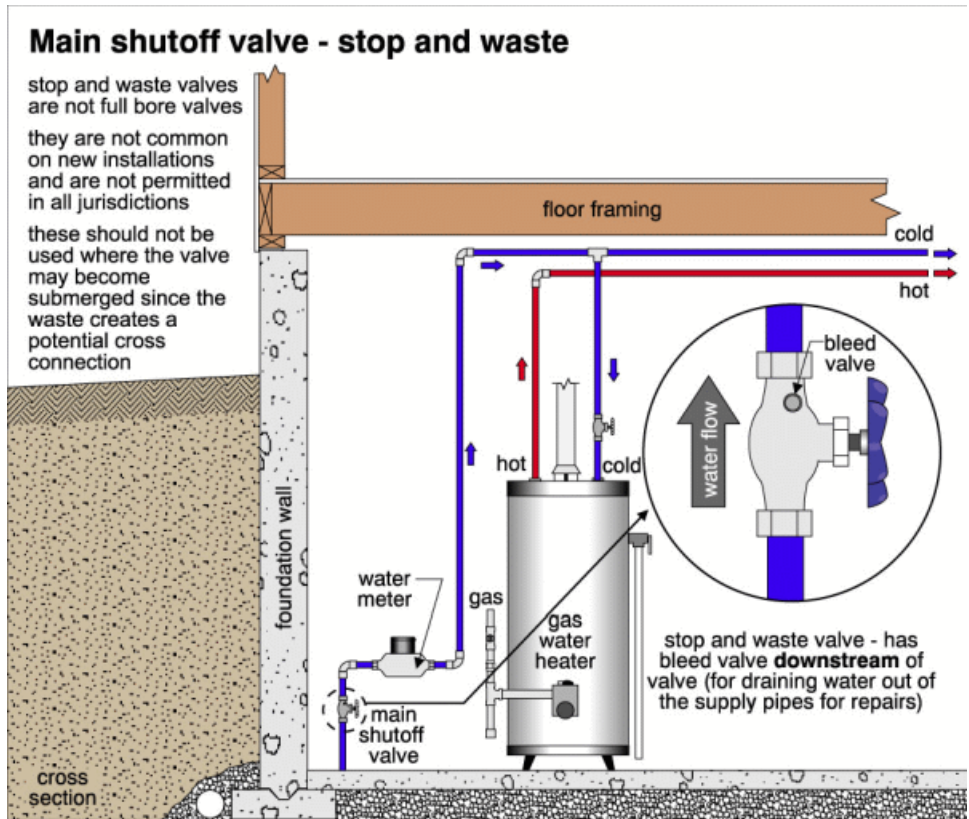
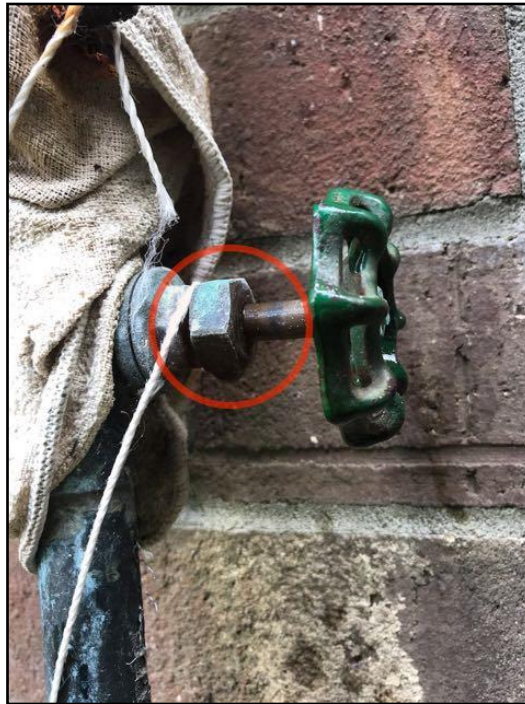
83. Leak

**93. Condition:** • [Leak](#)

Constant dripping noted at main water valve.

**Implication(s):** Chance of water damage to contents, finishes and/or structure | No water

**Location:** Exterior Right

**Task:** Repair or replace

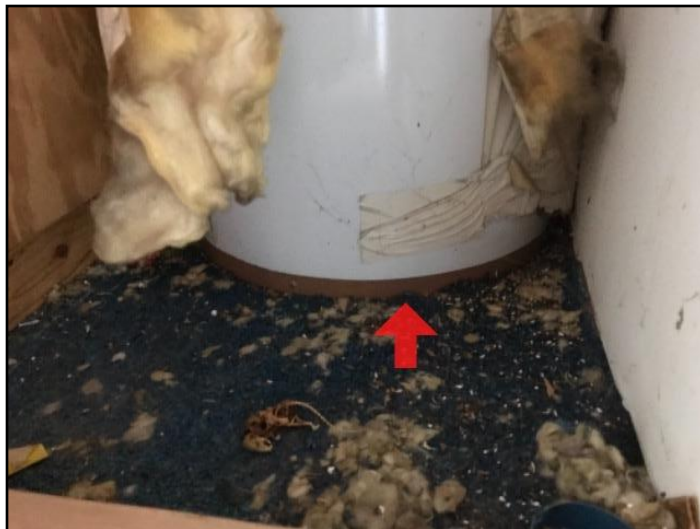
84. Safety pan and drain missing

**97. Condition:** • Safety pan and drain missing

**Implication(s):** Chance of water damage to contents, finishes and/or structure

Recommend installing an overflow drain pan underneath the unit and overflow drain line that terminates at the exterior.

**Task:** Further evaluation

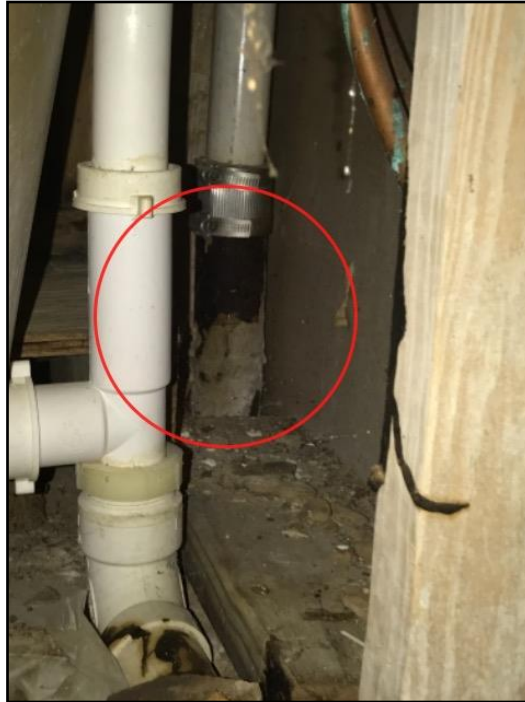
85. *Rust*

98. Condition: • [Rust](#)

Rusting observed at older style piping. Recommend monitoring for ongoing or future problems

**Task:** Monitor
