# Your Inspection Report

443 Pine Cone Lane  
Slidell, LA 70458

**INSPECTION DATE:**  
Tuesday, September 26, 2017

RE: Report No. 1336  
443 Pine Cone Lane  
Slidell, LA  
70458

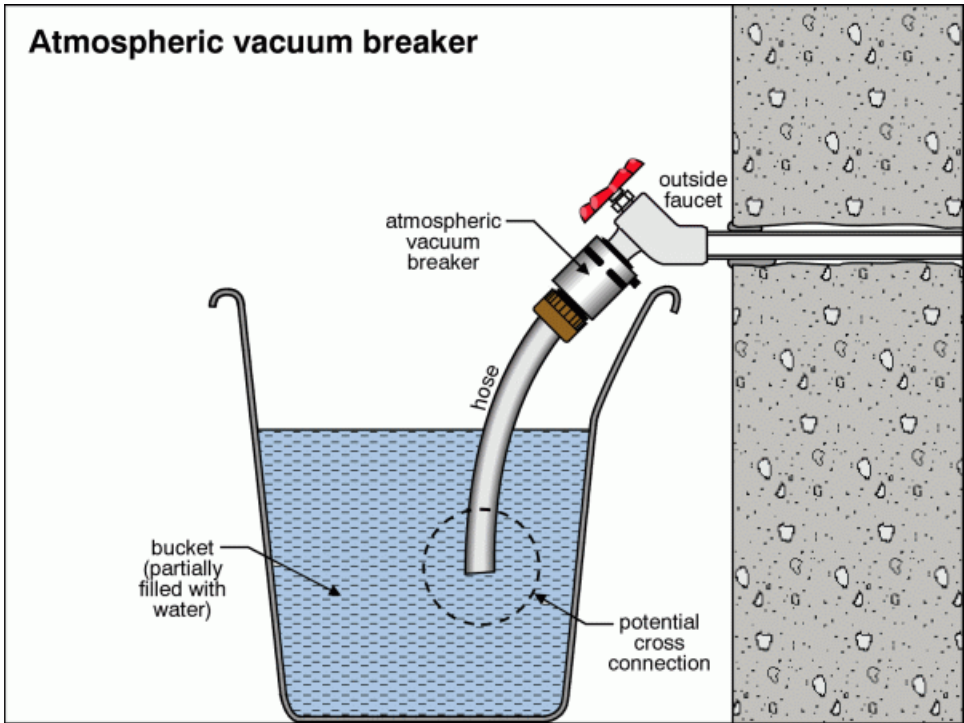
86. Backflow prevention missing

**99. Condition:** • [Backflow prevention missing](#)

**Implication(s):** Contaminated drinking water

**Task:** Improve

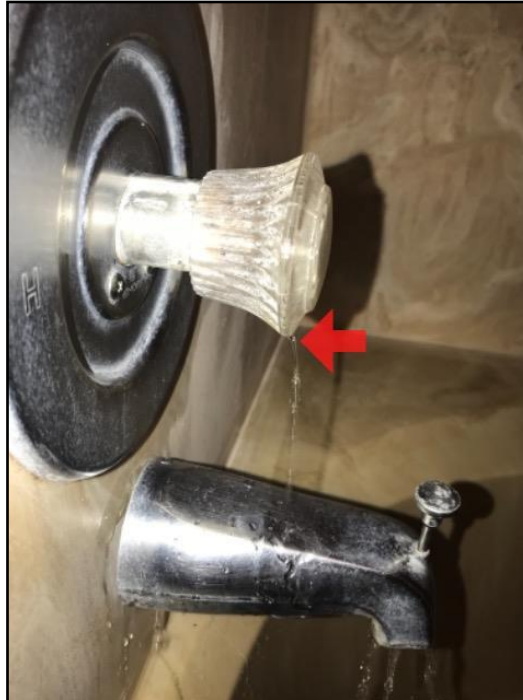
87. Drip, leak

100. Condition: • [Drip, leak](#)

Bathtub faucet handle leaks during operation.

**Implication(s):** Chance of water damage to contents, finishes and/or structure

**Location:** Master Bathroom

**Task:** Repair or replace

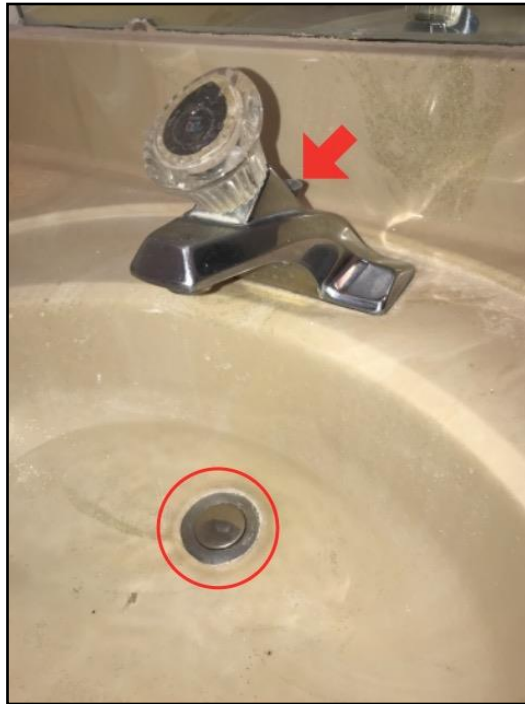
88. Drain stop ineffective

**102. Condition:** • Drain stop ineffective

Drain stopper needs repair/replacement at left sink.

**Task:** Repair or replace

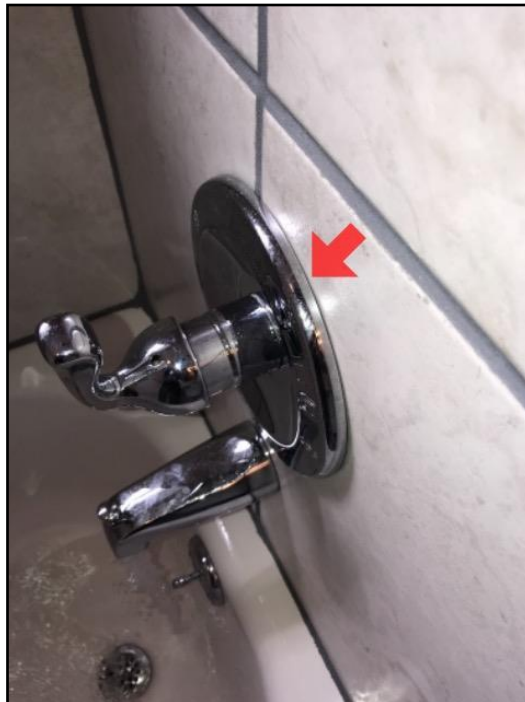
103. Condition: • Recommend sealing around fixtures to prevent water intrusion.

Location: Master Bathroom Hallway Bathroom

89. Recommend sealing around fixtures to preven...

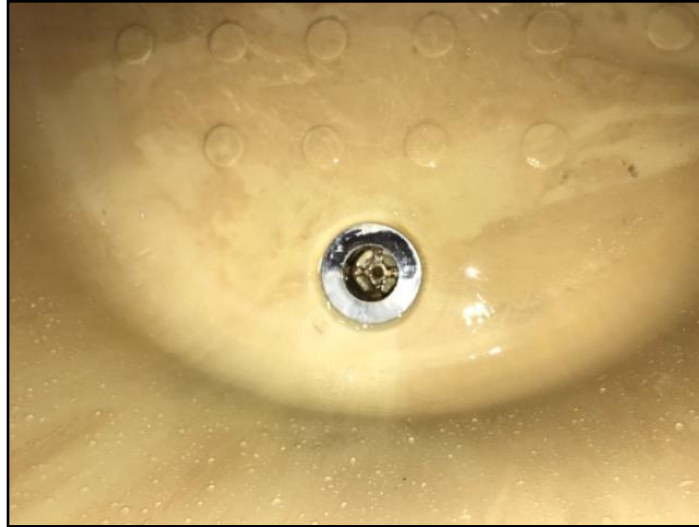
**90.** *Drain stop missing*

**104. Condition:** • Drain stop missing

**Location:** Master Bathroom

**Task:** Repair or replace

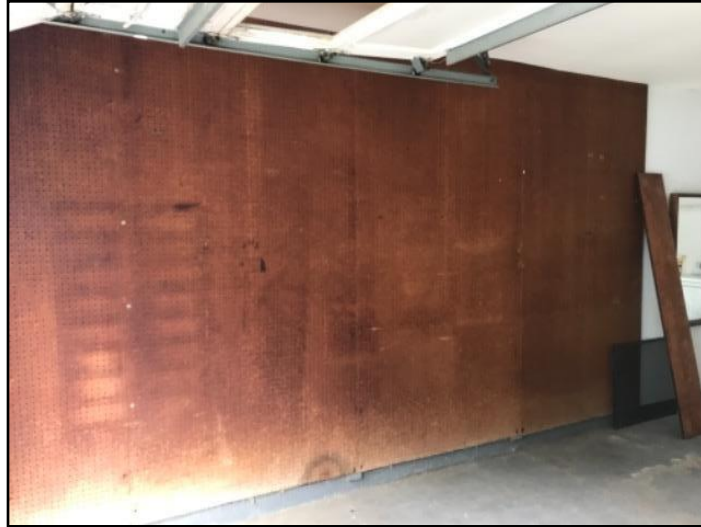
100. Garage

Areas of the garage walls are not accessible for inspection

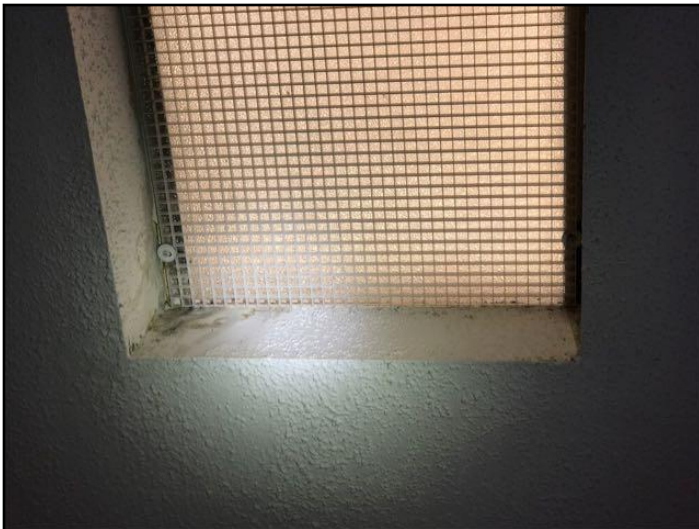
108. Condition: • Water stains  
Signs of past/present leakage observed. Unable to determine the status of these stains. Monitor for problems.

Implication(s): Chance of water damage to contents, finishes and/or structure

Location: Around interior skylights

102. Water stains

Task: Further evaluation

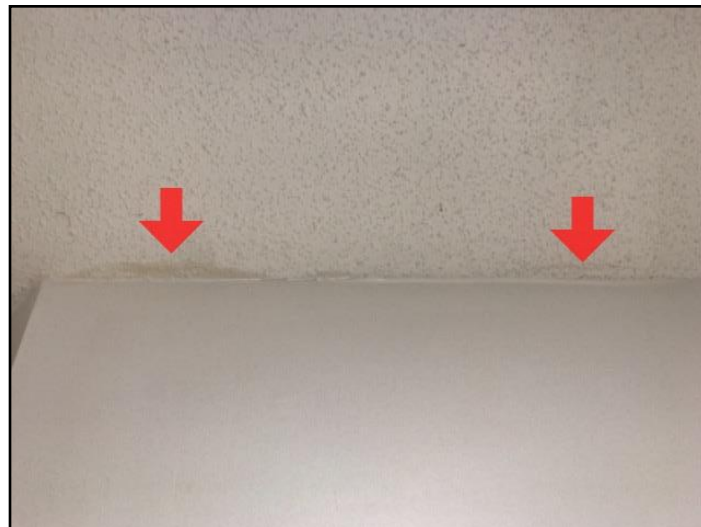
106. Water stains

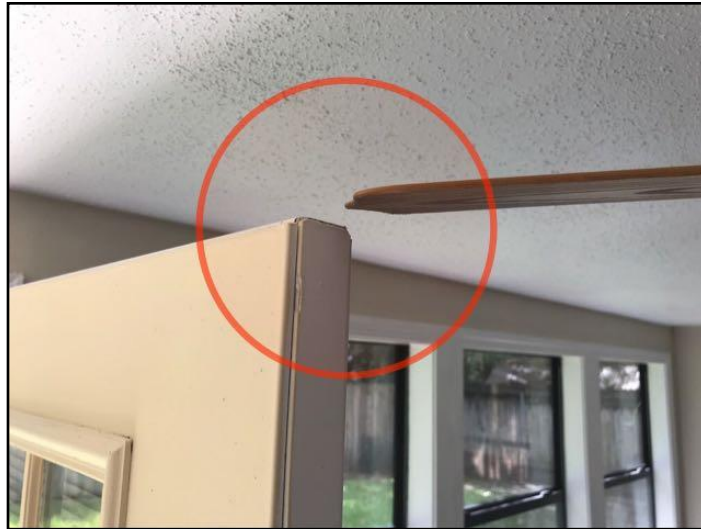
**111. Condition:** • Too low

**Implication(s):** Physical injury

**Location:** Sunroom

**107.** Too low

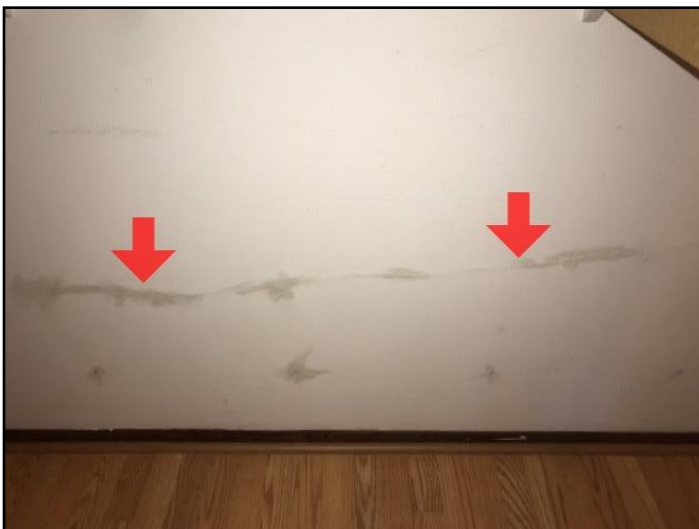
**112. Condition:** • Previous repairs noted. Recommend verifying reasoning with sellers and monitoring area for any problems

**Location:** Master Bedroom/Closet

**108.** Previous repairs

**Task:** Monitor

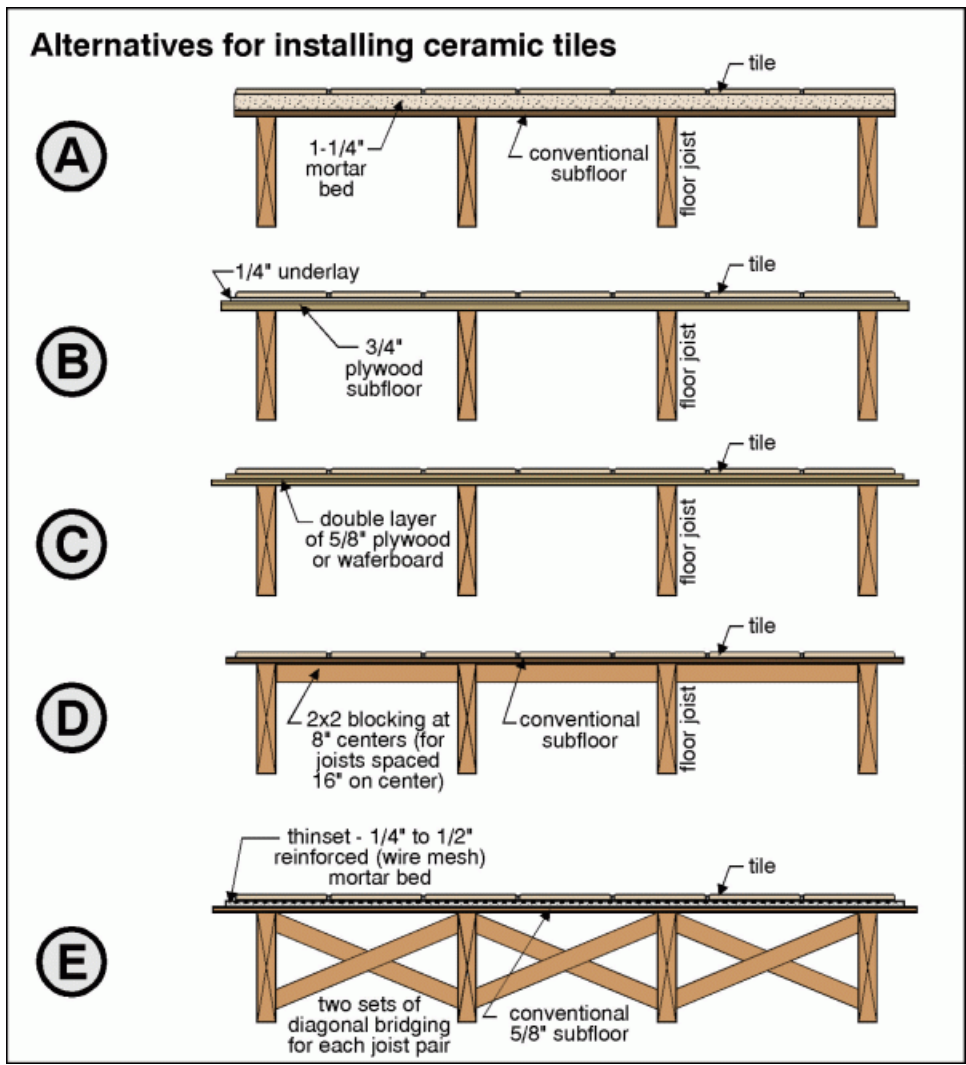
**115. Condition:** • [Tiles cracked](#)

**Location:** Kitchen

110. Tiles cracked

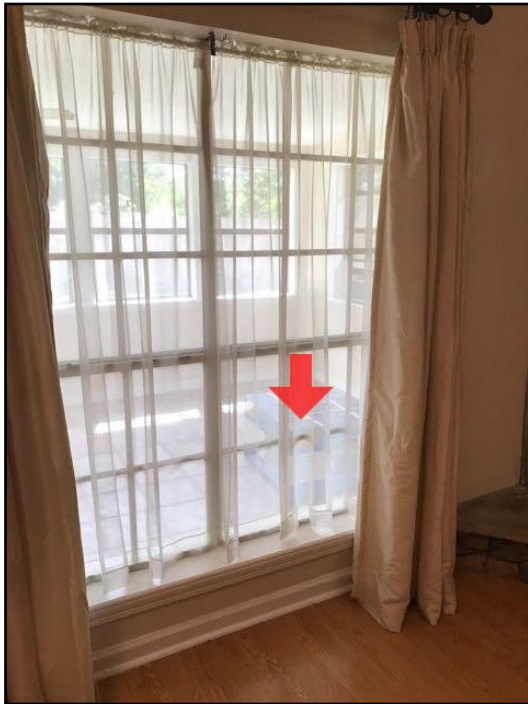
**116. Condition:** • Difficult to operate

112. Difficult to operate

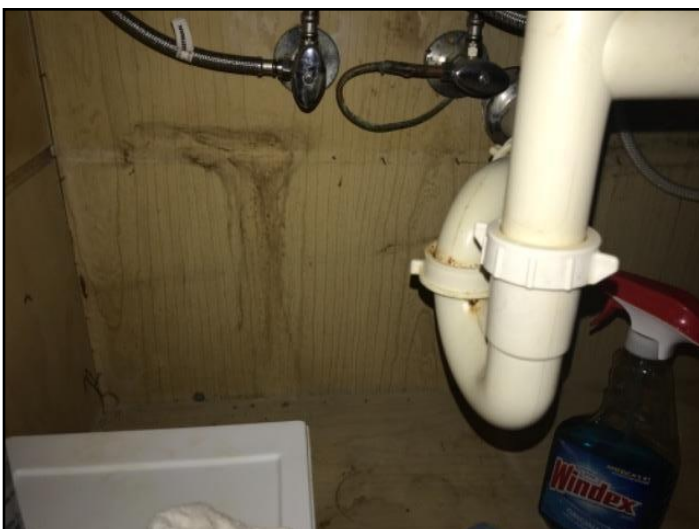
118. Condition: • [Stained, worn, damaged](#)

Implication(s): Material deterioration

Location: Kitchen, Bathrooms

114. Stained, worn, damaged

Task: Repair or replace

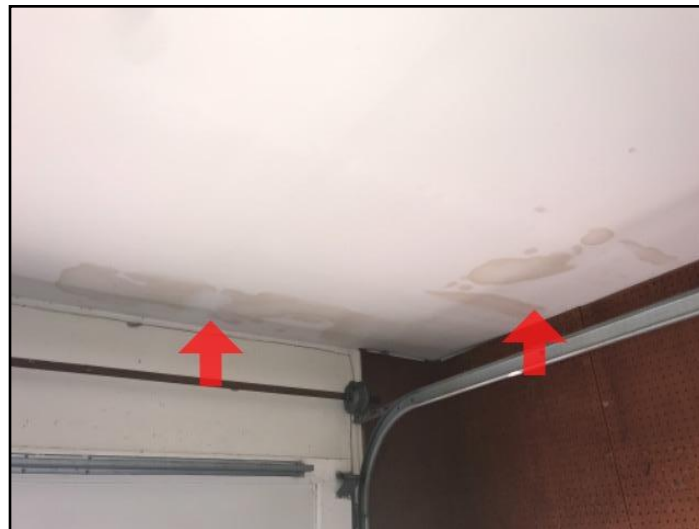
120. **Condition:** • Moisture stains observed at the garage ceiling.

117. Stains

**Task:** Further evaluation

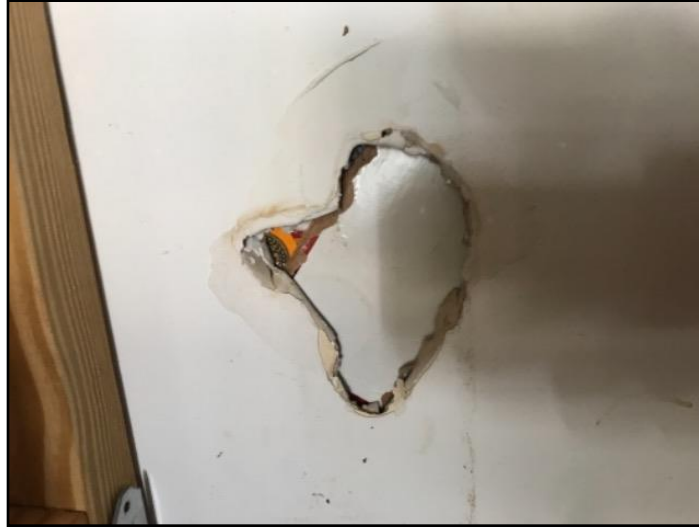
**121. Condition:** • Damage/deterioration noted. Drywall repairs needed.

**118. Damage**

**Task:** Repair

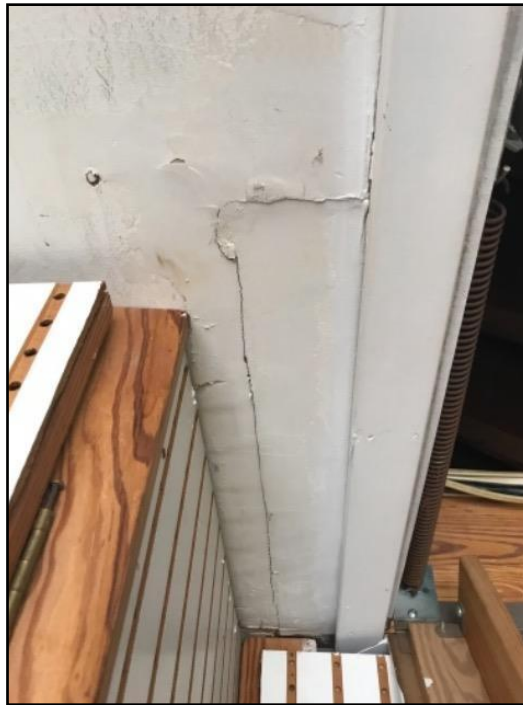
**122. Condition:** • Minor cosmetic issues observed.

Some cracking is to be expected at all interior surfaces as the property settles over time.

**119. Cracks**

**Task:** Repair

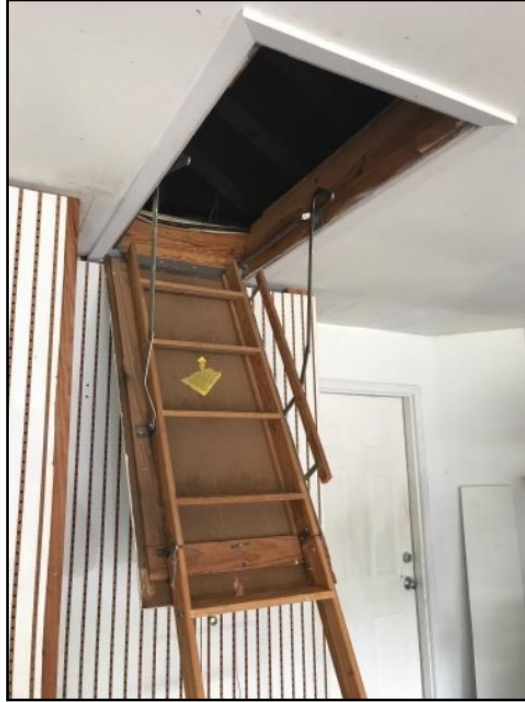
**124. Condition:** • Fire separation between garage and attic not adequate

**Implication(s):** Fire hazard

120. Fire separation between garage and attic no...

**Task:** Further evaluation

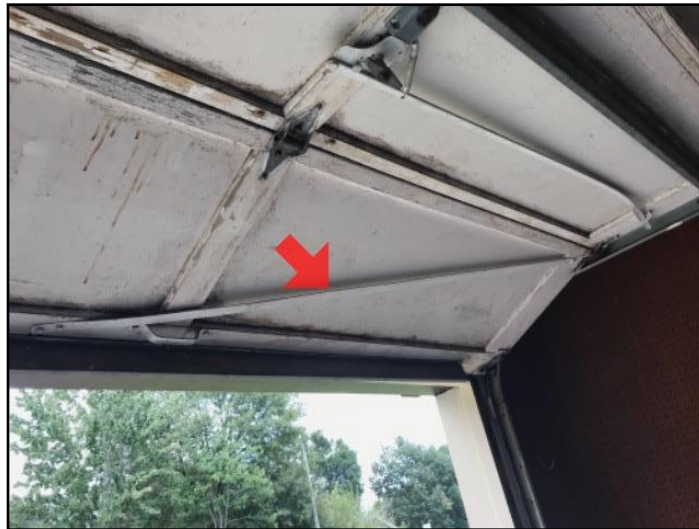
**125. Condition:** • Previous repairs/additional bracing noted at vehicle door.

121. Additional bracing

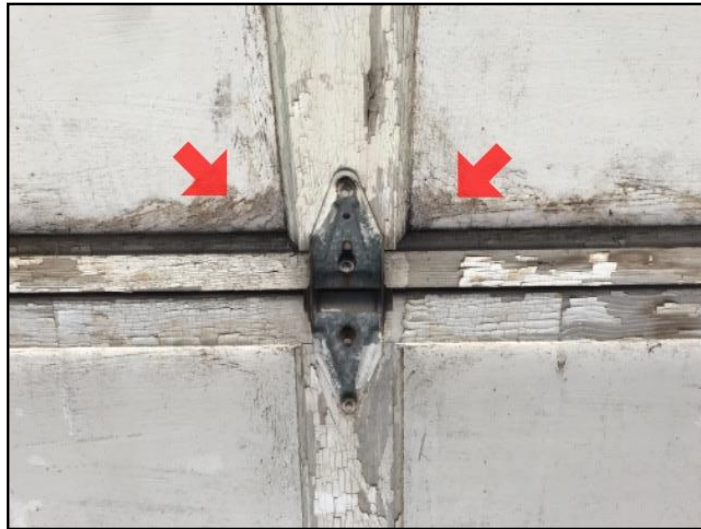
**126. Condition:** • Damage/deterioration

122. *Damage/deterioration*

**Task:** Repair or replace

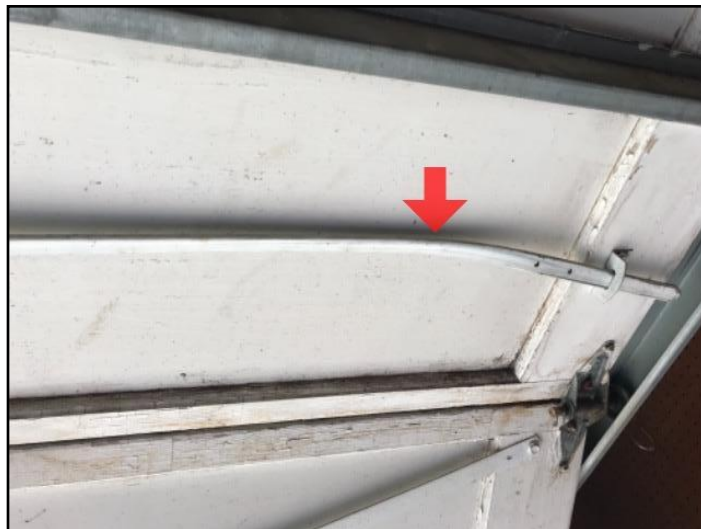
**128. Condition:** • Manual lockbar is damaged/bent

123. *Lockbar is bent*

**Task:** Repair or replace

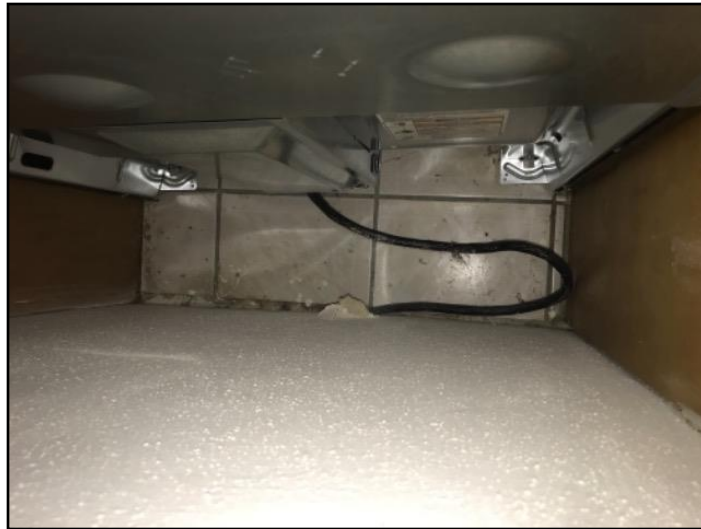
**129. Condition:** • Appliance is hardwired. Current safety standards recommend that a means of disconnect is supplied at the appliance (e.g. plugging into an outlet).

124. Hardwired

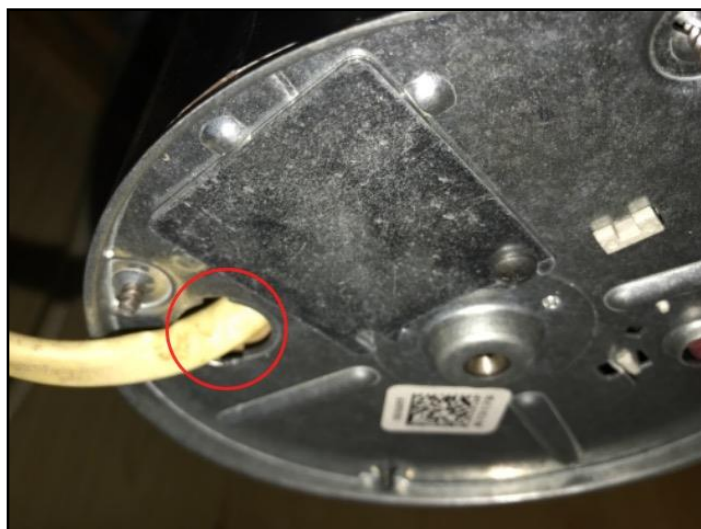
**133. Condition:** • Wiring exposed or loose

Missing strain relief wire clamp at disposal housing and rigid conduit for wiring.

**Implication(s):** Electric shock

125. Wiring exposed or loose

**Task:** Correct

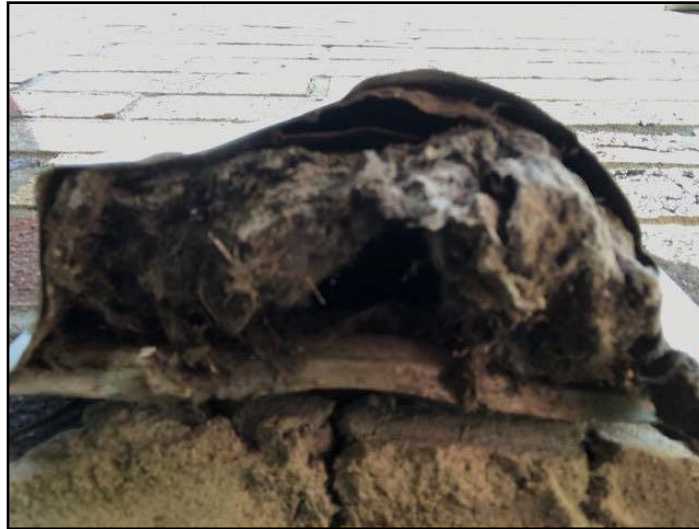
**134. Condition:** • Dryer vent obstructed

**Implication(s):** Equipment ineffective | Fire hazard

**Location:** Exterior Left

**126.** *Dryer vent obstructed*

**Task:** Clean
