INSPECTION CONDITIONS	3
EXTERIOR - FOUNDATION - BASEMENT	6
GROUNDS	12
ROOF - FLASHING SYSTEMS	18
PLUMBING	22
ELECTRICAL	25
BATHROOMS	29
GARAGE - CARPORT	34
INTERIOR - ATTIC	37
KITCHEN - APPLIANCES - LAUNDRY - WETBAR	44
HEATING - AIR CONDITIONING	50

INSPECTION CONDITIONS

DATE OF INSPECTION: 7/3/2020.
START TIME OF INSPECTION: 2pm.
END TIME OF INSPECTION: 5pm.
CLIENT NAME: Steven Prince.
INSPECTION SITE: 445 Evergreen Ct.

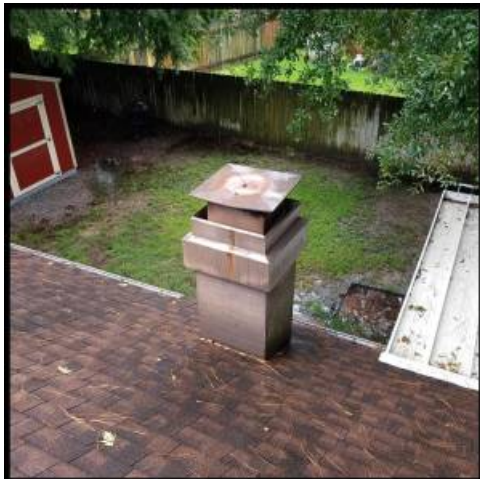
CHIMNEY:

MATERIAL: Metal.
CONDITION: Appears serviceable, Spark arrester noted, Rain cap noted.

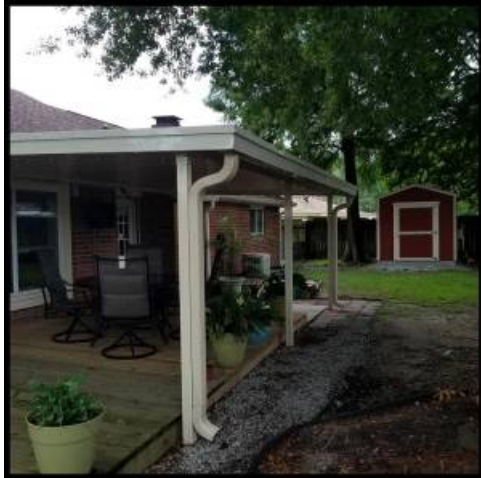
Rear Patio: Metal Awning

The following concerns were noted at the patio/porch cover:
Damage noted to the back side of the awning. Monitor for problems and repair as needed.

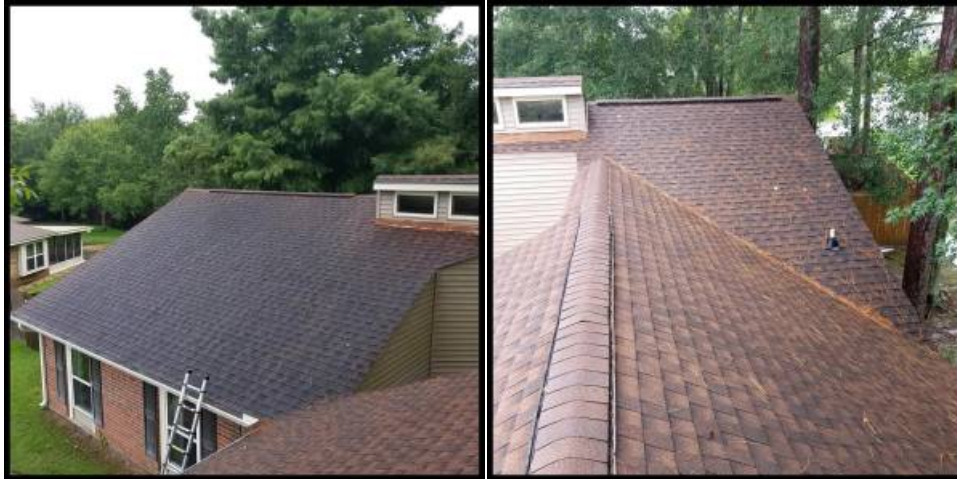
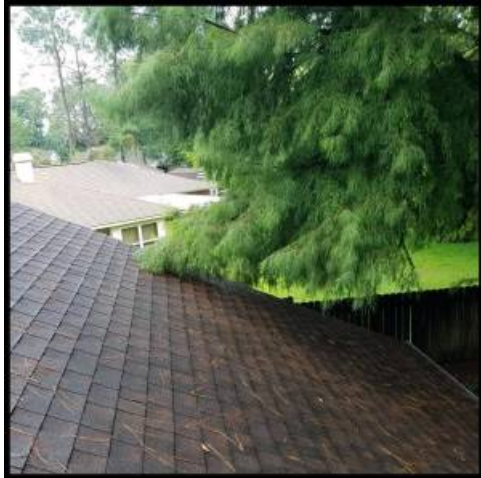
ROOF:

General condition appears serviceable with signs of weathering and aging. Regular maintenance and inspections are advised. Maintenance will help ensure the weather tightness of the building and should be performed on a regular basis.

The following concerns were noted at the roof:
Nails/Fasteners are exposed. Sealing is recommended.

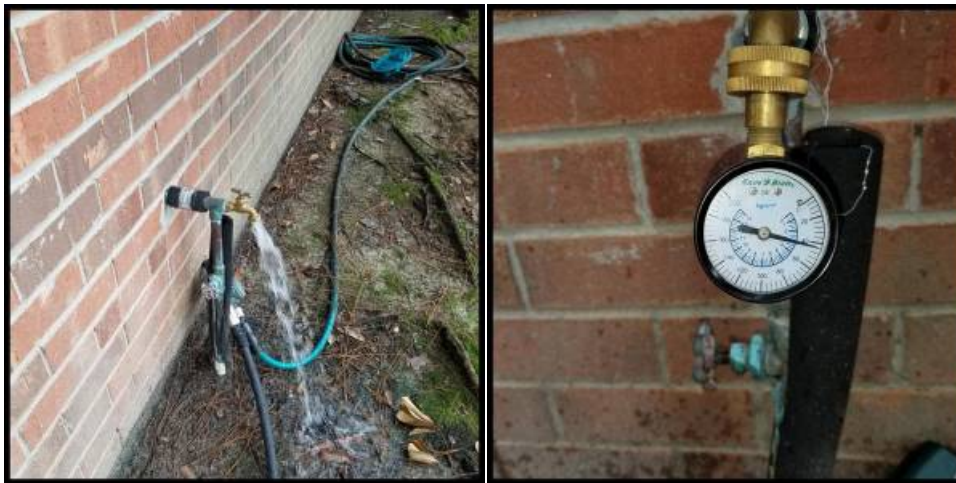
MAIN LINE:

MATERIAL AND SIZE: Copper, Main line is 3/4 inch diameter.
LOCATION: Main water shut off valve is located: at the right side of the house.
CONDITION: Appears serviceable, Valve is operational
Water pressure appears adequate, 40-50 PSI.

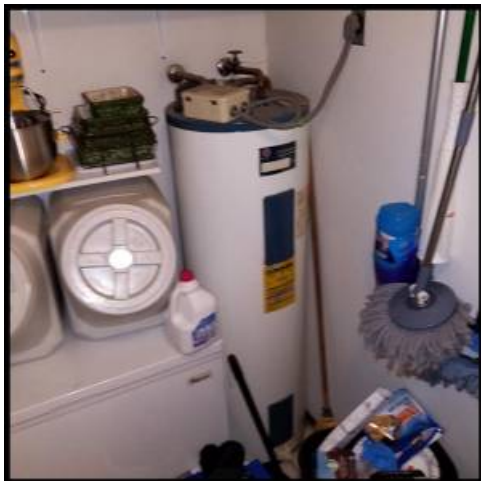
LOCATION:

Appears serviceable, but signs of wear and aging noted. Monitor for problems. Pressure relief valve noted, not tested, A water shutoff valve is installed.

The following concerns were noted at the water heater:
Recommend installing an overflow drain pan with an exterior routed drain line.

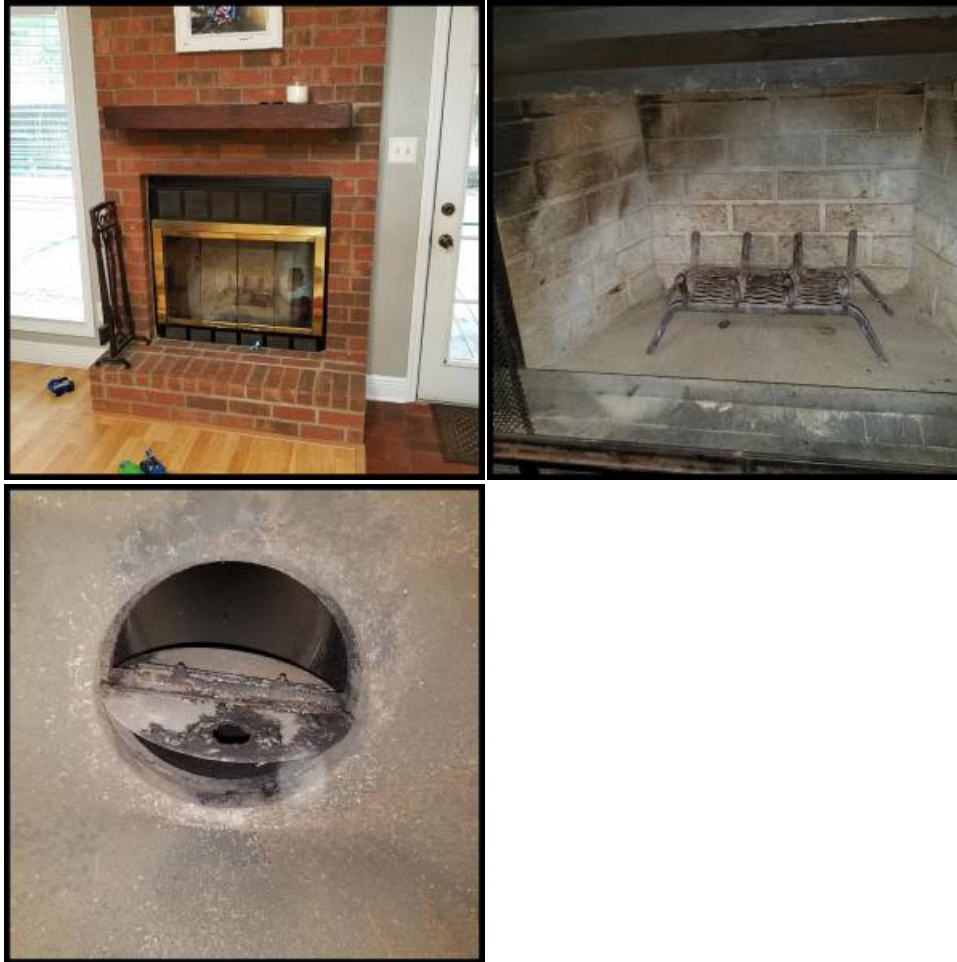
FIREPLACE/WOOD BURNING DEVICES:

LOCATION - TYPE - Location #1: Den
CONDITION: Type: Prefabricated metal
Fuel source: Wood burning

Fireplace appears serviceable, but signs of wear and aging noted. Monitor for problems.
Damper is operational.

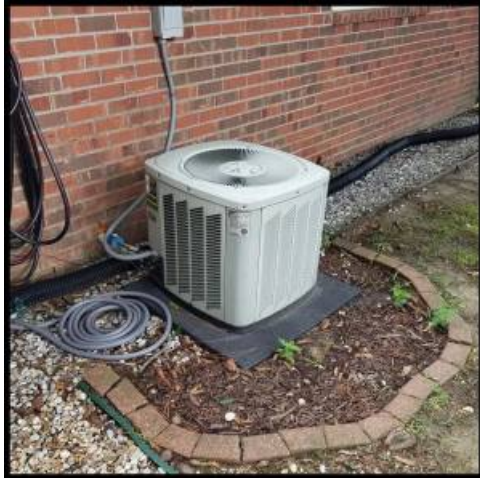
TYPE: Central (Split system)
AC CONDENSER/COMPRESSOR MANUFACTURER: American Standard.
CAPACITY OF UNIT: 3 Tons.
YEAR OF MANUFACTURE: 2003.
AC CONDENSER/COMPRESSOR POWER SOURCE: 240 Volt, Electrical disconnect present.

The following concerns were noted at the power source:
Panel appears to be without the benefit of protective grommet. Add as needed to protect the wiring.

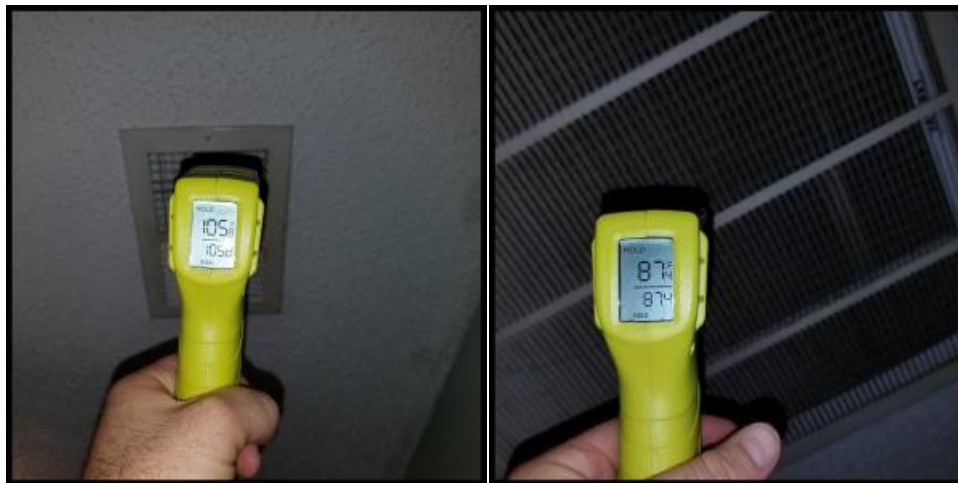
BURNERS/HEAT EXCHANGERS: The following concerns were noted at the burner/heat exchanger:
Heating does not appear to be adequate. Recommend further evaluation and repair or replace as needed.
Service recommended.

Recommend evaluation by a qualified licensed contractor and repair or replace as needed.
