This report is prepared exclusively for **Richard Moody**  
Inspected On: **05-06-2025**

107 Technologies

Older raised home that is well maintained on the inside but very poorly kept on the exterior. Lot of items will need attention for general repairs and safety.

Jason Koonce, Louisiana State License  
#LHI #11404

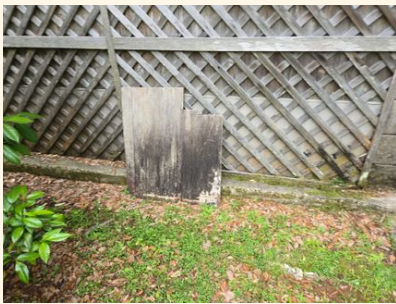
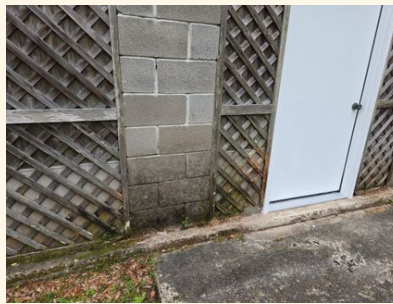
**(G-4) Repair:** Conditions conducive to wood destroying organisms were noted around the site. The organic way to reduce risks from wood destroying organisms is to eliminate conducive conditions around the property.

- Remove old rotted wood retaining wall material
- Eliminate siding to soils contact
- Eliminate wood to soils contact

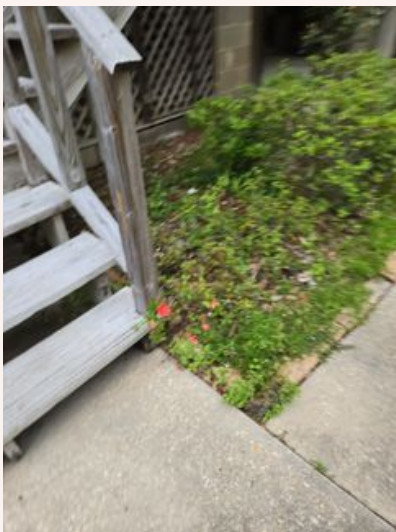
**(G-2) Recommended Maintenance:** Prune tree limbs and vegetation away from the building. This will help to protect the building from wood destroying organisms and other pests and rodents.

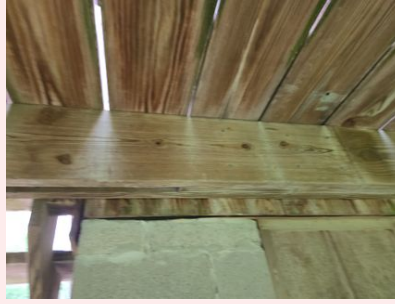
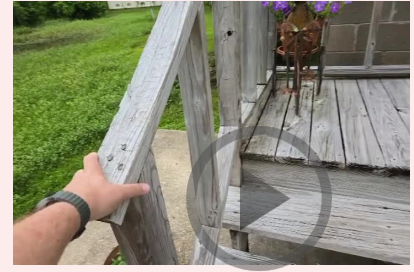
*(This video is only viewable online.)  
Railing is very loose and poses a safety risk.*

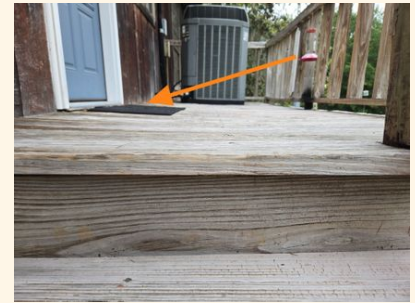
The porch has been installed in contact with the building's siding. This can lead to wood decay and moisture control problems. Repair as needed to eliminate contact and repair any water damage if necessary.

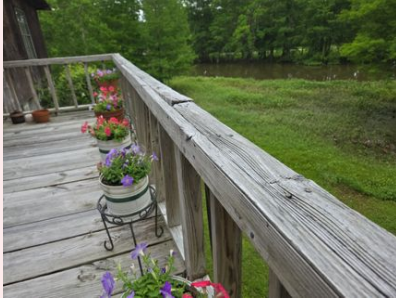
**⚠️ (G-7) Major Concern:** The patio is in poor condition. Repair or update the patio in the near term.

*Weather worn and warped materials which are starting to pull the nails loose and extending The cracking around the nails making them less effective*

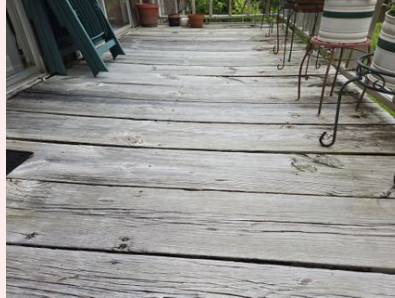
*Uneven cupping and where on the various boards*

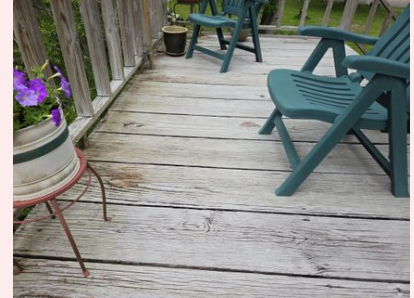
*Excessively weather worn and cracks beginning to show in the middle of the boards*

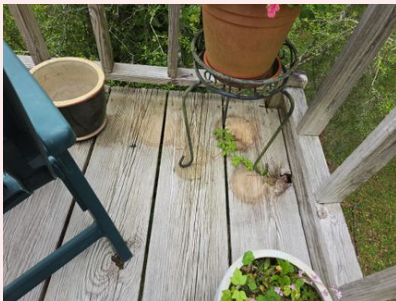
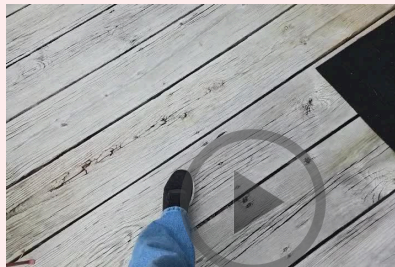
*Some boards are loose particularly in the middle where they have already pulled the nails free from the joist underneath*

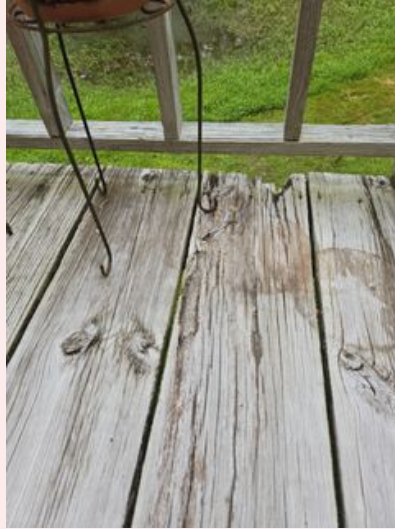
*Wood rot and excessive material loss at end of board near joist*

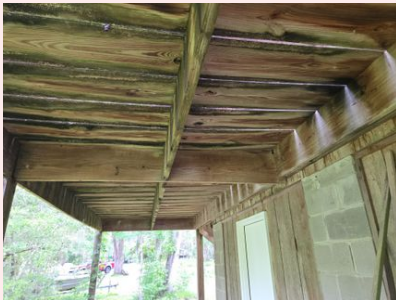
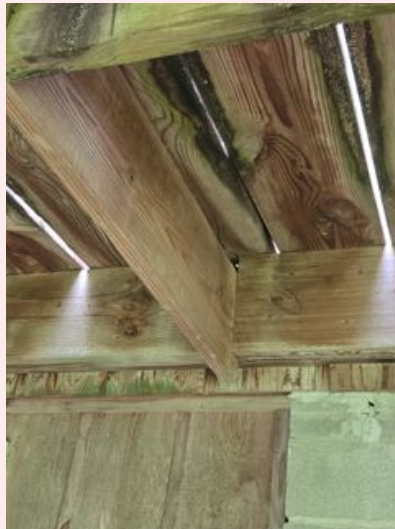
**⚠ (G-9) Major Concern:** Back patio structural support is minimal and failing. The one center joist is separated from the remainder of the framing, which is part of the loose board from the top of the deck. Additionally, the deck was attached via nails, not lag bolts. No clips/ties noted. A common, but not recommended practice.

Recommend replacing the deck by a qualified contractor for safety.

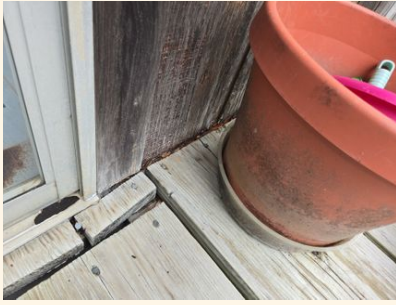
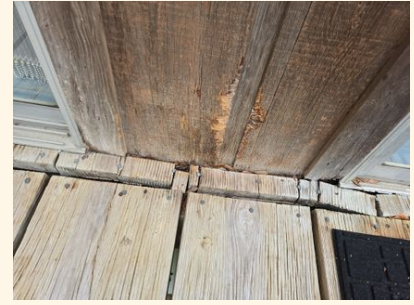
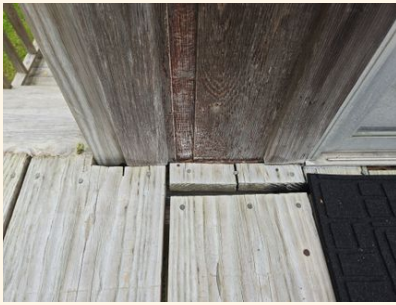
🔧 **(G-8) Repair:** The patio has been installed in contact with the siding. This can lead to wood decay and moisture control problems. Repair as needed to eliminate contact and repair any water damage if necessary.

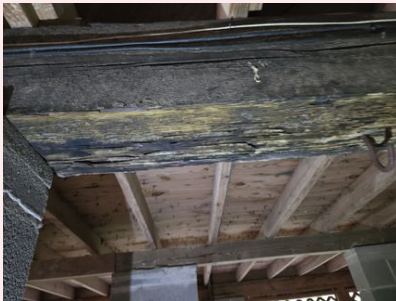
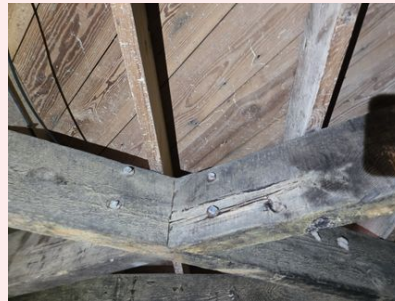
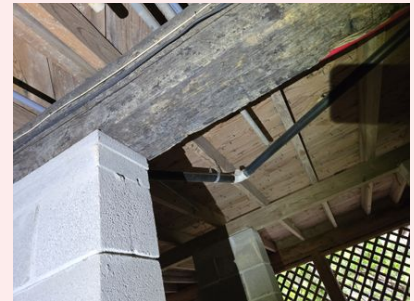
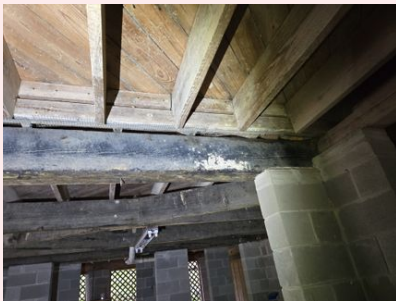
**⚠ (E-2) Major Concern:** Creosote-treated foundation beams pose potential health and environmental concerns due to the toxic nature of creosote. While creosote has been used to preserve wood for its durability, it's now recognized as a potential carcinogen and is restricted for use. Additionally, the beams are showing signs of their long term use as a foundation and beginning to show cracks along the length of the beams, particularly in/near bolt locations. Recommend further evaluation by a structural engineer and repair or replace as necessary.

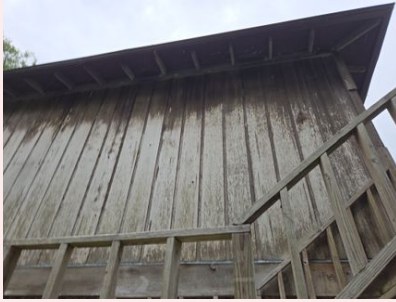
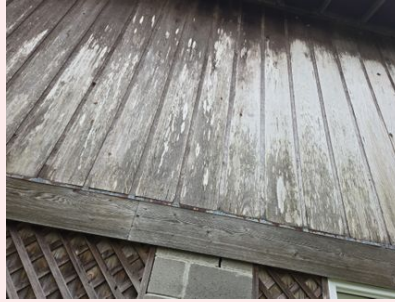
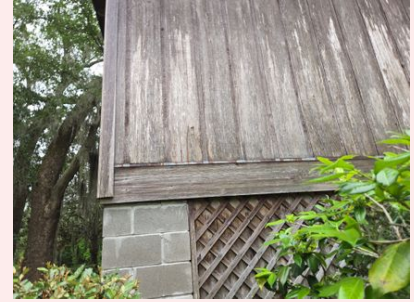
**⚠ (E-3) Major Concern:** Extensive repairs are needed to the wood siding system on this building. Hire a qualified contractor to further evaluate and repair the siding system as needed to ensure reliable performance. Examples of specific observations noted during inspection include:

- Localized wood decay was noted in the siding
- Localized wood decay was noted in the trim
- 🛠 - Please note that the siding may require a complete replacement
- 🛠 - Please note that conditions noted today could risk concealed damage

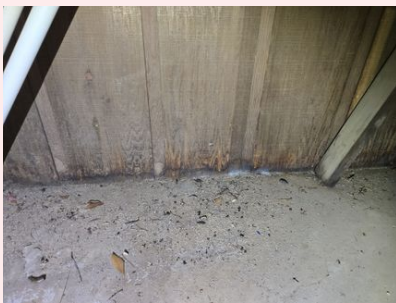
**⚠️ (G1-1) Major Concern:** Wood to concrete/ground contact. This is conducive to both wood rot and wood destroying insects. Recommend a qualified contractor repair or replace as necessary.

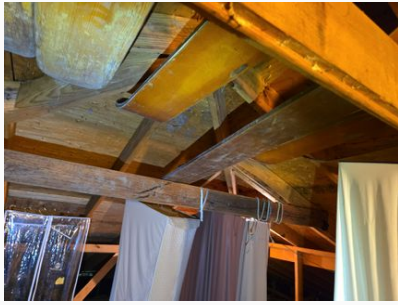
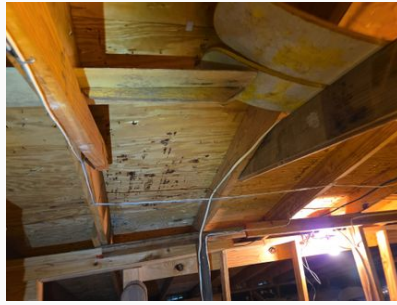
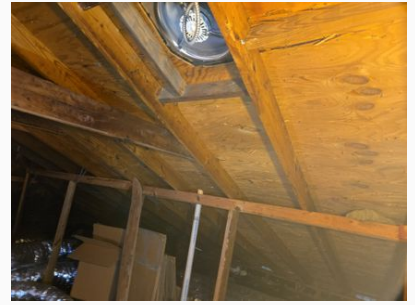
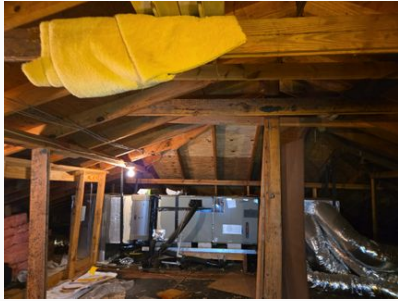
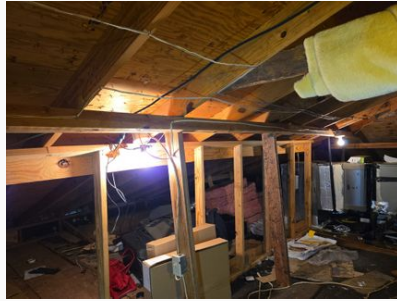
**Roof Structure:**  Rafters  Wood  Collar ties  Repairs needed

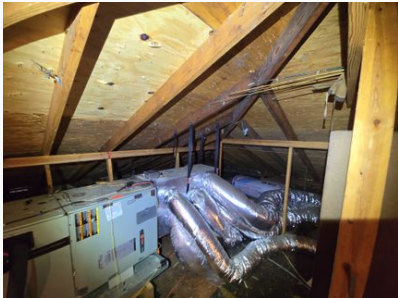
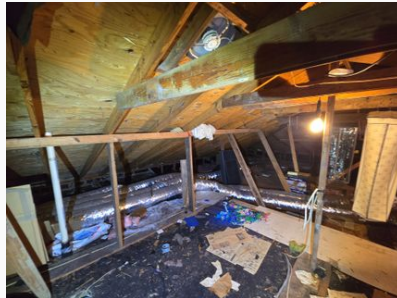
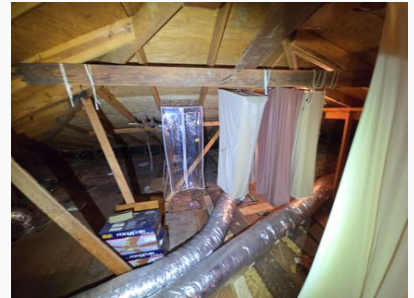
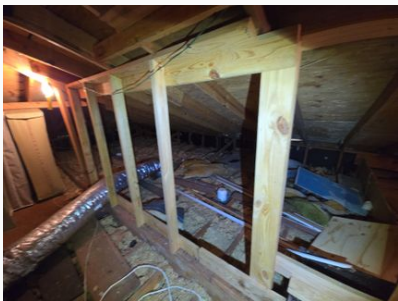
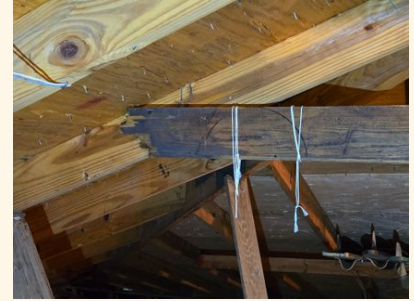
Repairs are needed to the roof structure. Observations noted during inspection include:  
Collar tie is rotted/broken where it meets rafter. This poses a structural integrity concern over time especially recommend repair or replace as necessary.

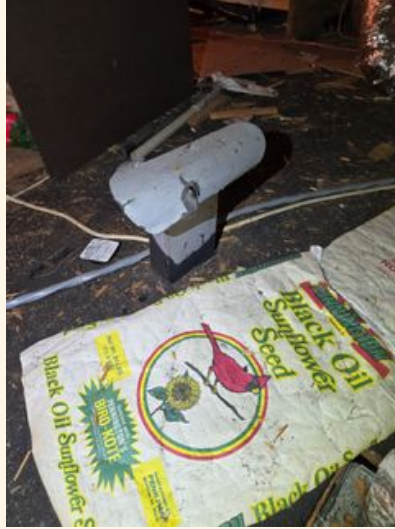
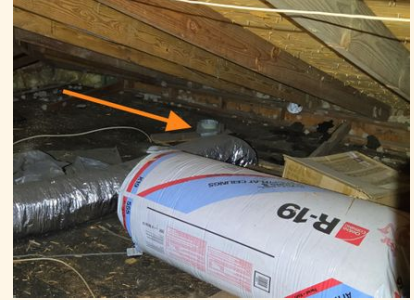
✂️ **(A-6) Repair:** Kitchen/bath fan exhaust vents in the attic are not correctly vented to the exterior. Repair is needed for moisture control.

*Unknown vent purpose.  
The floor in this area appears to  
be old roof structure. This is  
likely an old vent that is no  
longer in use. Unable to  
determine at time of inspection.*

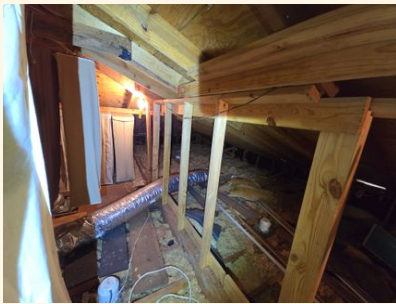
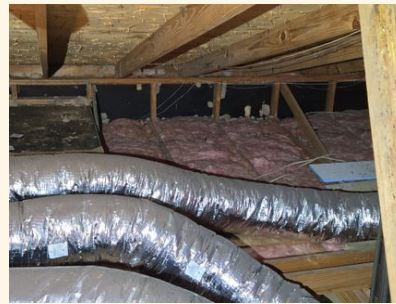
✂️ **(A-7) Repair:** The HVAC ductwork in the attic is laying on the floor. It is recommended to be hung for moisture control and efficiency.

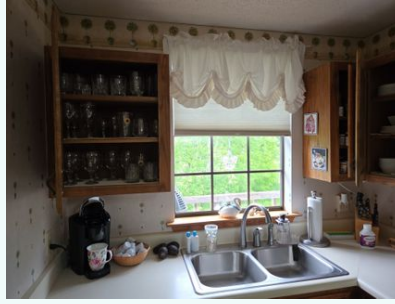
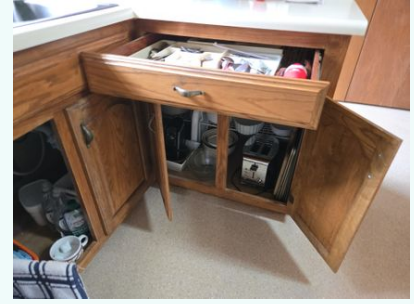
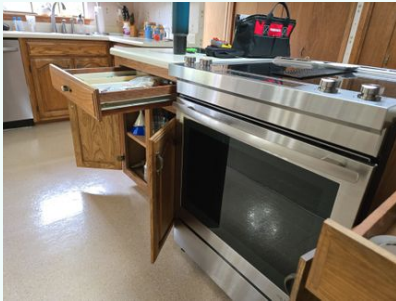
📷 (K-6) Monitor: Sink Cabinet: 📷

*Previous moisture damage noted. This can lead to microbial growth underneath however does not appear to be an active leak. Recommend monitor and repair or replace as necessary by qualified contractor.*

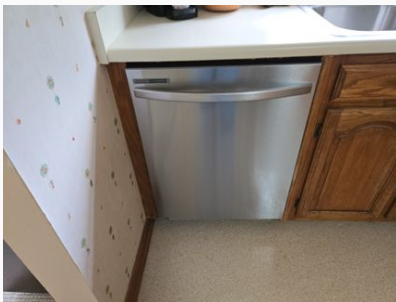
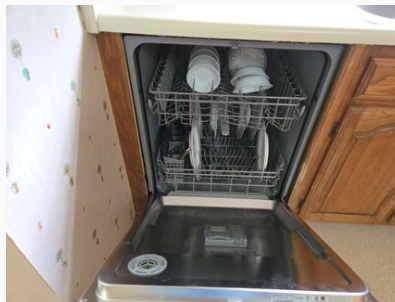
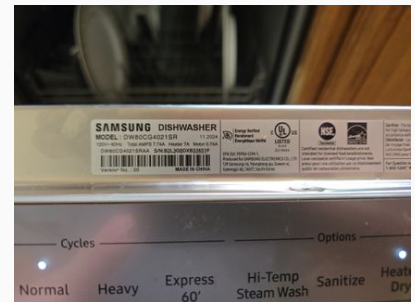
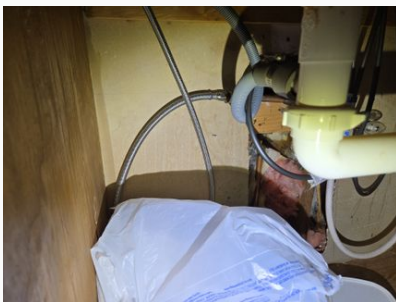
📌 **Inspection Notes:** No [air gap](#) noted for the dishwasher waste line but they did run a high loop. This is not done to WA state standards, but is generally satisfactory and many jurisdictions in the state allow for simply a "high loop" installation.

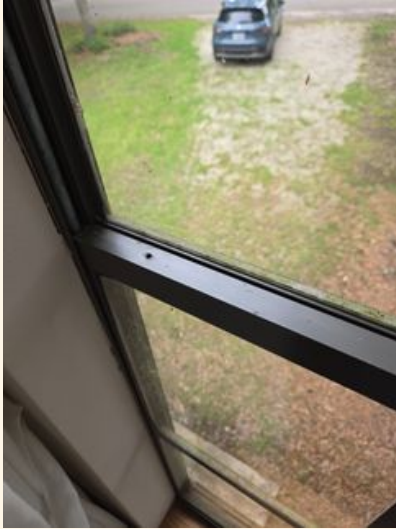
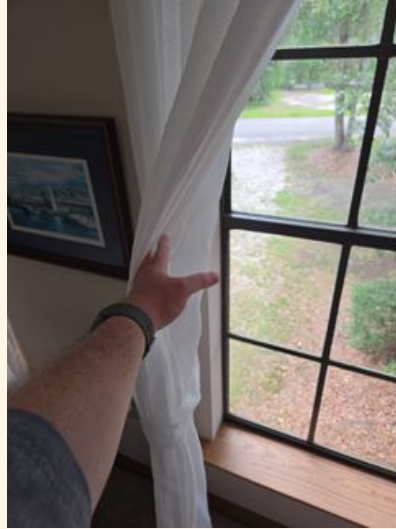
✂️ **(CR-1) Repair:** Repairs are needed to the window(s).

- Broken/missing hardware

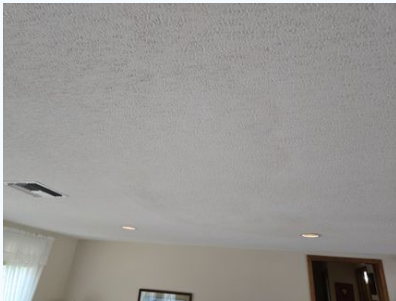
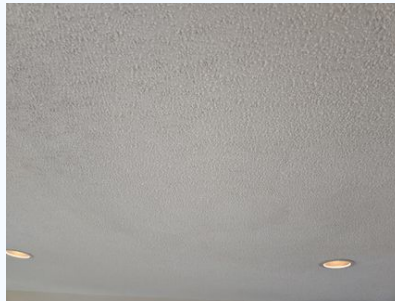
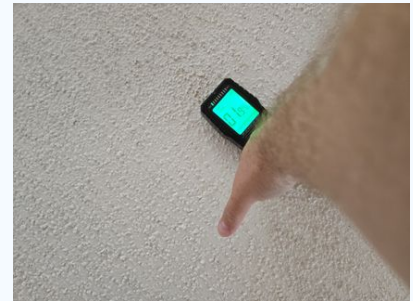
🔍 **(CR-2) Due Diligence:** Water stains were noted on wall/ceiling material. These tested dry at the time of inspection. This indicates a prior moisture control problem which is difficult to verify or fully understand in the context of a one-time inspection. These can be from seasonal leaks or leaks that occur as a result of occupant behavior in the building. Inquire with the seller for additional information and repair stains/damage as needed. Monitor as additional repairs could be needed to address the underlying moisture control problem that may not be disclosed or evident at the time of the home inspection.

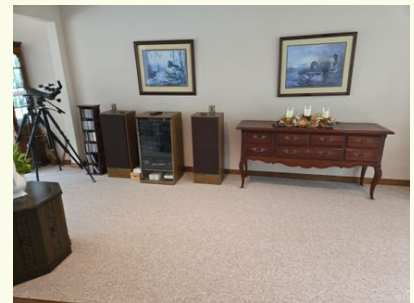
**Electrical Receptacles (Outlets):**  Not accessible (not tested)  Repairs needed

**Limitations:** Occupants personal belongings blocking the pack to most outlets or they are filled up unable to test represent the majority.

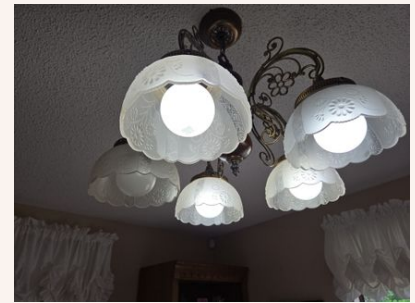
**🔧 (CR-5) Recommended Maintenance:**

One light bulb not working at time of inspection. Recommend replacing bulb and verifying operation prior to end of inspection period.

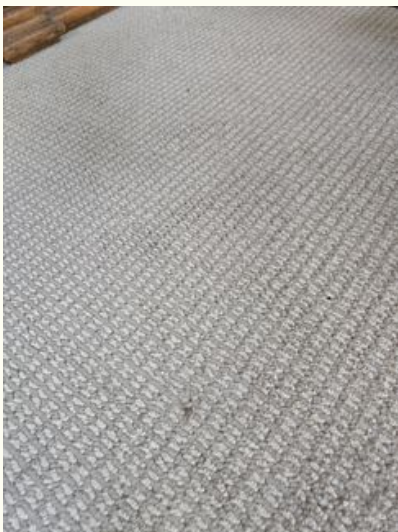
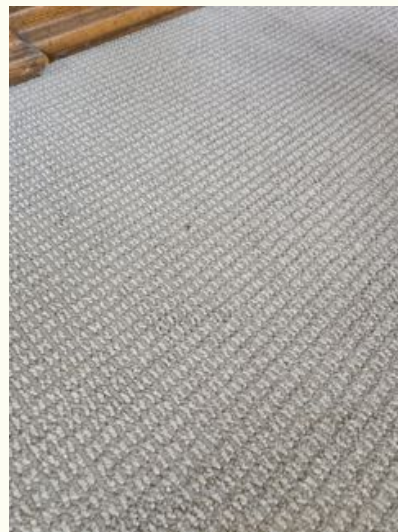
**📍 Inspection Notes:** Minor stains and holes in carpet

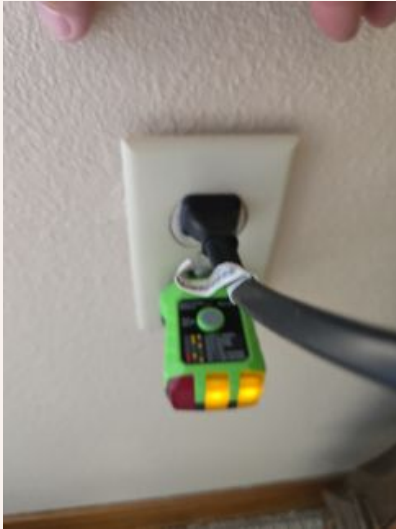
**(CR-7) Recommended Maintenance:** Repairs are needed to the electric receptacles.

- Loose receptacle(s)

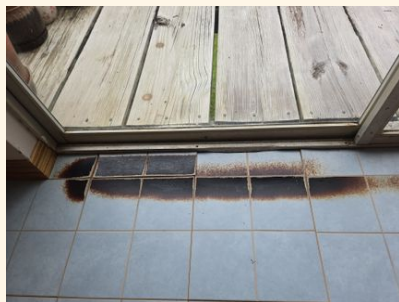
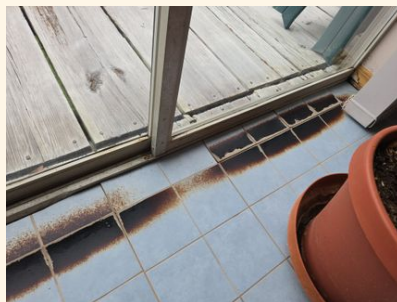
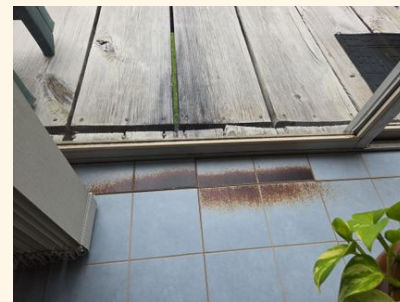
**(CR-9) Repair:** Repairs are needed to the floor transition to the sliding glass doors this part is linoleum that has appeared to be burnt and crumbling in spots.

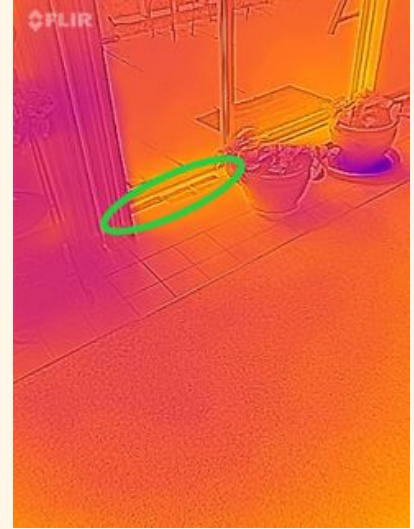
*Thermal imaging of sliding glass door transitions.*

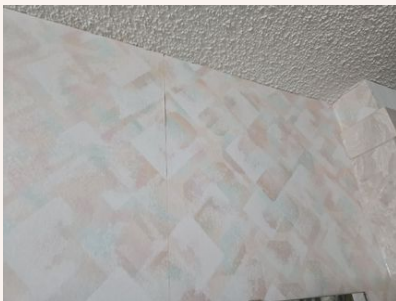
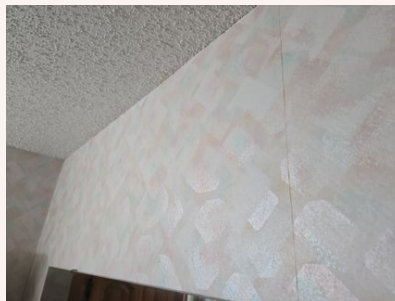
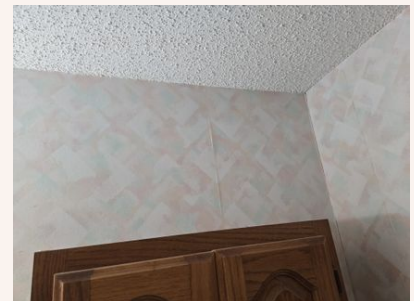
**(B-2) Recommended Maintenance:** High humidity area has the wallpaper beginning to peel at the seams. Recommend repair or replace as necessary by qualified professional.

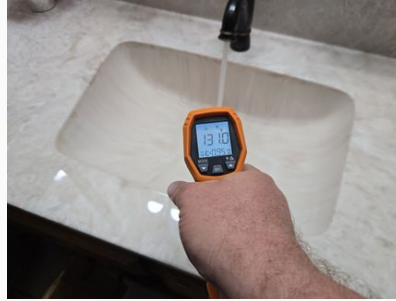
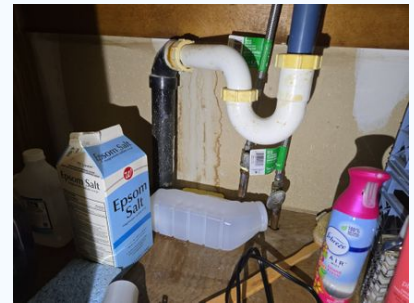
#### 🔍 (B-4) Due Diligence:

Previous water damage noted in sync cabinet. Currently testing dry with a moisture meter.  
Recommend inquiring of seller or previous leaks and repairs that were conducted.

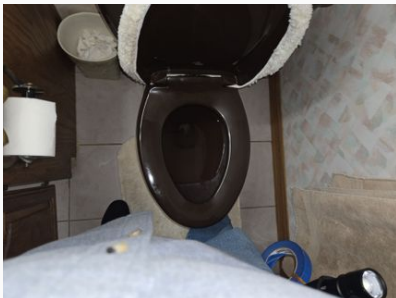
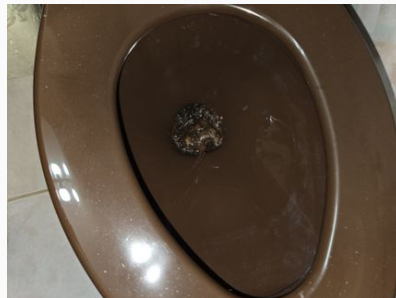
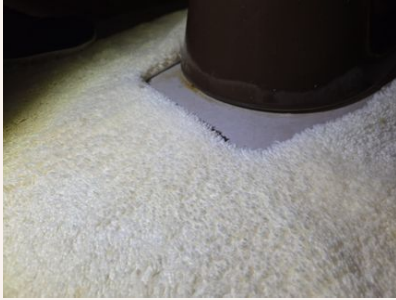
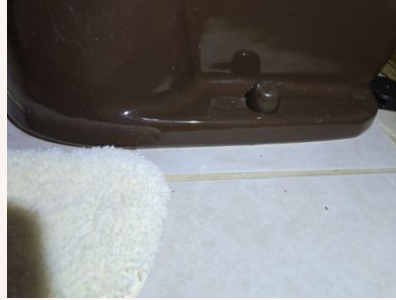
**Caulking Needed:**  Around the toilet

**🔧 (B-5) Recommended Maintenance:** Caulking is needed around the toilet to secure the toilet and for moisture control.

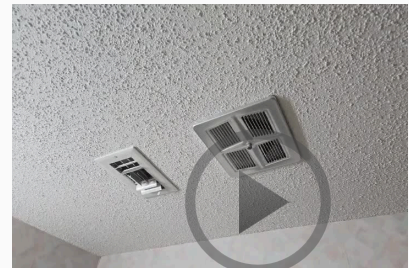
*Bathroom Ventilation:* 📷/👤  
*Fan and heater both appear to be operating correctly.*

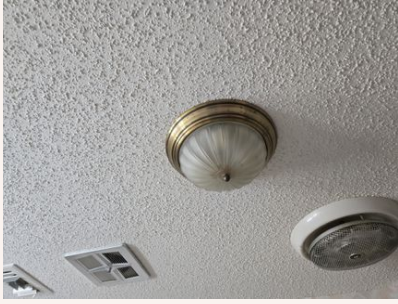
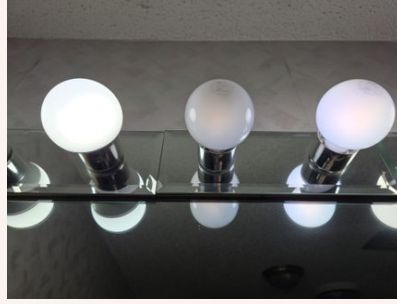
**🔧 (B-10) Recommended Maintenance:** Overhead light does not appear to be operative light bulb could be burnt out recommend replacing light bulb and verifying function prior to end of inspection.

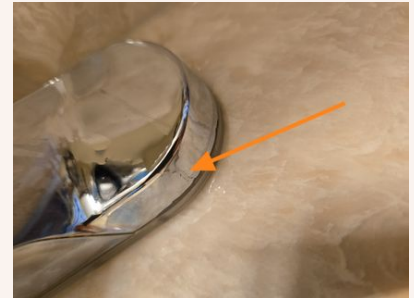
The sink faucet is leaking and requires repair.

*Minor leak noted. Recommend  
maintenance to stop leak.*

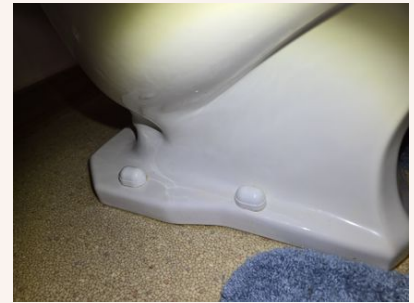
Caulking is needed around the toilet to secure the toilet and for moisture control.

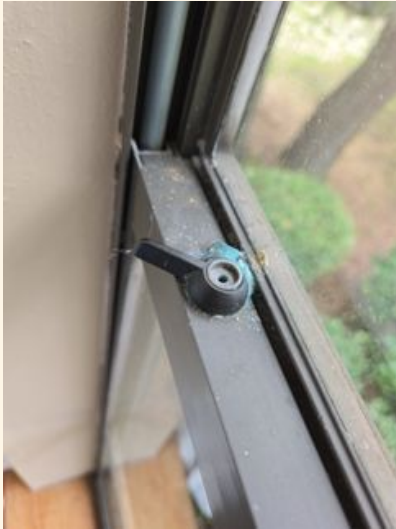
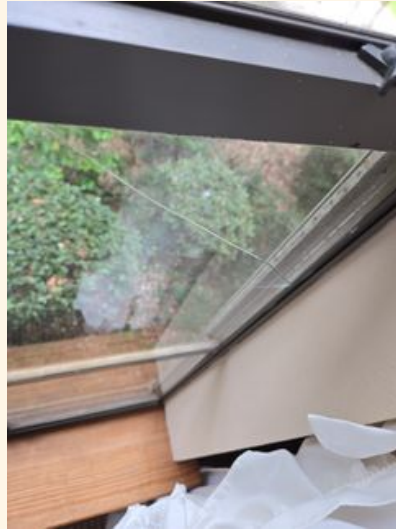
- 🔧 **(B1-3) Repair:** Repairs are needed to the window(s).  
Corroded door latch prevented one window from being opened
- Cracked glass

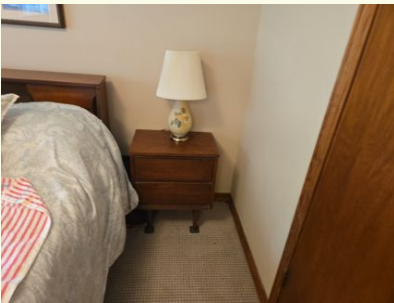
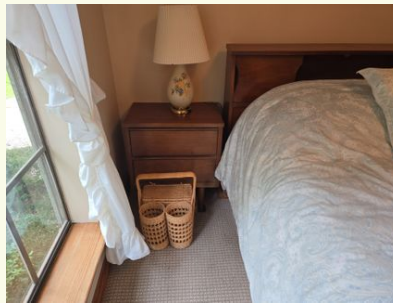
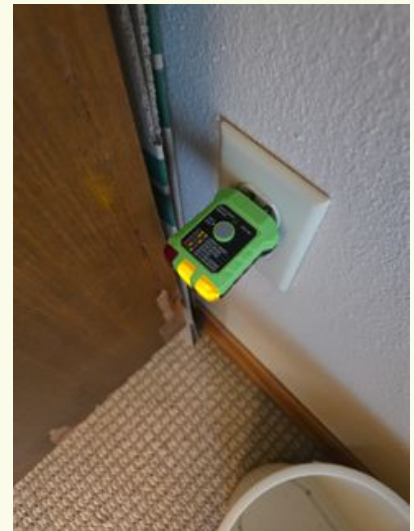
Repairs are needed to the electric receptacles.

- Loose receptacle(s)

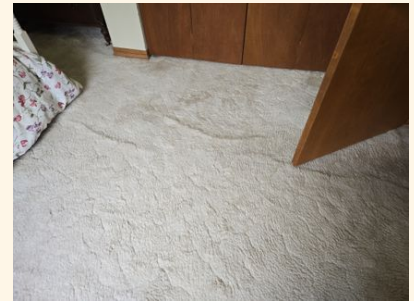
Repairs are needed to the floors.

Loose carpet makes for a trip pattern recommend repair places necessary

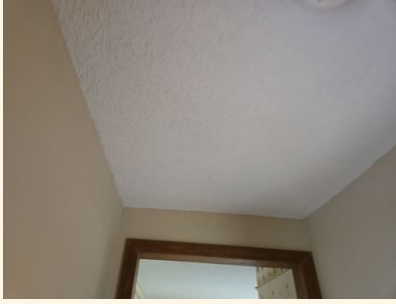
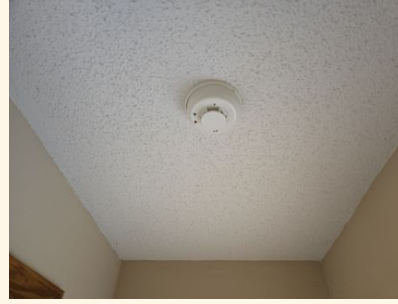
**(B2-6) Repair:** No carbon monoxide alarm was found outside of the sleeping bedroom. A CO alarm is recommended outside all sleeping areas for safety.

*It's supposed to be a smoke alarm not a CO2 and is located between bedrooms two and three*

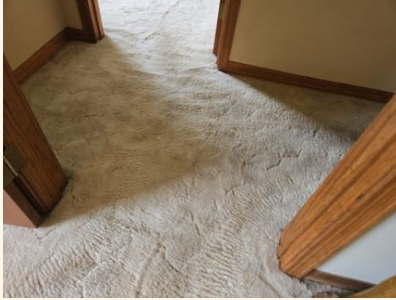
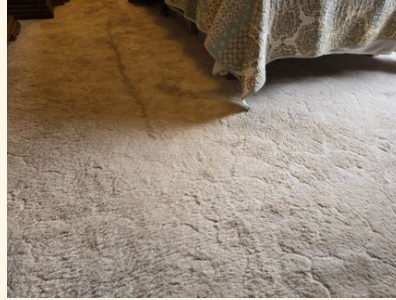
**(B3-2) Repair:** Repairs are needed to the floors.  
Loose carpet in hallway up to and including the bedroom floor

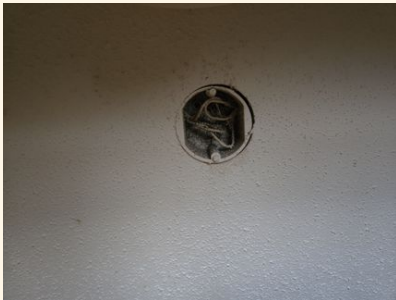
**(B3-3) Repair:** Closet light receptacle is missing and temporary is also non-operational  
recommend repair replace it as necessary by qualified contractor

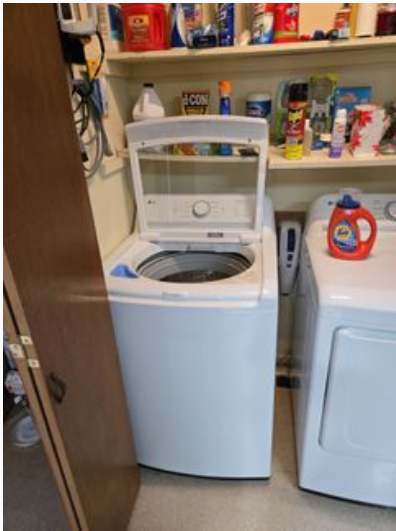
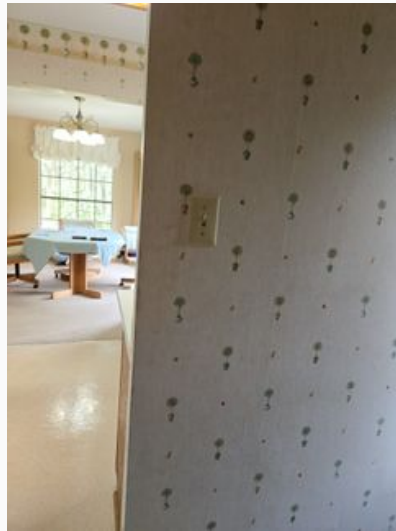
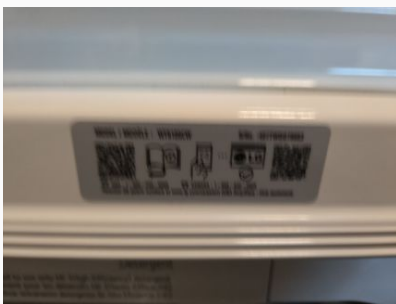
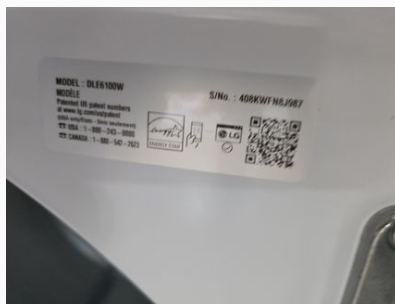
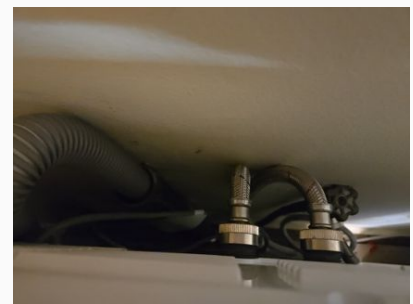
Repairs are needed to the electric receptacles.

3 prong receptacle noted for the dryer. For safety purposes recommend a 4 prong receptacle. A four-prong receptacles considered modern standards for grounding and fire hazard safety. Recommend replace on a qualified contractor as soon as practical.

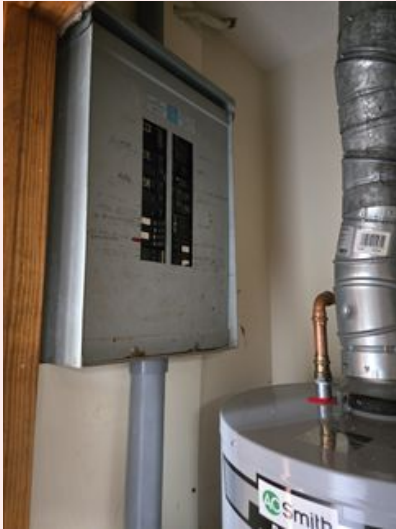
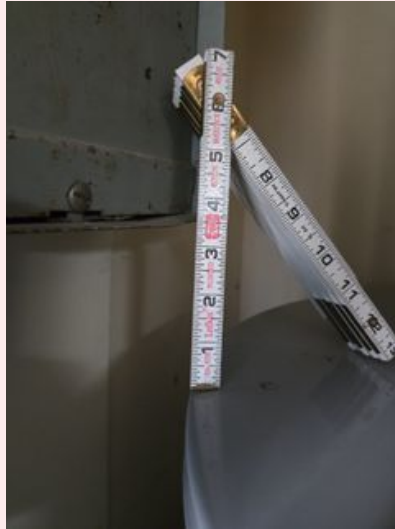
**⚠ (ESE-1) Major Concern:** The electric panel was located in The same closet as the water heater not providing adequate clearance. Recommend further evaluation by qualify the electrician and repair, replace or relocate as necessary.

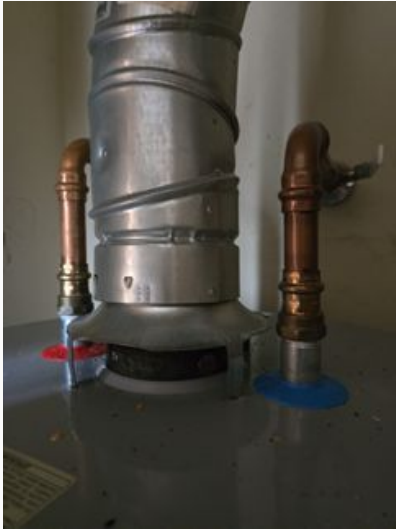
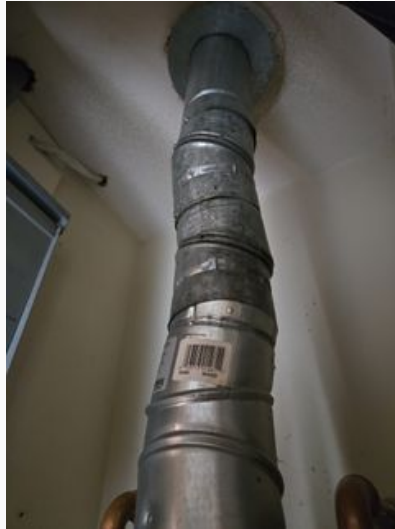
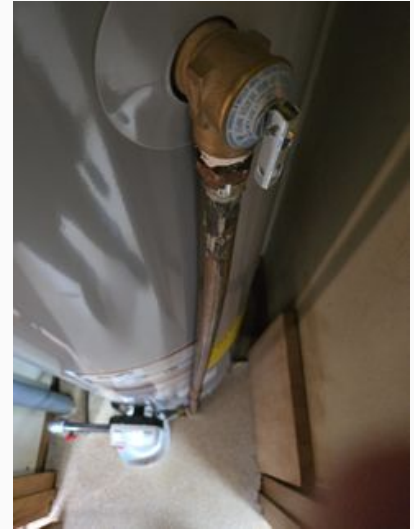
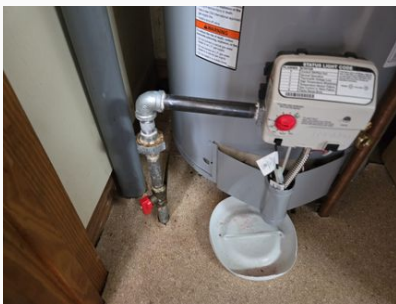
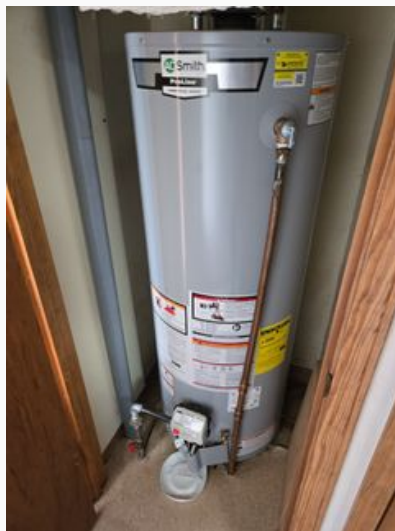
**Drain Pan:**  None noted - recommended

The water heater is located where a leak could damage interior finishes. Installation of a drain pan with a drain pipe to an exterior or unfinished location is recommended for improved moisture control.

- One option if a pan is not feasible is a moisture alarm system.

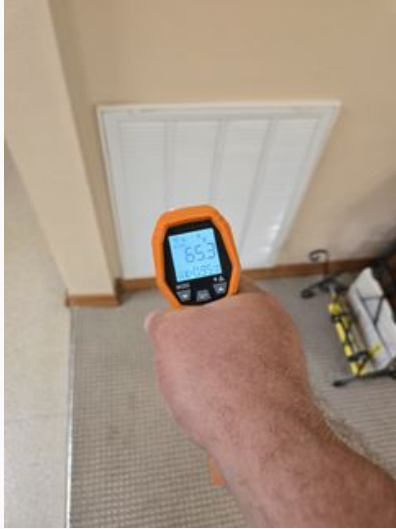
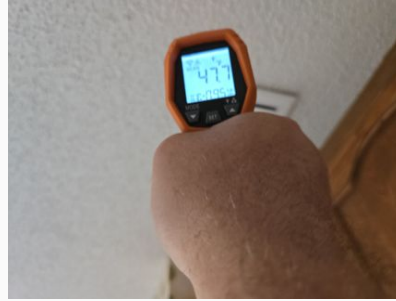
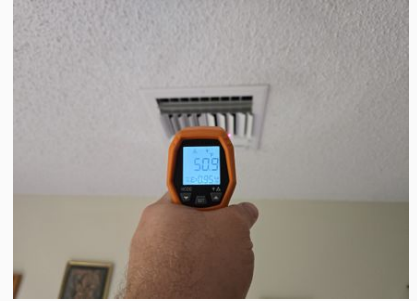
**Distribution System Condition:**  Tested and operating 📷

*Thermal images show the heating distribution system operating at the time of inspection.*

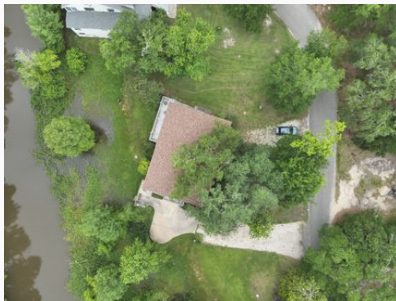
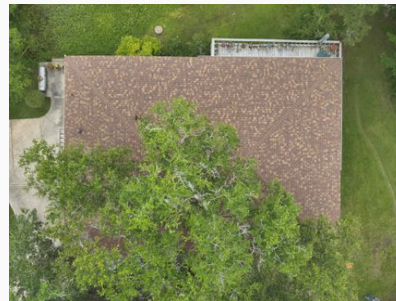
*A drone was used to inspect the roof. This ensures the safety of the inspector and prevents the inspector from damaging the roof when walking on it.*

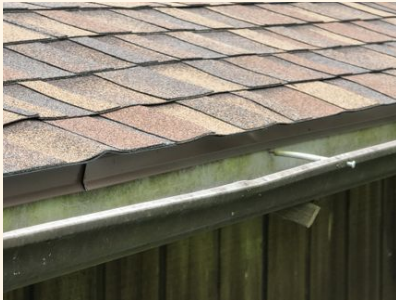
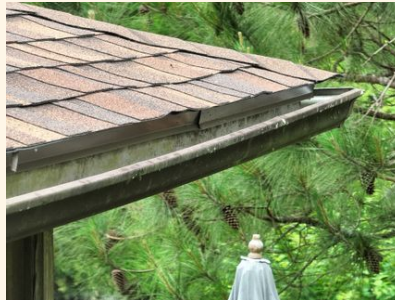
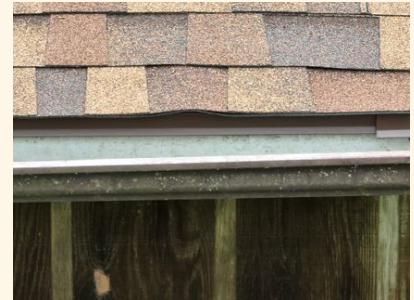
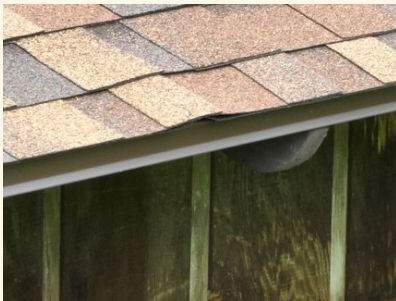
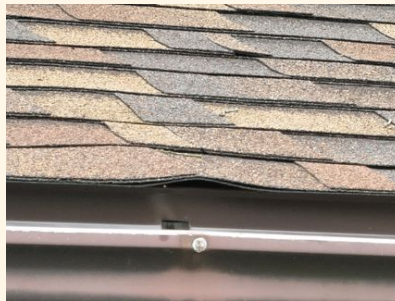
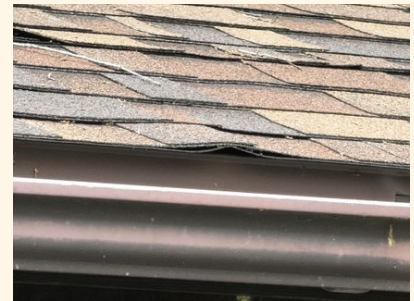
**(RCH-2) Repair:** The eaves had unusual lift for this style of roof system (Fortified roof, certificated 1/7/2025).

Examples of observations noted during inspection:

Recommend seller follow-up with roofing contractor for remediation of concerns to ensure the Fortified certificate remains valid with IBHS.

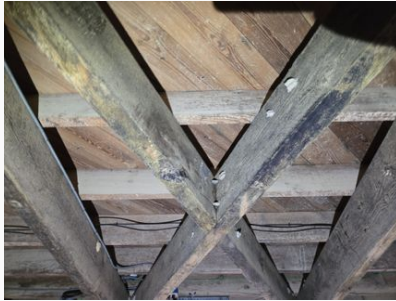
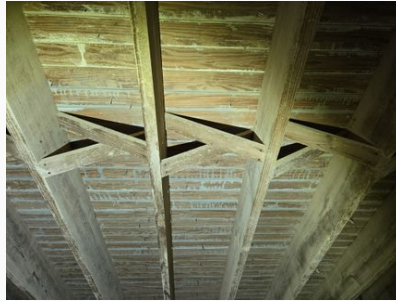
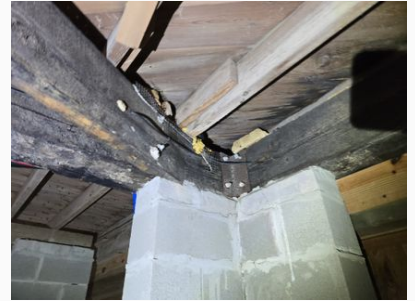
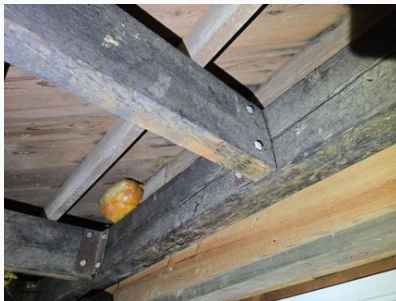
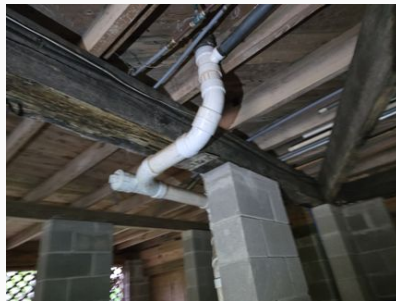
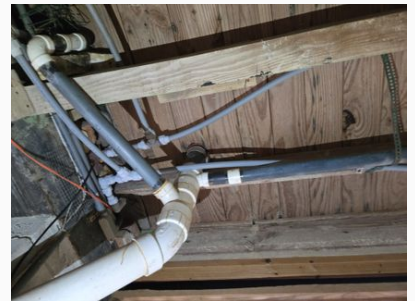
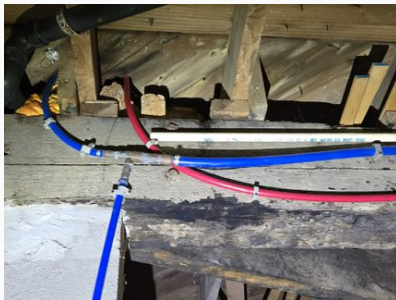
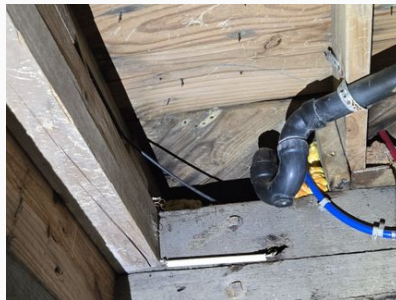
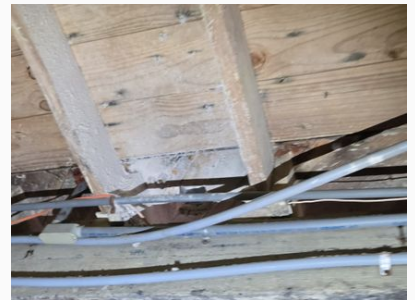
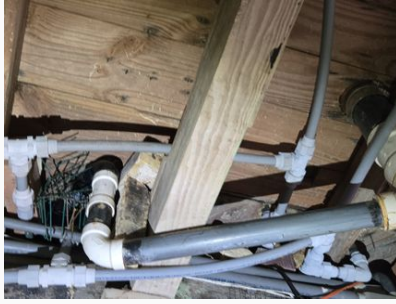
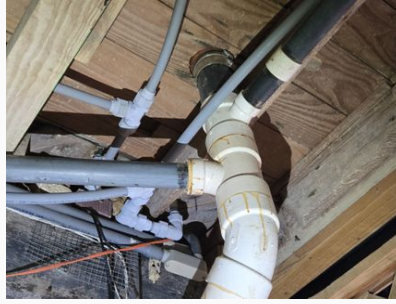
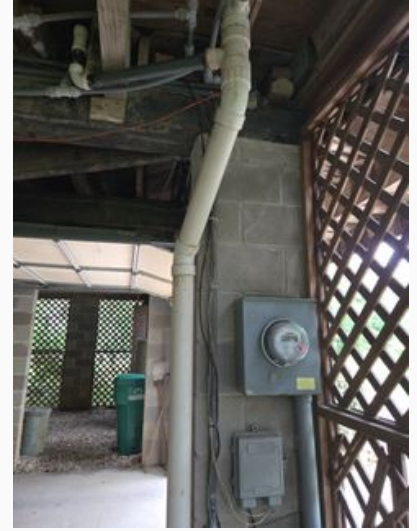
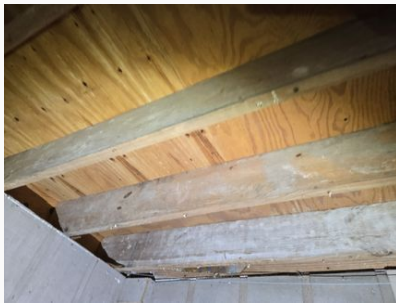
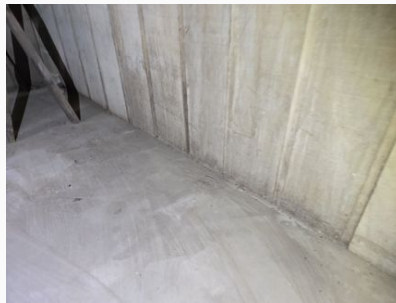
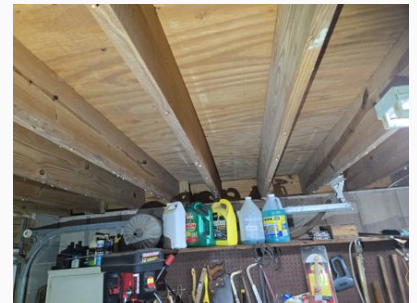
*This includes general representative photos of the crawl space.*

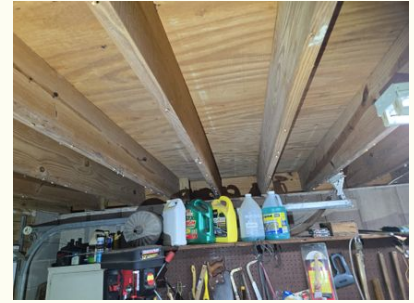
Right elevation appears to be an addition from the original home. Recommend 2X12's for floor joists to ensure they hold up over time.
