## Structural Inspection

March 3, 2026

Kirk Hartsell  
1224 Maris Stella St.  
Slidell, La. 70460

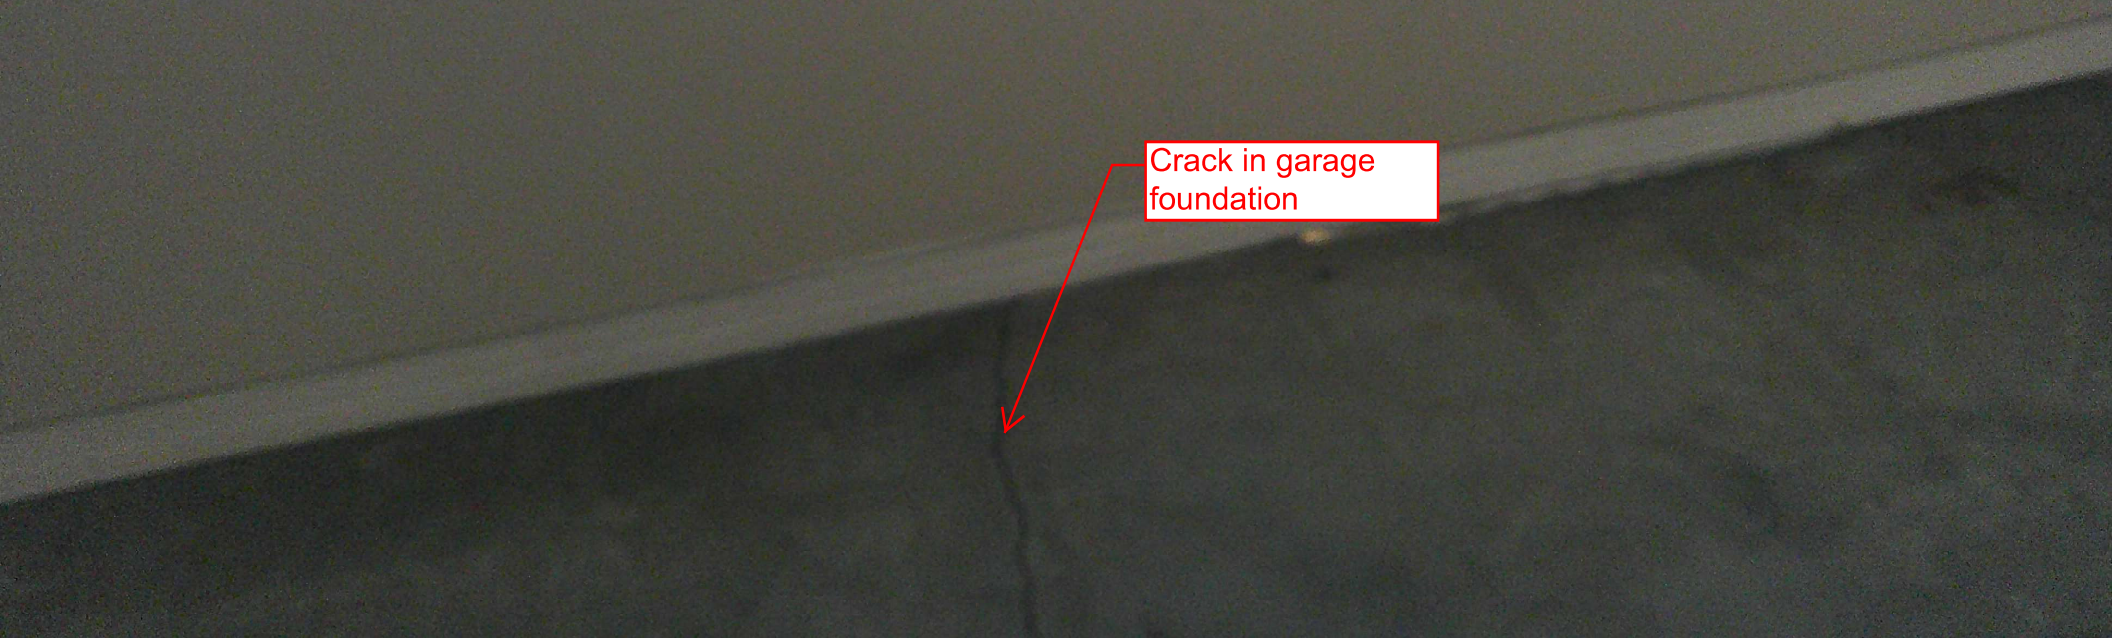
A visual inspection of the interior of the home was conducted. The garage floor has several cracks in the foundation and from the middle of the garage to the exterior window there is a 3/4" fall. No cracks in the sheet rock walls and ceilings were noted inside the home only in the garage.

Crack in garage  
foundation
