Structural Inspection

May 21, 2025

RE:
105 W Pear Dr.
Slidell, La. 70461

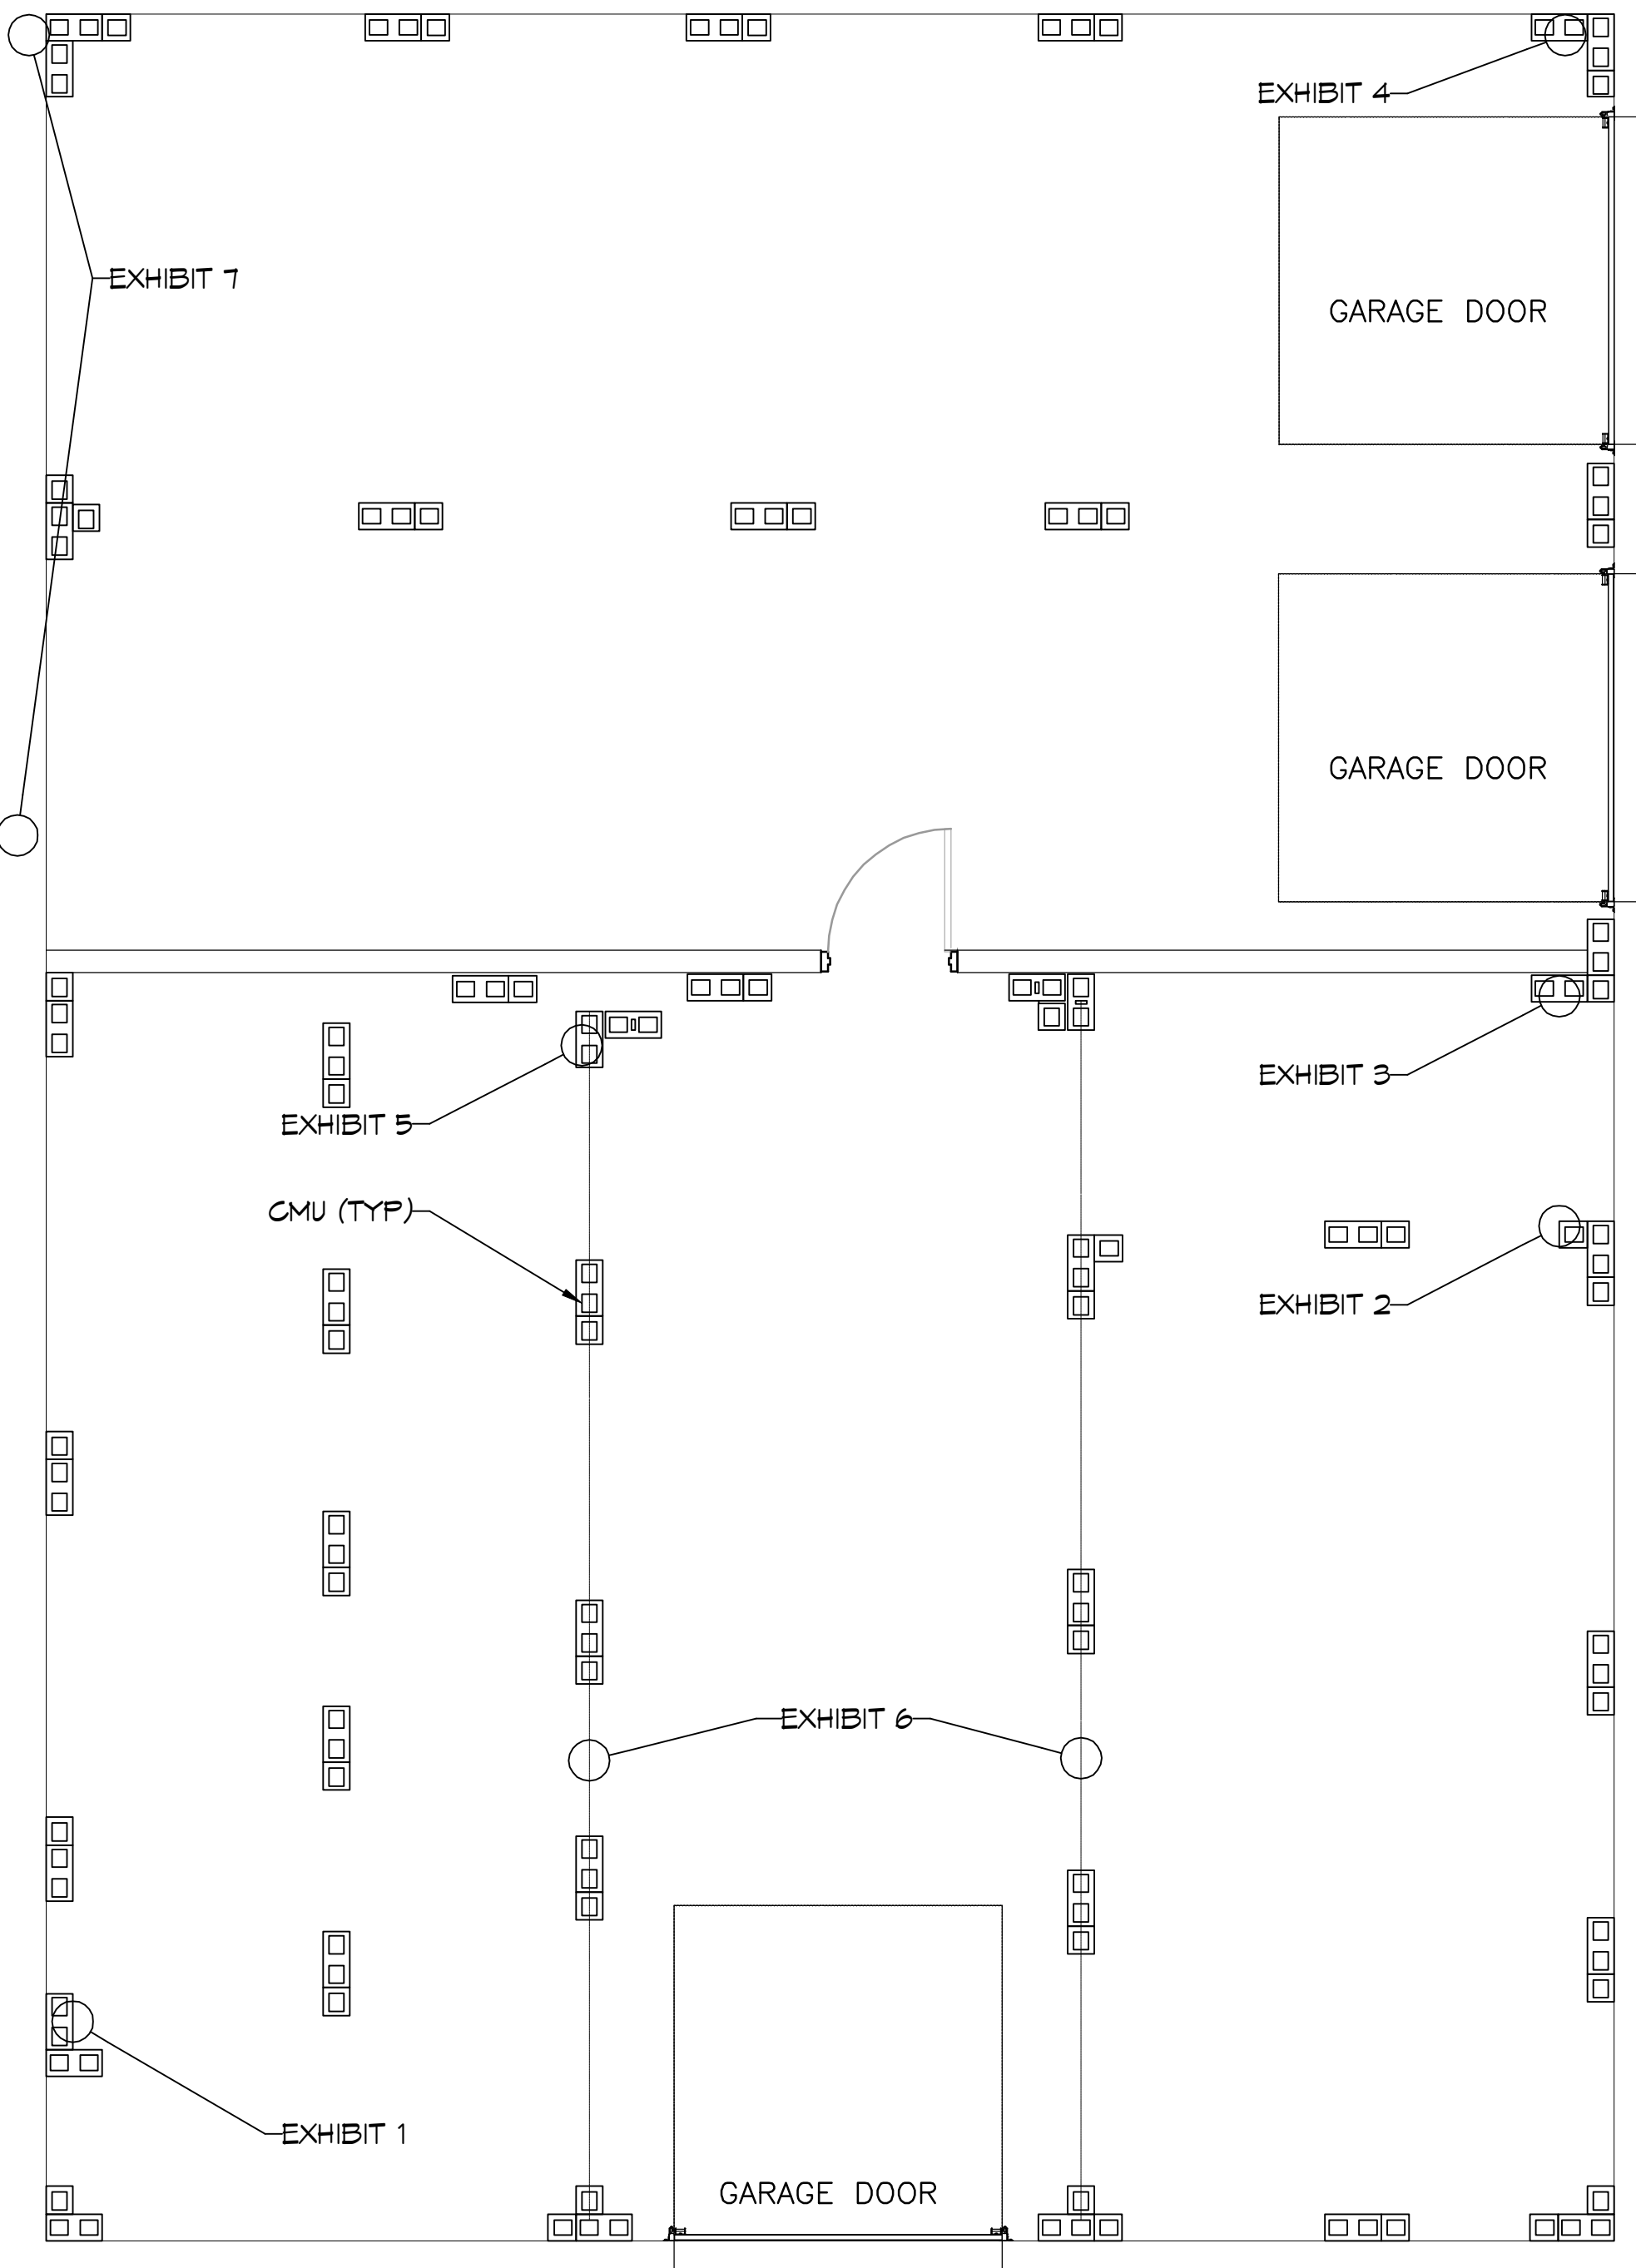
EXHIBIT 4

Exhibits 1 – 4 shows different levels of stress cracks in the CMU, see attached exhibits and recommendations to repair them.

GARAGE DOOR

Replace all CMU's this column that have developed cracks

Remove and replace all CMU's that have developed cracks. Repoint/tuck point all mortar using a non-shrink precision grout.
