Shingle to Slab Home Inspections, LLC  
(504) 723-5655  
shingletoslab.com

## Home Inspection Report

263 Audubon Dr  
Slidell, LA 70458

Prepared For Kimberly Tate, Salem Tate  
Inspected on Wed, May 27, 2026 at 1:00 PM

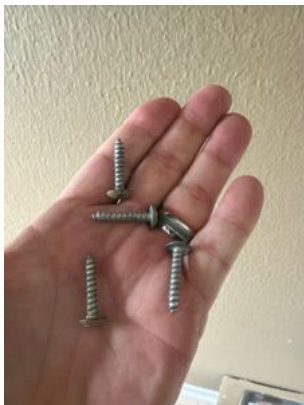
**Safety Concern**

Sharp tipped screws are securing panel. This is a safety concern and they can pierce conductors within panel and electrify the panel. Use only blunt-tipped screws to secure dead front cover to panel.

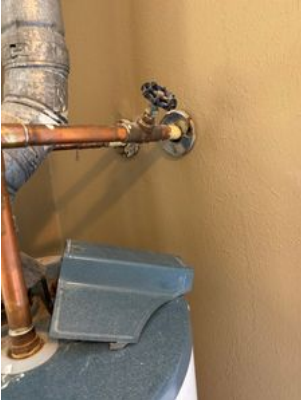
### **Comment 25** **Repair or Replacement Needed**

This water heater has no drip pan. Since it sits at the same level of the living area, any leak can cause damage to surrounding materials and easily enter the home. Recommend adding drip pan and plumb to the exterior.
