SAENGER THEATRE

HISTORIC PRESERVATION CERTIFICATION APPLICATION PART 2

SUBMISSION FOR:
NATIONAL PARK SERVICE

SUBMITTED BY:
EHT TRACERIES, INC.
SEPTEMBER 2009

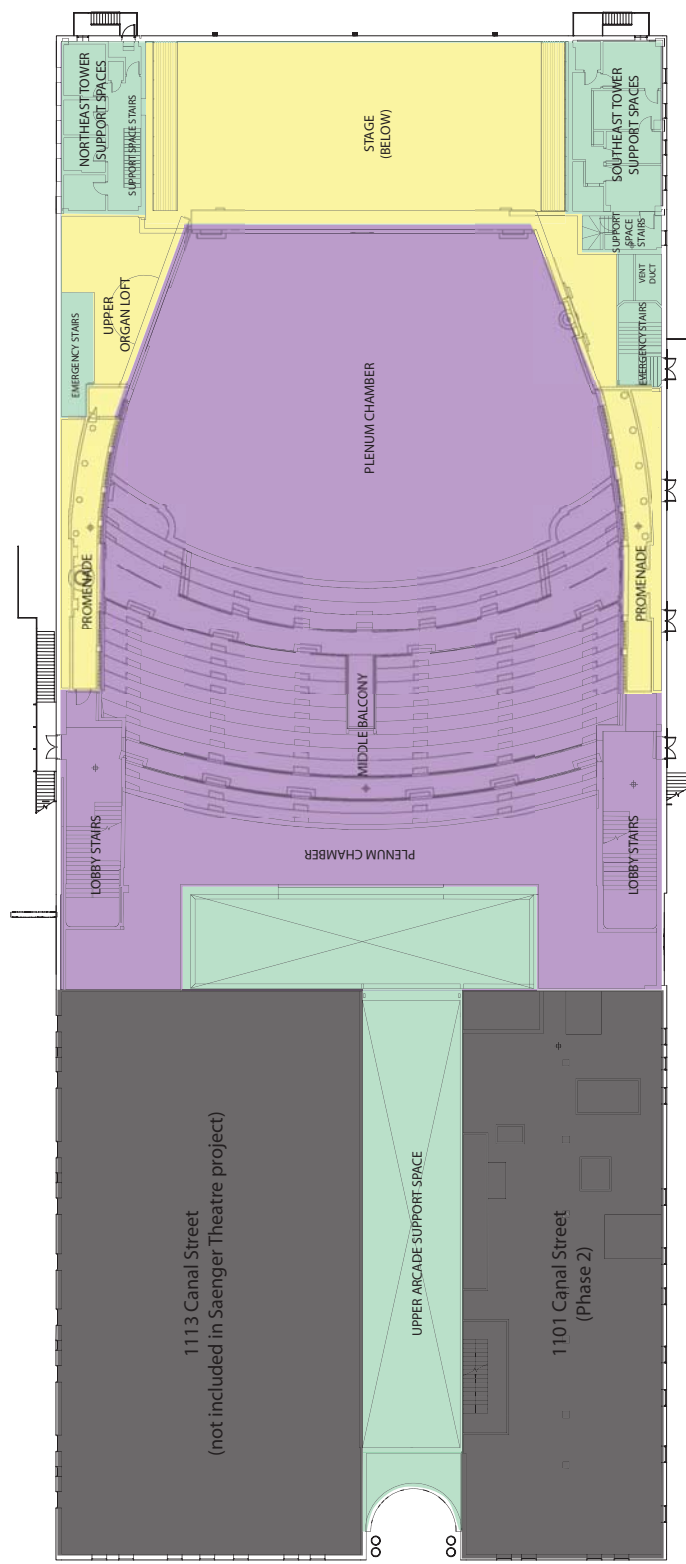
PRESERVATION ZONING
MIDDLE BALCONY LEVEL

- ZONE 1
- ZONE 2
- ZONE 3
- ZONE 4

The following text provides a description of each Zone and its corresponding treatment. Each zone is assigned a color that is used to code individual interior spaces on the existing conditions drawings that are attached to the Part 2 application.

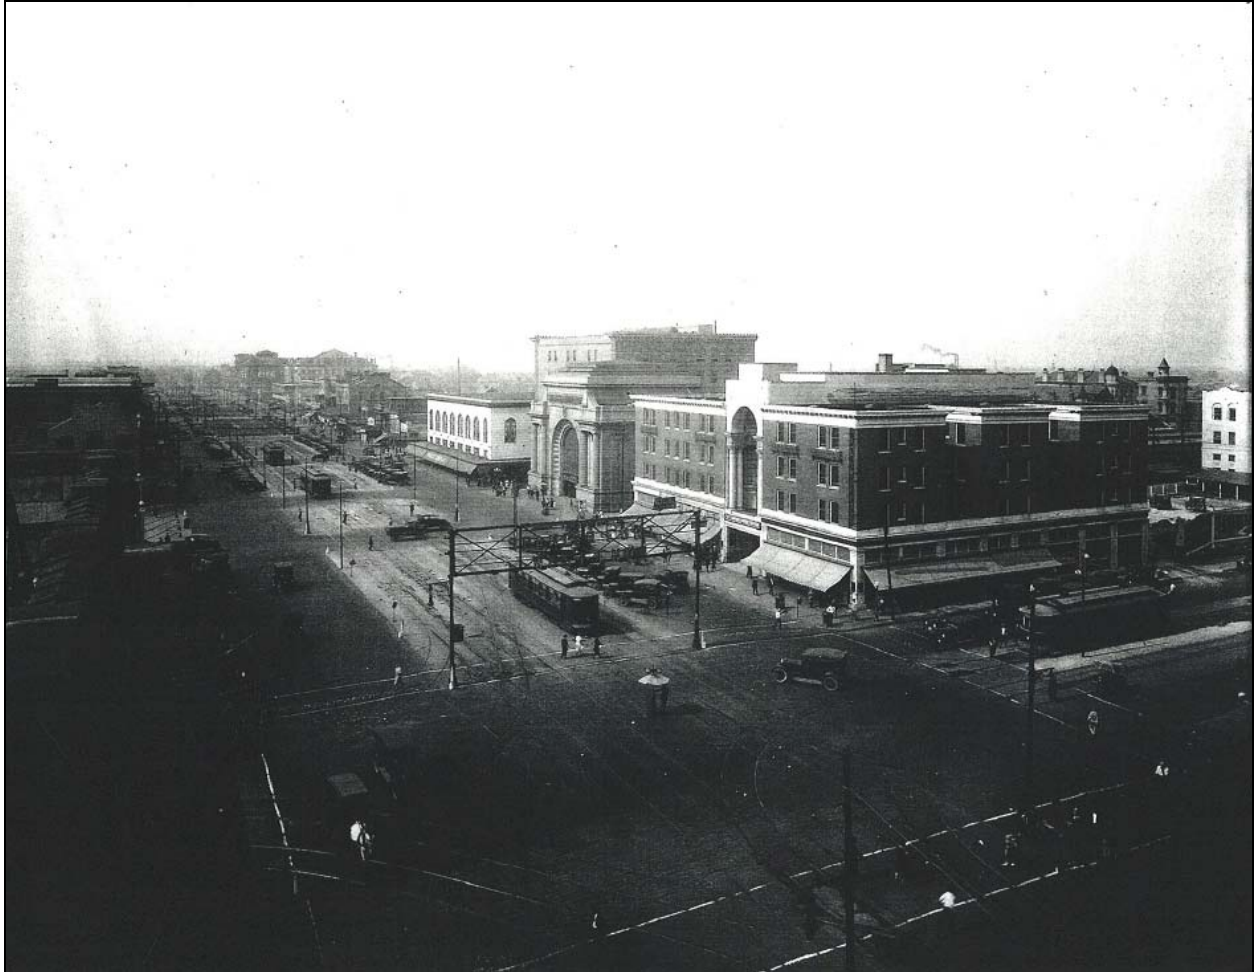
Figure 1: Photograph of front arcade of Saenger Theatre, Canal Street, looking north (c. 1924)
Historic New Orleans Collection (1979.325.5039)

Figure 1: Photograph of front arcade of Saenger Theatre, Canal Street, looking north (c. 1924)
Historic New Orleans Collection (1979.325.5039)

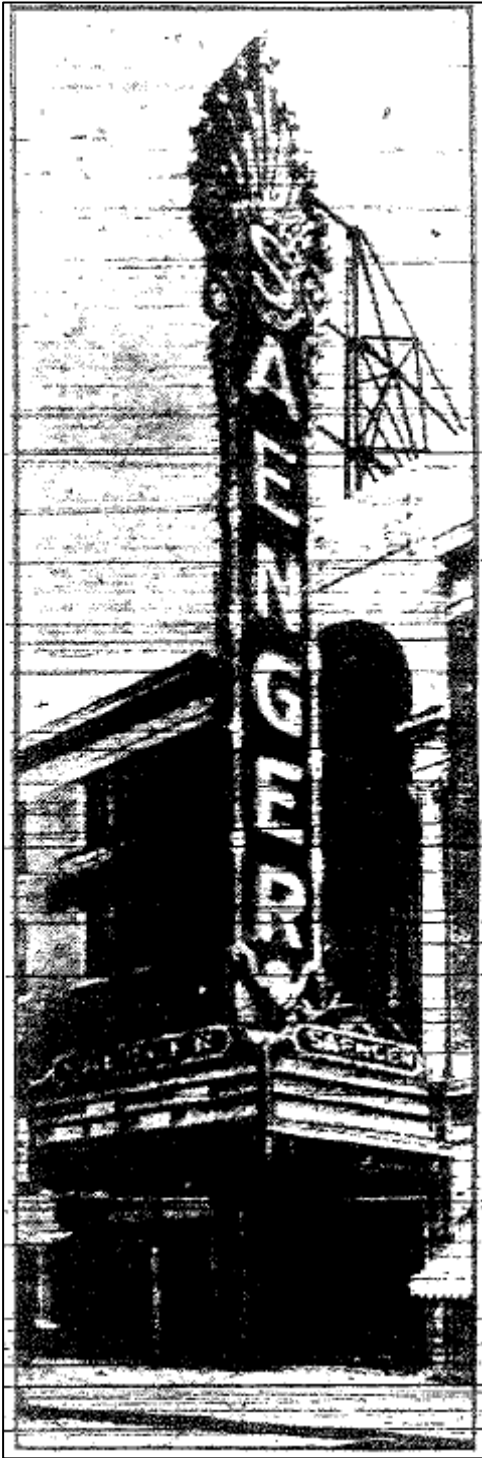
Figure 2: Photograph of Saenger Theatre, Canal Street entrance (ca. February 1927)
Times Picayune
Saturday, February 5, 1927
Section 3, Page 2

Figure 2: Photograph of Saenger Theatre, Canal Street entrance (ca. February 1927)
Times Picayune Saturday, February 5, 1927, Section 3, Page 2

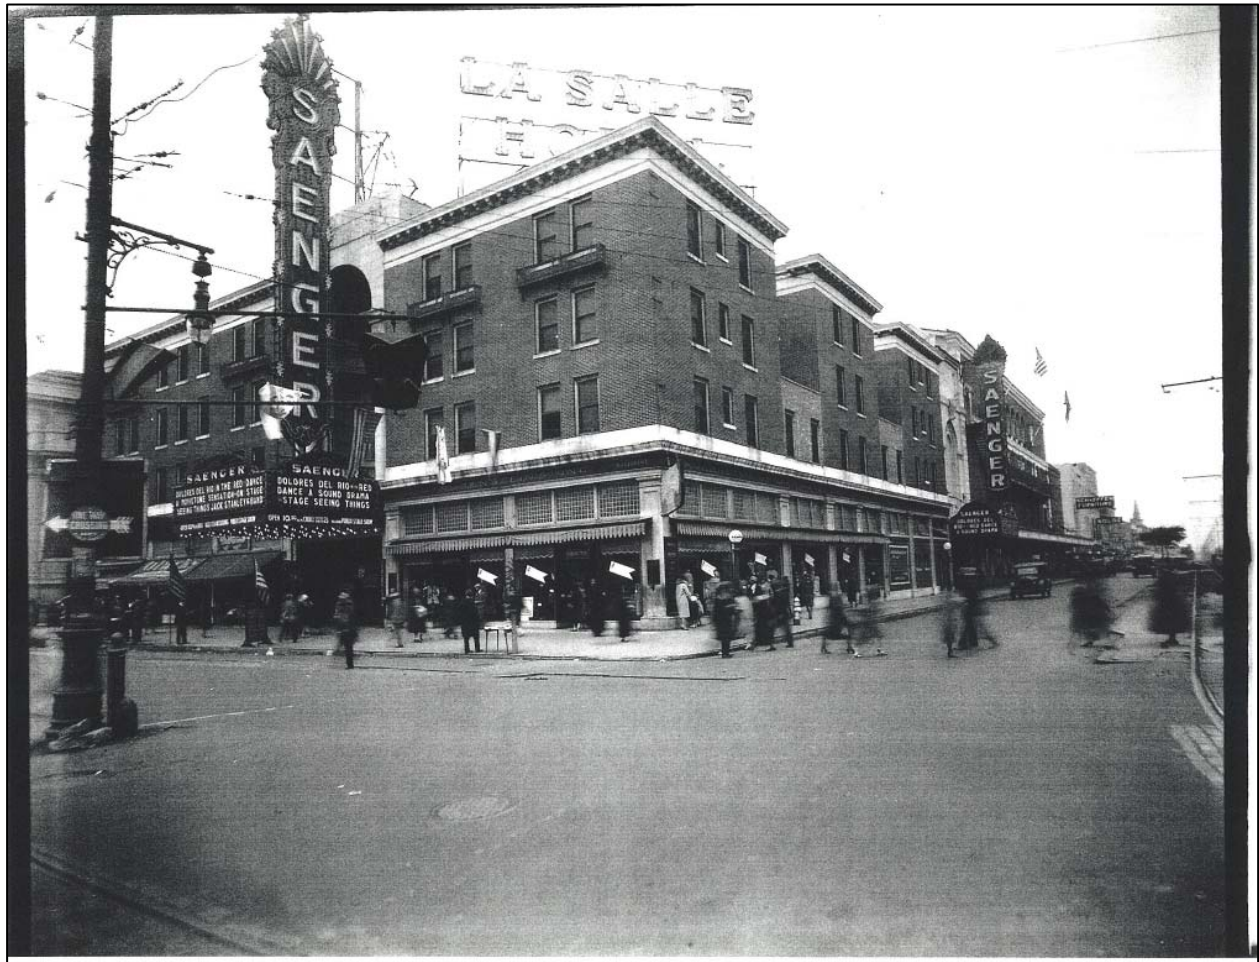
Figure 4: Photograph of Saenger Theatre, Canal and Rampart streets (ca. 1928)
Historic New Orleans Collection (cf005921)

Figure 4: Photograph of Saenger Theatre, Canal and Rampart streets (ca. 1928)
Historic New Orleans Collection (cf005921)

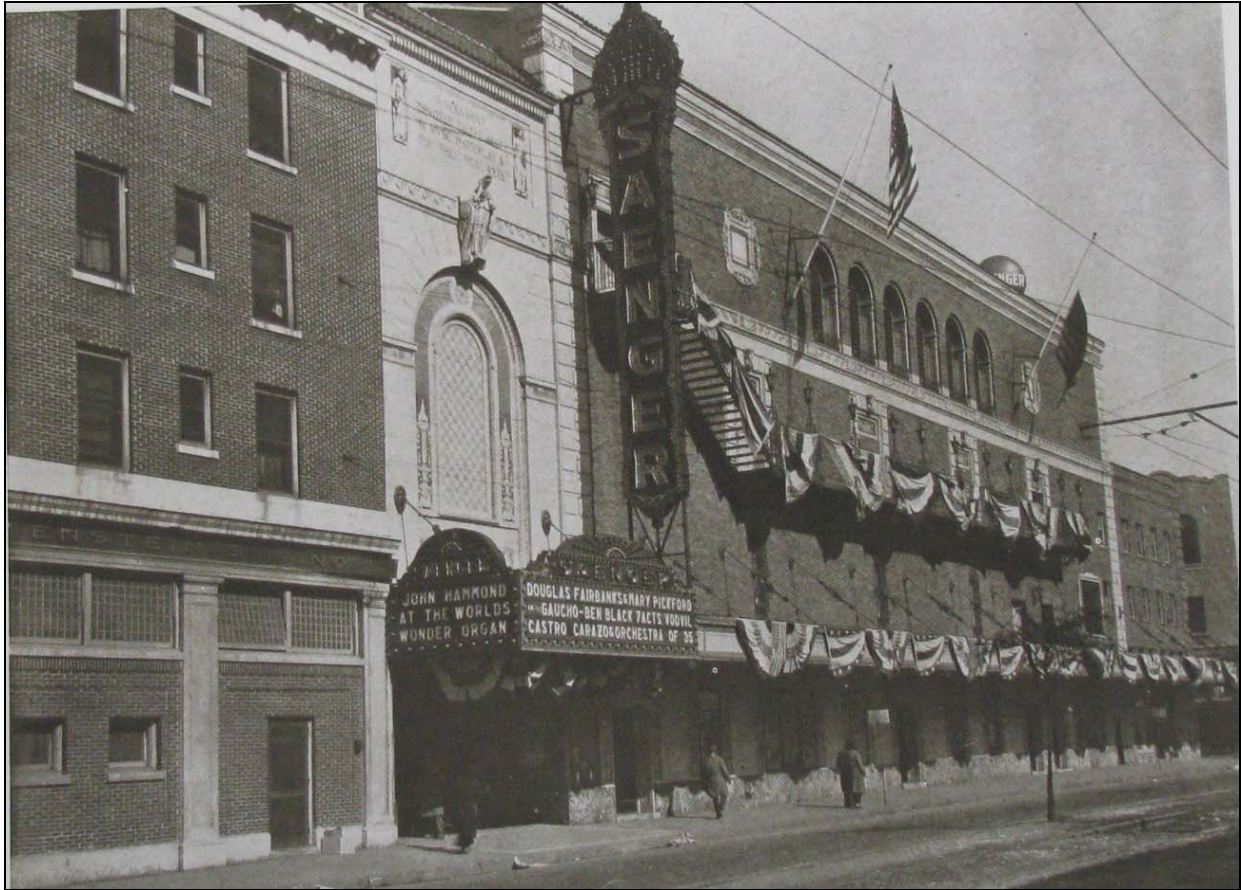
Figure 5: Photograph of Saenger Theatre, Rampart Street entrance (ca. 1927)
Illustrations of Selected Work of Emile Weil, Architect, New Orleans 1900-1928
Collection 82, Emile Weil Office Records, Folder 14
Southeastern Architecture Archives, Tulane University

Figure 5: Photograph of Saenger Theatre, Rampart Street entrance (ca. 1927)
Illustrations of Selected Work of Emile Weil, Architect, New Orleans 1900-1928, Collection 82, Emile Weil Office Records, Folder 14, Southeastern Architecture Archives, Tulane University

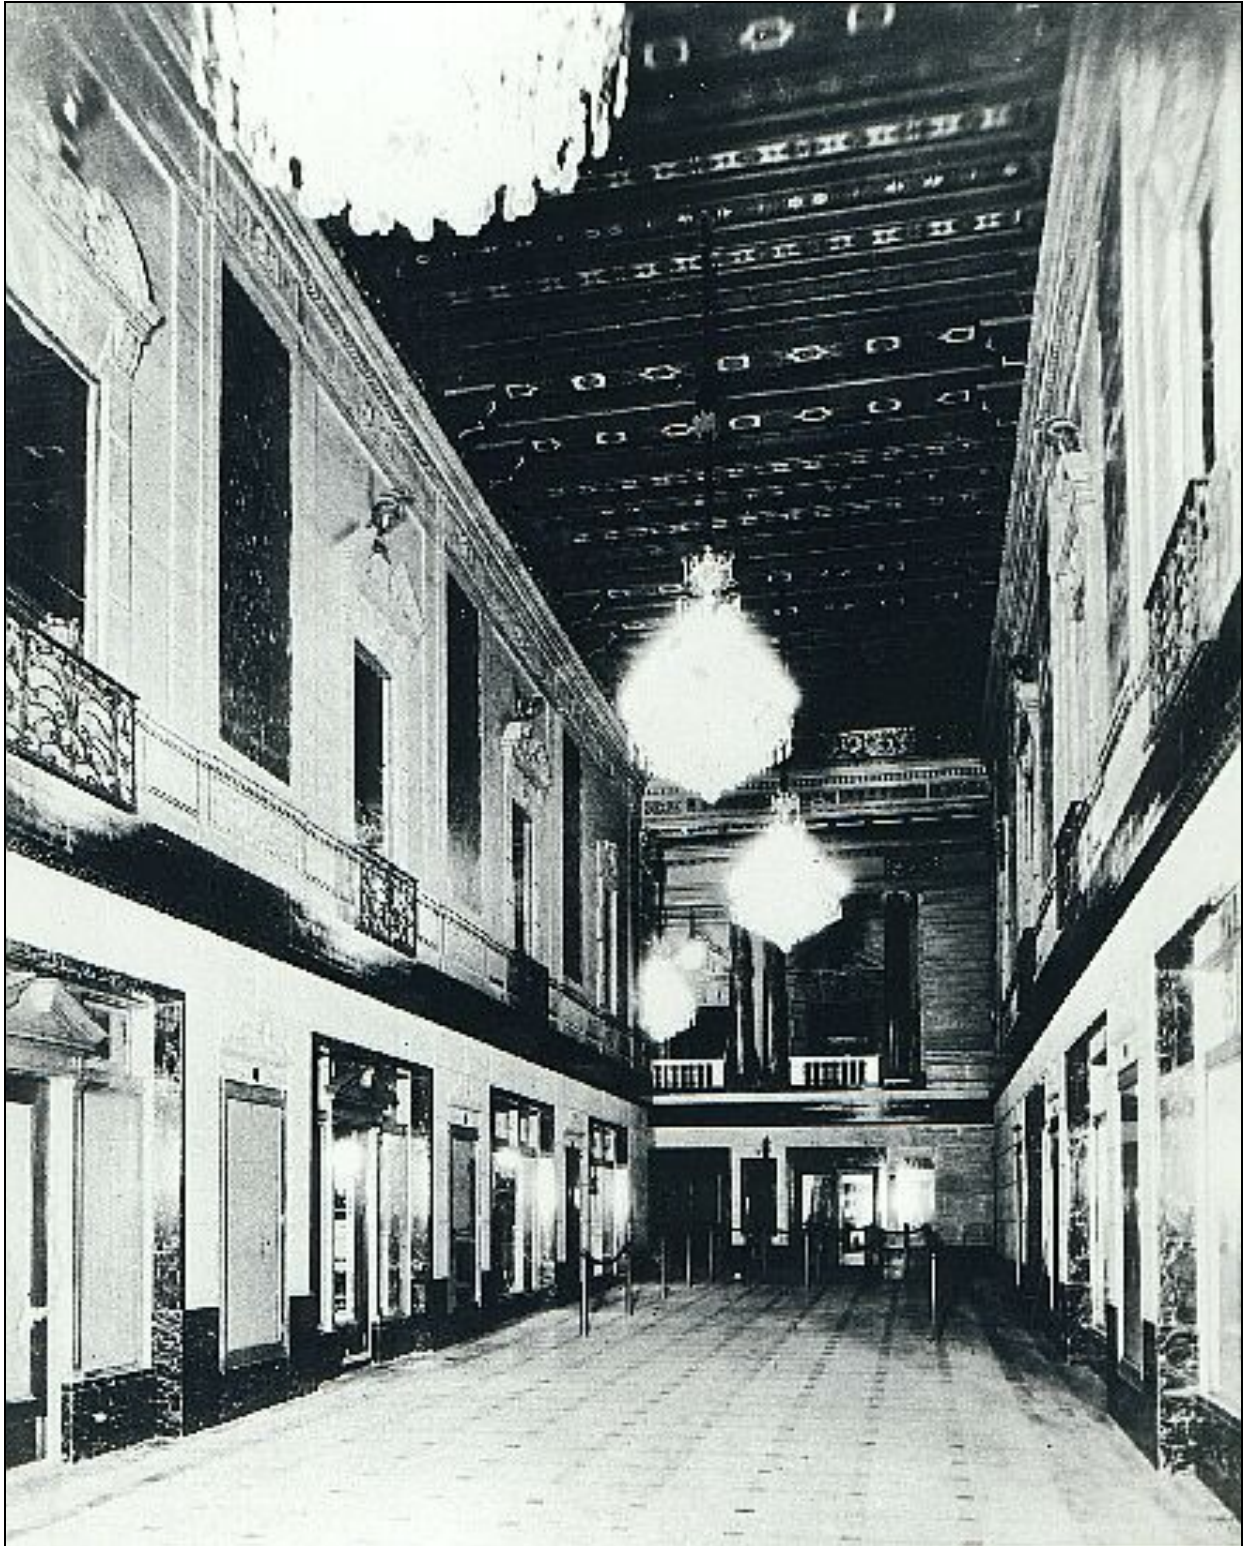
Figure 6: North-South Arcade, looking north (1927)
Motion Picture News, April 1, 1927, v. 35, no. 13

Figure 6: North-South Arcade, looking north (1927)
Motion Picture News, April 1, 1927, v. 35, no. 13

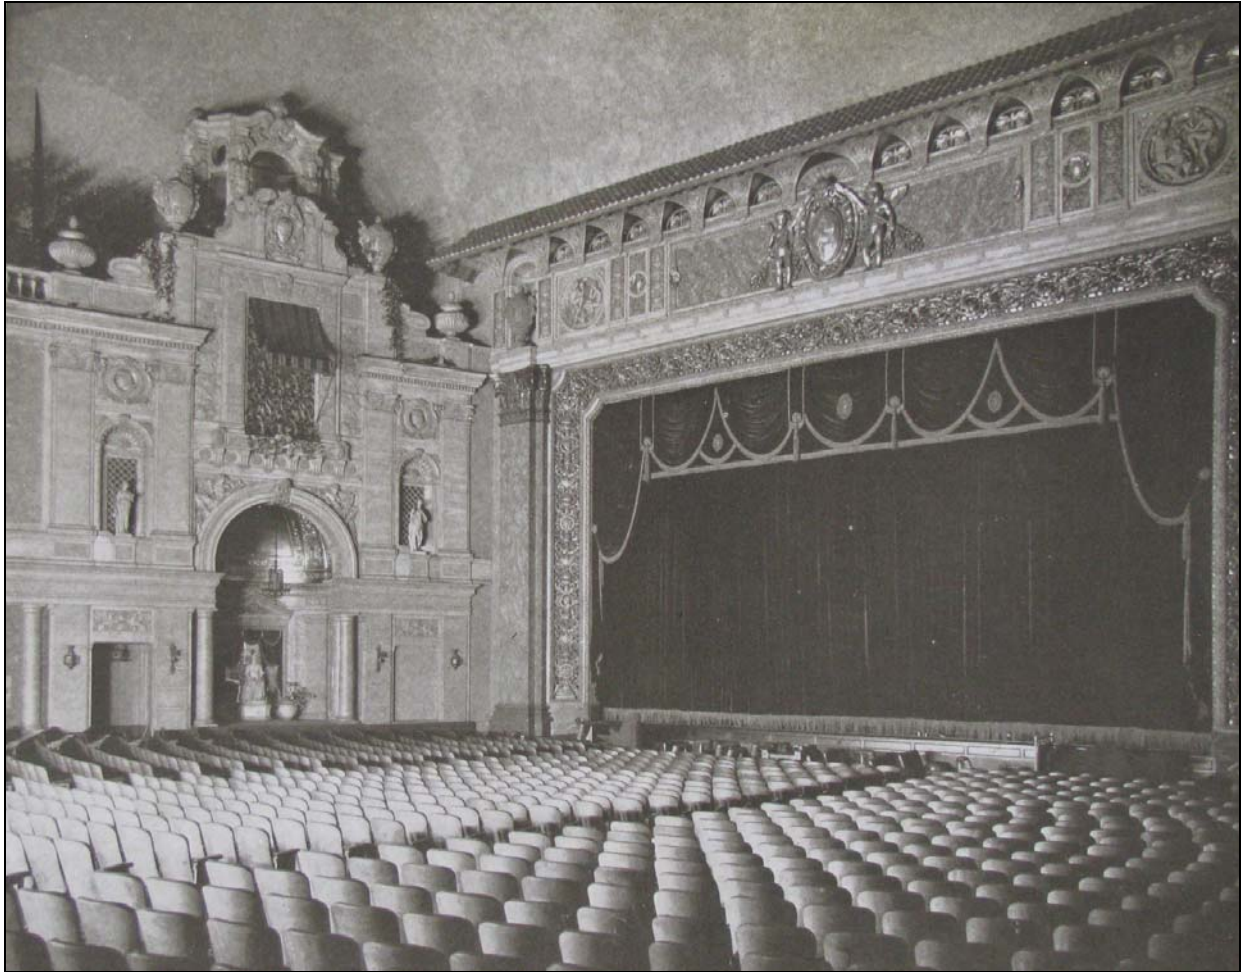
Figure 7: Photograph of Saenger Theatre, Auditorium (ca. 1927)
Illustrations of Selected Work of Emile Weil, Architect, New Orleans 1900-1928
Collection 82, Emile Weil Office Records, Folder 14
Southeastern Architecture Archives, Tulane University

Figure 7: Photograph of Saenger Theatre, Auditorium (ca. 1927)
Illustrations of Selected Work of Emile Weil, Architect, New Orleans 1900-1928, Collection 82, Emile Weil Office Records, Folder 14, Southeastern Architecture Archives, Tulane University

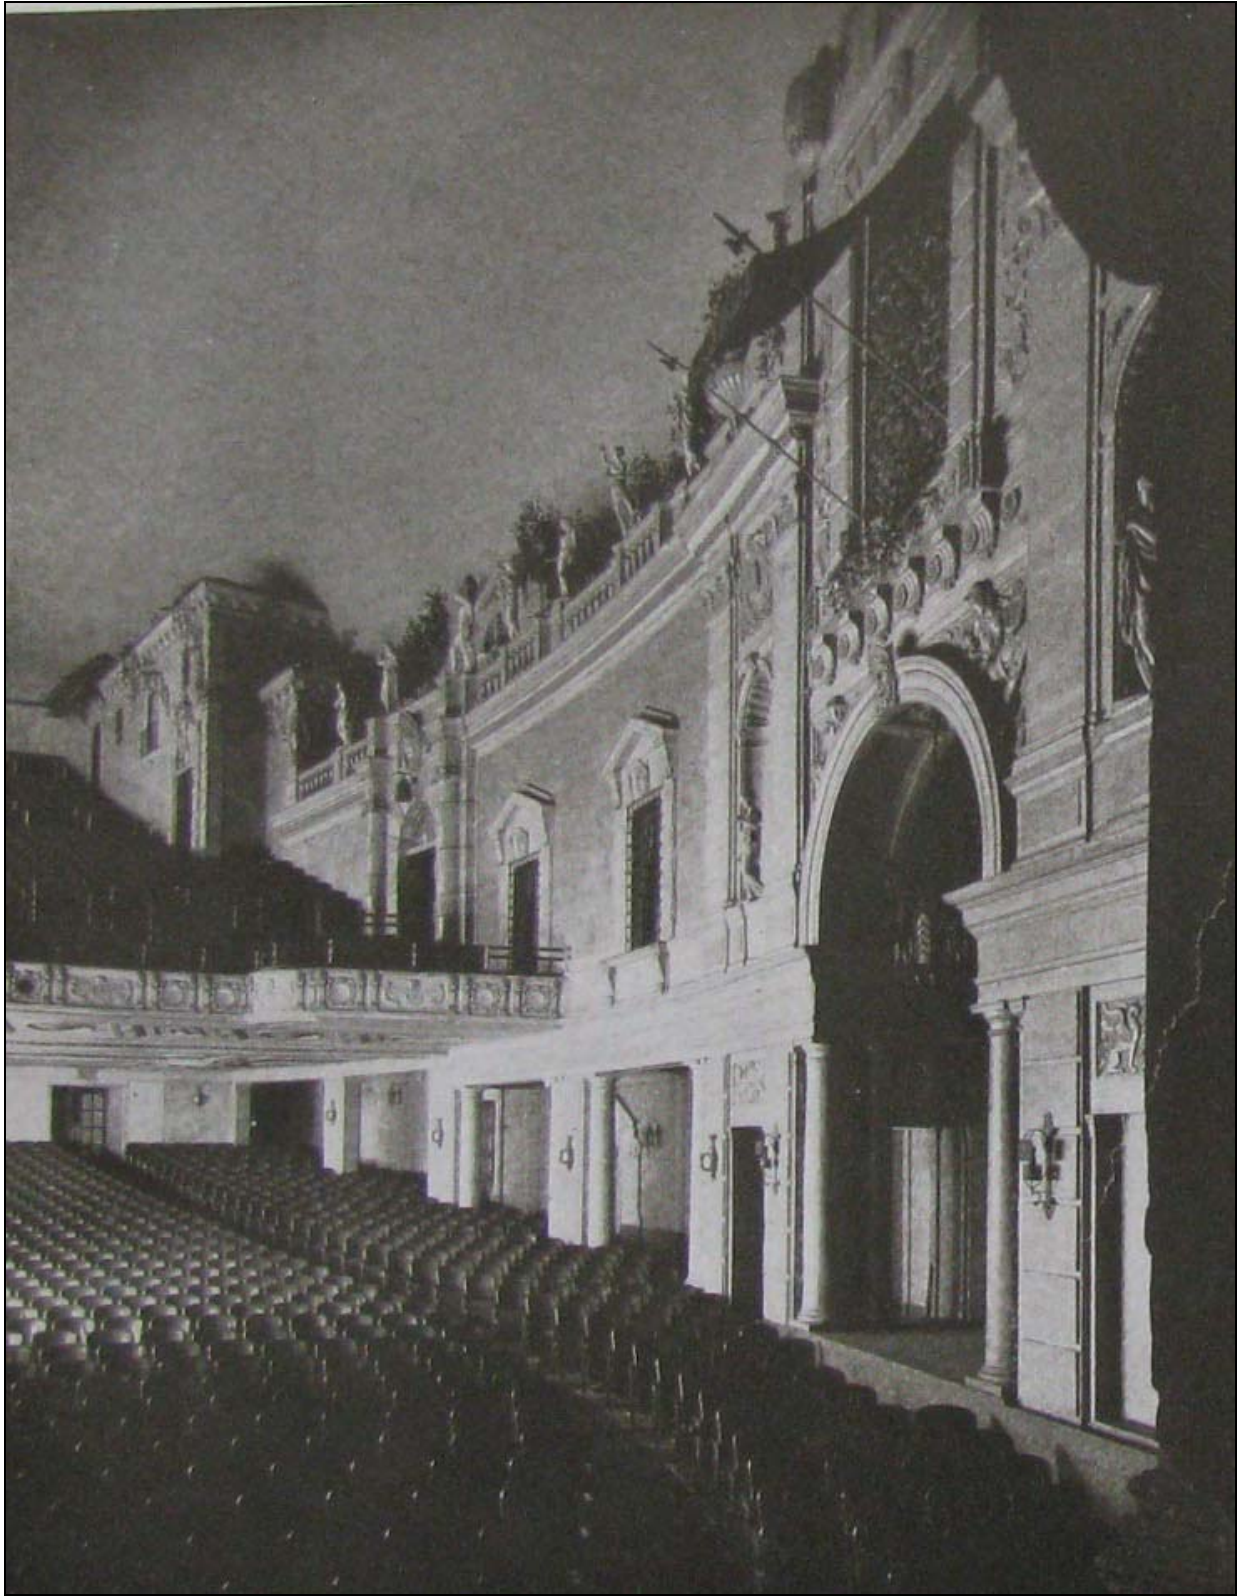
Figure 8: Photograph of Saenger Theatre, Auditorium (ca. 1927)
Illustrations of Selected Work of Emile Weil, Architect, New Orleans 1900-1928
Collection 82, Emile Weil Office Records, Folder 14
Southeastern Architecture Archives, Tulane University

Figure 8: Photograph of Saenger Theatre, Auditorium (ca. 1927)
Illustrations of Selected Work of Emile Weil, Architect, New Orleans 1900-1928, Collection 82, Emile Weil Office Records, Folder 14, Southeastern Architecture Archives, Tulane University

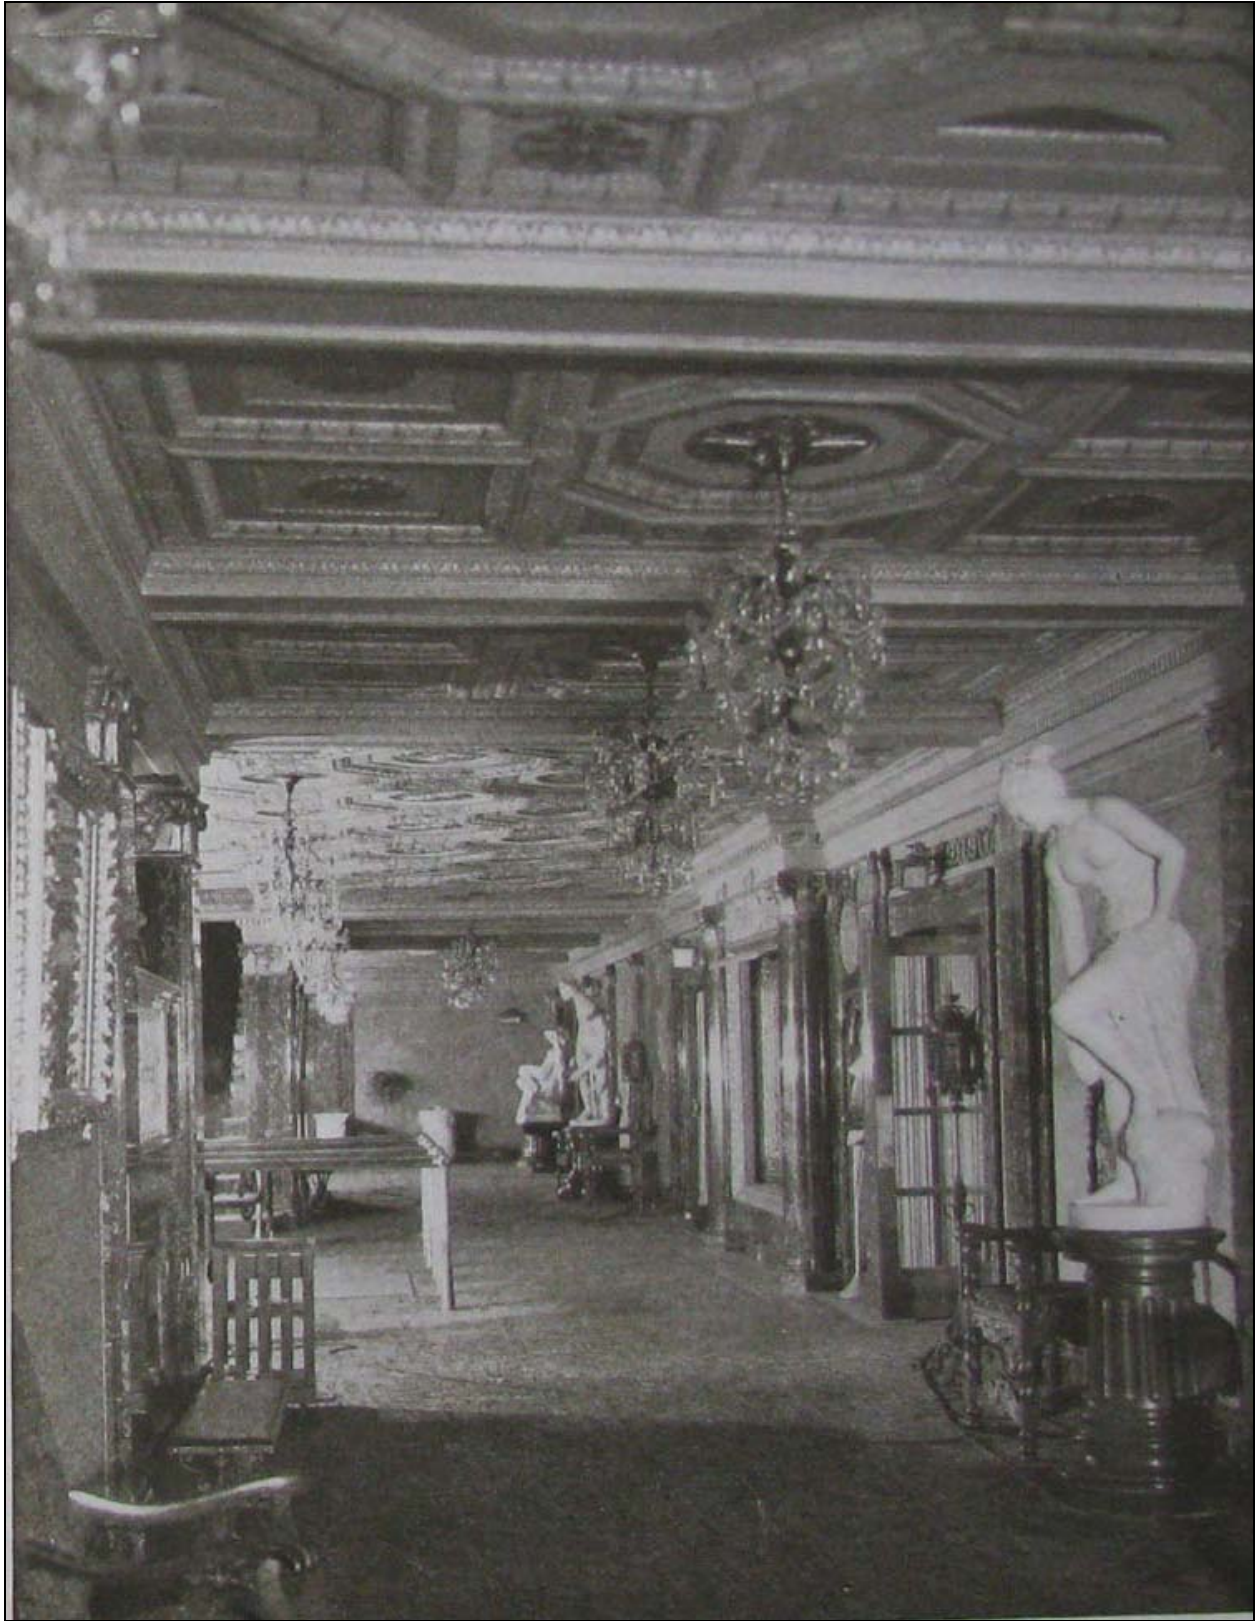
Figure 9: Photograph of Saenger Theatre, Lounge (ca. 1927)
Illustrations of Selected Work of Emile Weil, Architect, New Orleans 1900-1928
Collection 82, Emile Weil Office Records, Folder 14
Southeastern Architecture Archives, Tulane University

Figure 9: Photograph of Saenger Theatre, Lounge (ca. 1927)
Illustrations of Selected Work of Emile Weil, Architect, New Orleans 1900-1928, Collection 82, Emile Weil Office Records, Folder 14, Southeastern Architecture Archives, Tulane University
