# Standard Guide for Selection of Structural Details for Ship Construction<sup>1</sup>

The principal aim of this guide is to depict recommended practices related to the design of ship structural details. The importance of structural details is clear:

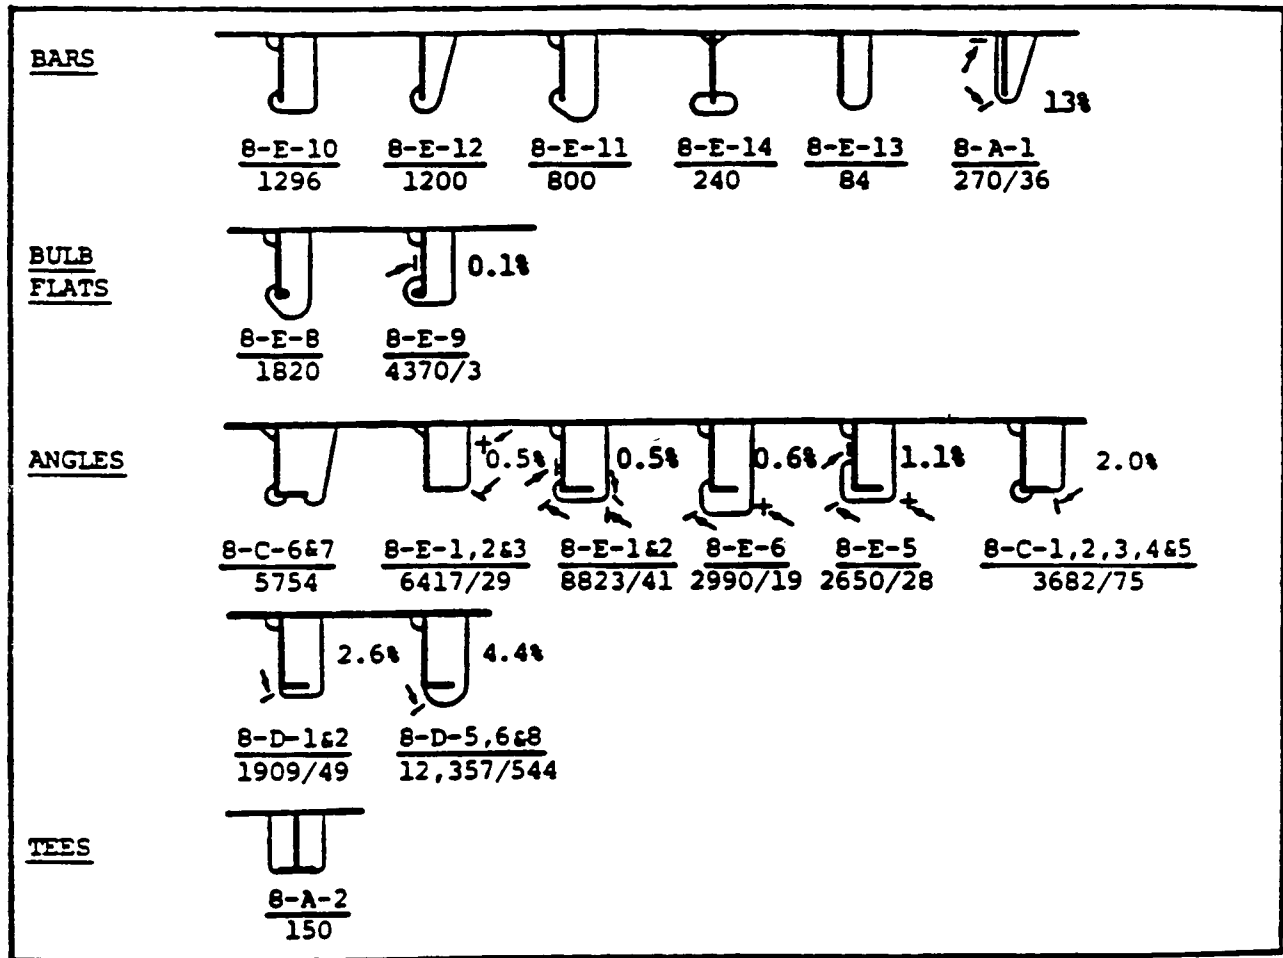
FIG. 20 Performance of Stiffener Clearance Cutout Details (Family No. 8)

4.1.1.11 The clearance cutouts of family no. 8 (Fig. 20) are basically non-tight collars without the addition of the collar plate. Suggestions made for non-tight collars and miscellaneous cutouts are applicable for this family.

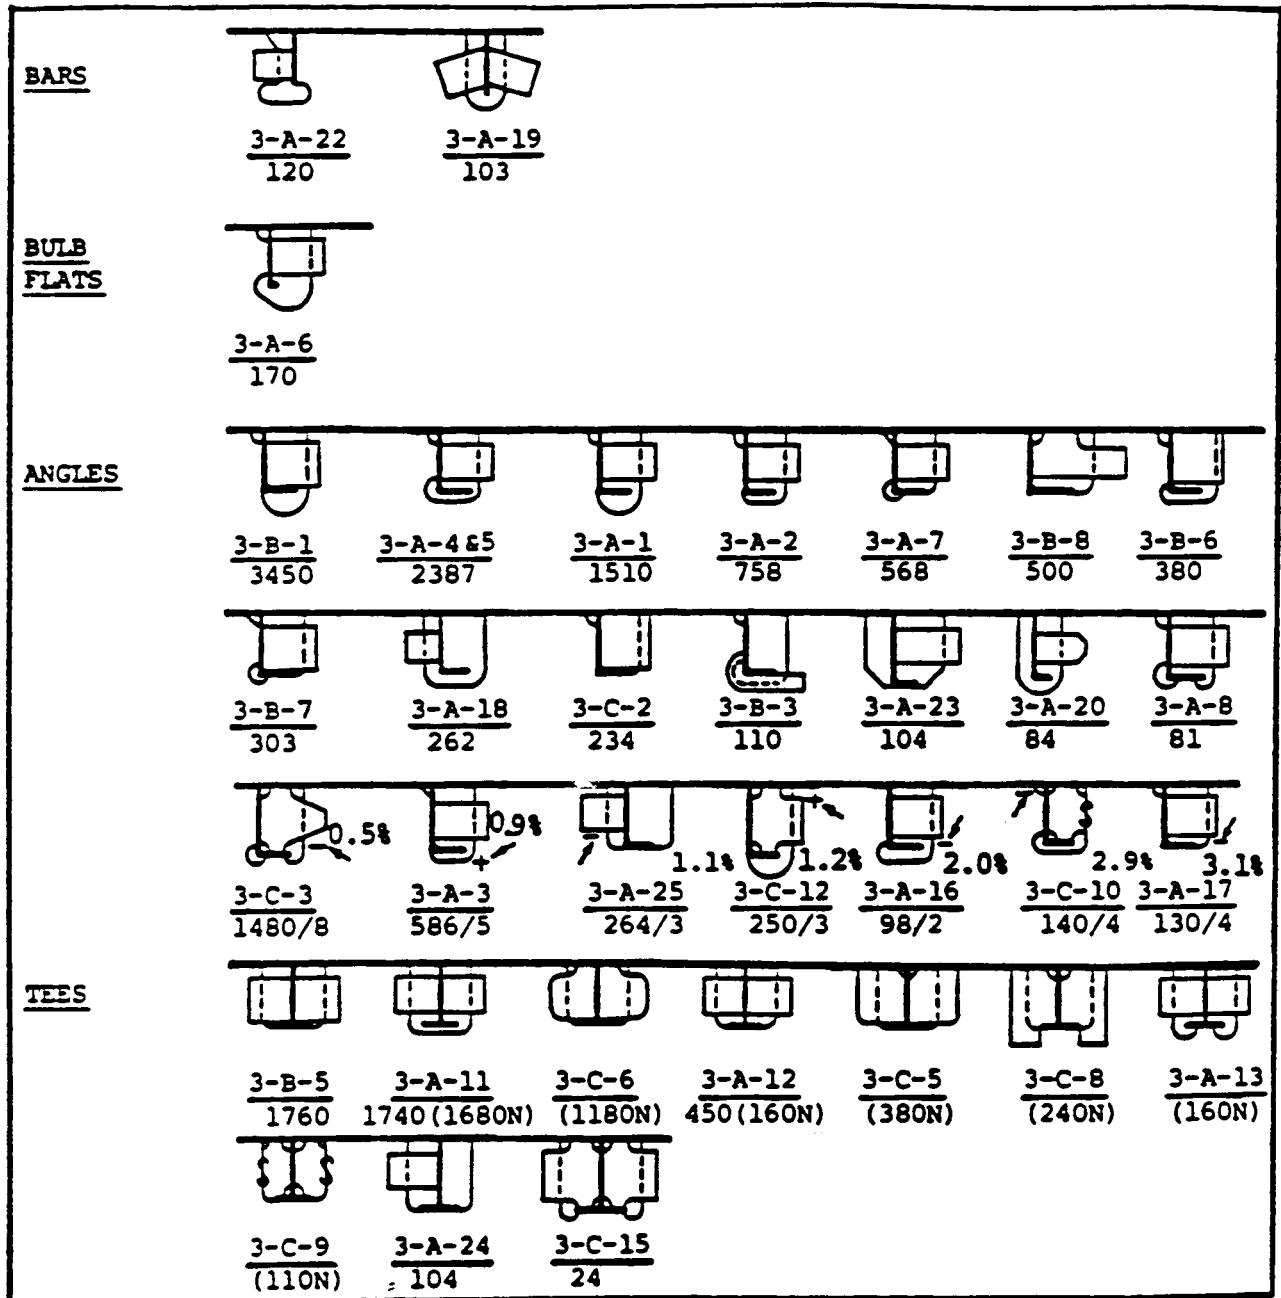
FIG. 21 Performance of Non-Tight Collar Details (Family No. 3)

4.1.1.8 The non-tight collar configurations of family no. 3 (Fig. 21) experienced only a few failures. There are considerations, however, that must be used by the designer to ensure the continuation of this trend. The cutouts should be provided with smooth well rounded radii to reduce stress risers. Where collars are cut in high stress areas, suitable replacement material should be provided to eliminate the overstressing of the adjacent web plating. These considerations should reduce the incidents of plate buckling, fatigue cracking, and stress corrosion observed in this family.

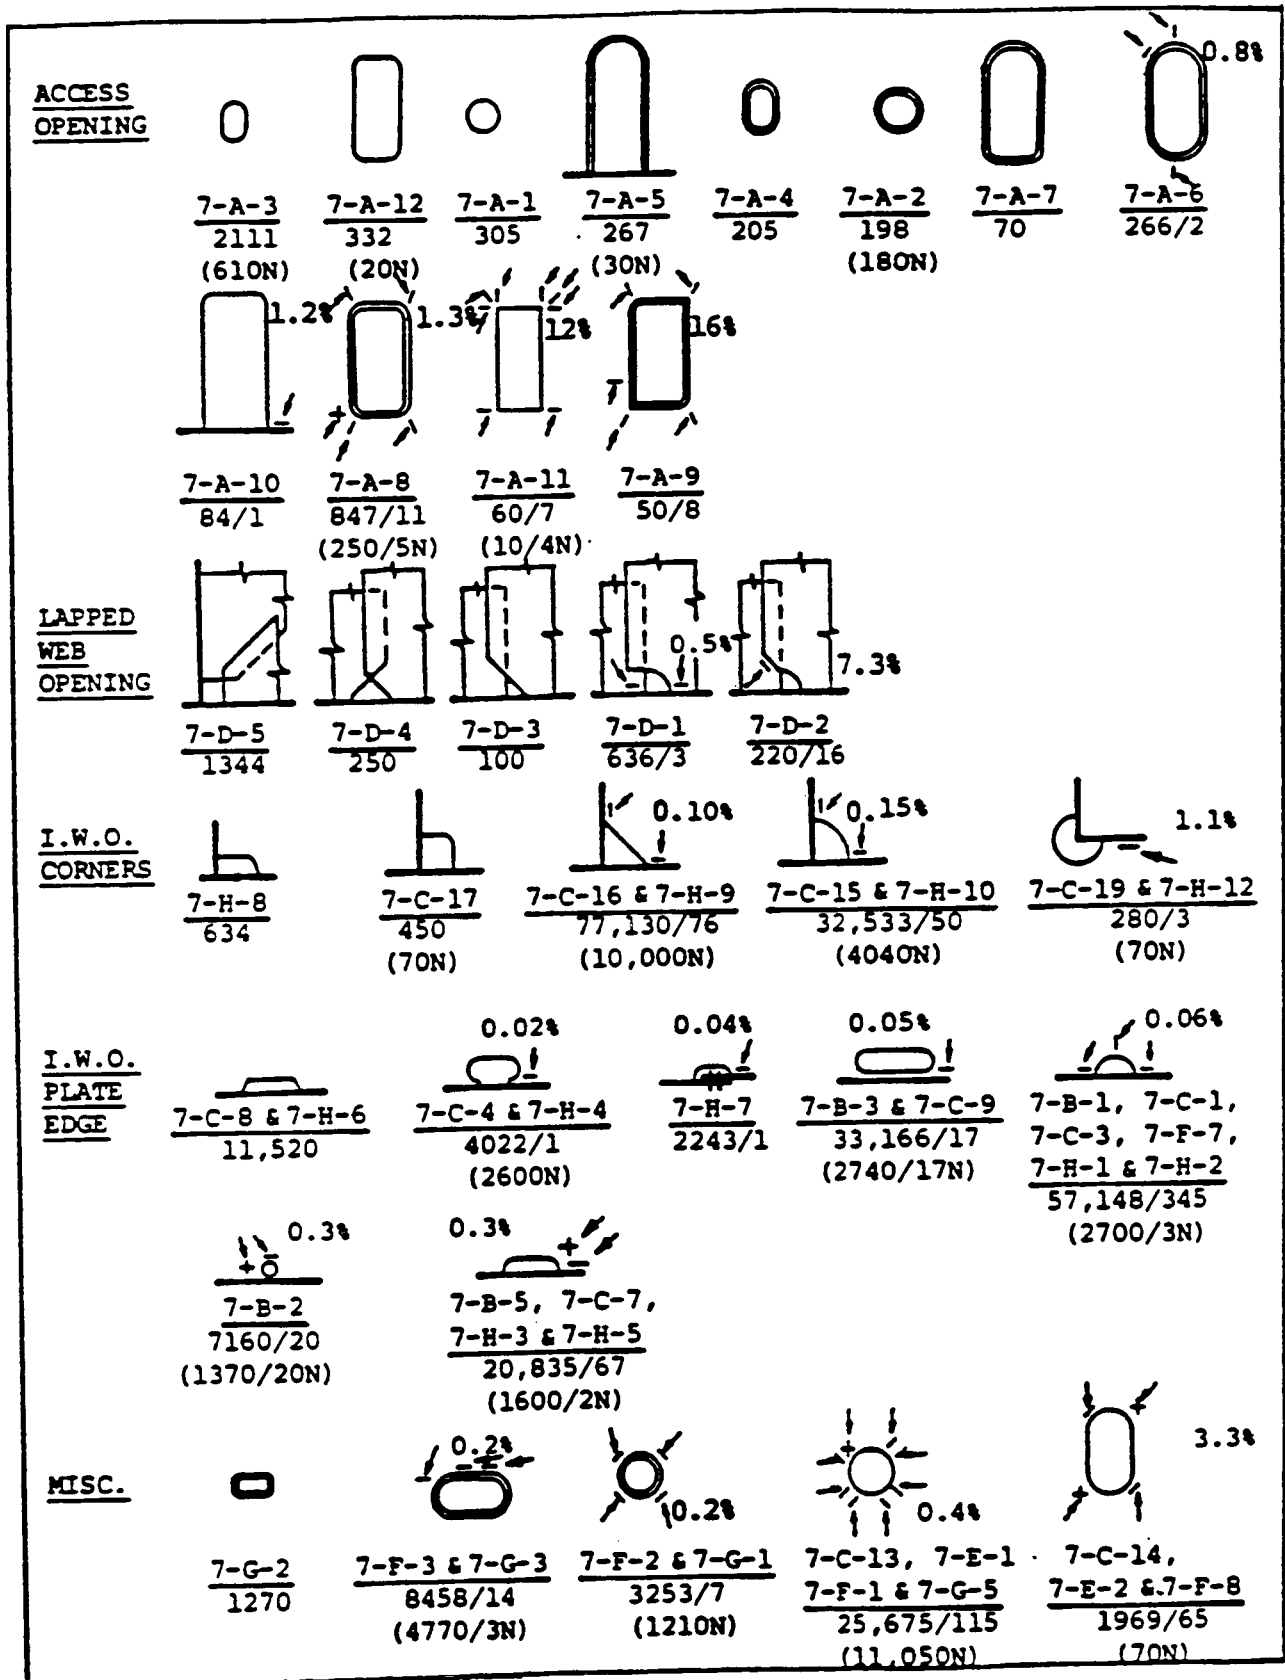
FIG. 24 Performance of Miscellaneous Cutout Details (Family No. 7)

4.1.1.9 For detail family no. 7, miscellaneous cutouts, (Fig. 24), the reasons for failure were as varied as the types of cutouts. Potential problems can be eliminated by the designer if, during detail design, proper consideration is given to the following:
