typical interior  
hoistway wall,  
some existing,  
some being  
replaced due  
to damage

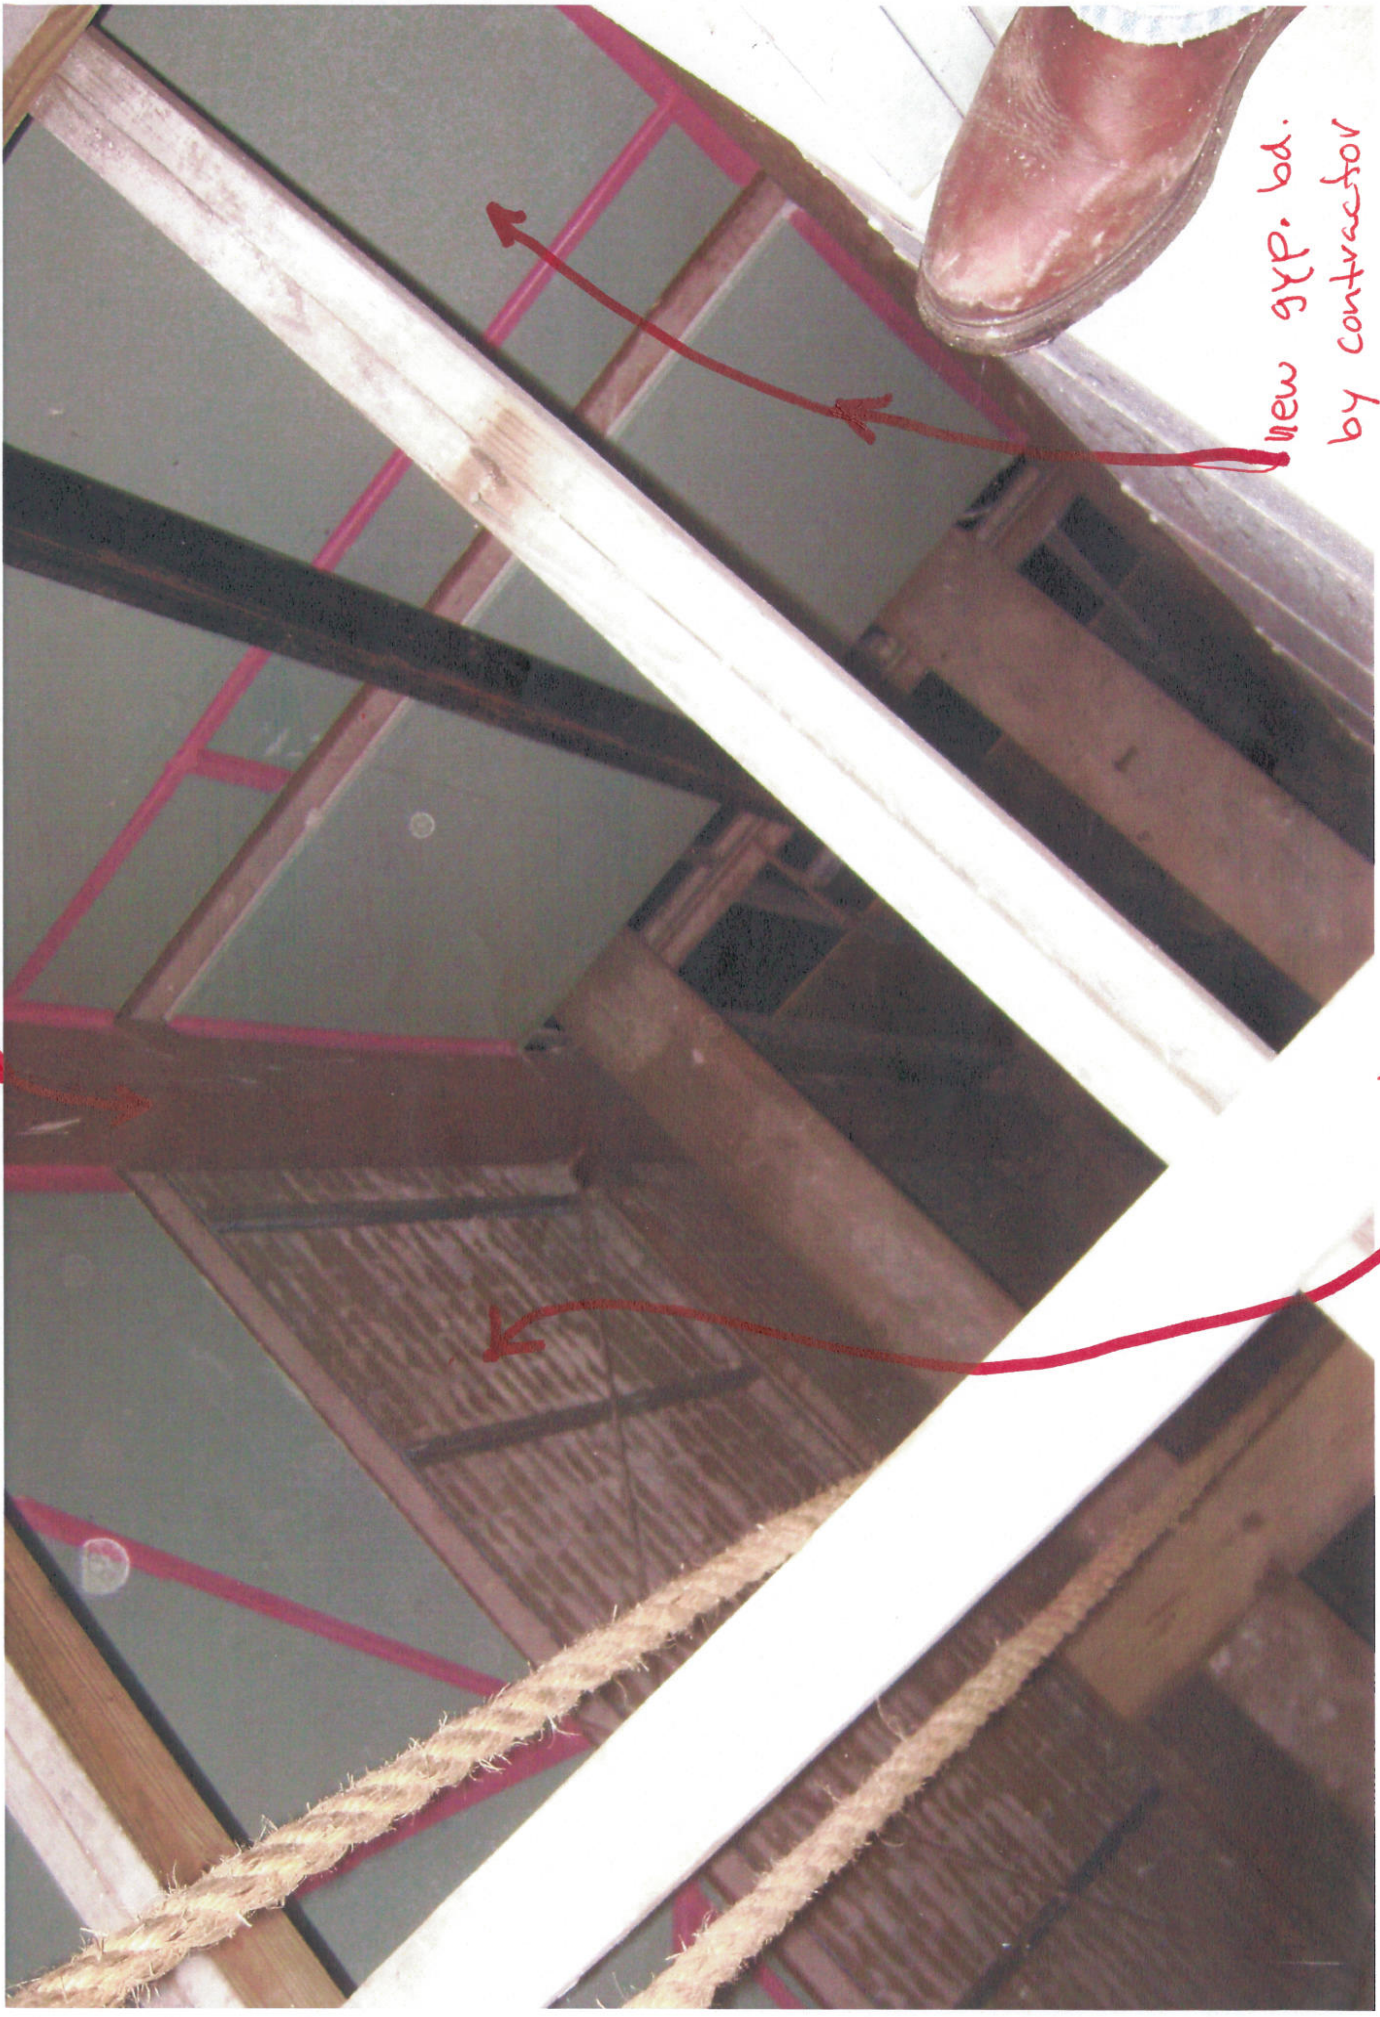
existing exposed structure

new gyp. bd.  
by contractor

existing exterior wall

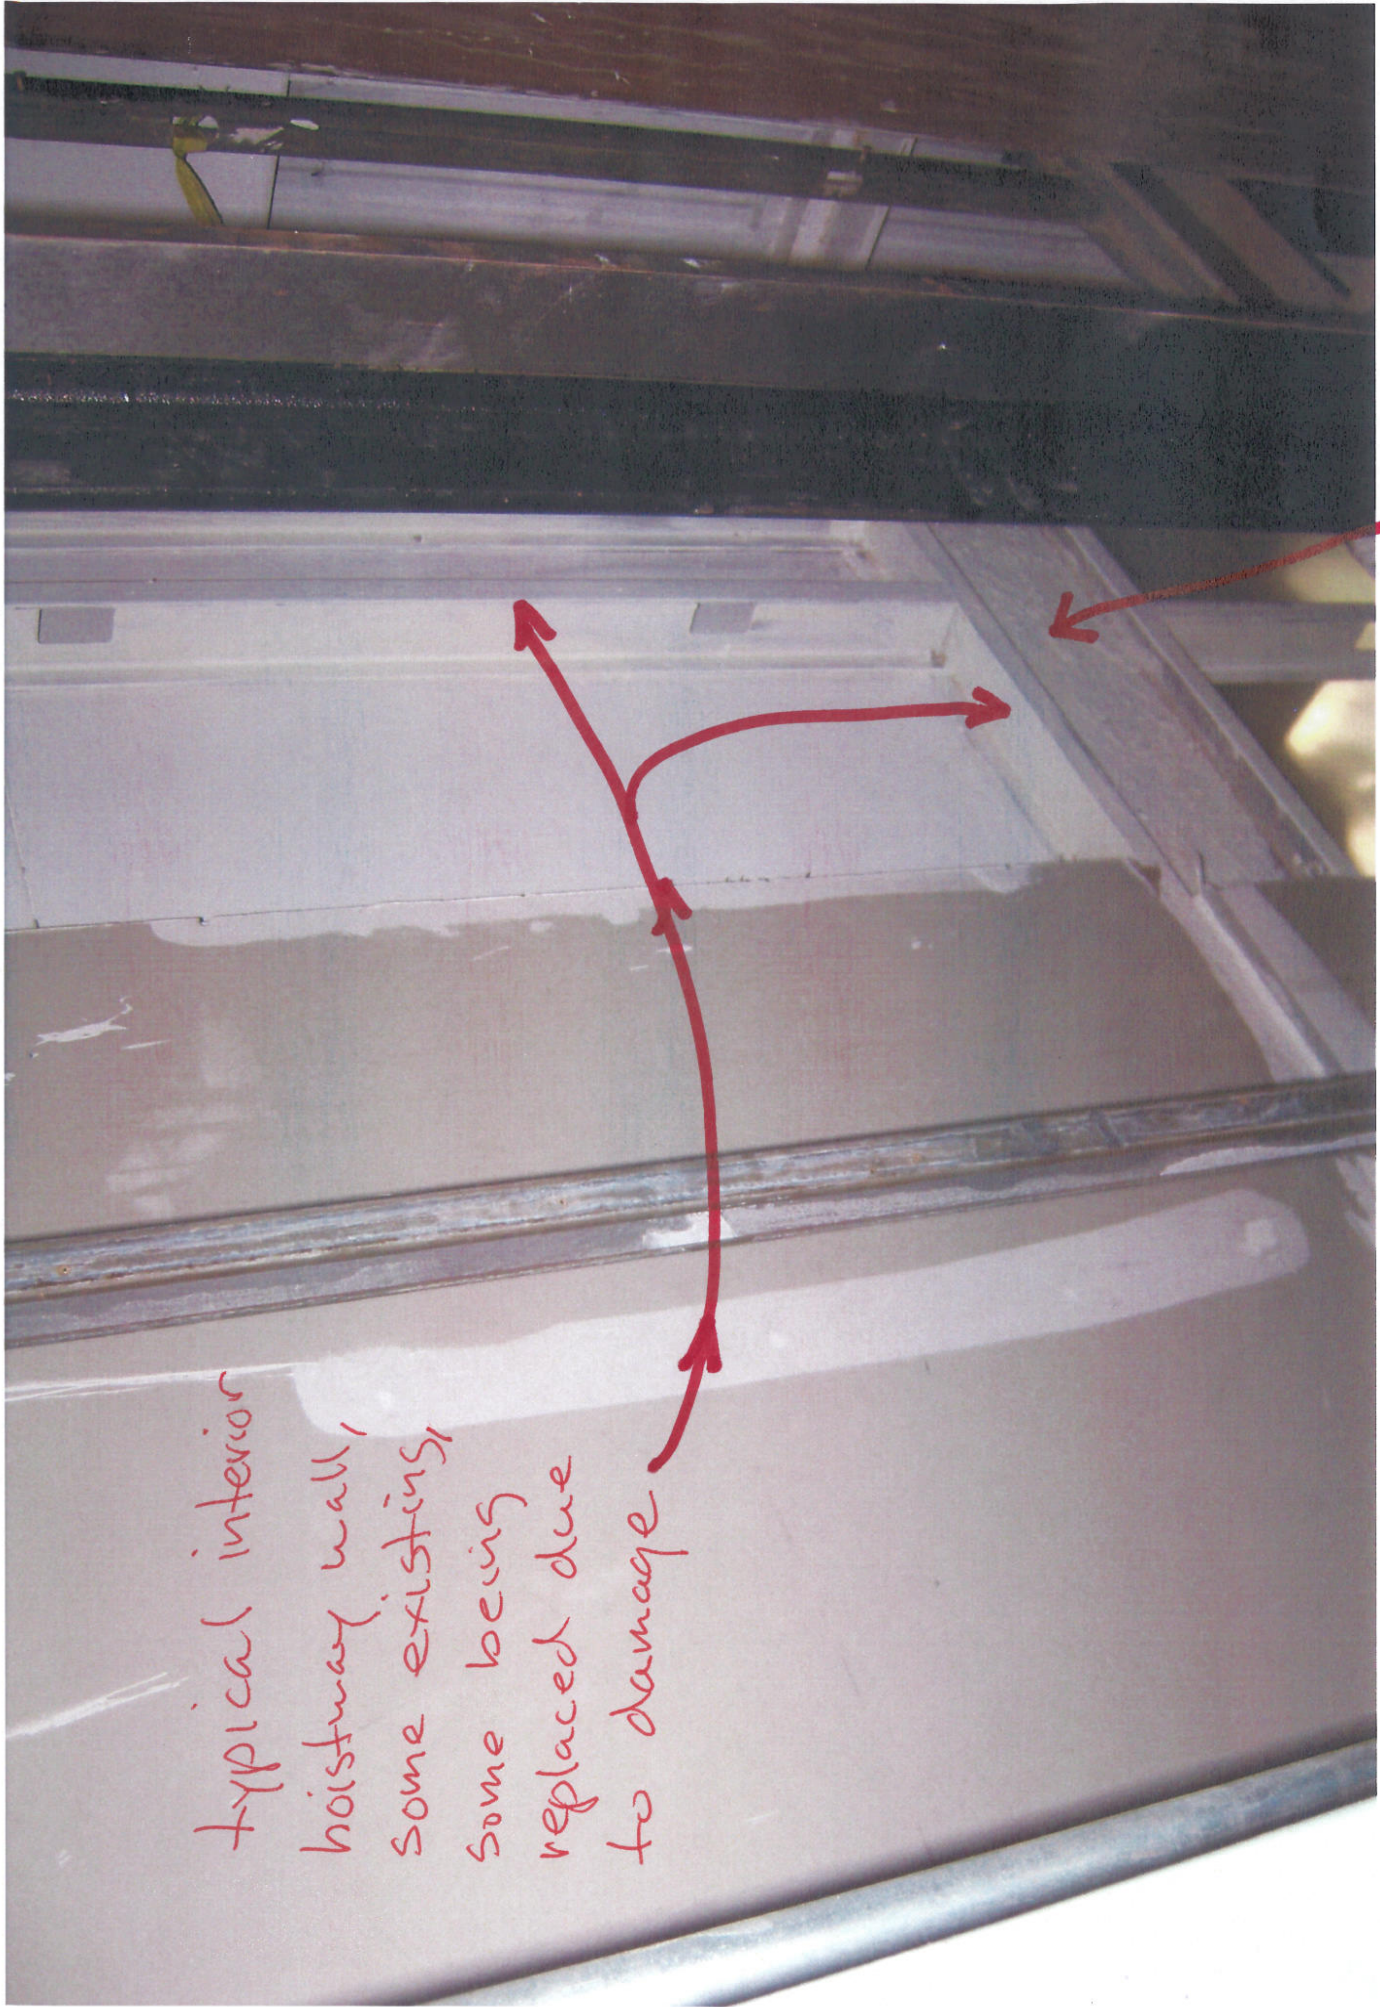
existing concrete floor slab

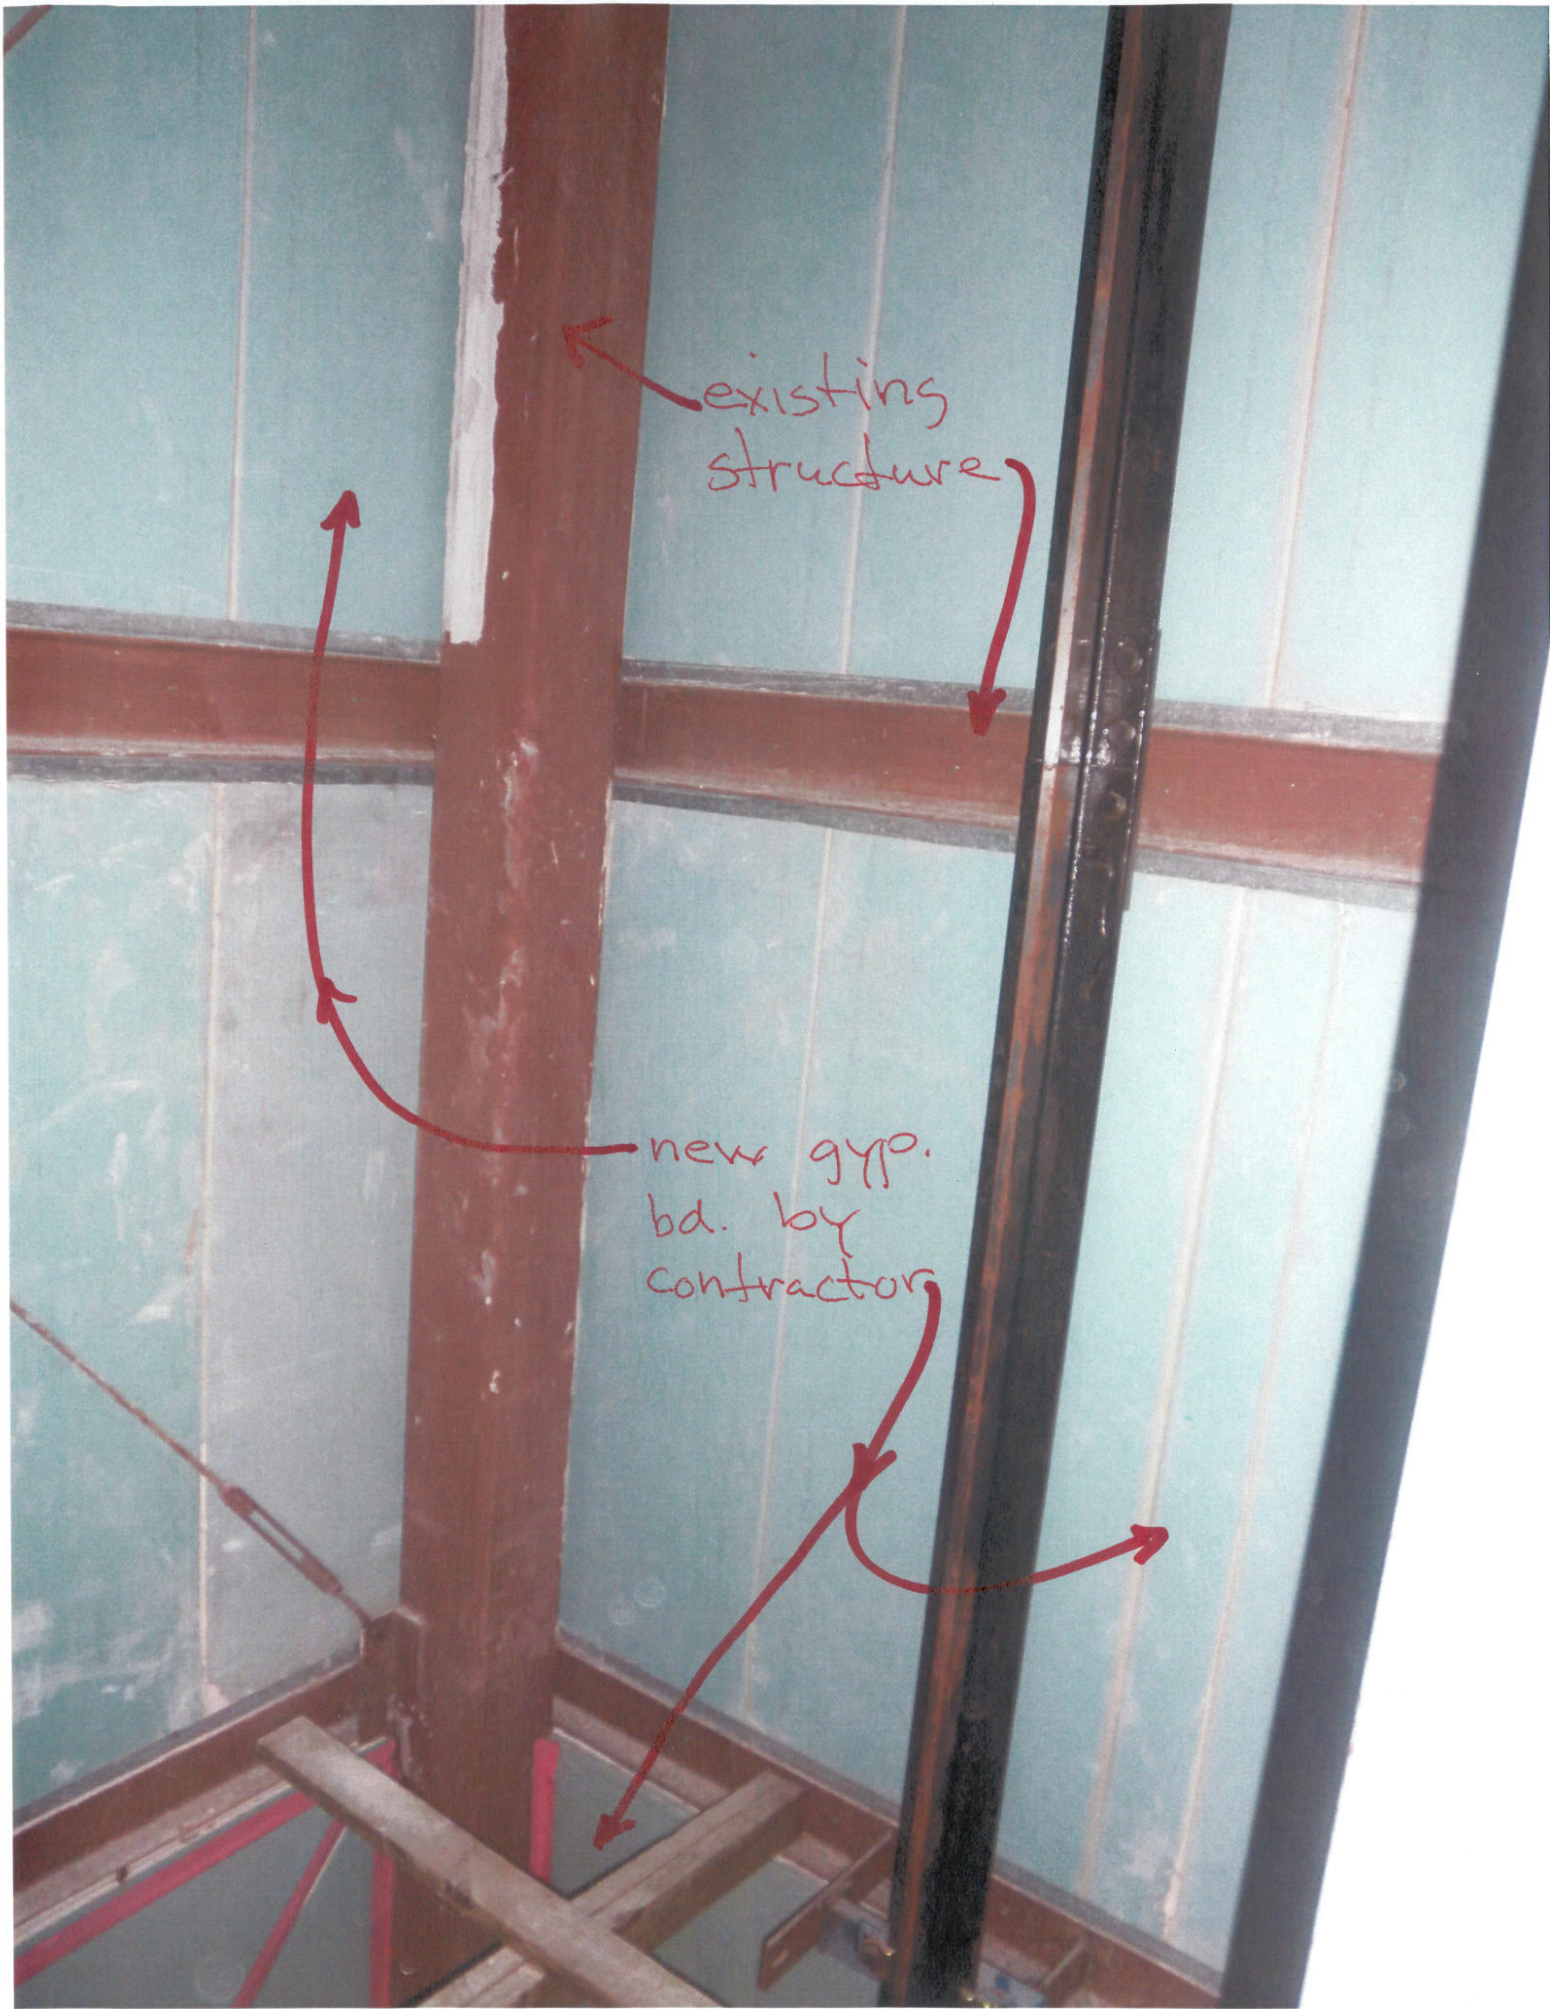
existing structure

new gyp.  
bd. by  
contractor
