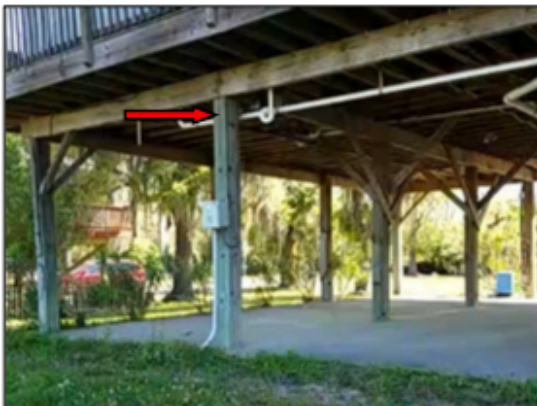
Photo 10:1

Type: Slab-On-Grade Foundation walls Pillar/post
Condition: Satisfactory Marginal Poor
 Warping/distorting (at pillar/post - see Photo 10:1)
