# WOOD CHAR DEPTH: INTERPRETATION IN FIRE INVESTIGATIONS

(Presented at *International Symposium on Fire Investigation*,  
Fire Service College, Moreton-in-Marsh, United Kingdom, 28 June 2004)

**Vytenis Babrauskas, Ph.D.**

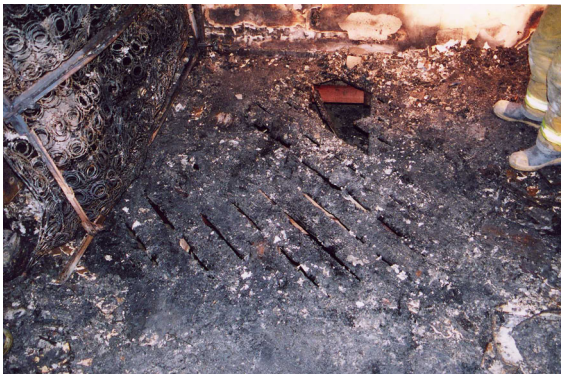
**Figure 1** Hole burned through hardwood floor and subfloor underneath a mattress fire  
(Courtesy Lew Kingman)

The burn patterns of most interest to investigators are often those on the floor. The laboratory studies examined above indicate that significantly greater charring rates should be expected for floors, even under ‘ideal’ conditions, i.e., no unprotected joints or gaps. But real wood floors will likely have unprotected joints or gaps. In addition, the floor is often in a position where a strong in-draft takes place, due to air being pulled into the fire from an open window or door. Under such conditions, it does not take a long time (nor use of any liquids!) to burn up floorboards. Figure 1 shows the aftermath of an accidental fire where the victim unintentionally set her bed on fire with a cigarette. The only areas of severe floor damage are those directly underneath the mattress. Hardwood flooring is completely gone, as is a piece of the subfloor consisting of 25×150 mm (1"×6") rough-sawn planks, laid diagonally. Typically, a polyurethane foam mattress will burn up in 5 min or less, so the time available to cause this damage was quite limited. If the fire exposure time is taken as 5 min, then the charring rate was roughly 7.6 mm/min in this fire.

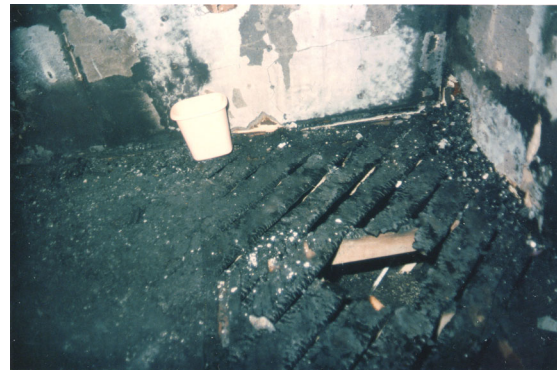
**Figure 2** Floor burn-through in a Santa Ana Fire Dept. fire test; no liquids were used  
(Courtesy James C. Albers)

Figure 2 shows the burn-through damage seen after a test conducted by the Santa Ana Fire Dept. where an actual, full-scale furnished house was burned. A summary of these tests is given in a report by Walton et al. [44], and the test is identified as being at 1309 S. Bristol Street. The burn-through location was near the ignition source, which was a plastic wastebasket; an unburned exemplar is shown in the photo. The subfloor comprised 25×150 mm (1"×6") rough-sawn Douglas fir planks, laid diagonally. On top of this were oak floorboards, approximately 12.7×31 mm (1/2"×1.25") size, laid horizontally. Residues of the oak floorboards are not visible in the photo since these boards completely burned up. The subfloor planks were charred fully through and substantial charring had also penetrated into the wood joists supporting the floor. Total burn time was 23.7 minutes, but peak temperatures were only around 600°C and for only a duration of about 16.1 minutes was 200°C exceeded at the ceiling level. If 15 min is taken as the fire duration, then the effective charring rate would be 2.5 mm/min, however, even 15 min is likely too high an estimate of effective fire duration and, in addition, the time was more than enough to fully char through the floor. Thus, a better estimate may be 3.5 mm/min.

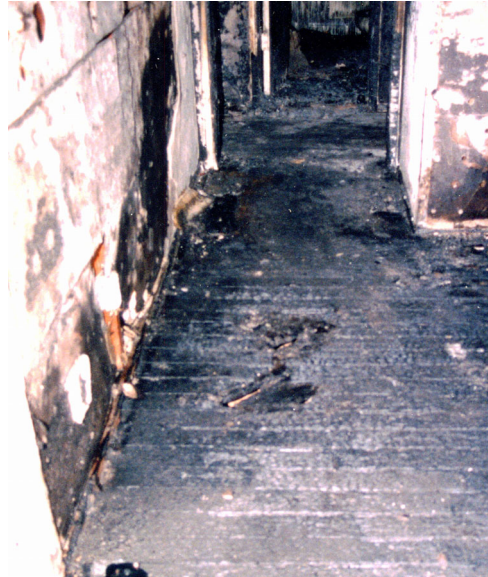
**Figure 3** Floor burn-through in another Santa Ana Fire Dept. fire test; no liquids were used  
(Courtesy James C. Albers)

Figure 3 shows the burn pattern in another similar test (1247 S. Bristol Street) conducted by the Santa Ana Fire Department. Albers discussed this fire test [45], pointing out that fire investigators tended to consider the pattern to be the consequence of a flammable liquid pour, even though no liquids were used and this particular room was actually unfurnished. The deep burns were a consequence of the fact that this area formed the ventilation path for the fire, with an open door being located about 1 m away. In the same test, another area of the floor showed extremely deep burns despite, again, being a place where no movable fuel load was present. Those burns, while more extensive, did not mimic the outlines of a pour pattern, however. The latter area was also in a location which was subject to the draft of the incoming air. The total fire duration in this test was 20.2 min, but it was observed that the floor did not ignite in the area where the burn-through is shown until 9.8 min into the test. Thus, active charring lasted only about 10.4 min; on this basis, a charring rate of 3.7 mm/min can be estimated. In the same test series, it was noted [46] that, in the case of a very rapidly developing fire, floorboards buckled early in the fire. Once this occurs, penetration of fire along the sides will become significant.

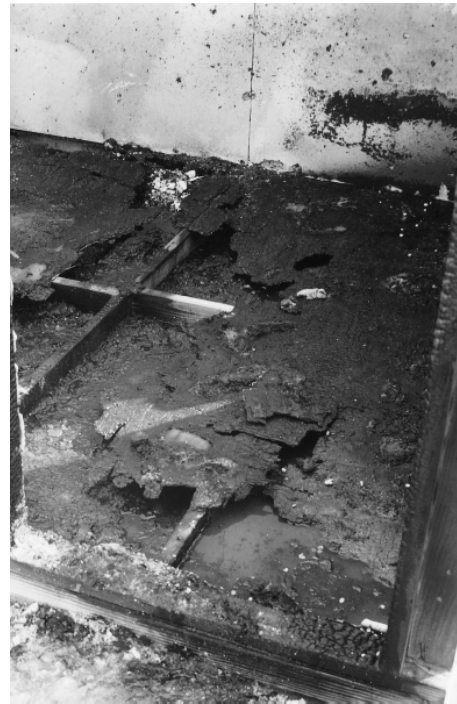
**Figure 4** Burn-through of carpet and 12.7 mm plywood floor in a room fire test involving no liquids and less than 4 min of post-flashover burning  
(Courtesy John D. DeHaan)

Icove and DeHaan described a room test where a bed was lit on top, without use of liquid accelerants [43]. Figure 4 shows the charring underneath the bed. Apart from the burning of the carpet, the wood effectively charred at a rate of 3.2 mm/min.

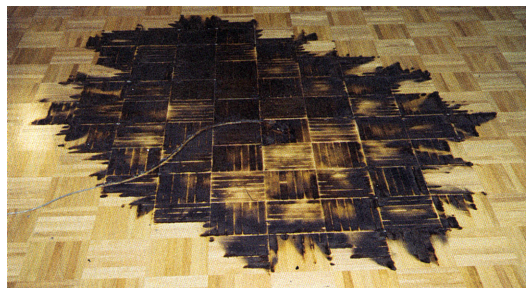
**Figure 5** Char pattern from a 1 L gasoline pour onto a wood parquet floor  
(Courtesy Anthony Putorti)

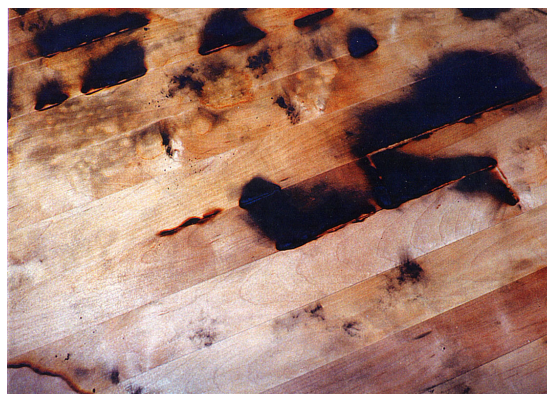
**Figure 6** Char pattern from an 0.6 L gasoline pour onto a wood floor consisting of 25 mm maple floor boards, atop two layers of 13 mm plywood  
(Courtesy Fred Fisher)

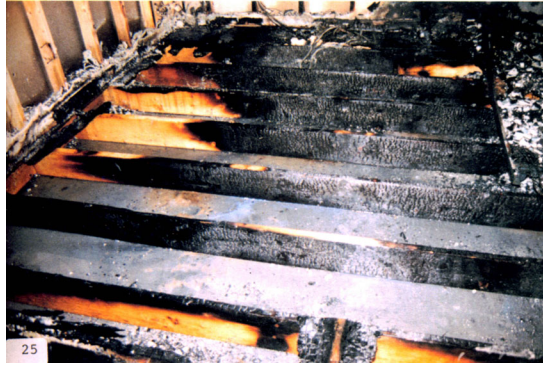
**Figure 7** Floor burn-through in USFA test initiated by pouring gasoline on floor; ample ventilation (Test #4)

The US Fire Administration conducted several burn tests [13] where floor burn patterns were examined. In one test (Test #4), 1.75 L of gasoline was poured on the floor of a fully-furnished room. The subfloor comprised 9.5 mm plywood on nominal 2"×8" joists. On top of the subfloor were a carpet and carpet pad, of unspecified composition. The room flashed over at 40 s and the fire was extinguished at 10.3 min. The aftermath of the fire was that the floor system fully burned through, and fairly widespread (but unmeasured) charring took place to the joists (Figure 7). Note that a comparison test was not run without liquid fuel. Thus, this outcome demonstrates the charring due to a flashed-over fire, but not a characteristic unique to liquid-fueled fires.

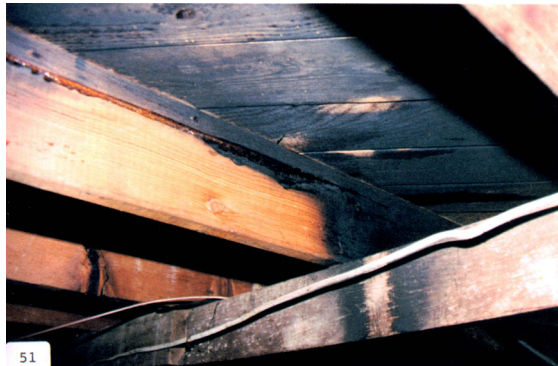
**Figure 8** Floor burn-through in USFA test initiated by pouring gasoline on floor; limited ventilation (Test #6)

The same types of furnishings, carpet, and pad were then used in a test (Test #6) in a different house. This building also had a plywood subfloor, but of unknown thickness. The fire was also started with 1.75 L of gasoline. Flashover took place at 30 s. At 1.5 min, fire penetrated into the basement underneath; this basement fire was extinguished so as not to create a two-sided challenge to the floor system. The authors speculated that the ignition mechanism of this basement fire involved liquid accelerant seeping down through joints in the subfloor, with ignition being made possible by flame penetration through a sufficiently large gap. Despite the flashover conditions, the room fire subsequently banked down because window glass did not fall out. The fire was extinguished after 7 min of burning. Most of the carpet, pad, and subfloor remained uncharred at the end of the test. Figure 8 shows local burn-through near the area of origin.
