Structural Inspection

June 12, 2024

Georgia Collier-Bolling
753 Kostmayer Ave
Slidell, La. 70458

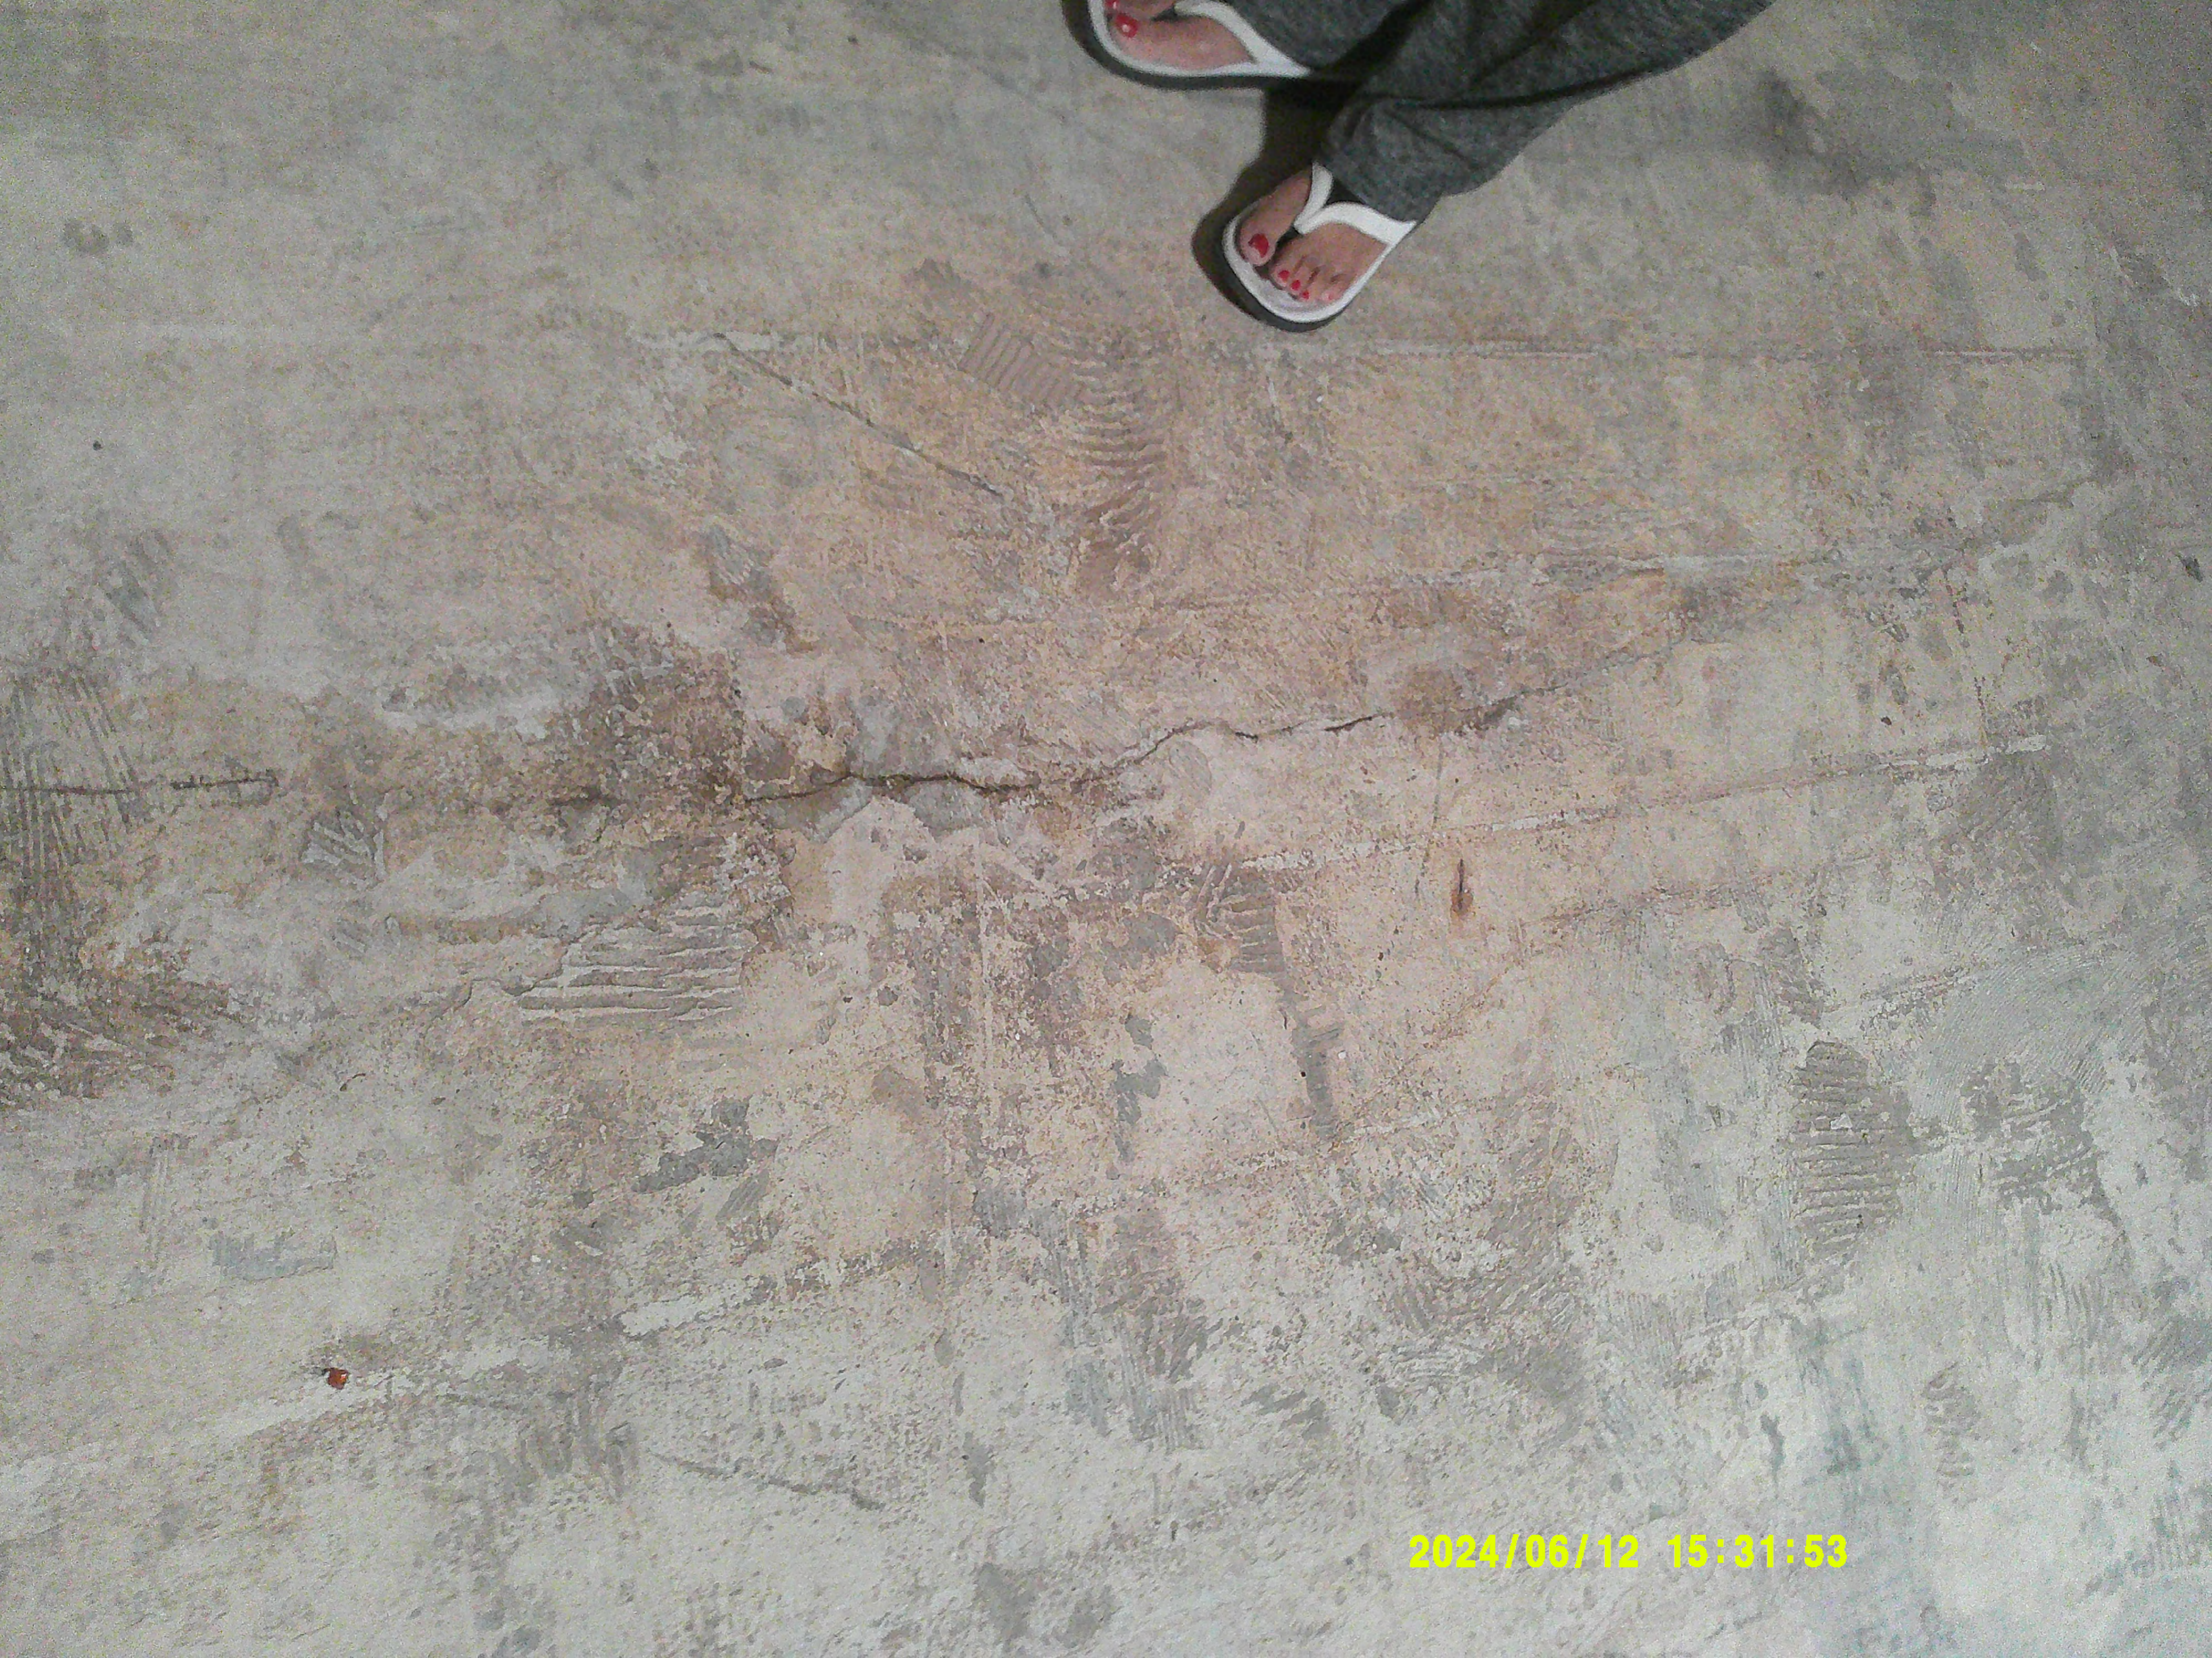
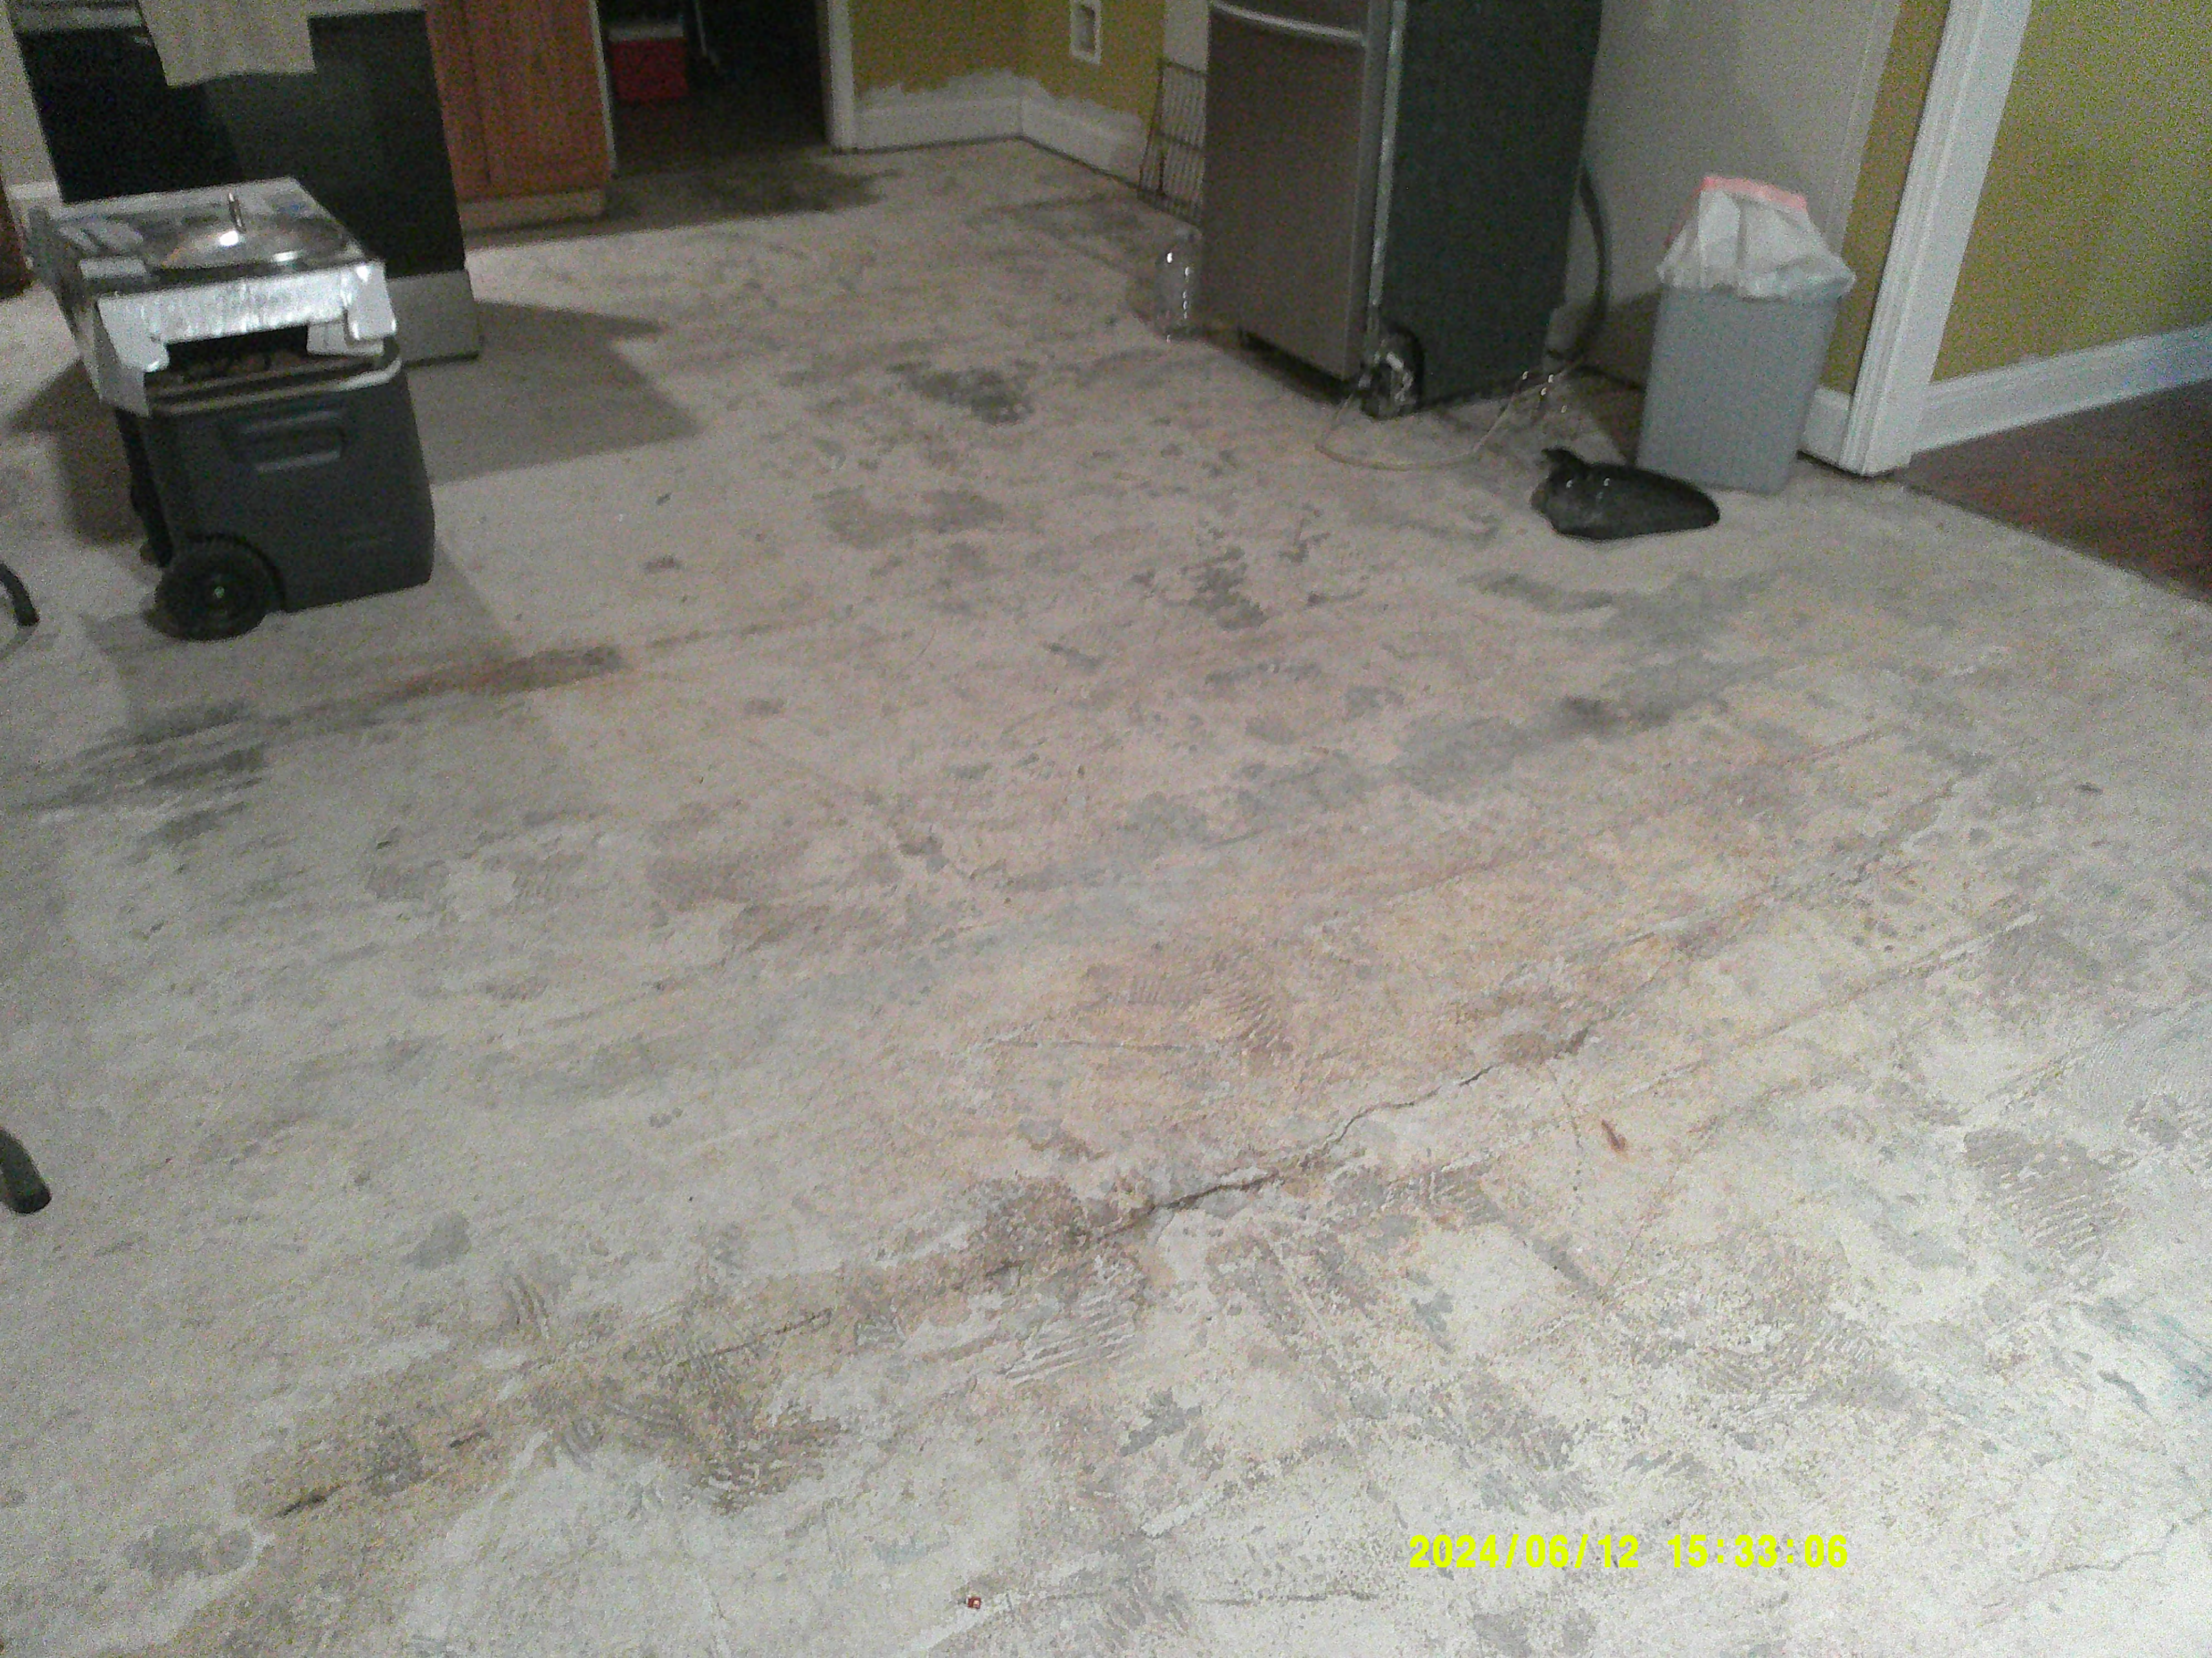
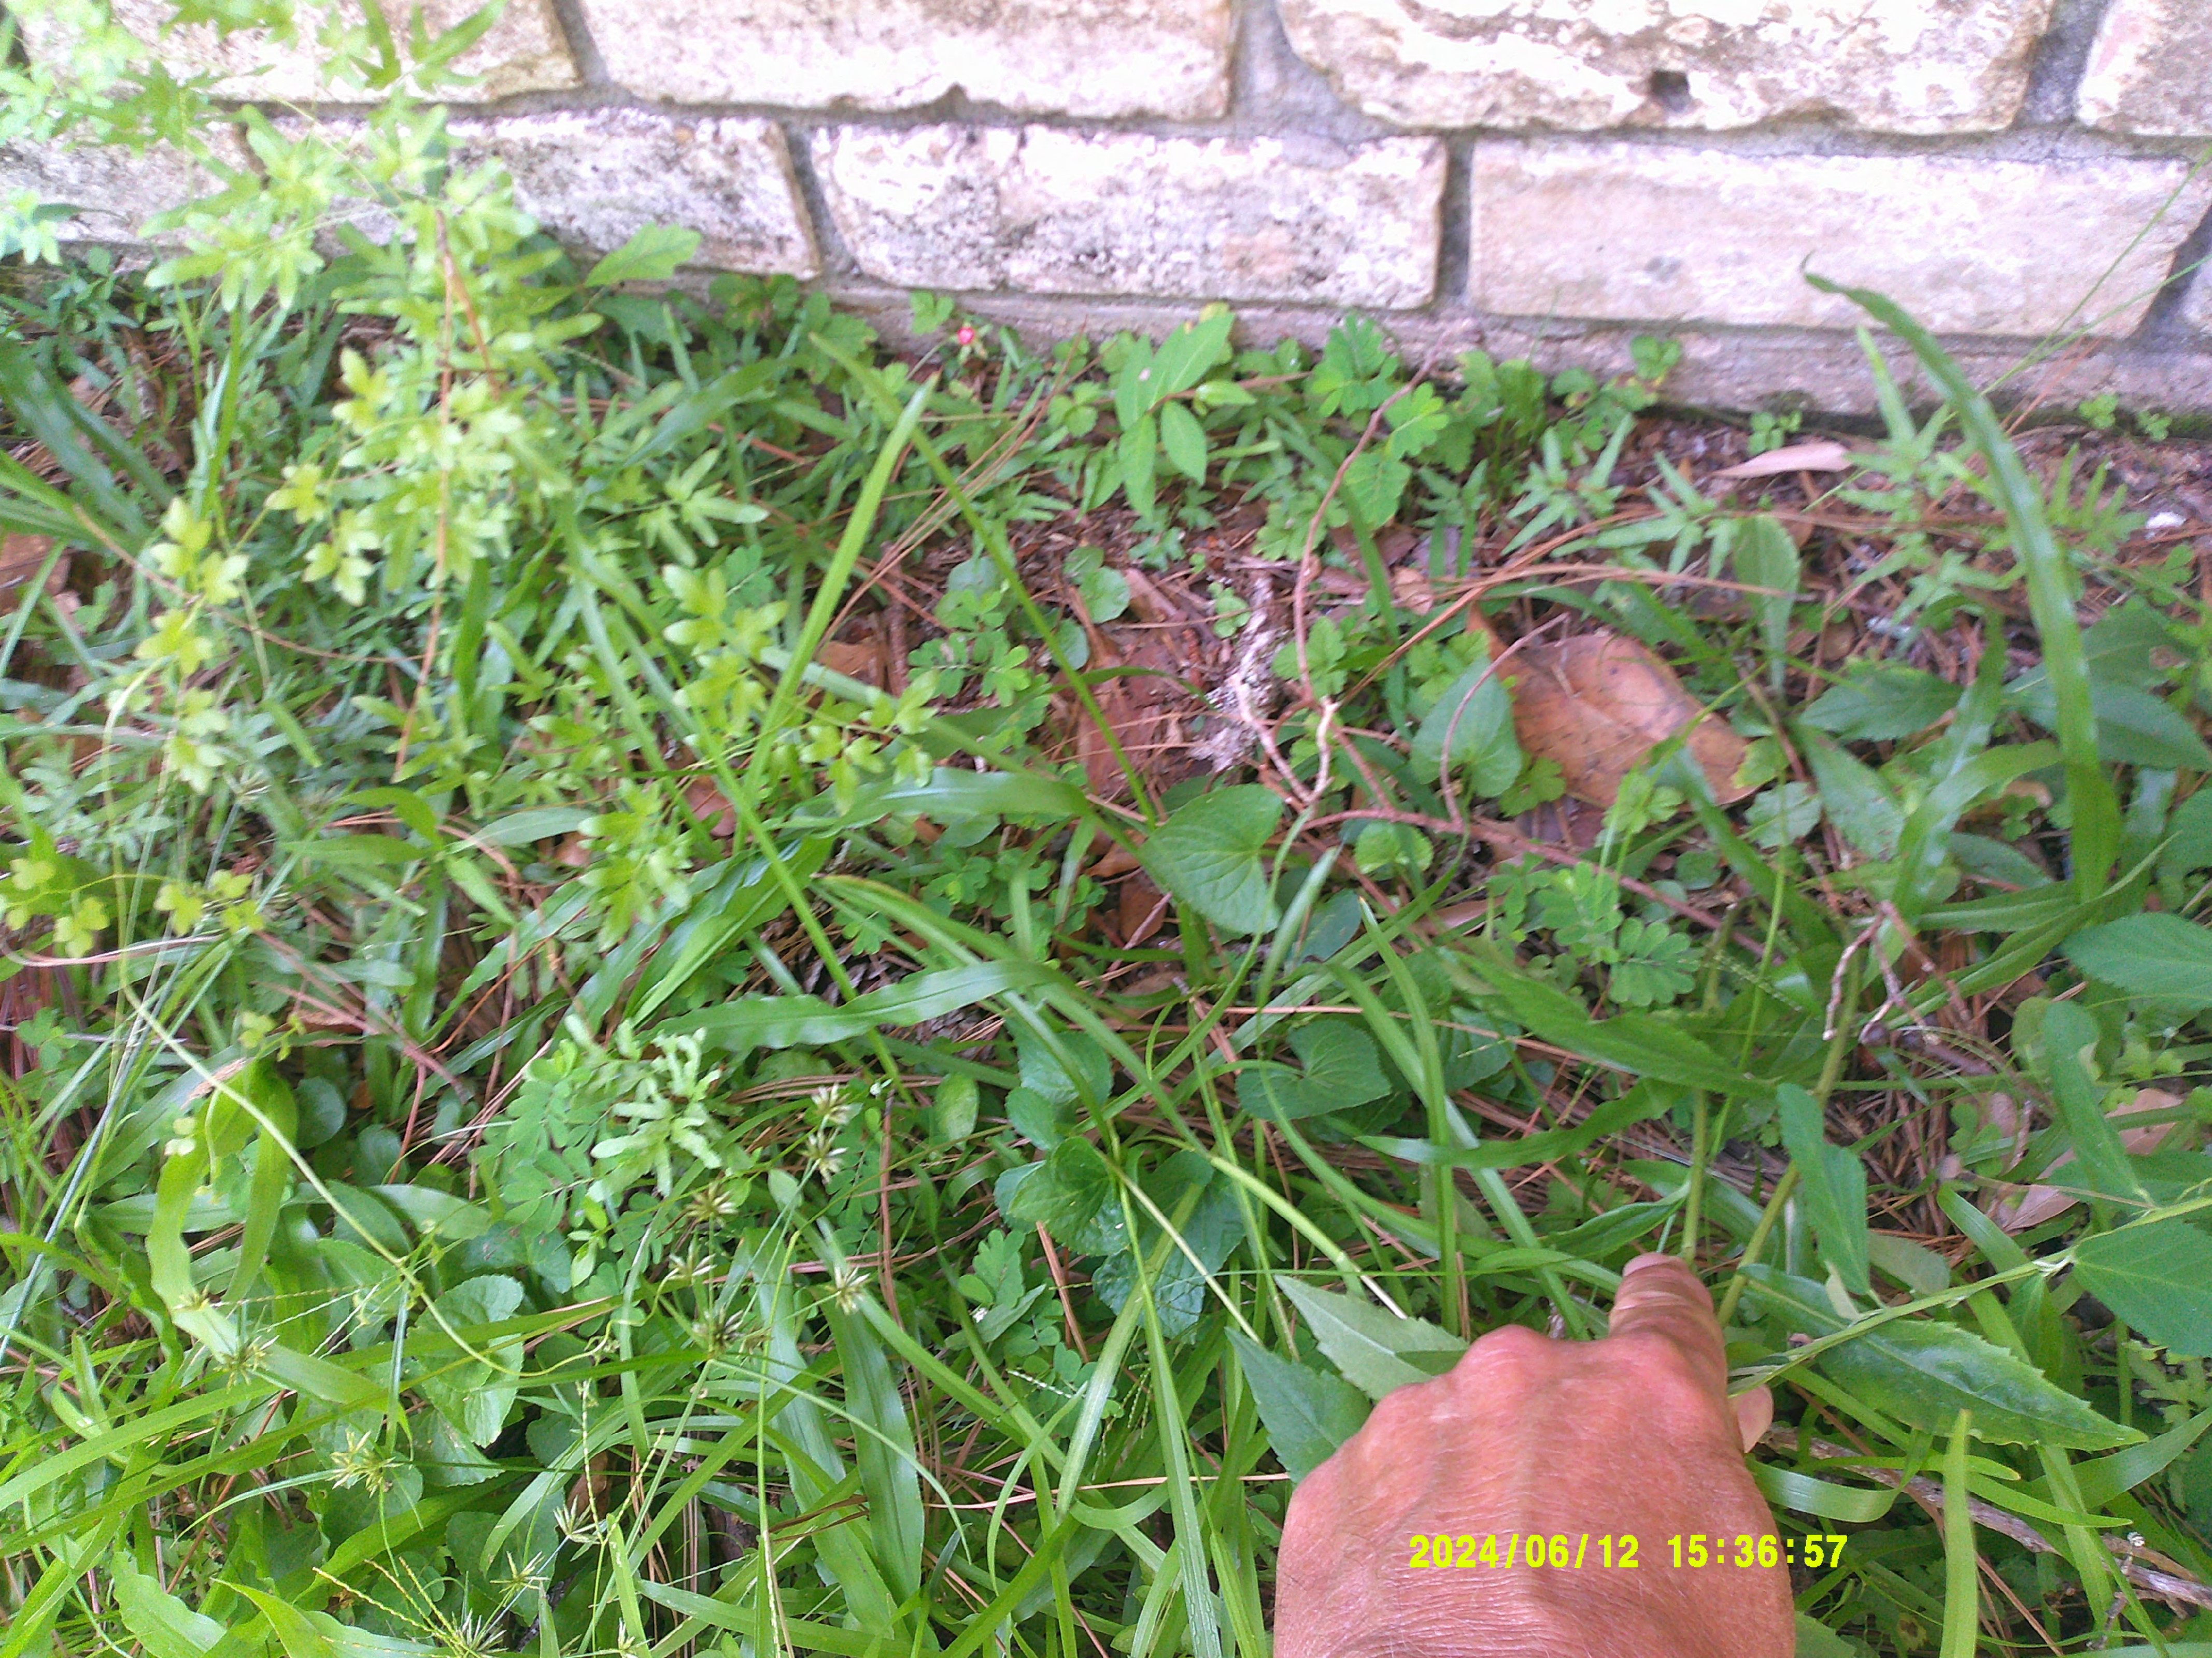
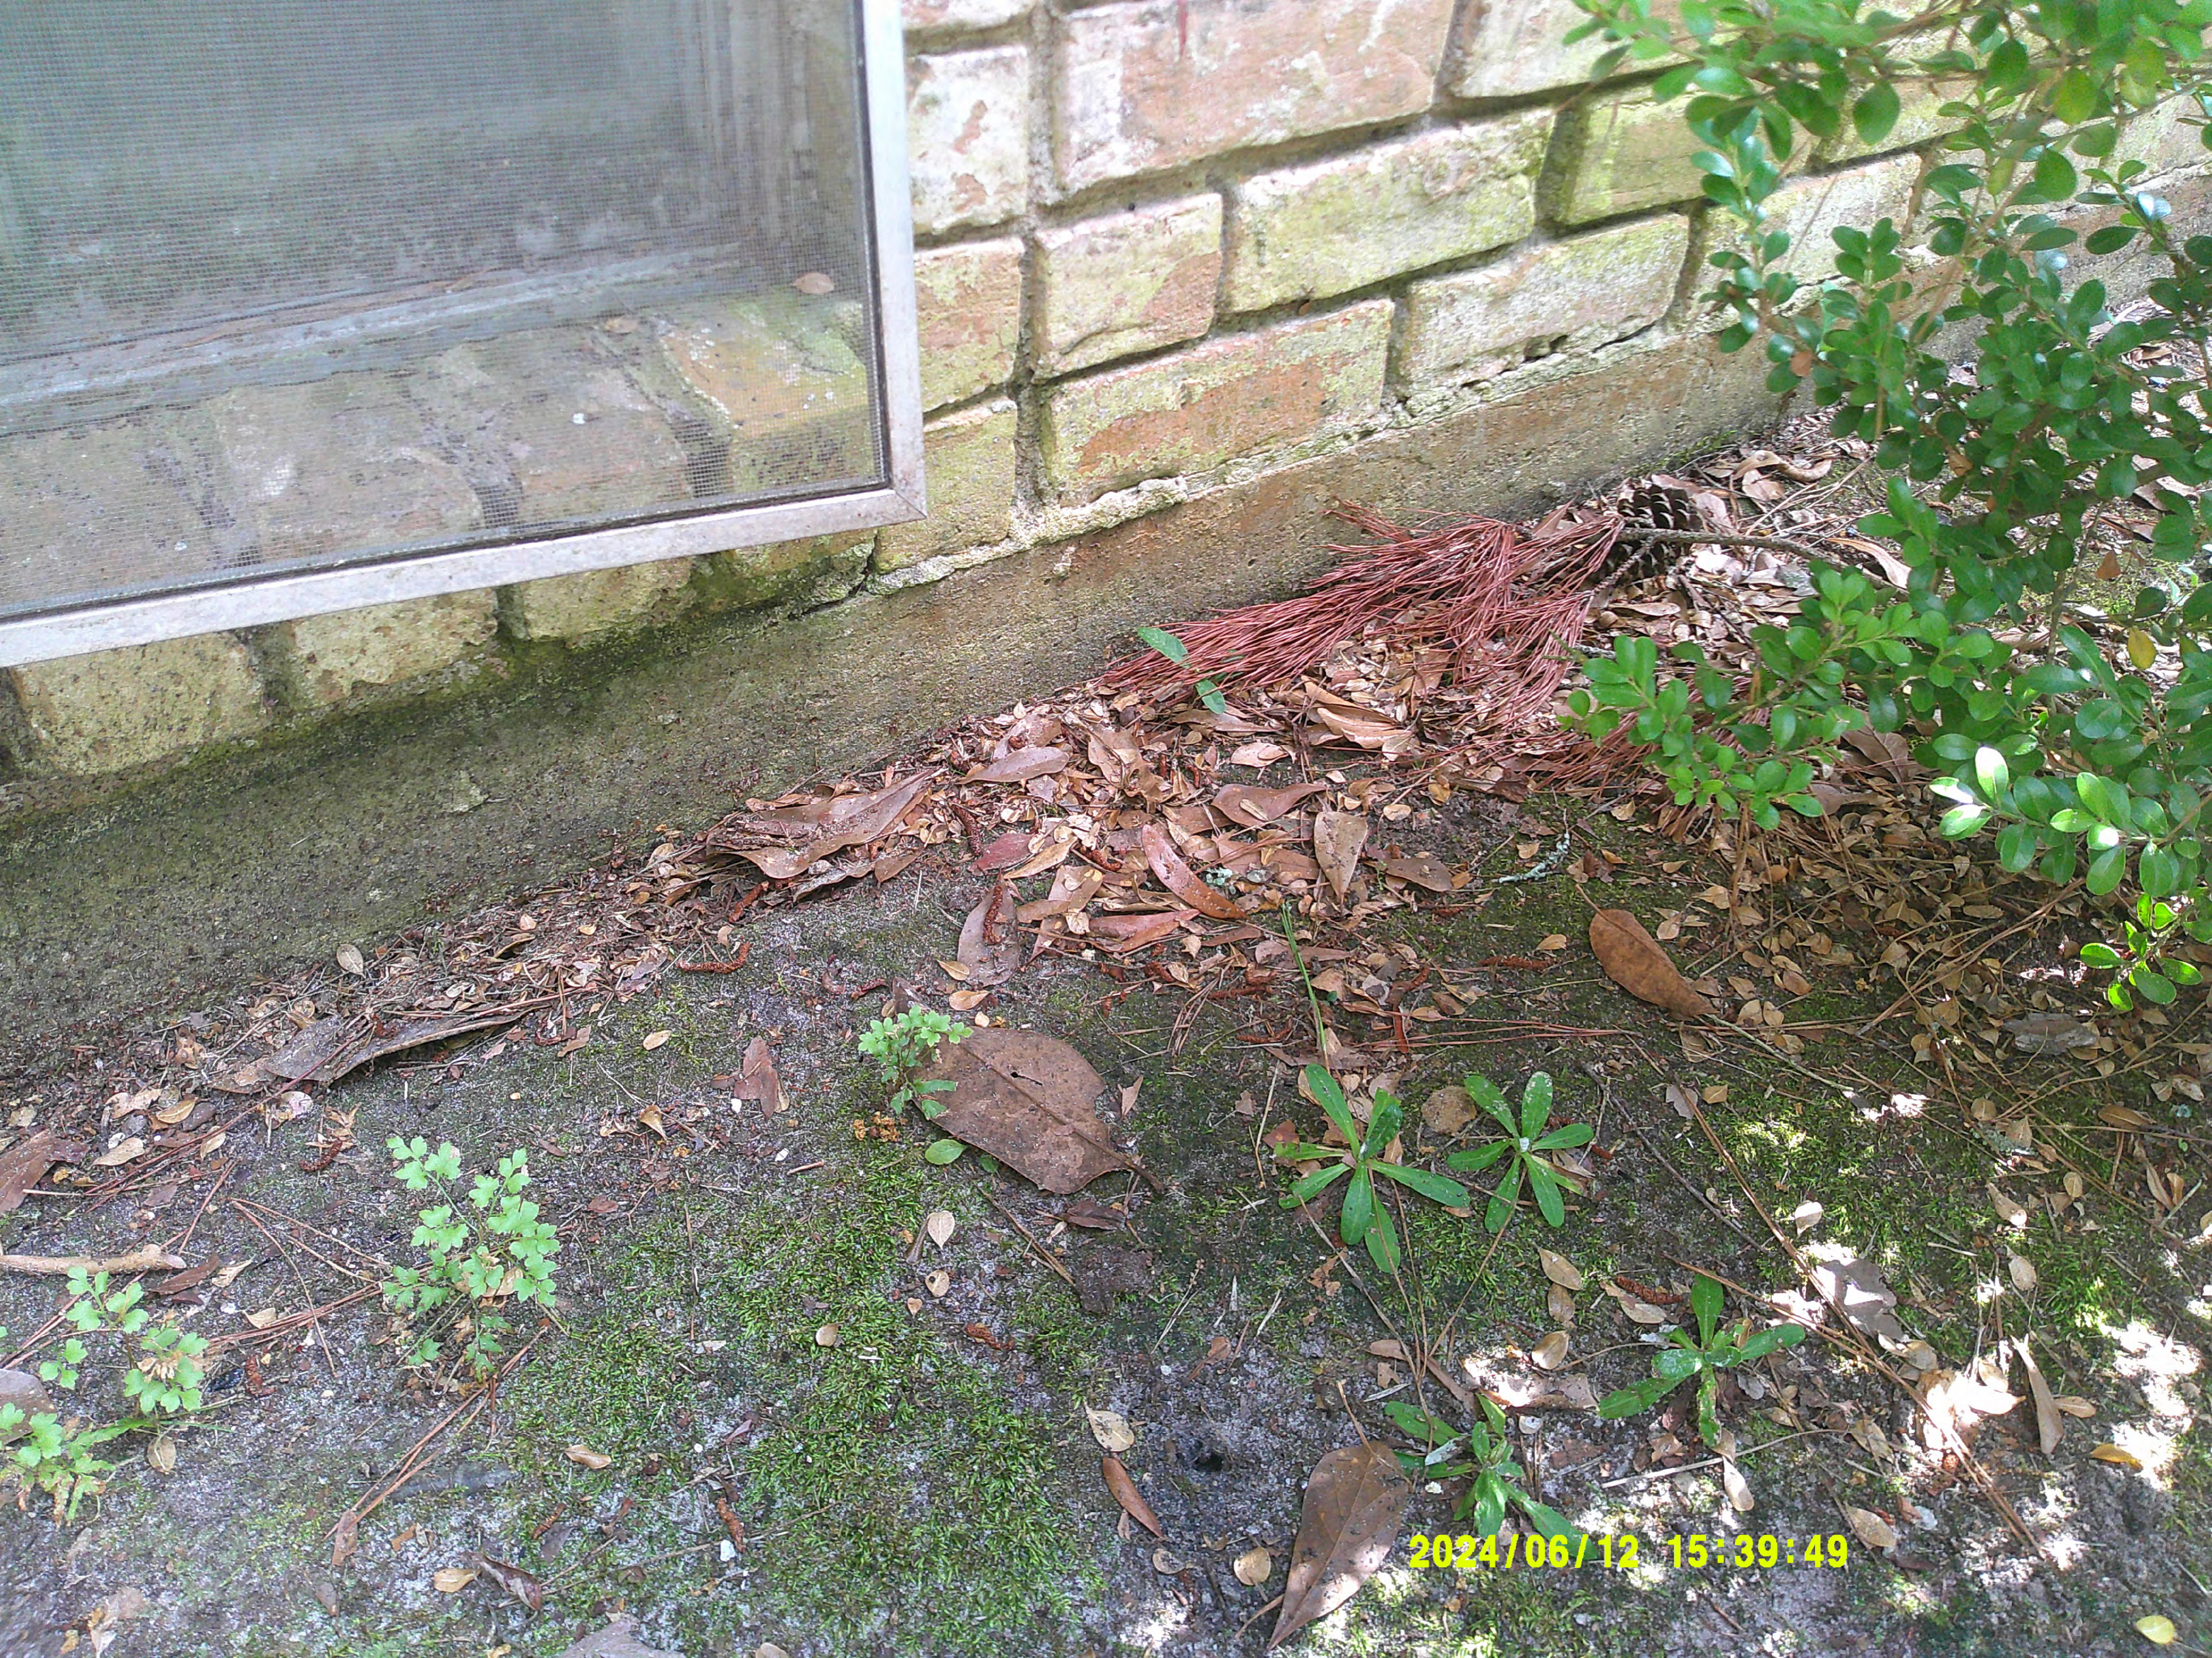
Upon inspection, the kitchen foundation was observed to have a crack in it that ran from the living room stud wall to the outside kitchen stud wall. No cracks were noted in the sheetrock ceilings or sheetrock walls.

An overall visual inspection of the exterior of the home was conducted and did not note and cracks in the brick veneer or the exposed foundation.

- 1) Provide proper drainage of rainwater away from the foundation and keep dry.
- 2) Seal the crack in the foundation with a non-shrinking grout, to prevent insects and water from entering the home.
