Block piece literally popped out of wall and fell in front of me inside! Missed me by a couple feet.

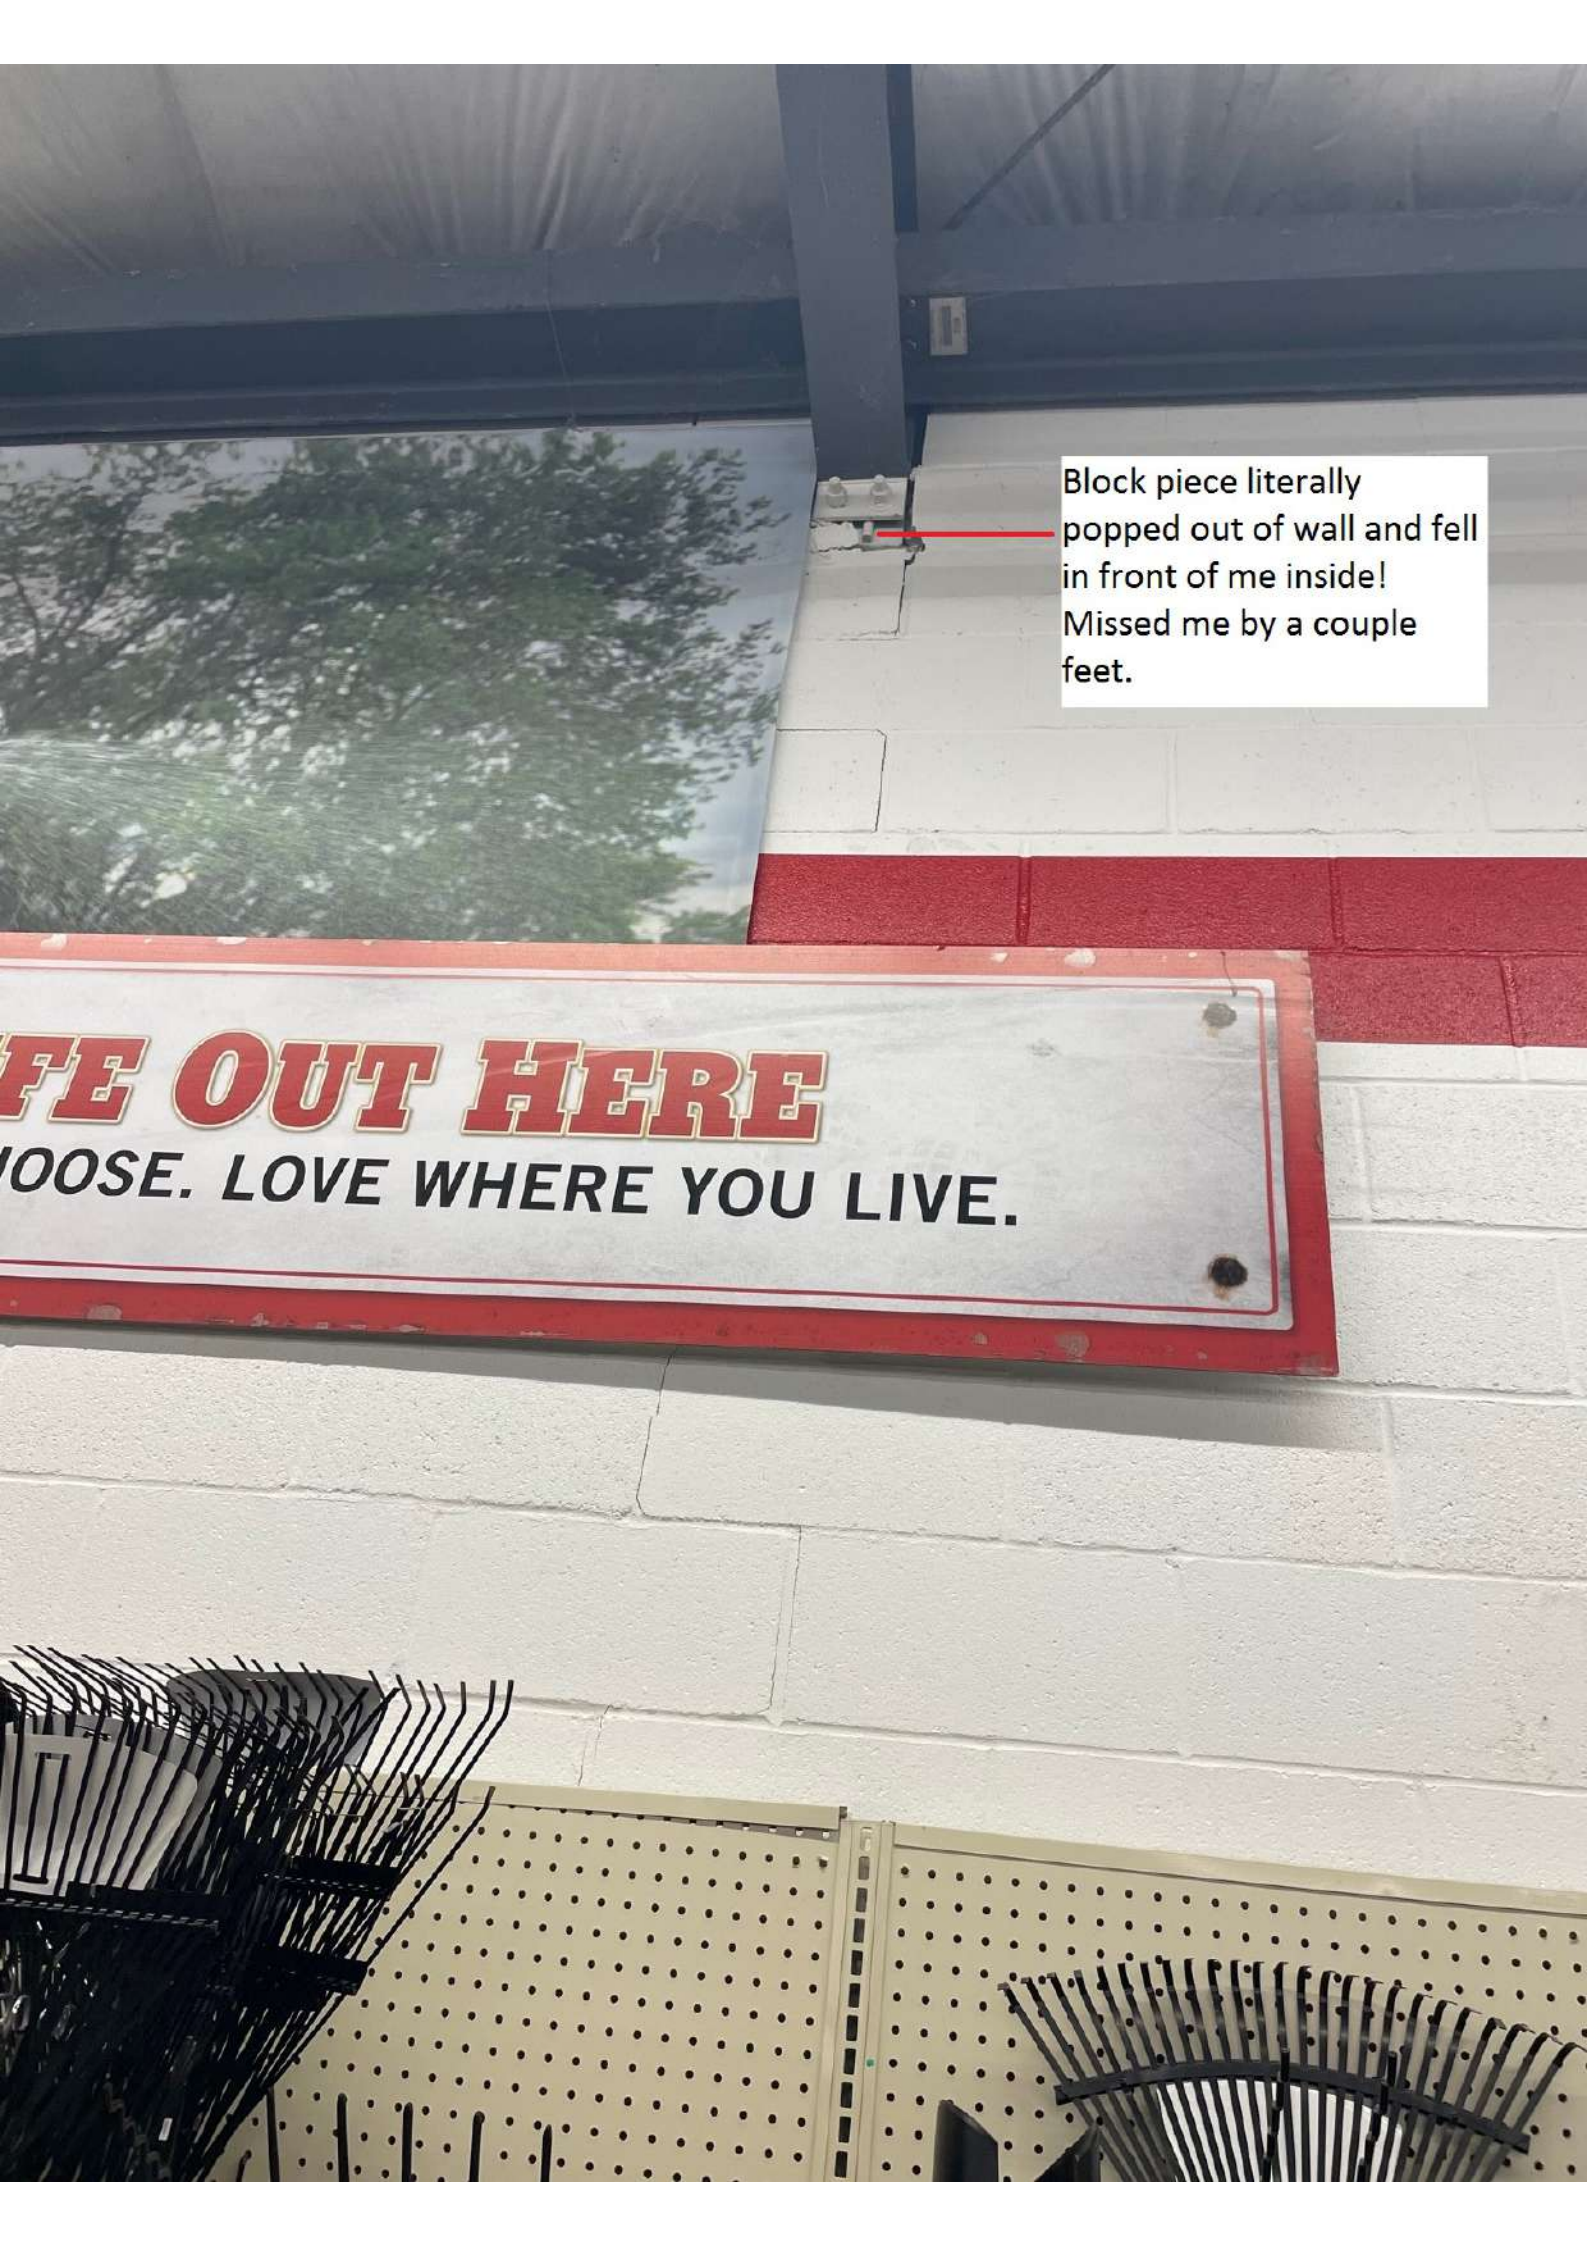
A photograph of a store's exterior wall. The wall is made of light-colored concrete blocks. A red horizontal band runs across the wall. Below the band is a white sign with a red border. The sign has the text "LIFE OUT HERE" in large, bold, red letters, and "MOOSE. LOVE WHERE YOU LIVE." in smaller, black letters below it. A red line points to a loose concrete block at the top of the wall, just above the sign. A white text box with a red line pointing to the block contains the text: "Block piece literally popped out of wall and fell in front of me inside! Missed me by a couple feet."

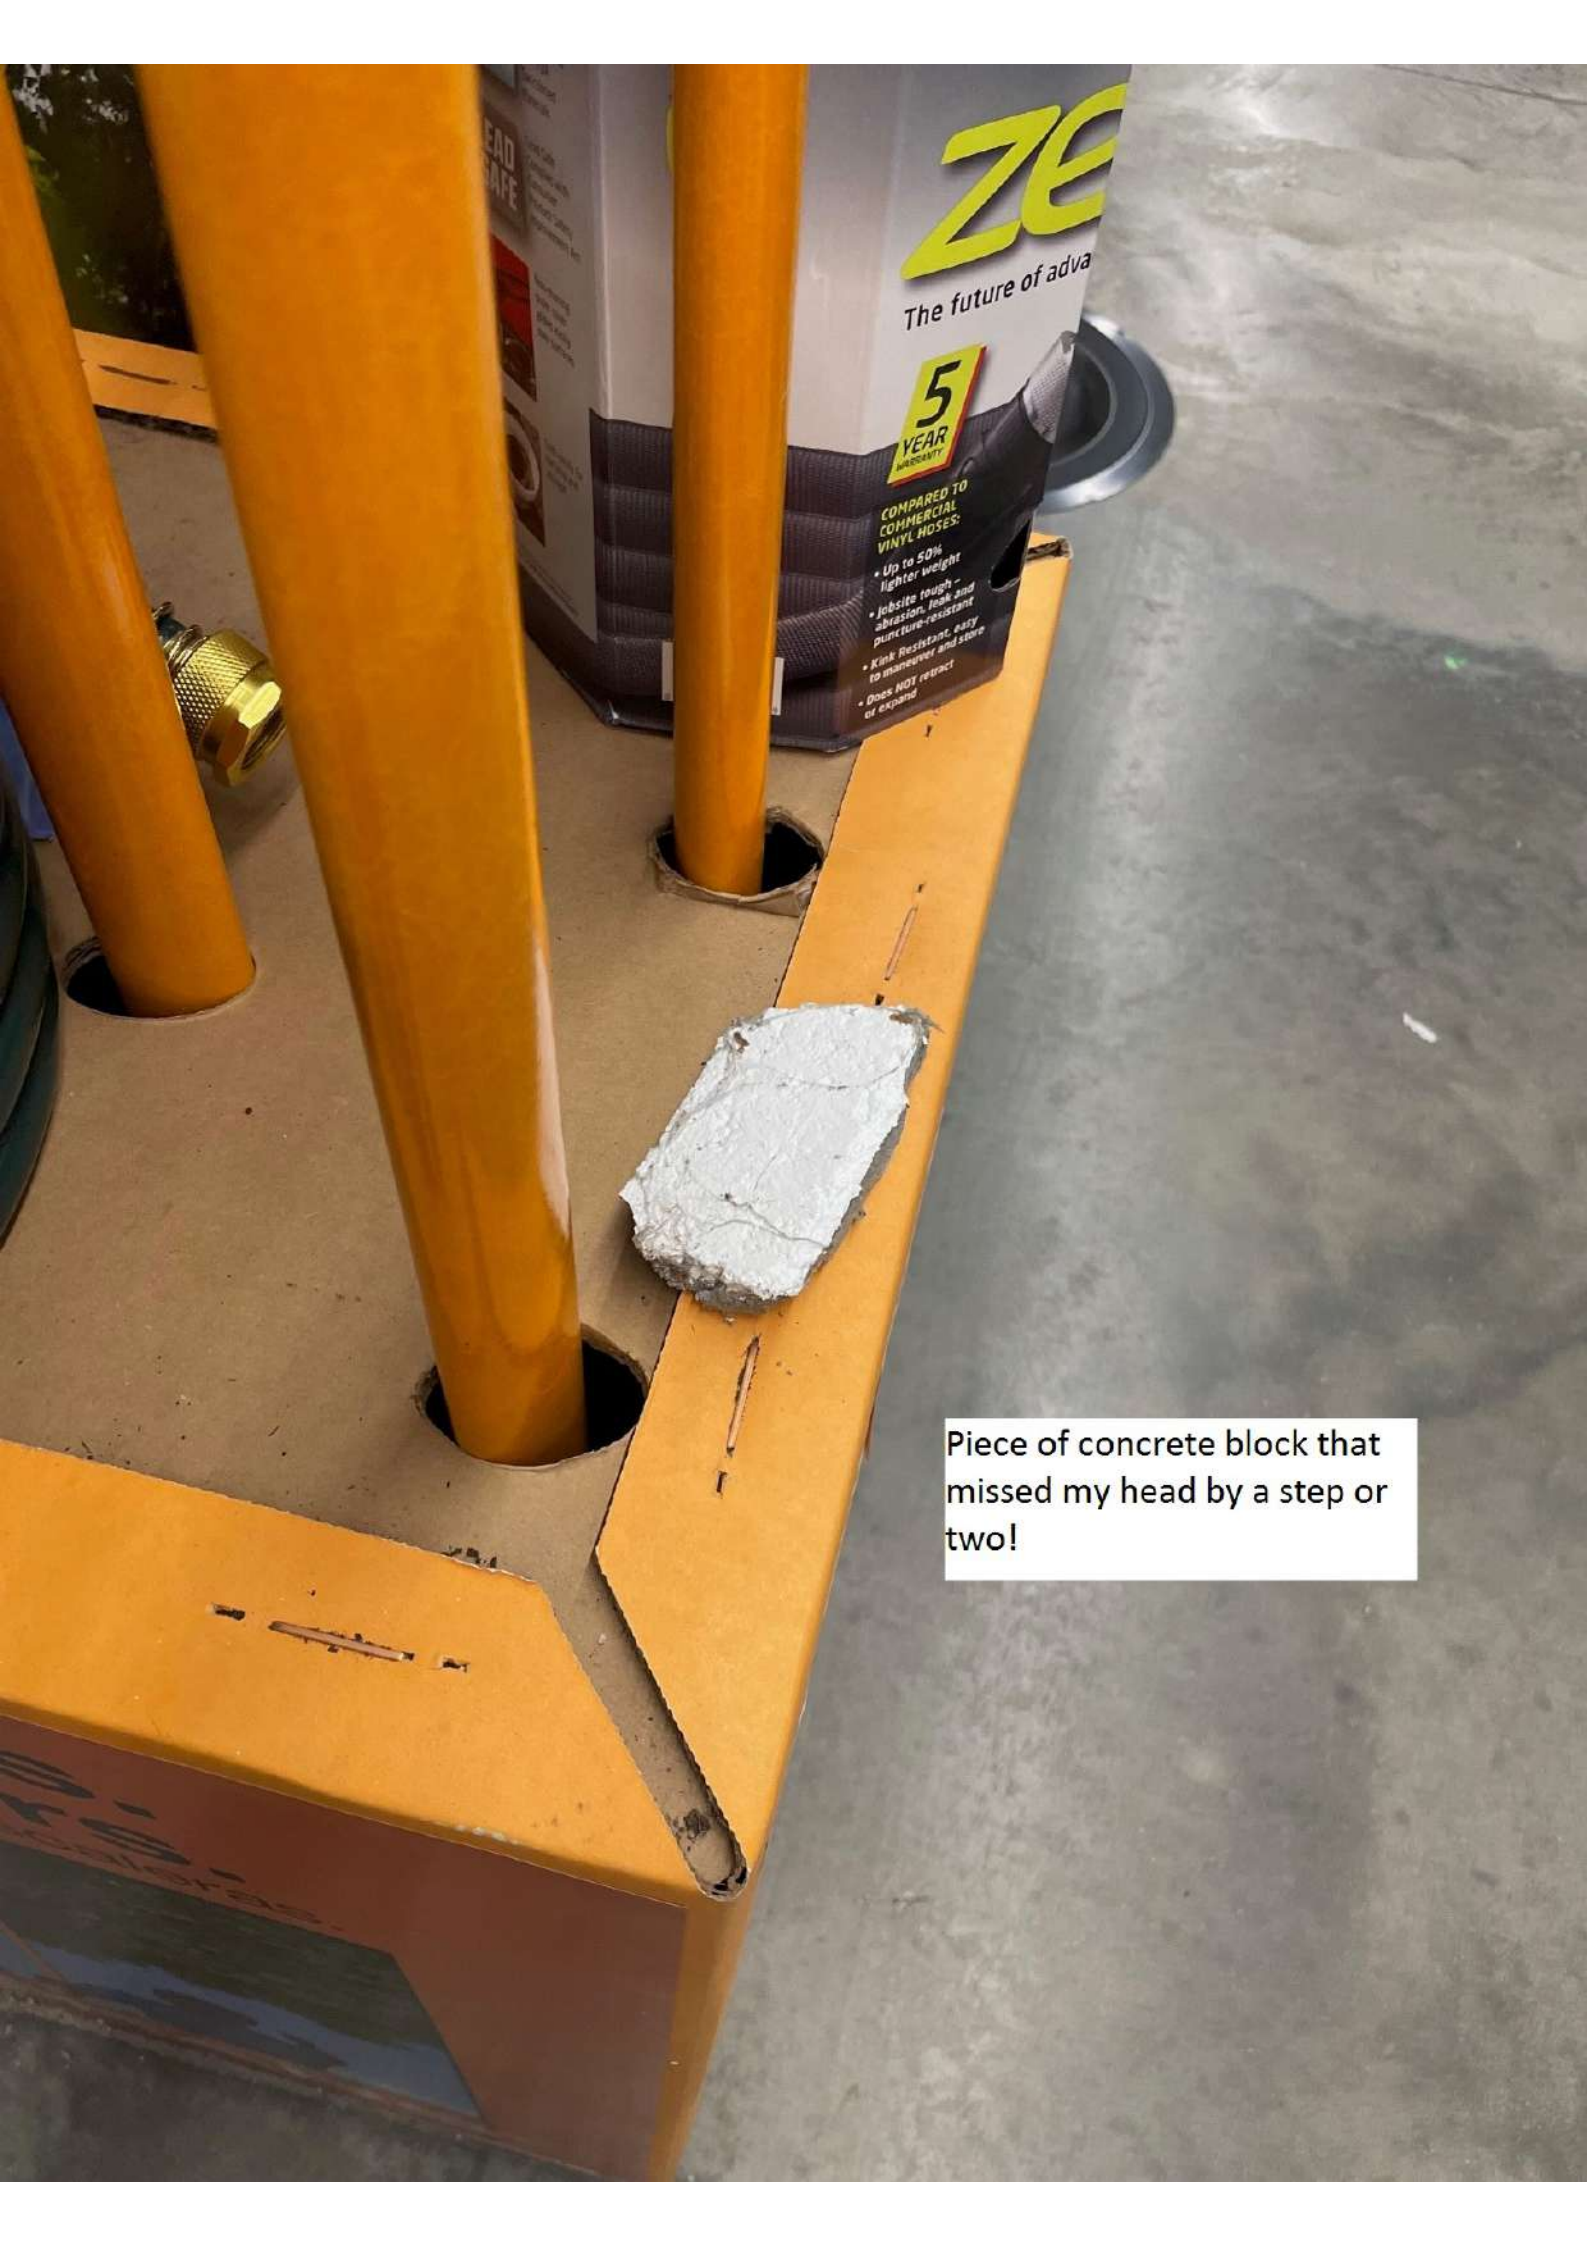
Piece of concrete block that missed my head by a step or two!

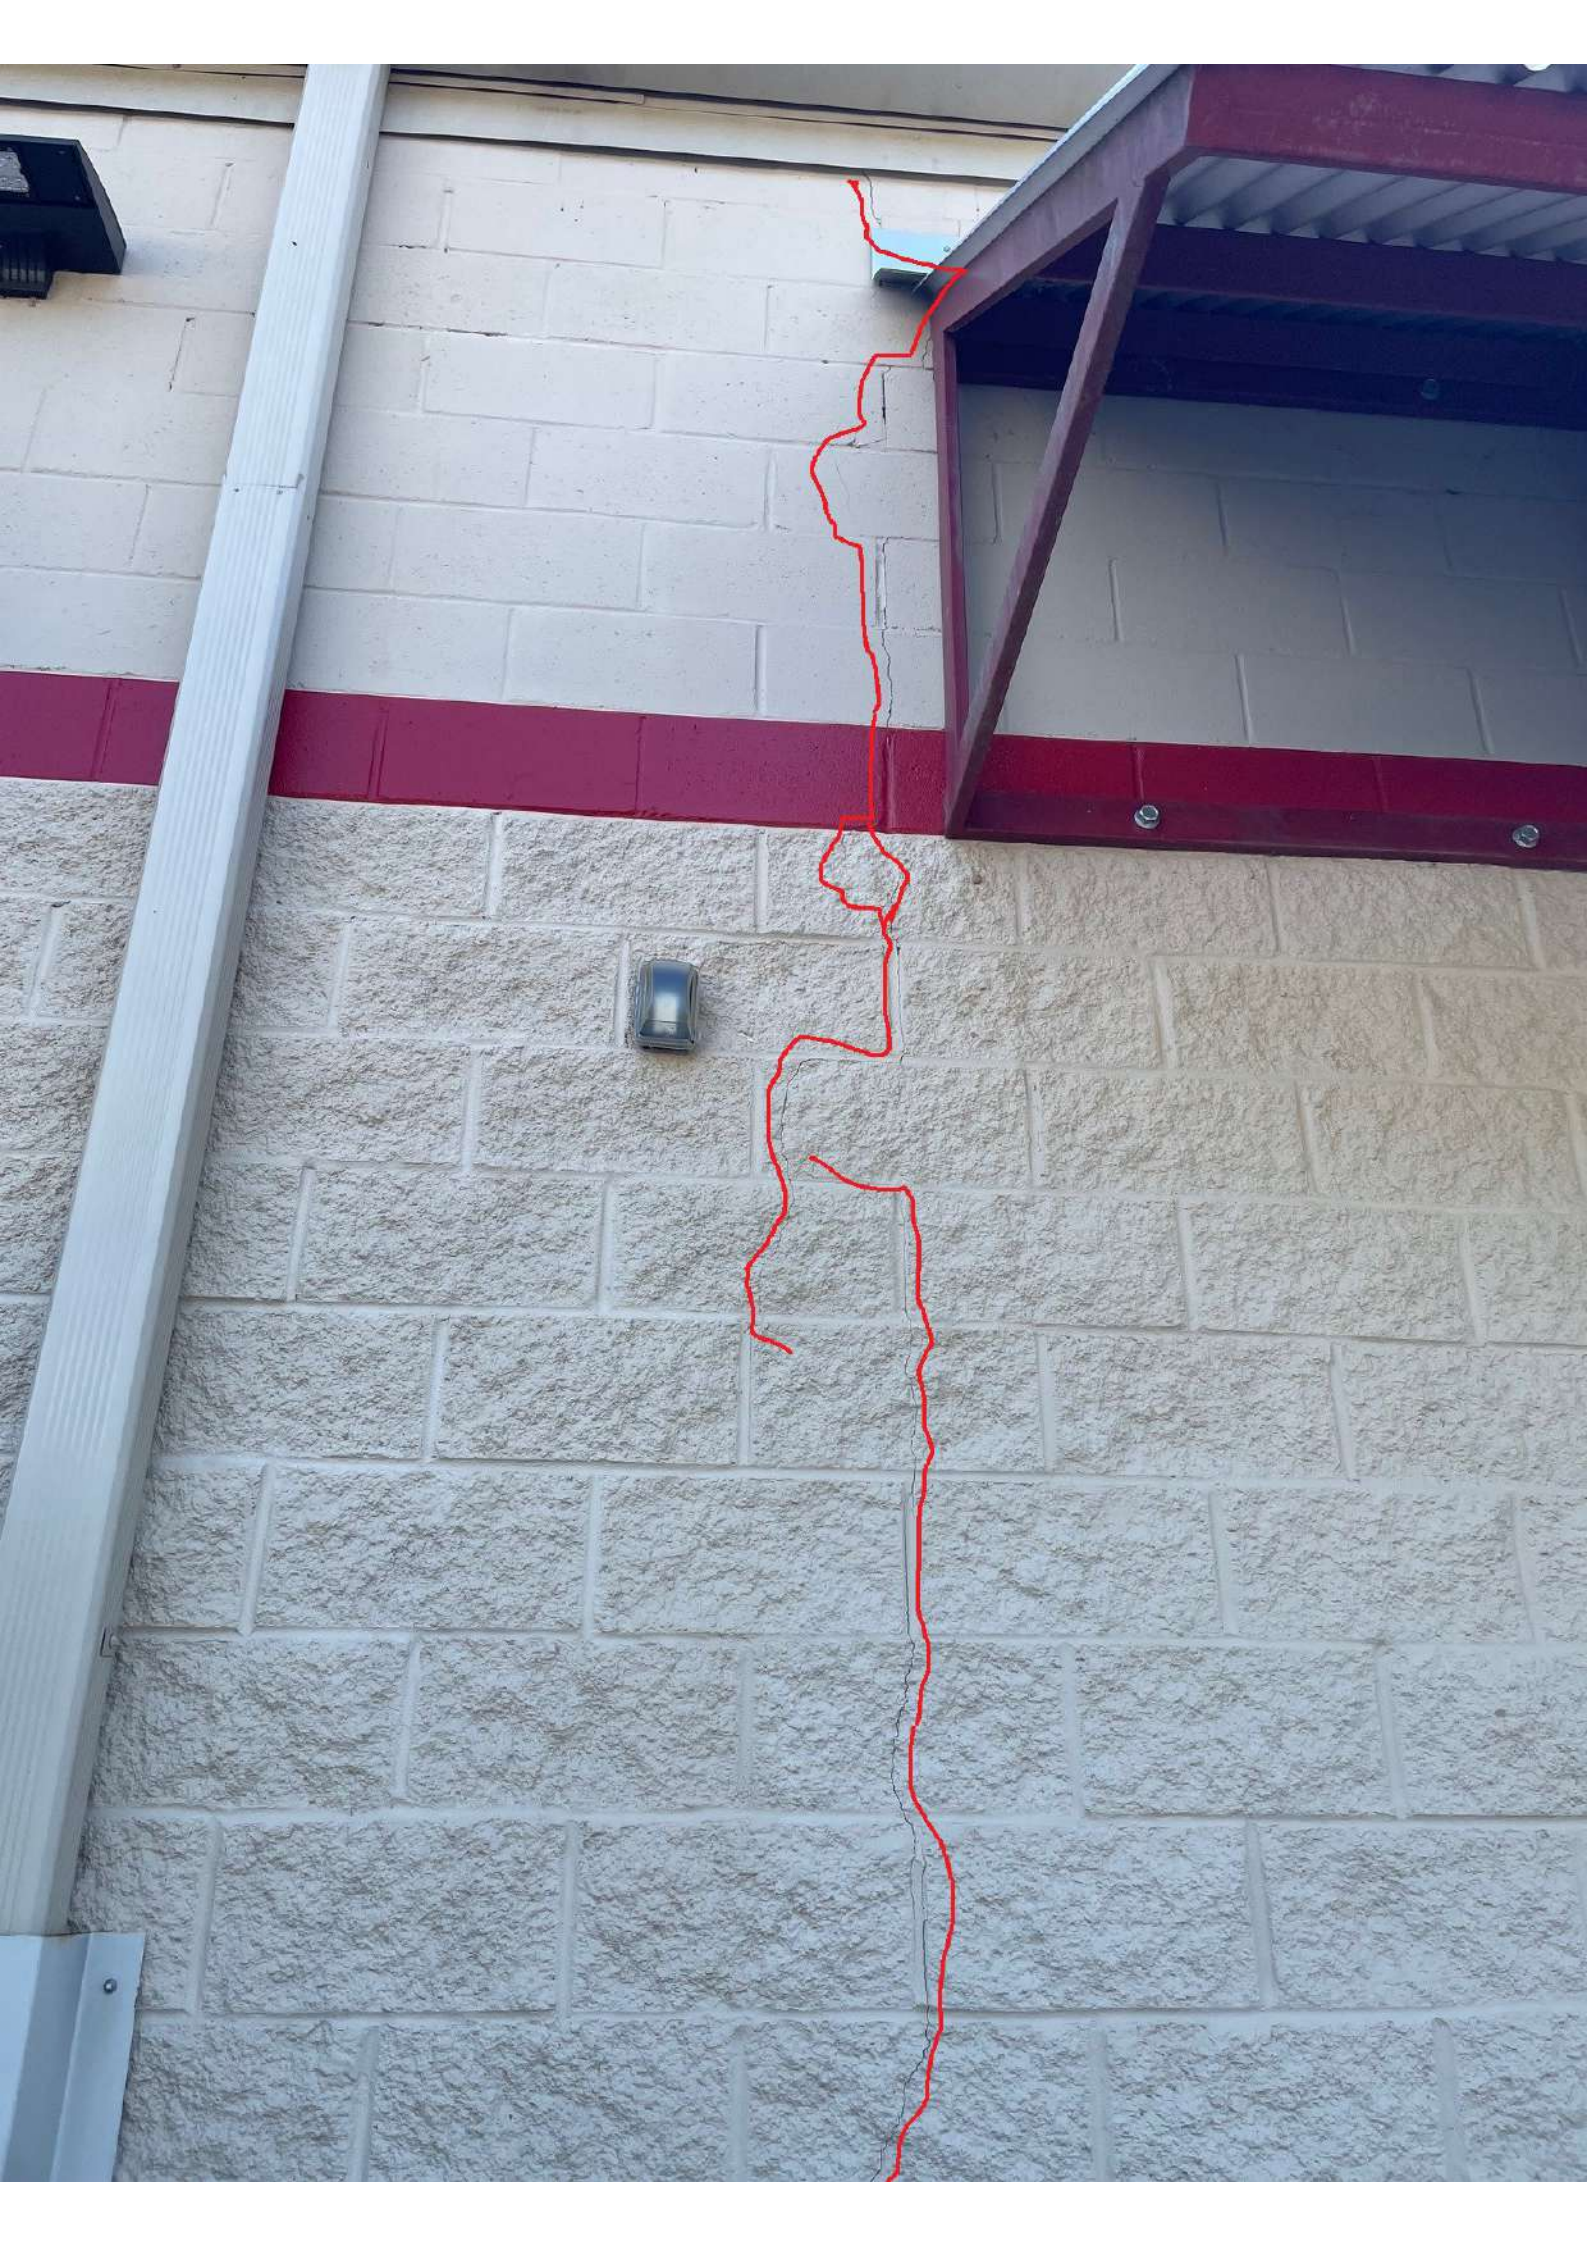
Block facade has popped off here. Directly behind hole is a steel beam holding a roof truss.

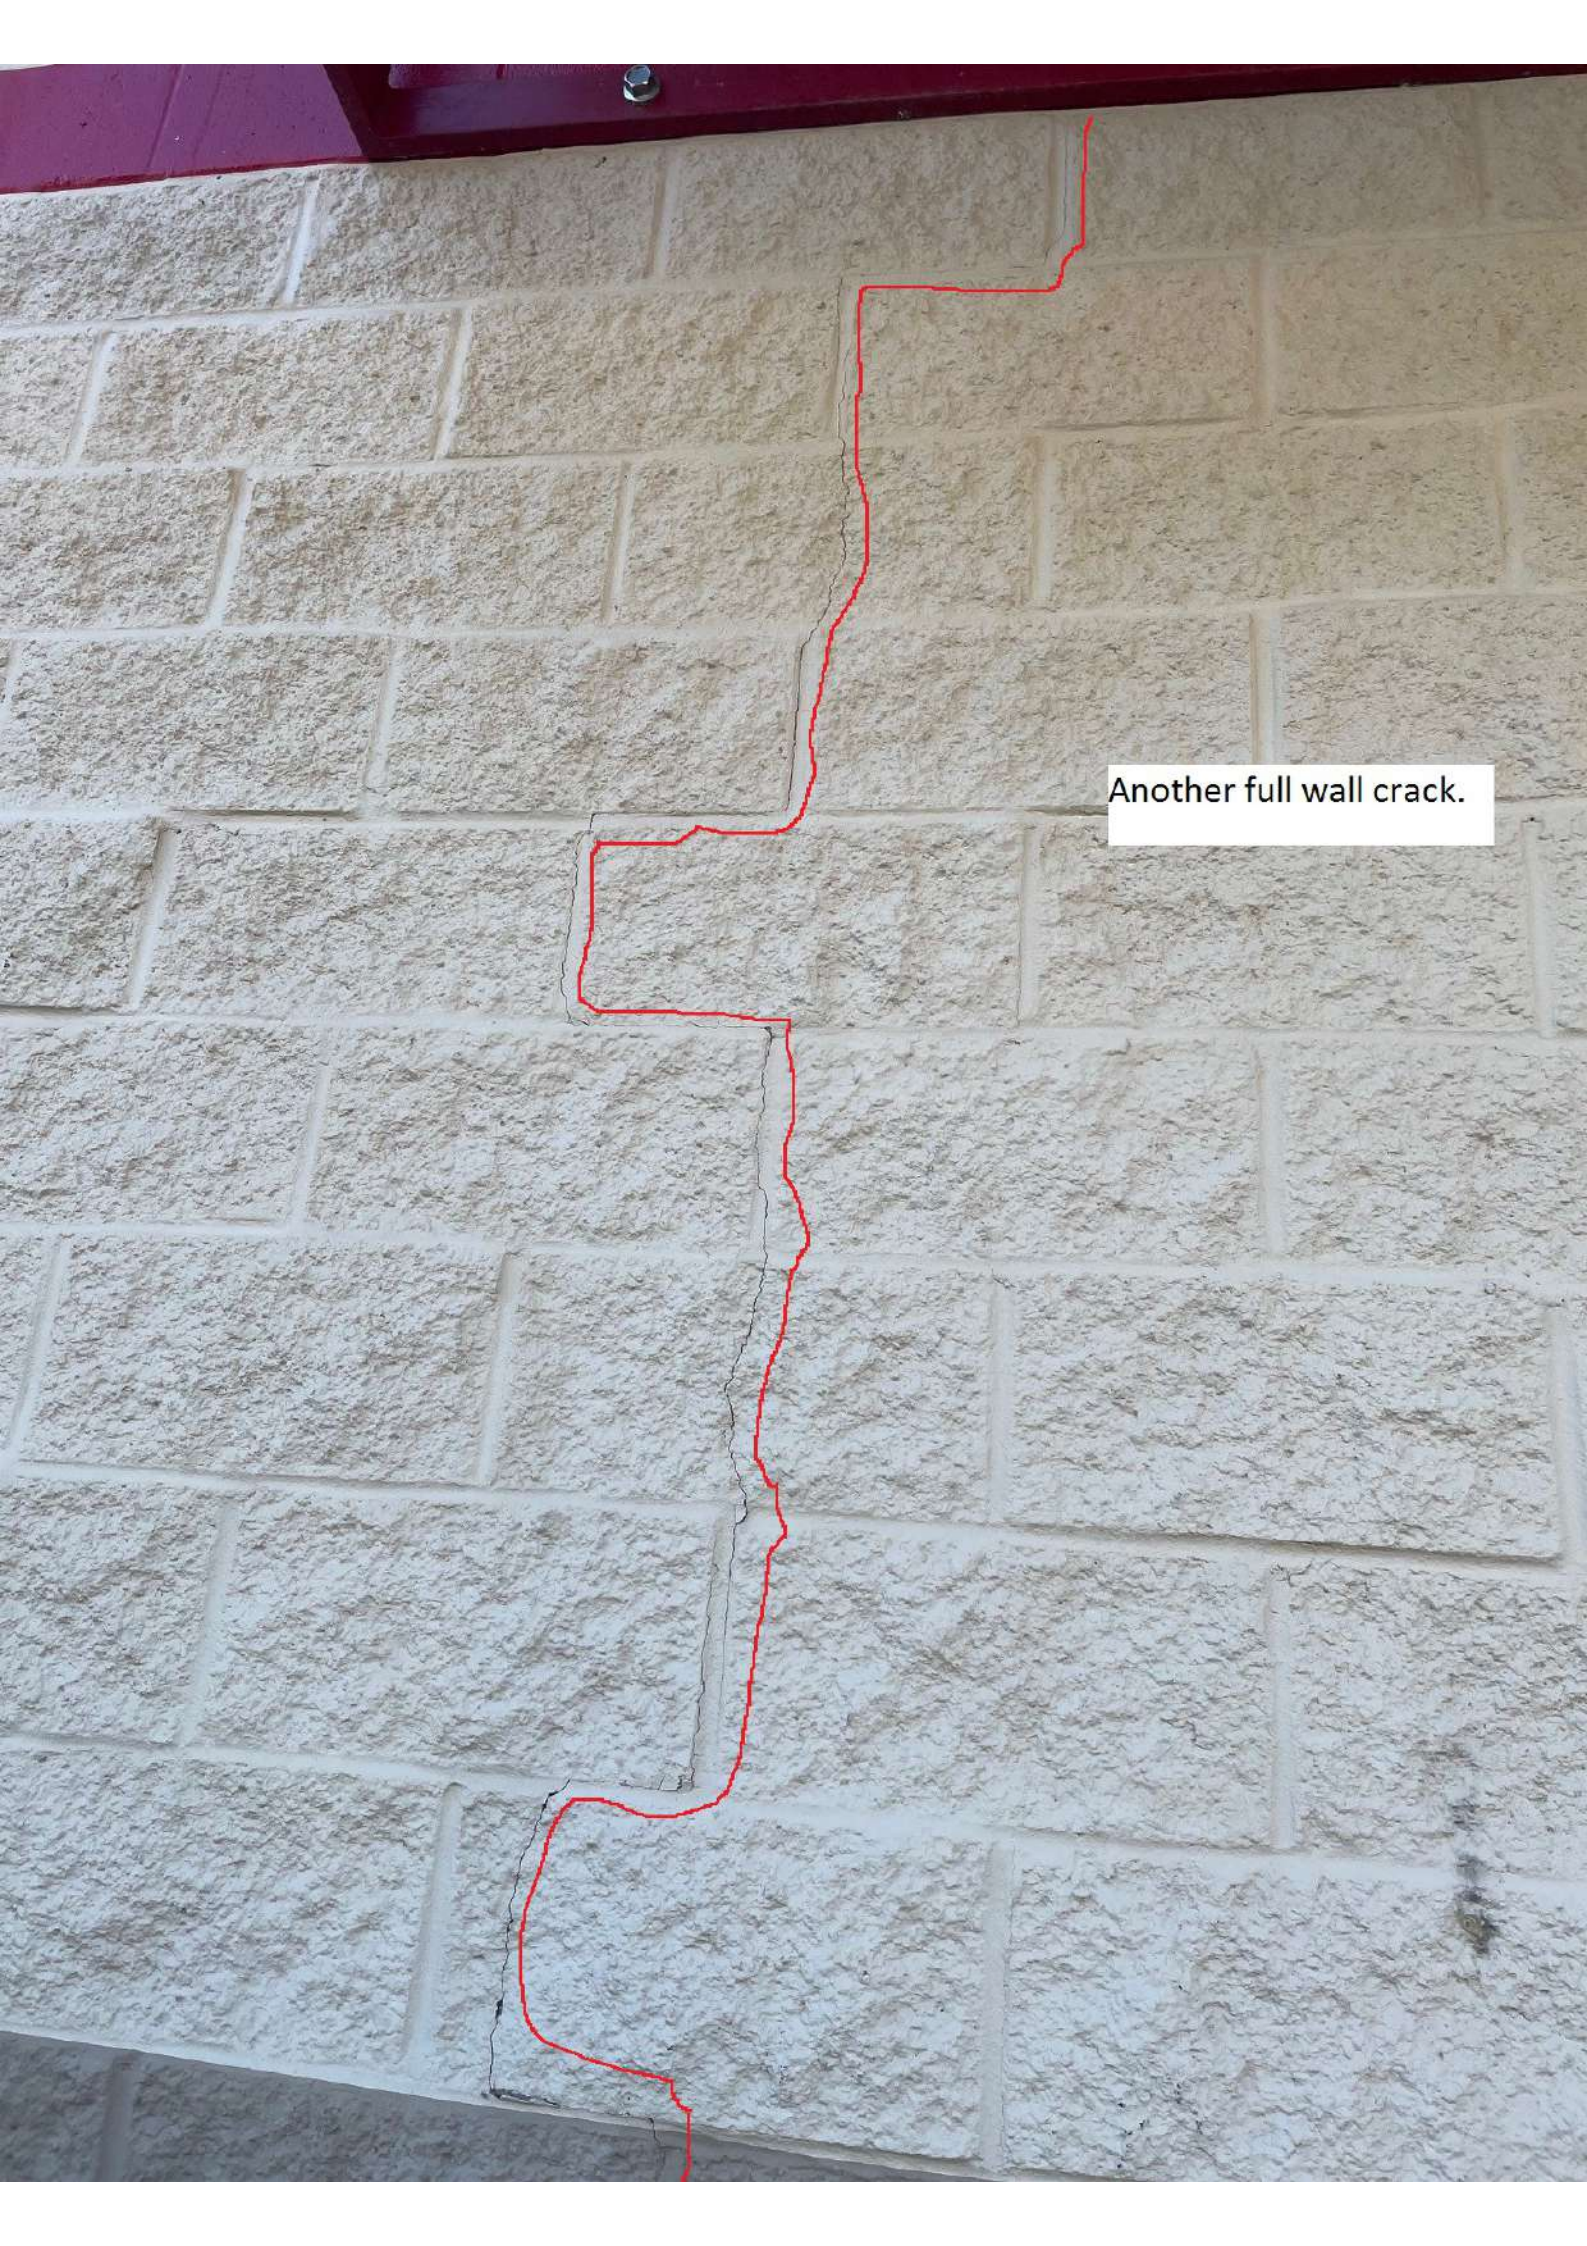
Another full wall crack.

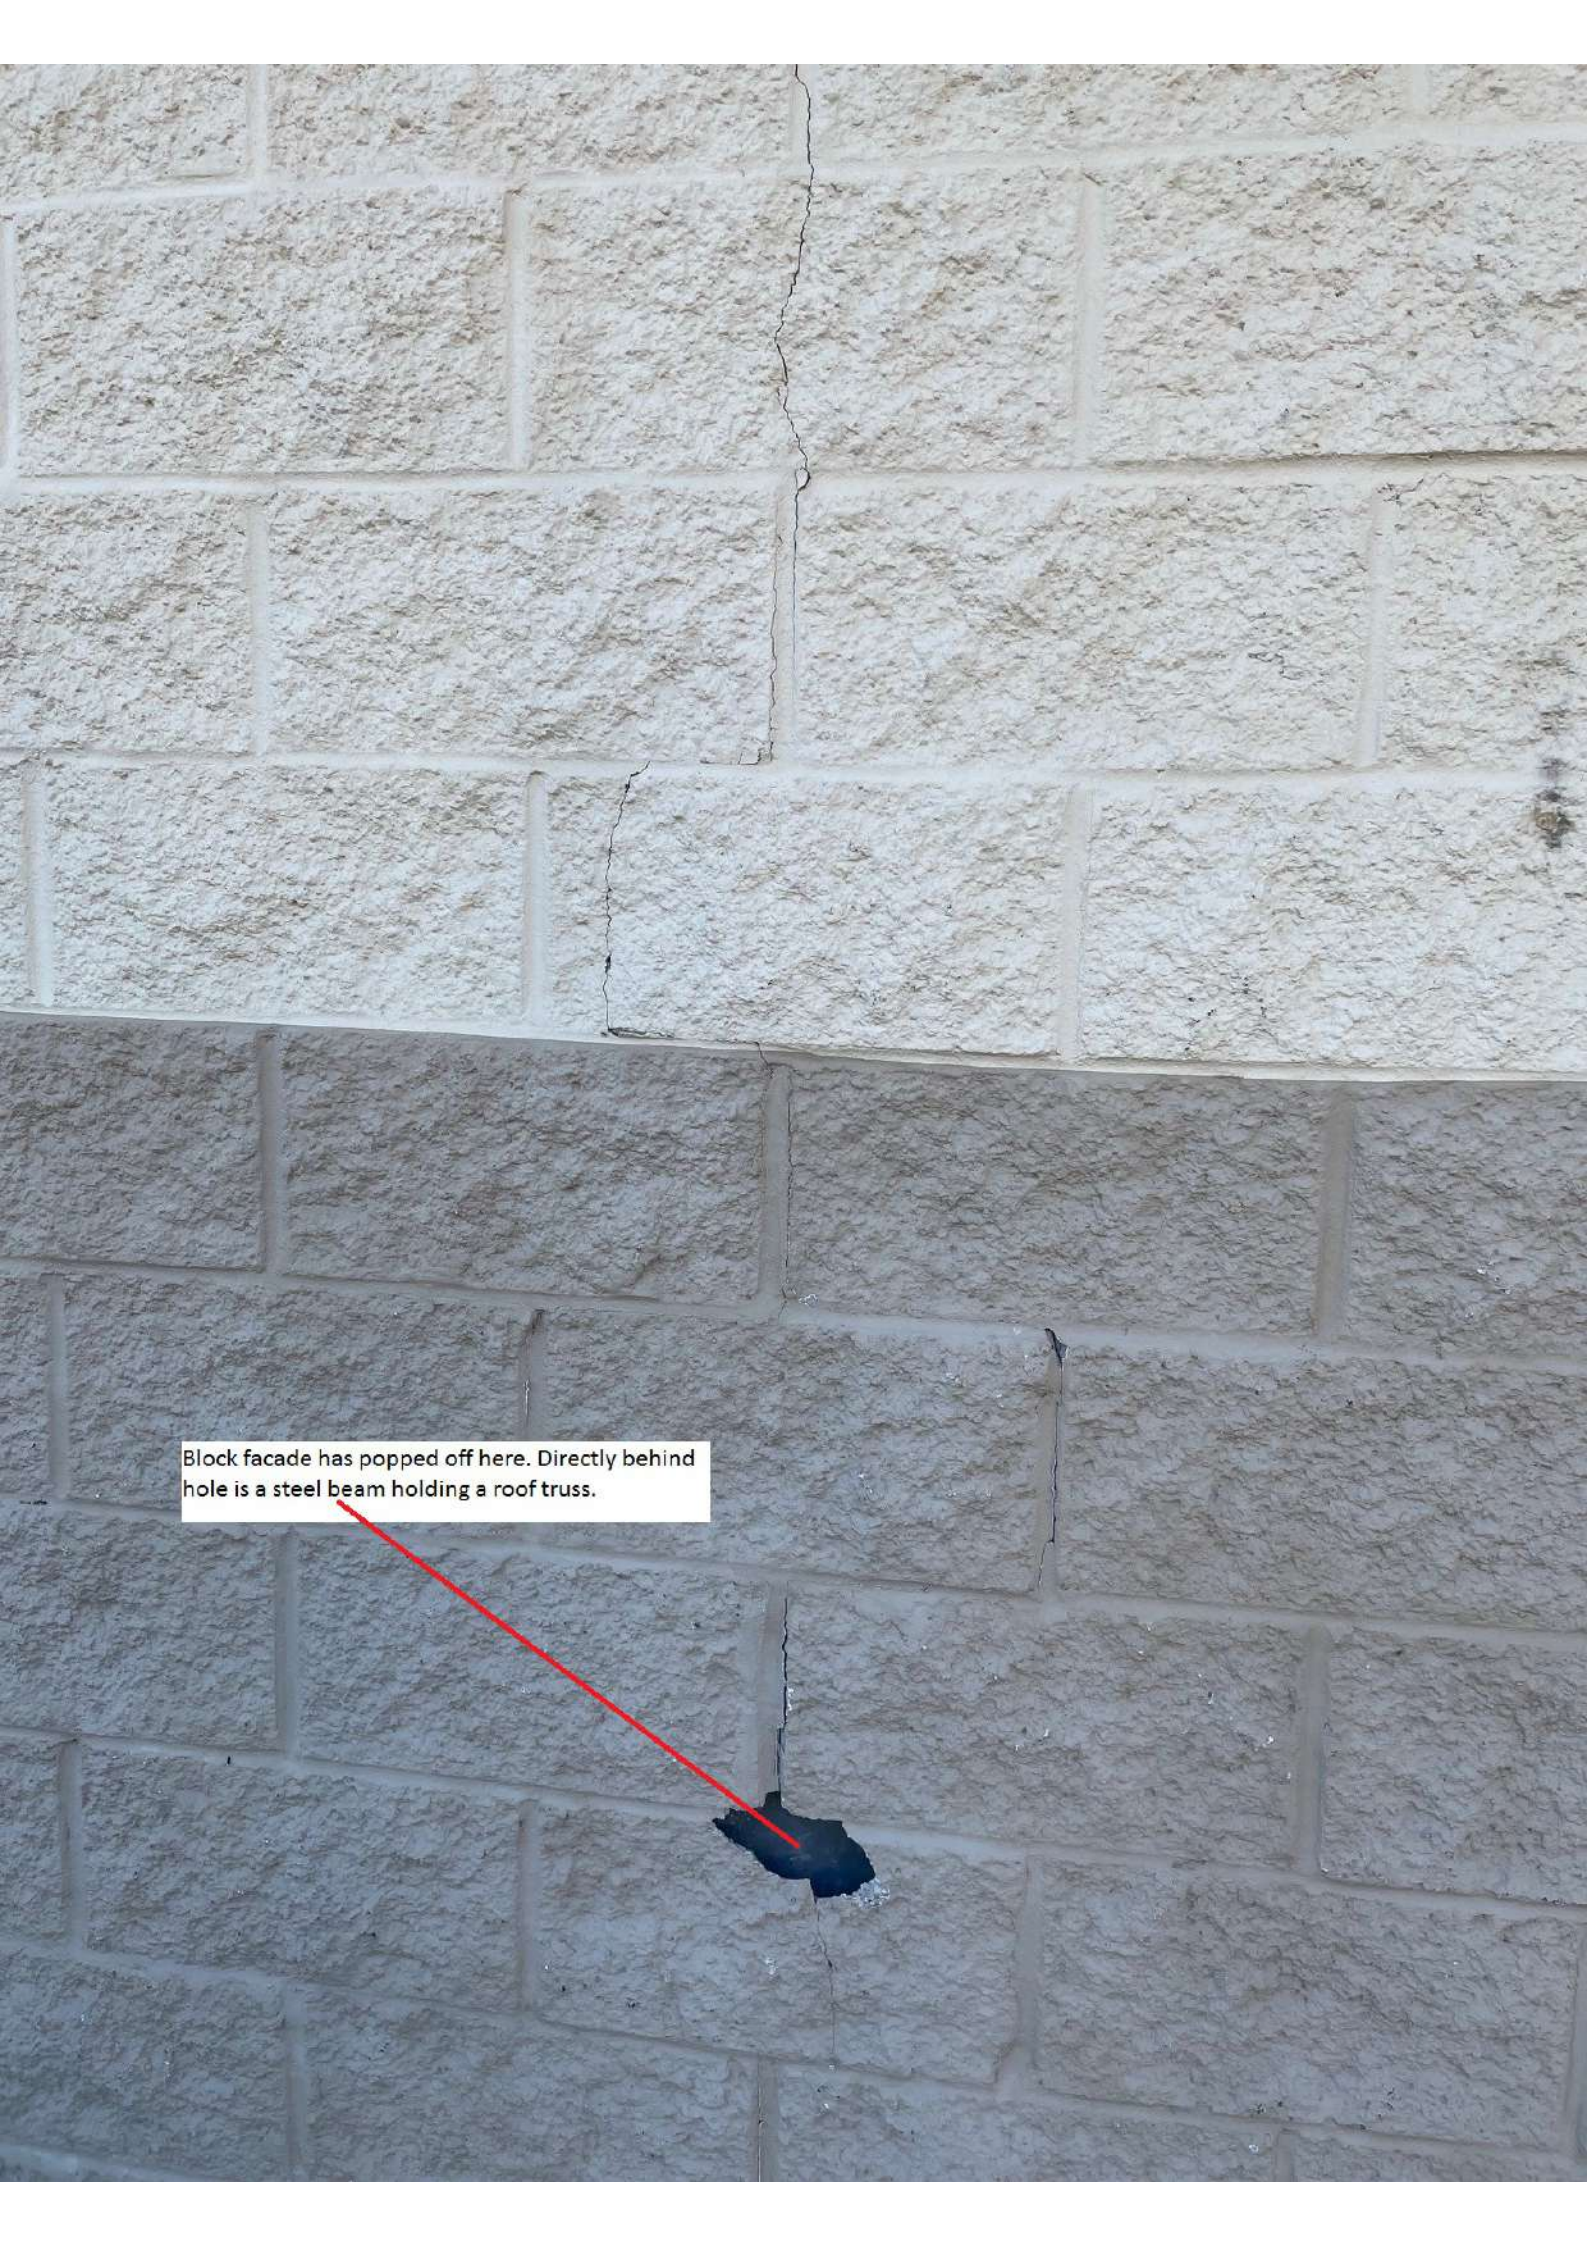
A photograph showing a close-up of a light-colored stone wall. A vertical crack runs down the wall, starting from the top and extending past the middle. In the foreground, there is a blue emergency water tap with a white handle. To the right of the wall, there is a chain-link fence supported by a metal post. The background shows a glimpse of an interior space with some furniture.

Ladies restroom is directly opposite this location.
They can see out the building while seated.

Major crack and buckling with block popping off ...and about to pop out.

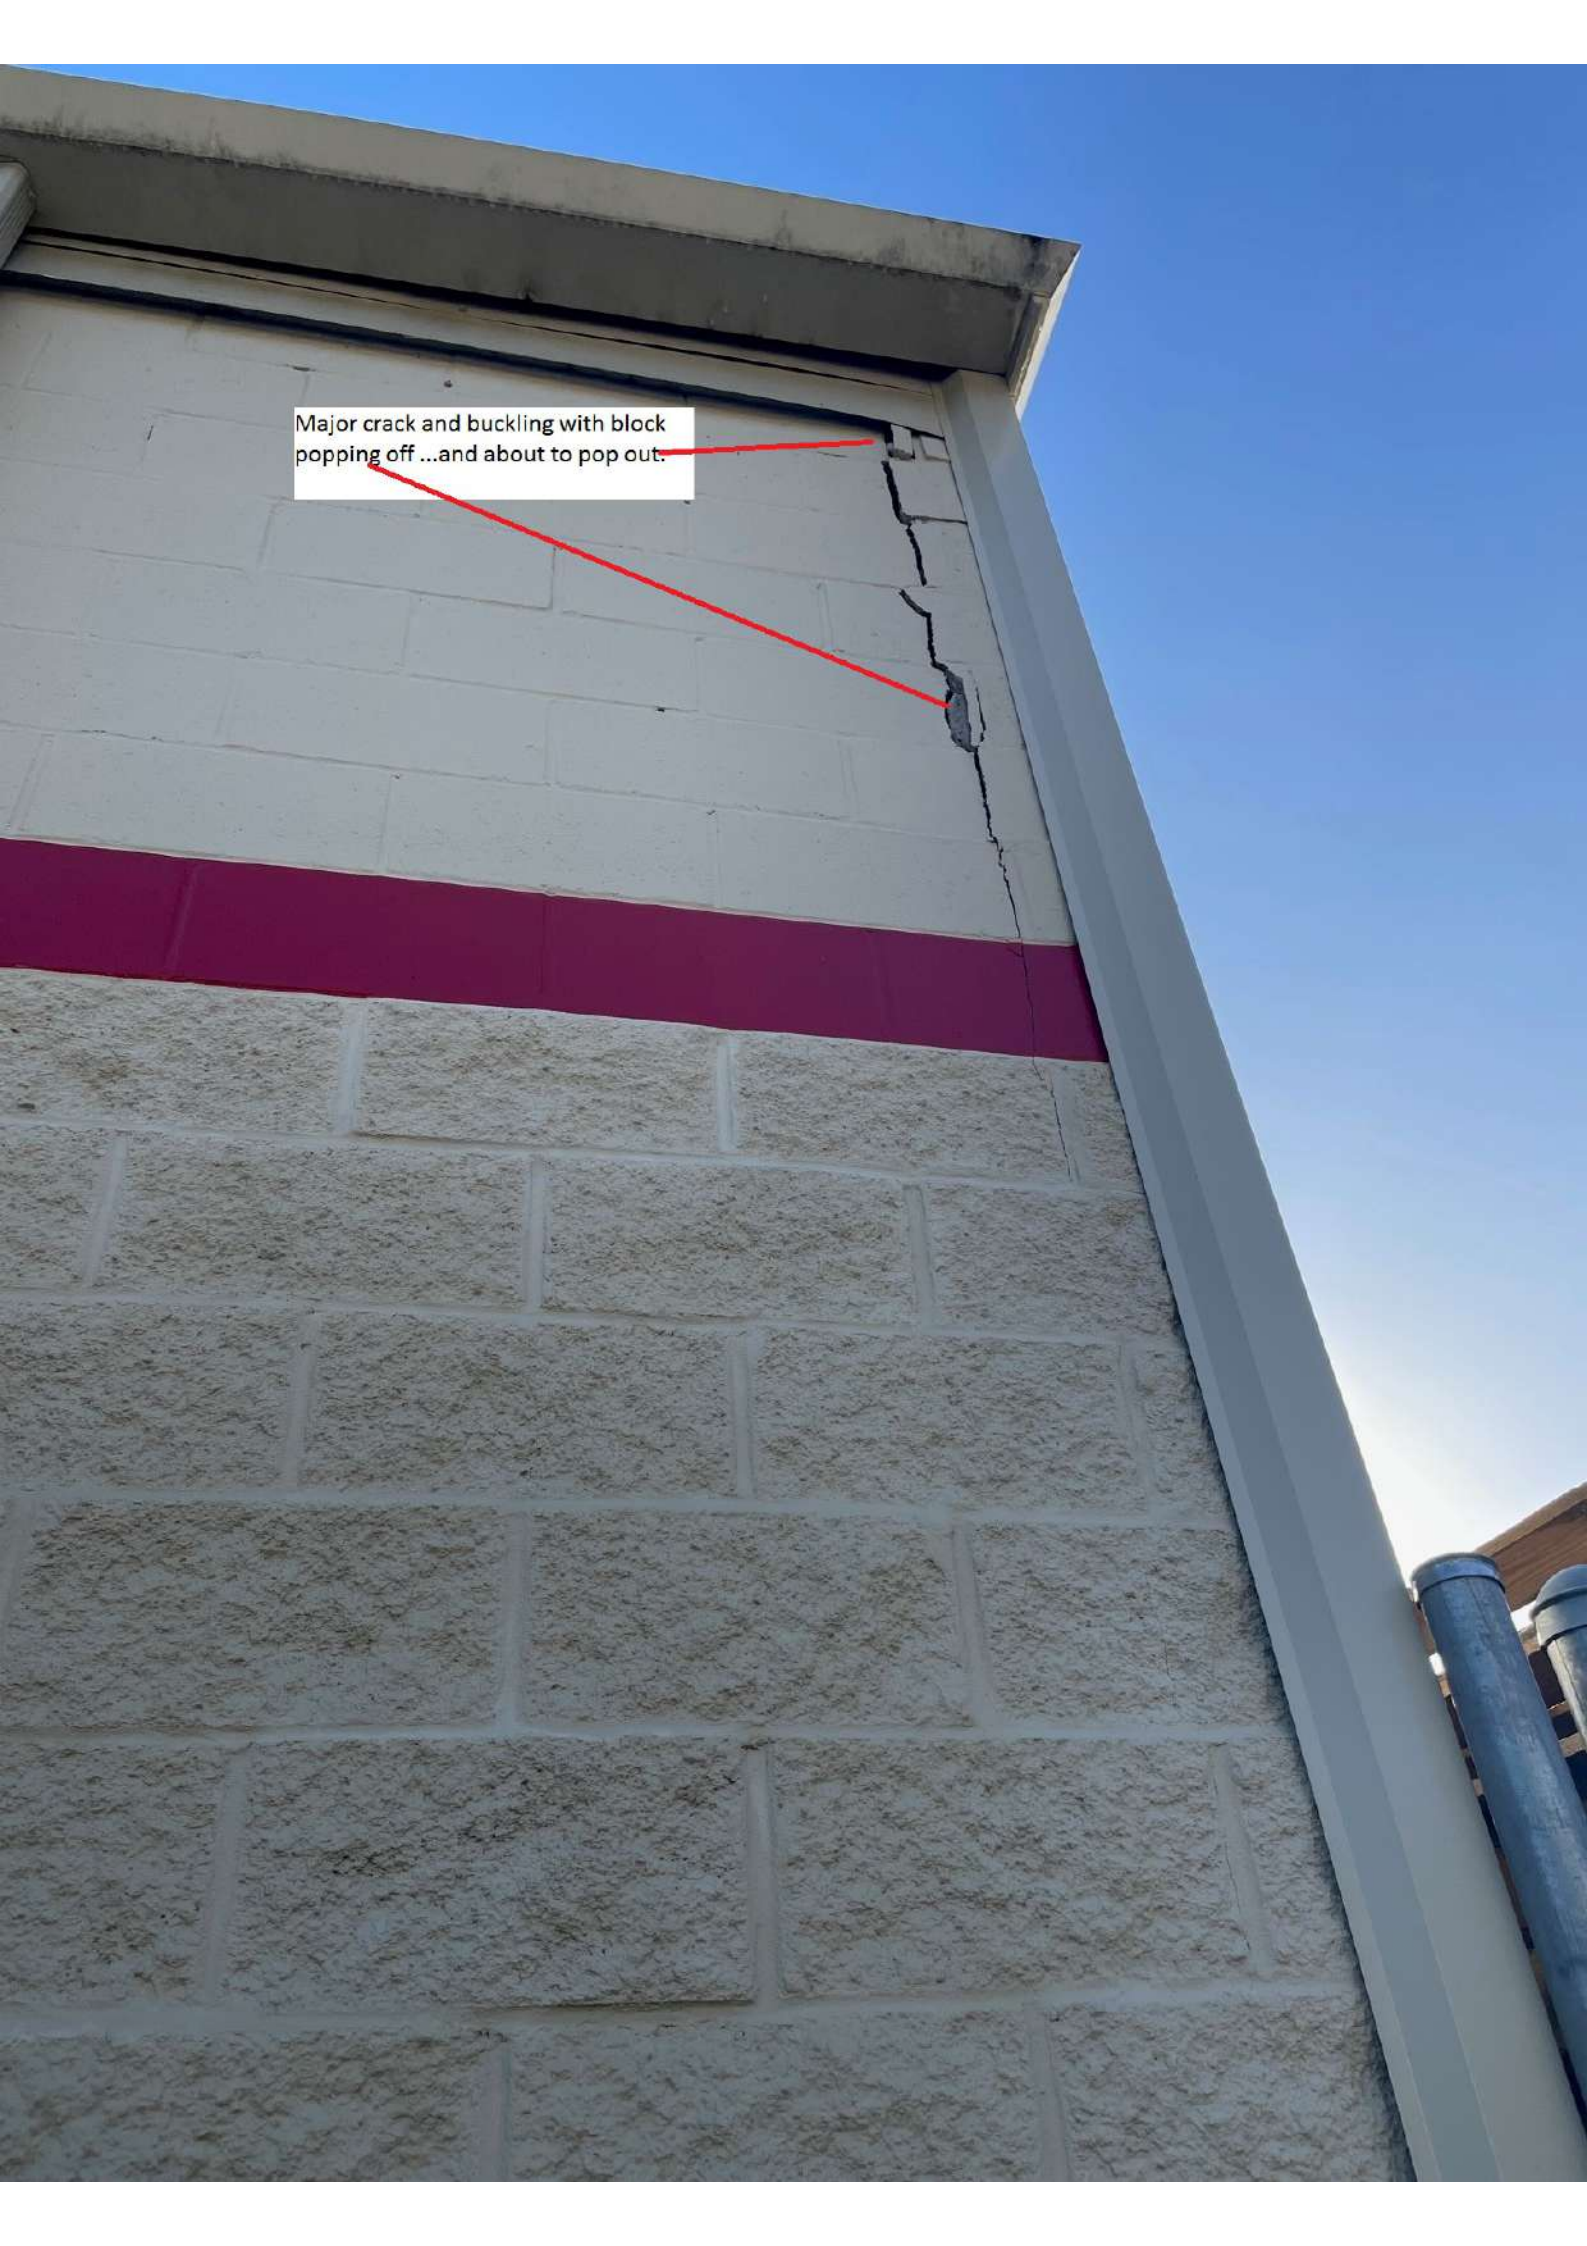
Significant buckling and full wall cracking at all locations where roof truss lands on vertical steel beam (behind block wall). I have traced red line on this photo to help see what is typical at all truss/beam intersections. Cracking from top ...all the way to the ground.
