Block piece literally popped out of wall and fell in front of me inside! Missed me by a couple feet.

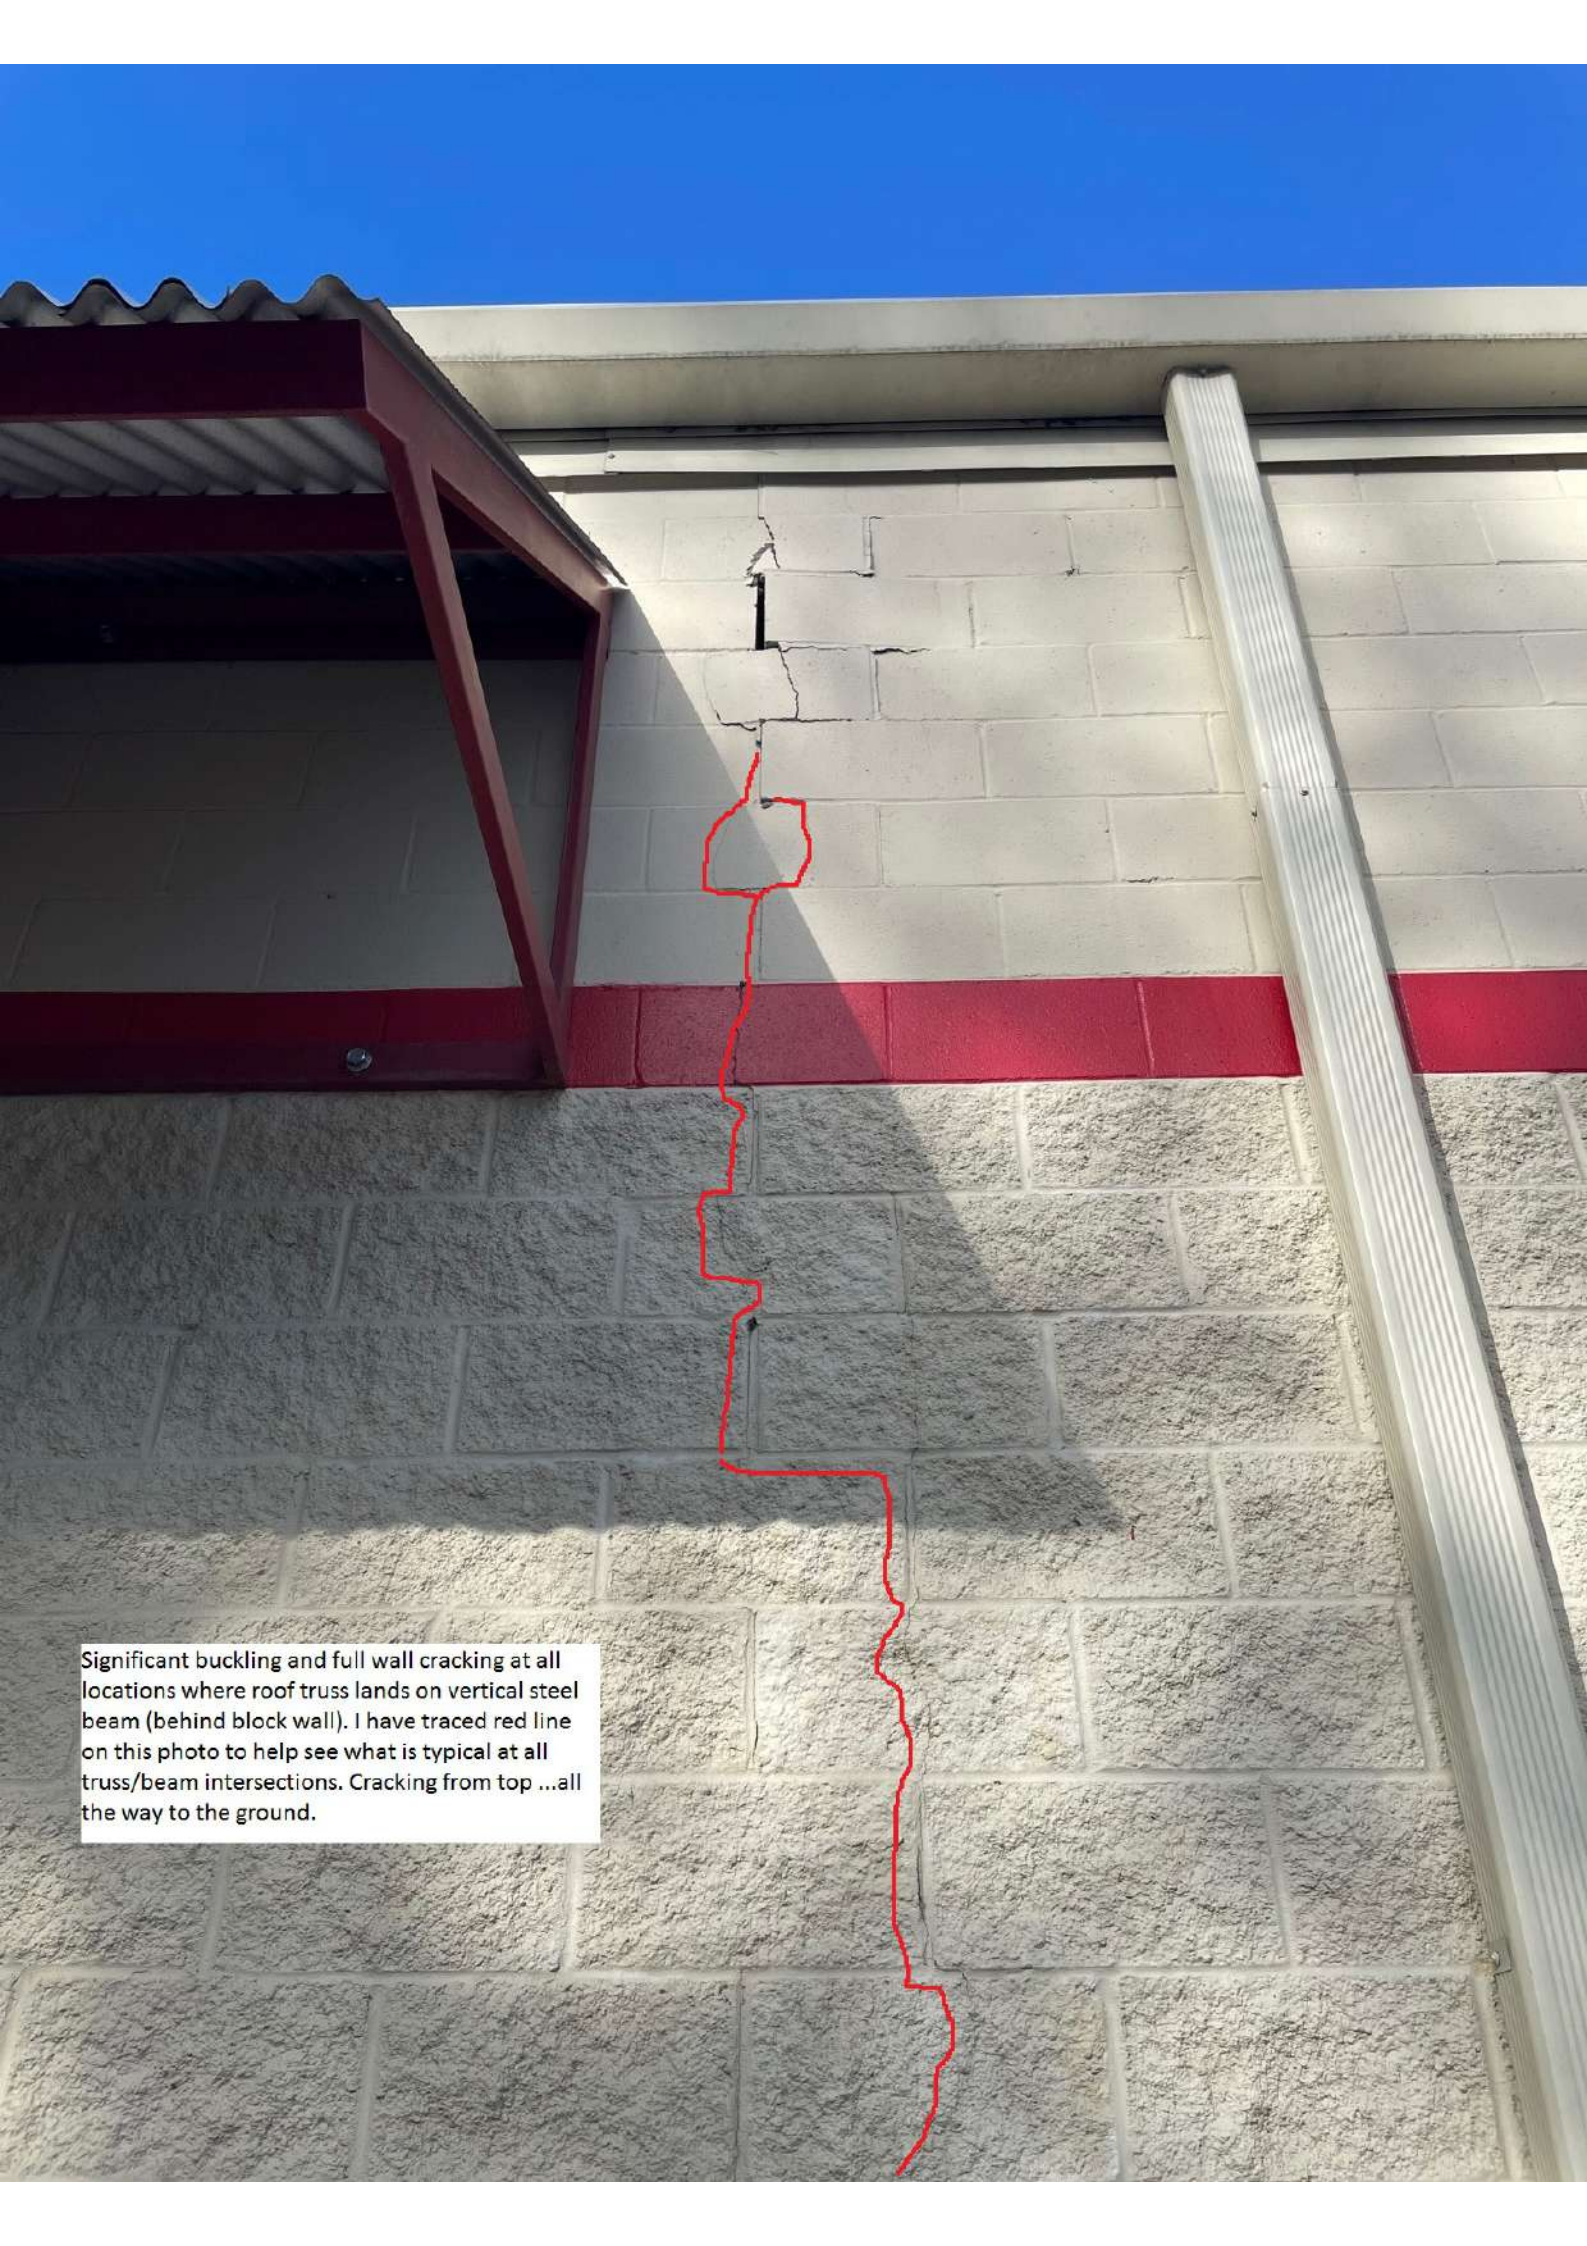
Significant buckling and full wall cracking at all locations where roof truss lands on vertical steel beam (behind block wall). I have traced red line on this photo to help see what is typical at all truss/beam intersections. Cracking from top ...all the way to the ground.
